Working Instruction

Working Instructions

MB 100 Series Installation of Dual Mass Flywheel For OM 662 Engine Only

MB 100 Series Engine Hydrostatic Lock Modification

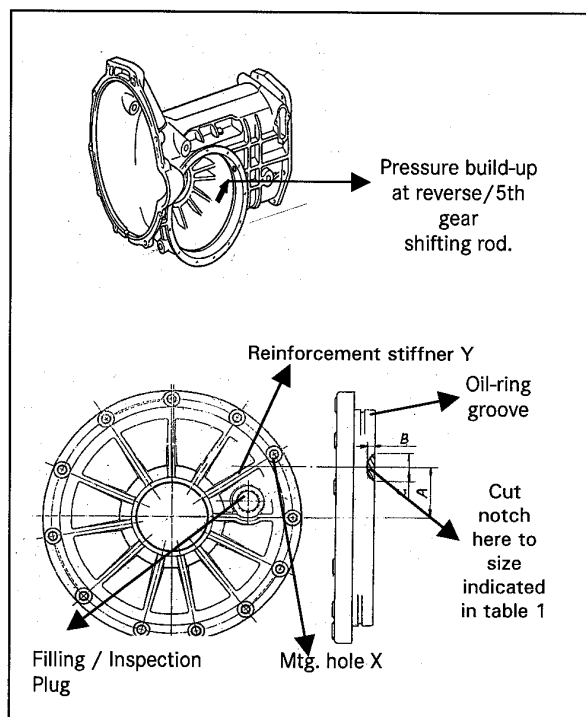
Figure 1

This is caused by transmission oil pressure at the end of the reverse/5th gear-shifting rod. The pressure builds up when it cannot drain out quickly from the chamber between the end of the shifting rod & the inner face of the differential cover.

1. First remove left side drive shaft & axle assembly as detailed in repair instructions microfilm 33-1265.
2. Drain out transmission fluid.
3. Remove differential cover
4. Remove shaft seal & O-ring.
5. Place the cover on a worktable with its internal surface pointing upwards. Locate the cover reinforcement stiffner Y that is between the filling /inspection plug & the mounting hole X.
6. Mark the notch outlines with one end aligned with stiffner Y as shown in Figure 2. The depth & width is indicated as A & B in Table 1.

8. Clean cover.
9. Renew the shaft seal & O-ring.
10. Lightly lubricate the O-ring with transmission fluid before installing the cover.
11. Clean & lightly lubricate the drive shaft & seal.
12. Install driveshaft & axle assembly as detailed in repair instruction microfilm 33-1265.
13. Fill up transmission fluid.
14. Perform road test and check for leakage and smooth gear shifting.

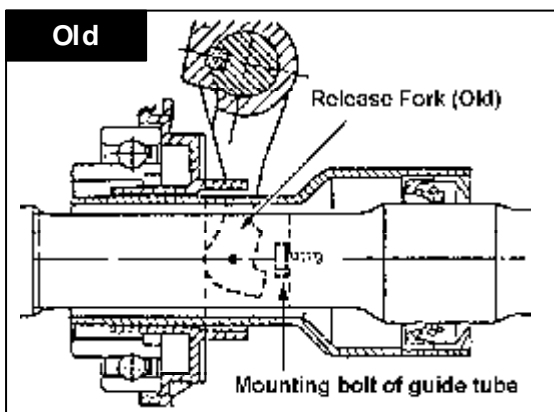
(Figure.1)

Due to the wear of the clutch disc, the clearance between clutch release fork and the head of the mounting bolt of the guide tube is reduced. Hence, there is possibility for back of clutch release fork touching the head of mounting bolt of the guide tube after releasing clutch pedal. The clutch slip problem may occur.

■ **Production remedy** : Clutch release fork was changed from January 1998, Chassis number 061110~

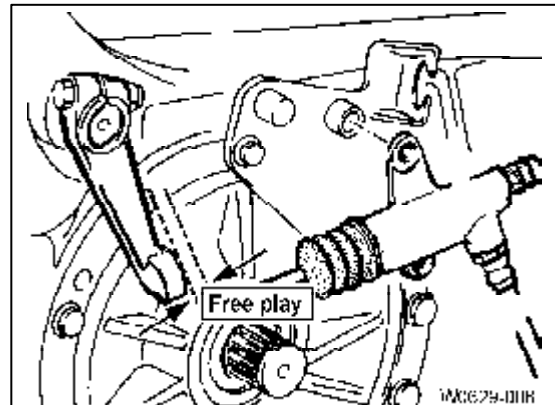
(Figure.4)

If there is no free play, release fork might touch the mounting bolt of guide tube. Then remove the transaxle. If you find out an extension at the back of arm of the release fork touching the head of mounting bolt of guide tube, the release fork should be replaced by new one. (Part no :661 293 3111)

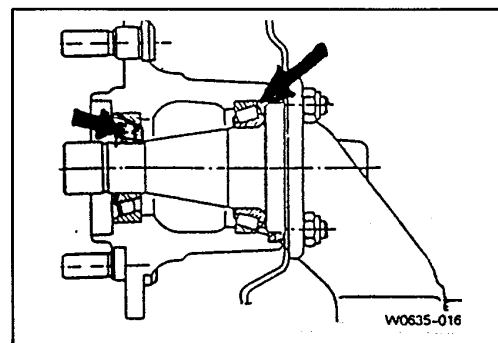
Figure 1.

Due to insufficient sealing of the rear wheel hub cup, under certain circumstances water may enter into the wheel hub and bearing damages are possible

Check inner and outer bearings for corrosion.
(see figure 1 arrows)

Service remedy : For all vehicles up to chassis serial numbers 018537 have to be checked for bearing corrosion and additional thrust washers installed.
For all vehicles up to chassis serial numbers 018537 to 036196 only the additional thrust washers have to be installed.

- If corrosion is found;**
2. Replace rear wheel bearings, refer to workshop manual 35-0100/1 to /7. 35-5300/1 to /7
Install wheel hub using additional thrust washer, refer to paragraph 3 and appendix of this Working Instruction.

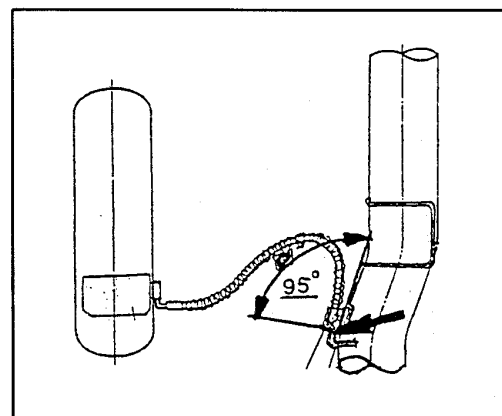
Figure 1

While driving, and turning the steering to full right or left turn, the front tires can touch the front brake hoses and wear them out. This can cause brake failure !

1. Remove both brake hoses from the right and left hand side mounting brackets at the frame.
Bend the mounting brackets to an approx. angle of 95° using a grip pliers and two self made steel plates 70x30x4 mm. (see figure 1 arrow)
Reinstall all brake hoses/pipes and tighten to 18 Nm. If necessary reroute pipes.
Air-bleed brake system, refer to the workshop manual page 42-1351/1 to /2

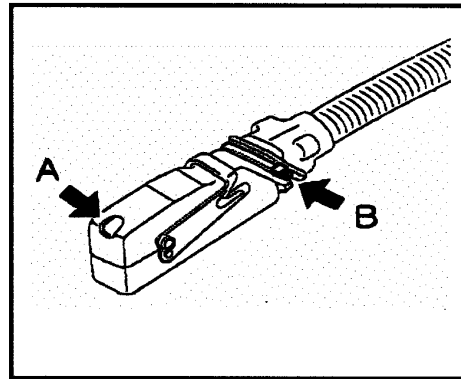
Figure 1

The MB100 Series Anti-lock braking system (ABS) may encounter failures (that is, ABS – Warning light comes 'ON') due to water entering into the ABS – Electronic Control Unit (ECU) via its wiring harness connector.

1. Disconnect battery negative terminal.
2. Remove hydraulic modulator cover.
3. Disconnect ABS-ECU wiring connector from hydraulic modulator and check connector terminal for corrosion. If corrosion is found, renew ABS wiring harness.
4. Check pins of hydraulic modulator port for corrosion. If corrosion is found, remove it using wire brush and dry compressed air duster. If any of the pins are broken due to corrosion, renew ABS hydraulic modulator.
5. Apply silicon sealant (commercially available) on the securing screw (part A, figure 1) of ABS-ECU harness connector to prevent water from entering.
6. Remove band-clip (part B, figure 1).
7. Install new band-clip on the rubber grommet and fasten tightly.
8. Connect ABS-ECU harness connector on hydraulic modulator and install hydraulic modulator cover.

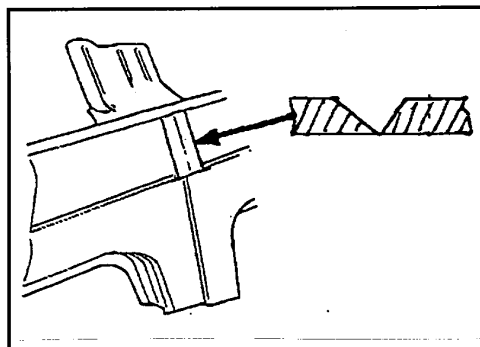
Refer to figure 1.

These repair instructions refer to cracks which develop in the area just above the sealant-filled line of the outer body side panels.

1. Open the crack at the upper C-pillar by grinding it to a "V" shape cut.

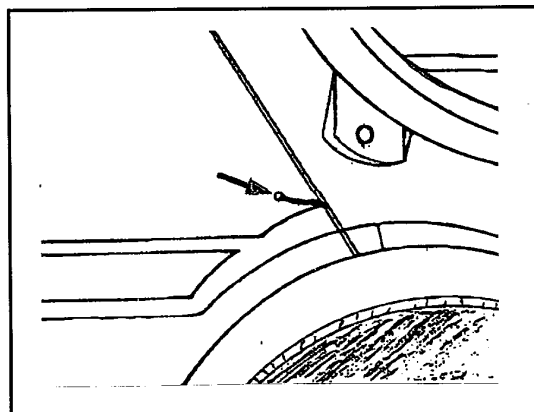
Figure 1

These repair instructions refer to cracks which develop in the area of the B-pillar panel near the front door switch.

1. Drill a $\varnothing 2.0$ mm bore at the end of the crack in order to stop the crack from developing further.

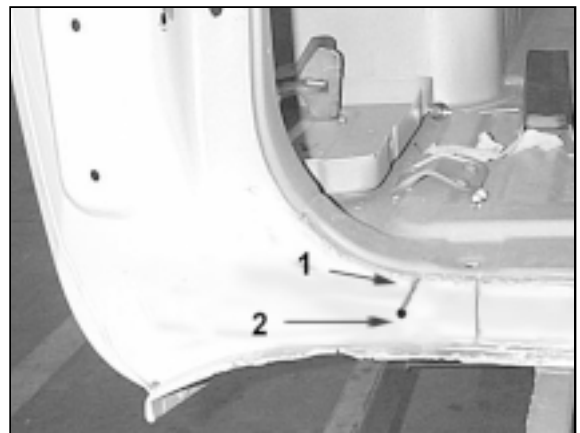
1. Crack
2. Drill hole (2.0mm)

These repair instructions refer to cracks which develop in the area of between lower D-pillar and rear end member near the tailgate.

1. Drill a 2.0mm bore at the end of the crack in order to stop the crack developing further.

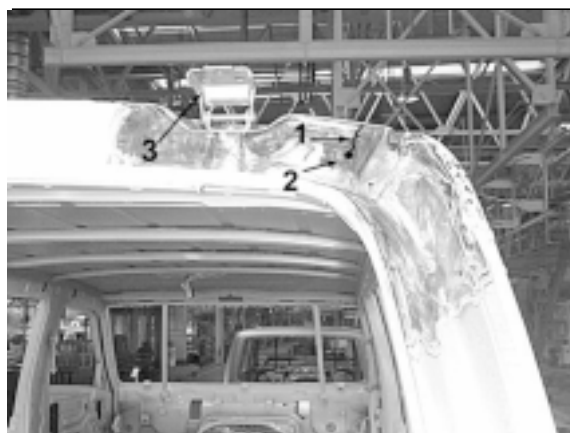
1. Crack
2. Drill hole (2.0mm)
3. Tailgate hinge

These repair instructions refer to cracks which develop in the area of between upper D-pillar and rear roof near the tailgate.

1. Drill a 2.0mm bore at the end of the crack in order to stop the crack developing further.
2. Remove tailgate hinge (3).

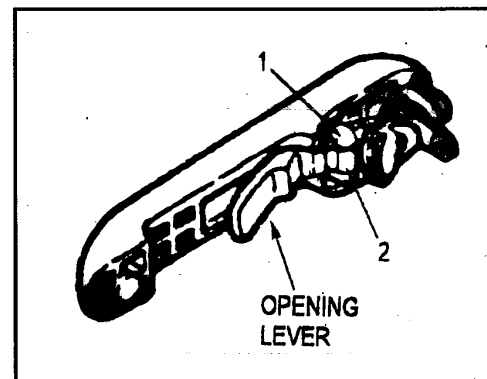
Figure1

Chassis no. 025000 to 040154 if vehicle is reported with broken door levers, all door levers have to be replaced .

1. Remove the damaged outside handle from the vehicle.
2. Remove the broken opening lever by removing the spring and lock pin.
3. Install new opening lever outside handle.
4. Install the modified o/s handle on the door.
