## SCOPRIO SC DC NEF LHD

## **SERVICE MANUAL**

**VERSION 1 – AUGUST 2006**

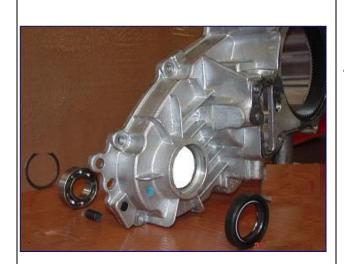
**Assembly - Case**

Lubricate bearings, oil seals, O rings, bushings and matching metal parts before assembly.

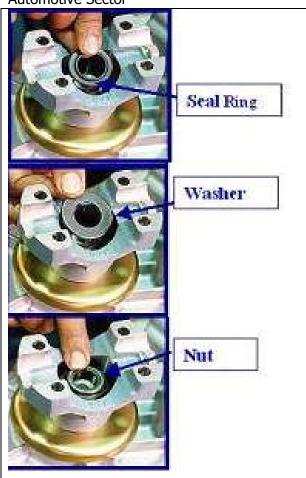
#### Assembly - Yoke

Position the output shaft in transfer case and install the end yoke assembly, seal, washer and nut.

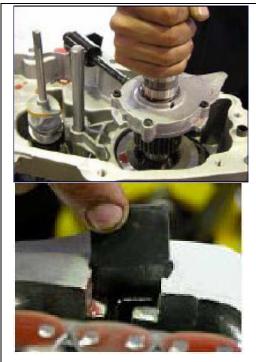
# **Assembly - Assembly Output Shaft** & Gerotor Pump

Install the output shaft spline into the reduction hub and engage the output shaft end with input shaft bearing.
