Working Instruction

Working Instructions

MB 100 Series Installation of Dual Mass Flywheel For OM 662 Engine Only

MB 100 Series Engine Hydrostatic Lock Modification

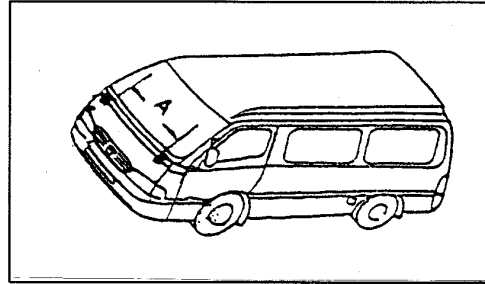
Figure 1

While driving through wet areas, the water running down from the windscreen is entering the engine/service compartment. This water can cause:

1. Install the new weather seal over the whole length between both maintenance flap hinges, onto the inner side of the flap.

See figure 1 distance "A" :1396mm

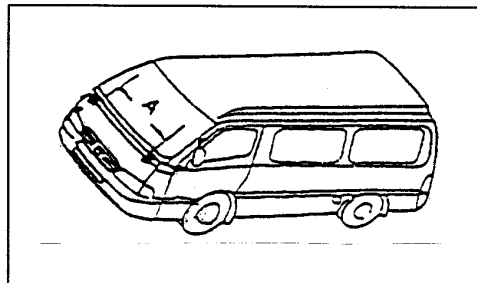
Figure 1

While driving through wet areas, the water running down from the windscreen is entering the engine/service compartment that can cause:

1. Install the new weather seal over the whole length between both maintenance flap hinges, onto the inner side of the flap.

See figure 1 distance "A" :1396mm

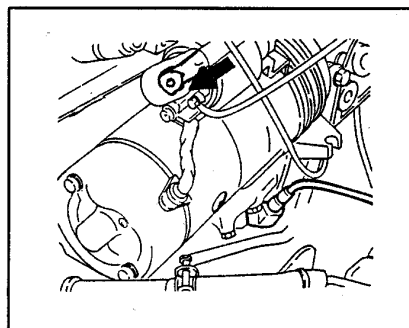
Figure 1

To prevent contact and wearing of the starter motor wires (+ 30 / 50) a rerouting has to be carried out.

1. Check gap between both wires
(see arrow figure 1, battery + 30
and 50) at starter motor.
If necessary enlarge gap by moving
wires as far as possible apart.
Retighten wires at terminals.

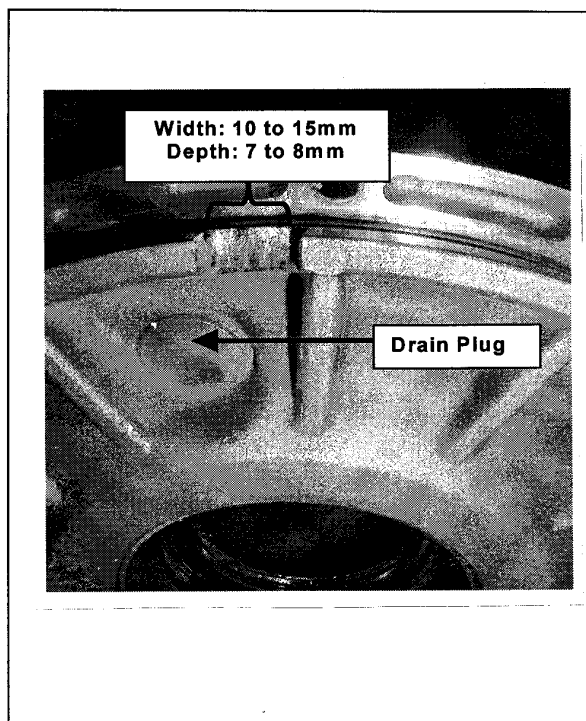
Figure 2

This is caused by transmission oil pressure at the end of the reverse/5th gear-shifting rod. The pressure builds up when it cannot drain out quickly from the chamber between the end of the shifting rod & the inner face of the differential cover.

1. First remove left side drive shaft & axle assembly as detailed in repair instructions microfilm 33-1265.
2. Drain out transmission fluid.
3. Remove differential cover
4. Remove shaft seal & O-ring.
5. Place the cover on a worktable with its internal surface pointing upwards. Locate the cover reinforcement stiffner Y that is between the filling /inspection plug & the mounting hole X.
6. Mark the notch outlines with one end aligned with stiffner Y as shown in Figure 2. The depth & width is indicated as A & B in Table 1.

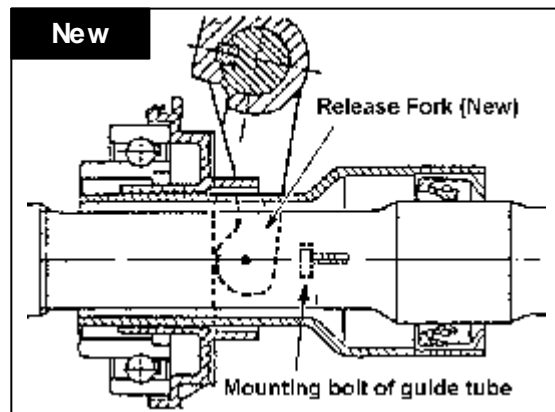
(Figure.2)

Due to the wear of the clutch disc, the clearance between clutch release fork and the head of the mounting bolt of the guide tube is reduced. Hence, there is possibility for back of clutch release fork touching the head of mounting bolt of the guide tube after releasing clutch pedal. The clutch slip problem may occur.

■ **Service remedy** : In case of premature wear of clutch disc under normal operation, clutch release fork should be checked. It is possible to check the clearance between the release fork and the mounting bolt of guide tube before remove transaxle.

If there is no free play, release fork might touch the mounting bolt of guide tube. Then remove the transaxle. If you find out an extension at the back of arm of the release fork touching the head of mounting bolt of guide tube, the release fork should be replaced by new one. (Part no :661 293 3111)

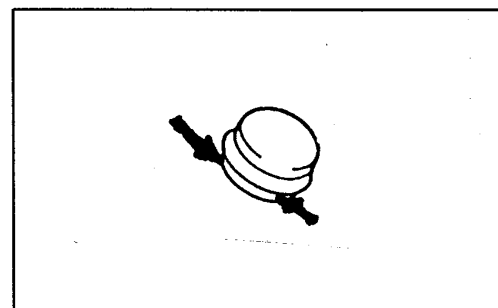
Figure 2.

Due to insufficient sealing of the rear wheel hub cup, under certain circumstances water may enter into the wheel hub and bearing damages are possible

If no corrosion is found;
Replace seal ring only if damaged.
Install wheel hub using additional thrust washer, refer to paragraph 3 and appendix of this Working Instruction.
Fill wheel hub cap with 30g GLS-2 DBL 6804.20 grease and coat hub cap sealing surface with Omnifit or Loctite 573 or Hylomar.
(see figure 2 arrows)

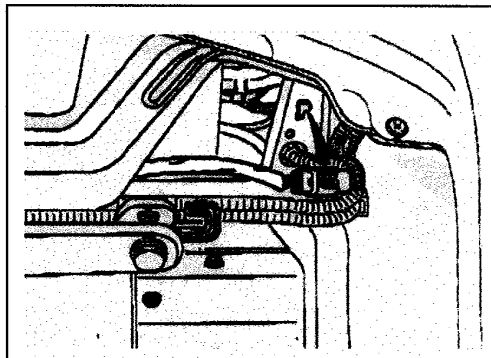
Figure 1

The MB100 Series Anti-lock braking system (ABS) may encounter failures (that is, ABS – Warning light comes 'ON') due to water entering into the ABS – Electronic Control Unit (ECU) via its wiring harness connector.

1. Disconnect battery negative terminal.
2. Remove hydraulic modulator cover.
3. Disconnect ABS-ECU wiring connector from hydraulic modulator and check connector terminal for corrosion. If corrosion is found, renew ABS wiring harness.
4. Check pins of hydraulic modulator port for corrosion. If corrosion is found, remove it using wire brush and dry compressed air duster. If any of the pins are broken due to corrosion, renew ABS hydraulic modulator.
5. Apply silicon sealant (commercially available) on the securing screw (part A, figure 1) of ABS-ECU harness connector to prevent water from entering.
6. Remove band-clip (part B, figure 1).
7. Install new band-clip on the rubber grommet and fasten tightly.
8. Connect ABS-ECU harness connector on hydraulic modulator and install hydraulic modulator cover.

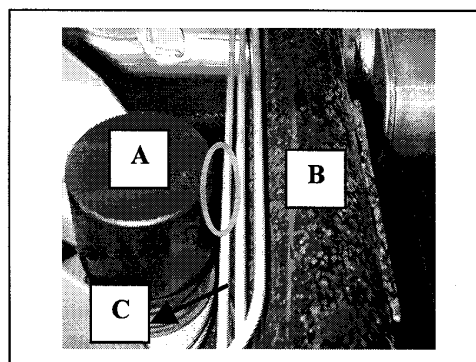
Figure 1

The insufficient clearance between the transaxle rear damper and the ABS pipe may cause vibration noises or ABS brake pipe damage. This is caused by variation and deformation of the ABS pipe during installation.

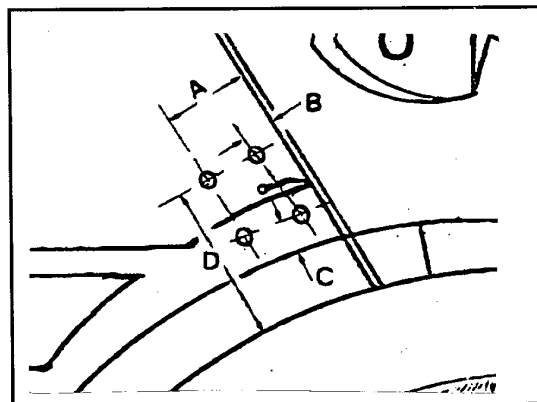
Figure 2

These repair instructions refer to cracks which develop in the area of the B-pillar panel near the front door switch.

2. According to measurements given in figure 2, mark and drill four $\varnothing 5.0$ mm bores beside the crack.

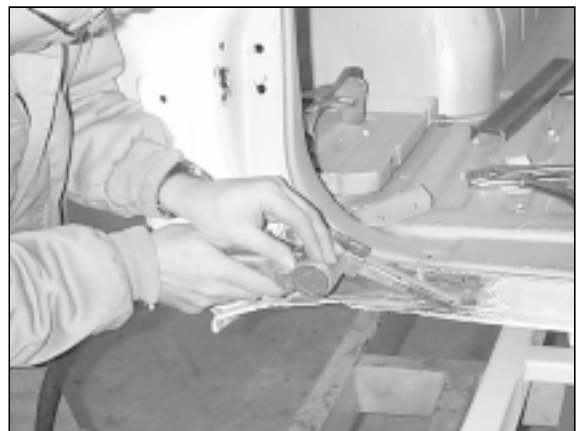
These repair instructions refer to cracks which develop in the area of between lower D-pillar and rear end member near the tailgate.

1. Crack
2. Drill hole (2.0mm)

1. Drill a 2.0mm bore at the end of the crack in order to stop the crack developing further.

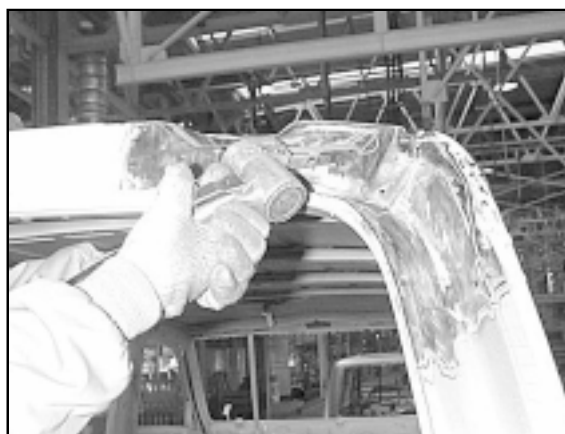
These repair instructions refer to cracks which develop in the area of between upper D-pillar and rear roof near the tailgate.

1. Crack
2. Drill hole (2.0mm)
3. Tailgate hinge

1. Drill a 2.0mm bore at the end of the crack in order to stop the crack developing further.
2. Remove tailgate hinge (3).

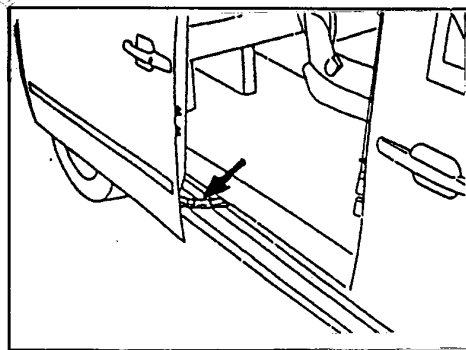
Figure 1

While opening the sliding door and slamming it to the stop, the door will no longer be flush to the body and damages at the lower part of the C-pillar are possible. To prevent these damages several modifications at the sliding door and the C -pillar have been introduced in the series production over the last months.

1. Remove old rubber stopper from the lower roller assembly bracket.
(Figure 1 arrow)

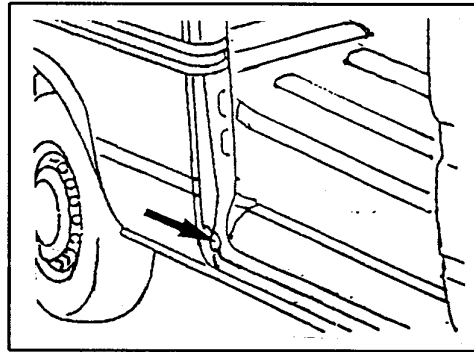
Figure 10

10. Check for damages at the C - pillar in the area of the previous lower rubber stop.

(Figure 10 arrow)

Minor damages,such as dents etc, do not need any repairs,this will be covered by the additional plastic cover,which has to be installed at all times.

Major damages,such as cracks etc,where the plastic cover does not cover the damaged area,have to be repaired as necessary.

Always carry out anti-corrosion measures

11. The supplied Plastic cover has to be installed if any damages at the C - pillar are visible.

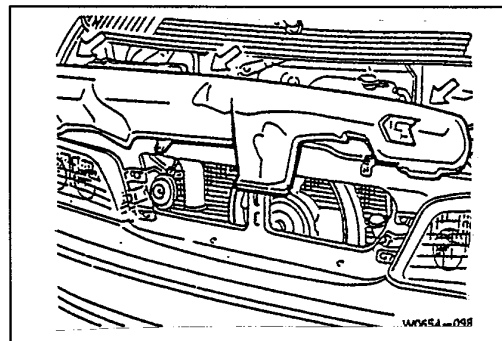
Figure 1

The windshield wiper linkage may be separated from the wiper motor during operation. This is caused by the dust cover of the windshield wiper linkage being rolled up.

1. Remove air intake duct
 2. Separate wiper linkage from wiper motor, without removing the whole wiper rod.
 3. Apply grease/ lubricate on the new dust cover.
 4. Replace the old dust cover (X) with the new improved dust cover.
-

Check and ensure that the new dust cover is not seized in the wiper linkage.
5. Install in reverse order.

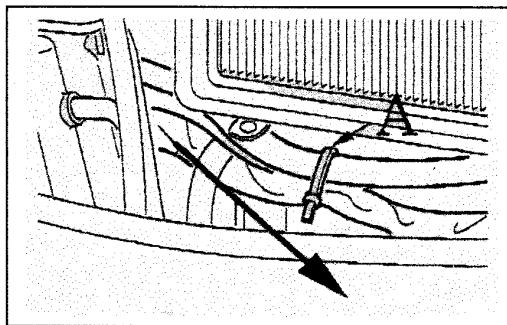
Figure 1

Note: Check ECU wiring harness is secured and not sagging near steering pump pulley.

1. Open maintenance flap fully.
2. Remove the air cleaner cover.
3. Pull out the ECU wiring harness toward front in the direction of arrow. (see figure)
4. Fasten the ECU wiring harness to the power steering reservoir hose tightly by using clip cable. (see figure)
5. Install the air cleaner cover.

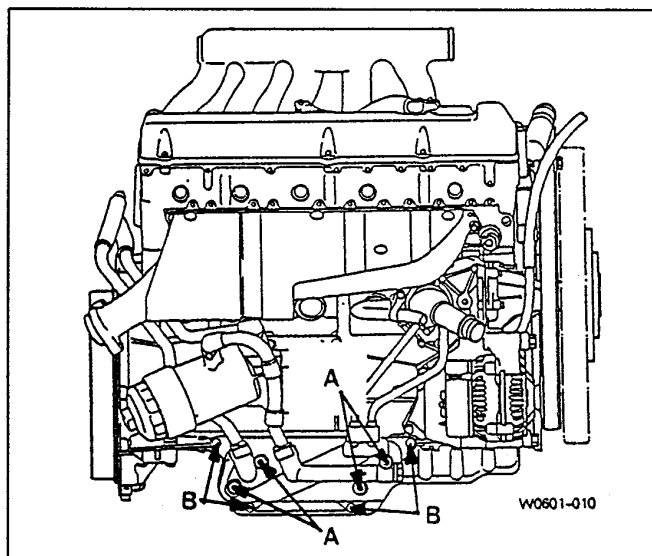
Figure 1

Due to unnecessary slackening of Oil-cooling element port nuts, (during retightening / removing of the Oil-cooler) ,internal leakages (engine oil entering the cooling system) are occurring. If the cooling element port nuts are not tightened correctly, the Oil-cooling element ports and housing will be distorted.

Under no circumstances must these four cooling element port NUTS " A " be removed or retightened !! This would lead to damages of the cooling element port gaskets and consequently to internal oil - leakages.

Always been carried out crosswise ! Mounting bolts " B " slacken one bolt slightly at the time and tighten it immediately to 25 Nm.

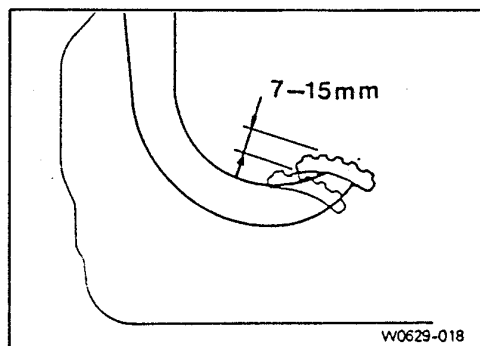
Figure 1

Nominal free play =	7 - 15 mm.
---------------------	------------

Check clutch pedal free play at the foot pad, see figure 1.

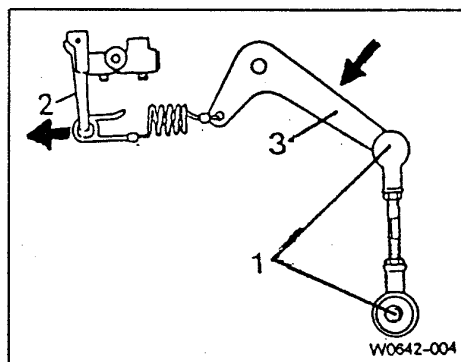
Figure 1

Due to excessive use of the Service and parking brakes (going fast down-hill with heavy loads, extremely hard use of the parking brake) ,brake juddering/shuddering can occur. This Service-bulletin should be your guideline to find the cause of the brake-juddering/shuddering as well as to assist you in solving the problem.

1. Carry out a road test to check the intensity of the brake - juddering/shuddering.
2. Disconnect connecting rod of the load conscious limiting valve (L.C.L.V.) at both ball joints (figure 1 pos. 1) and remove.Move both linkages (figure 1 pos. 2 and 3) to the arrows direction and fix levers.The L.C.L.V.valve is now in "0" position.
3. Again,carry out a road test to check the intensity of the brake - juddering/shuddering.

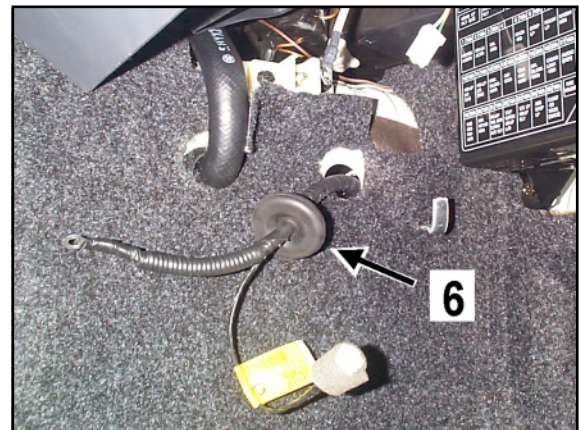
- 7 Pull alternator extension wiring and detach rubber plug (6) from engine tunnel.
8 Insert rubber plug with wiring into the engine tunnel tilted to one side.

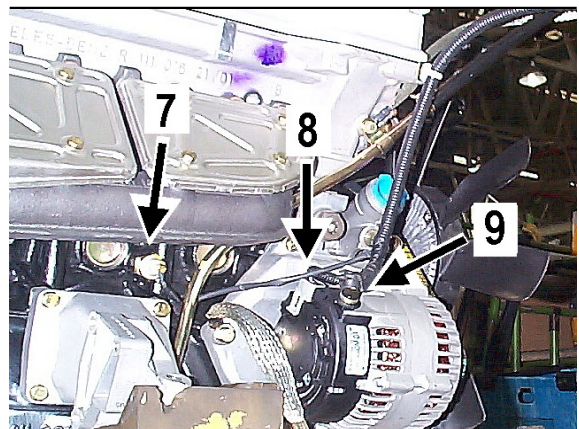
- 9 Unscrew screw of oil pressure switch (7) and ALT "B+" ring terminal (9) .
10 Disconnect ALT "D" connector (8) and replace wiring.
11 Replace alternator assembly.
(refer to Gasoline engine workshop manual 01-0007)
12 Install in the reverse order.

Check and ensure that the wiring is not interfered with exhaust manifold and cooling fan.

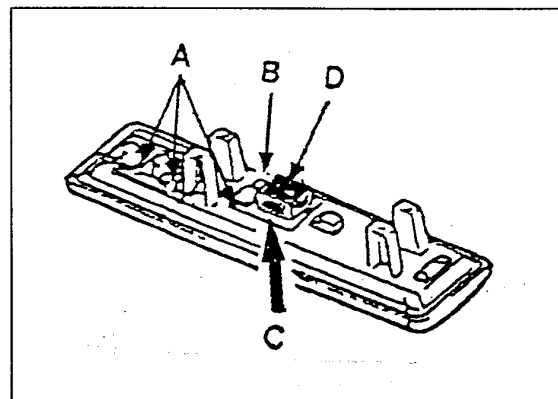
Figure 2

Due to improper routing and fixing of electrical wires inside the interior fluorescent lamp (**Manufacturer Sampoong Only**), some cases of short circuits may occur at this lamps.

1. Remove fluorescent lamp assembly and check the glass fuse 250v/2A, position B
2. Check the routing and insulation of wires near the heat sink (D), arrow position (c)
3. If necessary, insulate burned wire with insulating tape or replace wire.
4. Reroute all wires and fix them properly into the fixing slots, position (A)
5. Install a new **glass fuse, part no.661 825 43 03** if damaged and reinstall florescent lamp assembly.

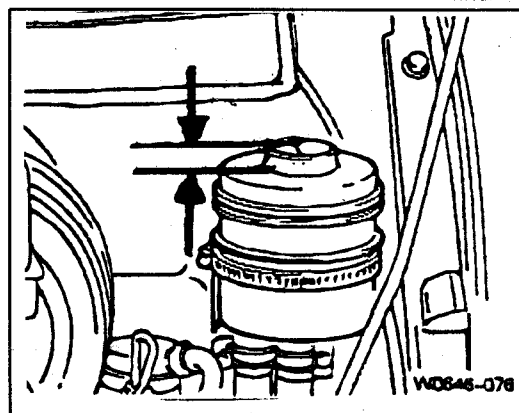
Figure 1.

While driving in heavy rain falls, the water running down the windscreen is entering into the service-compartment, directly onto the power steering oil reservoir. Some of the water may remains on top of the reservoir and is been sucked into the reservoir through the filler cap during steering operation. (Oil contaminaton, oil gets a milky colour). This can cause steering noise, stiff operation, etc.

The filler neck height has been increased by 5.0mm from 8.5 to 13.5mm

(see figure 1 arrows)

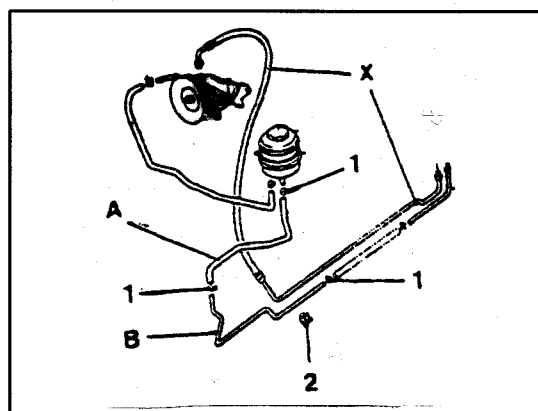
Figure 1

Due to high ambient temperatures in tropical countries the power steering oil temperature could increase excessively. This high oil temperature can cause, steering noise, oil leakages, stiff operation, etc.

1. Drain steering oil out of the system, into a suitable clean vessel, refer to workshop manual 46- 3415/1.
Remove the three hose clamps (1) of the return pipes/hoses (A and B). Remove hose pipe (A) and return (B). Check pipe clip (2) for damages, if necessary replace.
(Refer to figure 1)

Replace the old oil pressure hose (X) by the new one, spare part no. 661 997 82 82

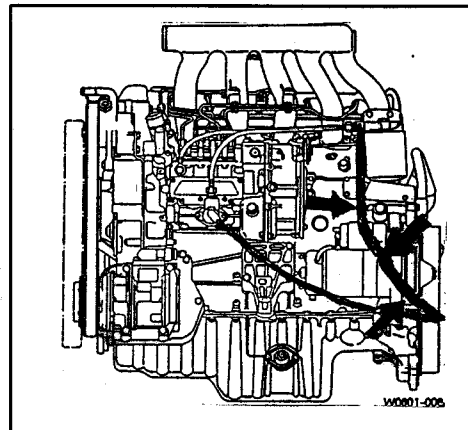
Figure 1

To prevent contact and wearing of the Fuel return line at the starter motor a rerouting has to be carried out.

1. Remove fixing clamps of fuel return line.

(Figure 1 arrows.)
