# 41TE & 42LE CODE BOOK

## **41TE & 42LE DIAGNOSTIC CODE BOOK**

### **INTRODUCTION**

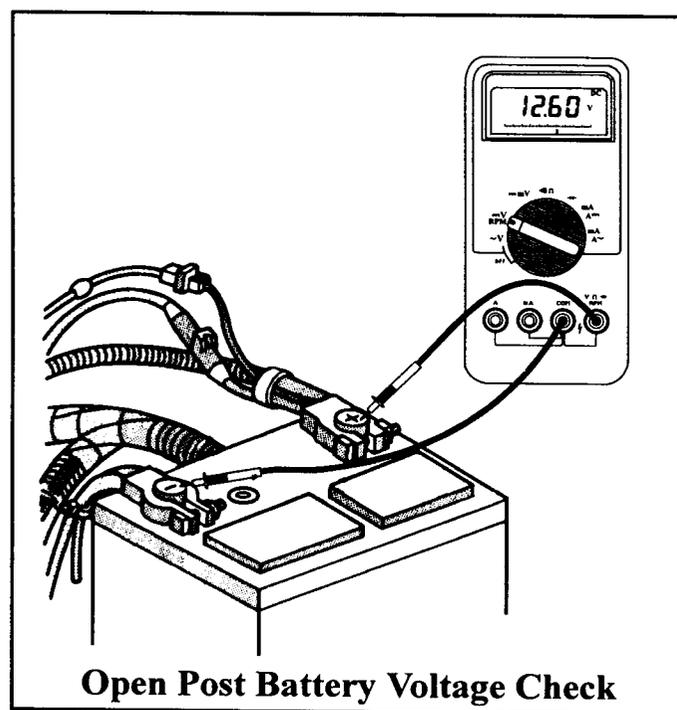
Figure 1

Using a DVOM set to DC volts, measure the open post battery voltage by placing the negative lead to the negative battery post and the positive meter lead to the positive battery post as shown in Figure 1.

A fully charged battery should measure approximately 12.60 volts. However, 12.40 volts is the average seen and is acceptable. If battery voltage is below 12.00 volts, the result may be erratic computer behaviour. Refer to the table in Figure 2 for the typical voltage values in relationship to percentage of charge.

With the volt meter connected to the battery as shown in Figure 1, start the vehicle. Turn on the headlights and blower motor to put a load on the voltage system. Approximately 13.5 to 14.4 volts should be seen (See Figure 3). If 15 volts or higher is seen, this may indicate an overcharging alternator which may result in erratic computer behaviour. This problem needs to be rectified before going to the next step.

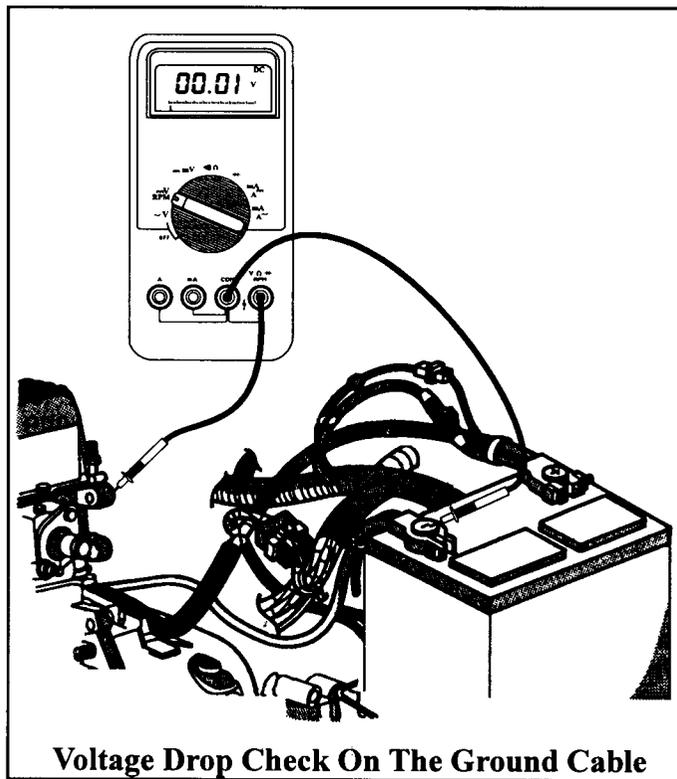
Figure 4

The next step is to perform a voltage drop test across the ground cable. This checks for corrosion or bad connections with the main ground cable itself. To do this, keep the vehicle running and turn on as many accessories as possible, i.e. headlights, AC, radio, etc. With the meter set to DC volts, place the negative lead of the meter to the negative post of the battery. Place the positive lead of the meter to either the body or engine block (See Figure 4). No more than 0.10 volts should be seen. A good ground will usually show 0.00 or 0.01 volts. If 0.20 or more is seen, clean and/or replace the main ground cable to obtain a 0.00 or 0.01 reading.

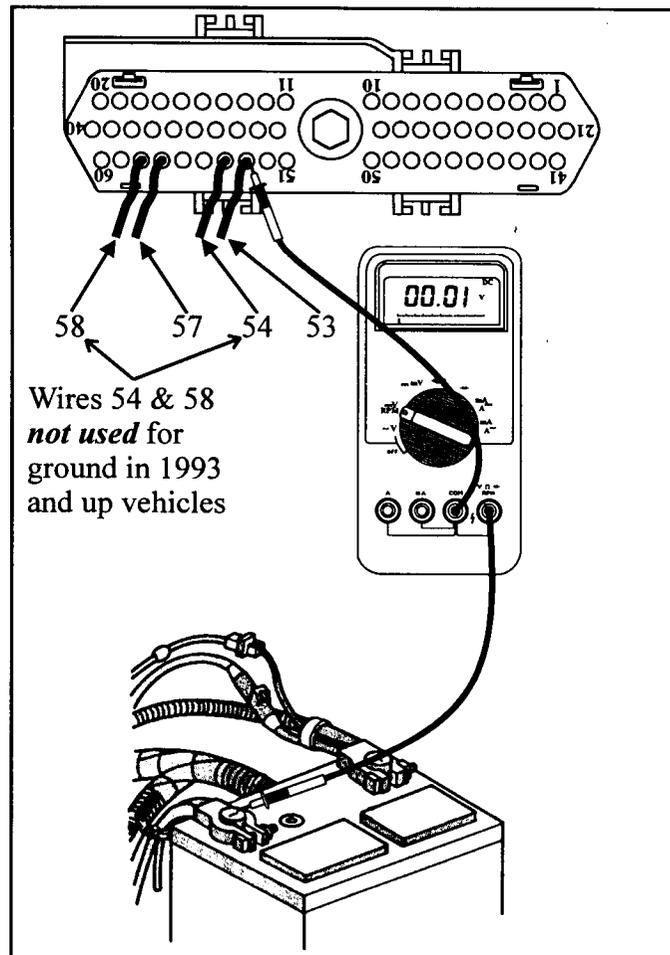
Figure 5

Locate the transaxle controller (See Pages 6 and 7). Once the controller is located, pop the plastic harness cover away from the wires going into the connector (Do not remove the center bolt). Once the cover is removed and the 60 way connector can be viewed from the wire side, locate the ground wires. 1989 to 1992 use wires 53, 54, 57 and 58 for ground (See Figure 5).

Start the vehicle and turn on several accessories. Set the meter to DC volts and place the positive lead of the meter to the negative battery post. Using the negative lead, carefully back probe each ground wire as shown in Figure 5. No more than 0.10 volts can be seen. If more than 0.10 volts is seen, that ground wire is bad.

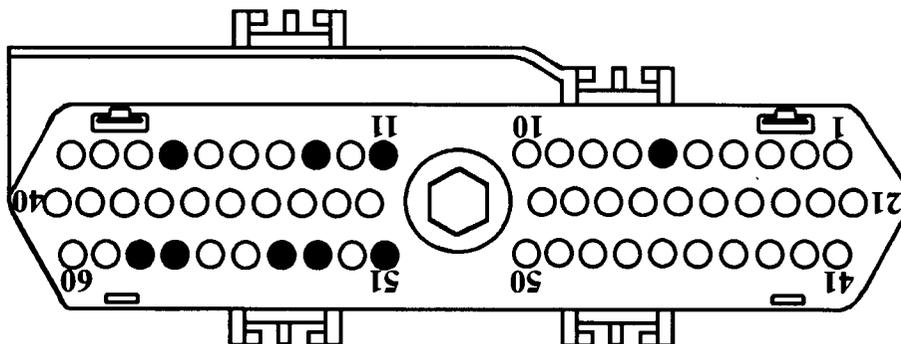
**Special Note: 1993 and later vehicles do not use terminals 54 and 58 for ground wires. Refer to Figure 6 for the controllers main ground wires per vehicle year and application.**

YEAR AND MAKE OF VEHICLE	WIRE # →	6	11	13	17	51	53	54	57	58
1989 - 1992 ALL VEHICLES							✓	✓	✓	✓
1993 DAYTONA		✓					✓		✓	
1993 DYNASTY		✓				✓	✓		✓	
1993 5th AVENUE						✓	✓		✓	
1993 IMPERIAL						✓	✓		✓	
1993 NEW YORKER						✓	✓		✓	
1993 - 1994 SHADOW		✓					✓		✓	
1993 - 1994 SUNDANCE		✓					✓		✓	
1993 - 1994 SPIRIT		✓				✓	✓		✓	
1993 - 1994 ACCLAIM		✓				✓	✓		✓	
1993 - 1994 LEBARON SEDAN		✓				✓	✓		✓	
1993 - 1995 LEBARON CONV/COUPE		✓					✓		✓	
1993 - 1995 CARAVAN (3.0L)		✓					✓		✓	
1993 - 1995 VOYAGER (3.0L)		✓					✓		✓	
1993 - 1995 GRAND CARAVAN (3.3 & 3.8L)							✓		✓	
1993 - 1995 GRAND VOYAGER (3.3 & 3.8L)							✓		✓	
1993 - 1995 TOWN & COUNTRY (3.3 & 3.8L)							✓		✓	
1995 - 1996 AVENGER & SEBRING			✓	✓	✓		✓			
1995 - 1996 CIRRUS & STRATUS						✓	✓		✓	
1995 - 1996 TALON			✓	✓	✓		✓			
1996 CARAVAN & GRAND CARAVAN						✓	✓		✓	
1996 VOYAGER & GRAND VOYAGER						✓	✓		✓	
1996 TOWN & COUNTRY						✓	✓		✓	
1996 SEBRING CONVERTIBLE				✓		✓	✓		✓

1996 BREEZE						✓	✓		✓	
1993 - 1997 ALL LH VEHICLES						✓	✓		✓

- Perform the *Preliminary Electrical Checks* outlined starting on page 3. Be sure to use the chart on page 5 when testing the controller's main ground wires.
- Inspect the 60 way controller connector for corrosion, distortion and/or cracks in the connector, pushed back or spread pin cavities. Particularly the power and ground wire pins (See Figure 12).
- If the above checks prove good, the controller will need to be replaced.

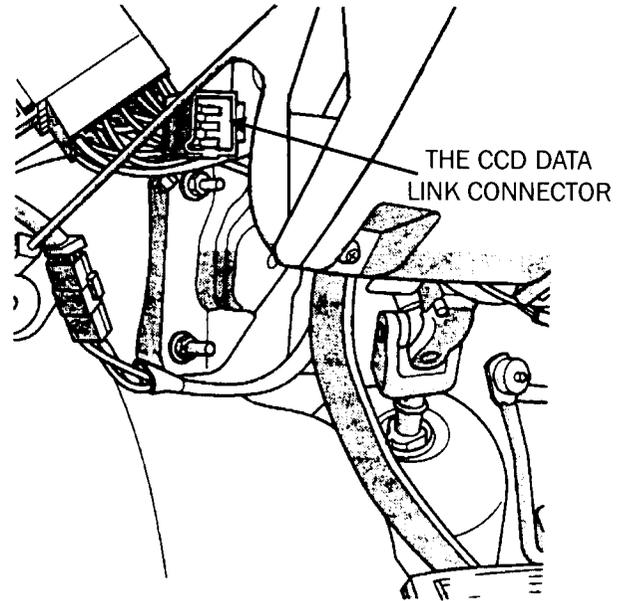
88-92 AA, AC, AY, AG, AJ  
89-95 AS  
93-95 AC, AY

Early 89 vehicles utilized only 4 pins in the light blue CCD data link connector. Midyear the connector went to the full 6 pins and remained light blue in color

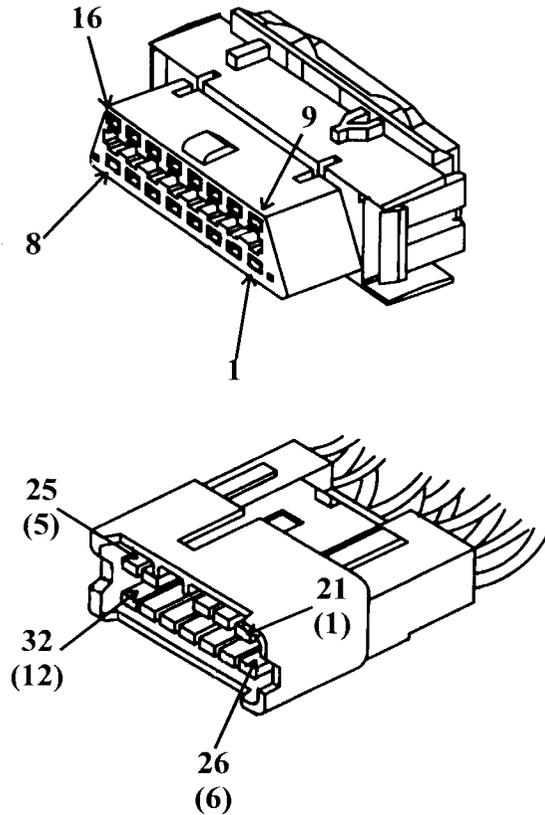
95-96 FJ22/F24S

#### 12 & 16 WAY DATA LINK TERMINAL I.D.

- 1...Diagnostic Control Signal
- 4...Ground (0.1 V or less)
- 5...Ground (0.1 V or less)
- 6...Transmission Control
- 7...SCI Transmit
- 8...Brake Control
- 9...Transmission Control Module
- 12..SRS Air Bag Control
- 13..Speed Control CTRL
- 14..Simulated VSS
- 16..Battery (12V)

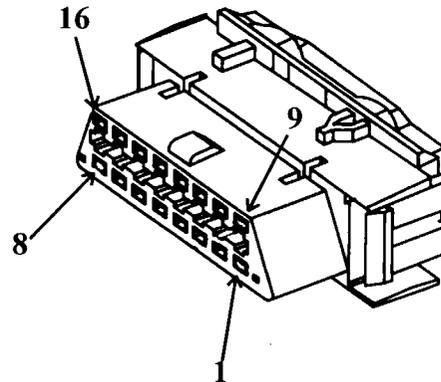
95-97 JA, JX  
96-97 NS  
96-97 LH

- 3...Serial Data Bus (+) (2.5 V)
- 4...Ground (0.1 V or less)
- 5...Ground (0.1 V or less)
- 6...SCI Receive
- 7...SCI Transmit/ISO 9141K
- 11..Serial Data Bus (-) (2.5 V)
- 14..TCM SCI Receive (96-97 JA, JX, NS)
- 16..Battery (12V)

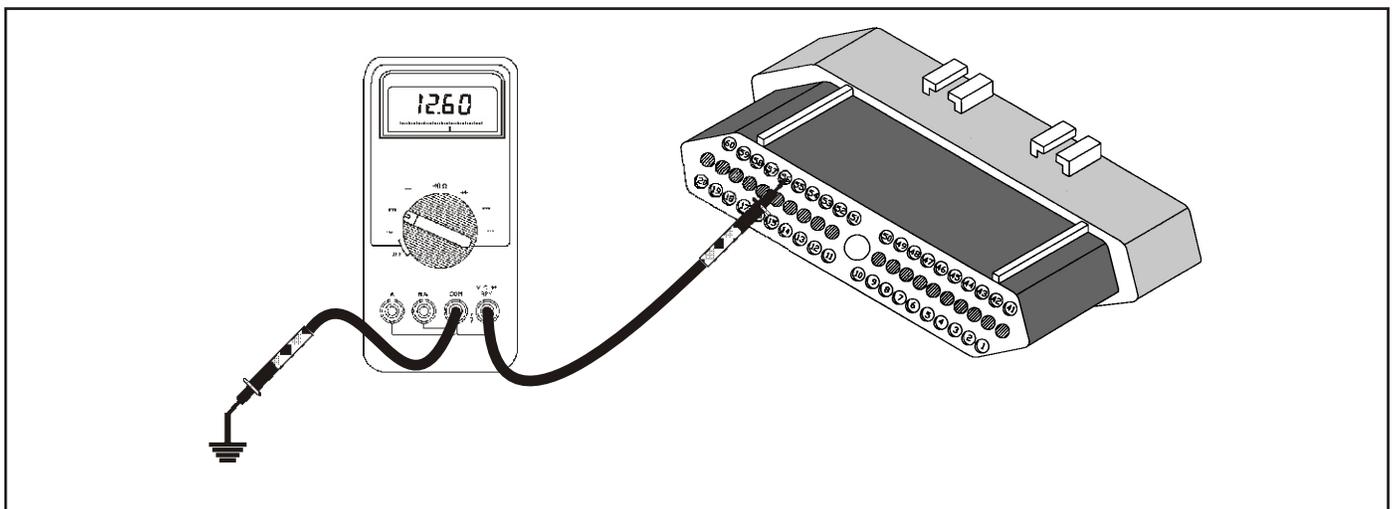
Figure 7

1. Locate the TCM (See pages 6 and 7) and carefully unplug the 60 way connector.
2. With a DVOM set to DC volts, check for battery voltage on the J11 circuit at pin 56 as shown in Figure 7. If battery voltage is seen, go to the next step. If battery voltage is not seen, go to step 4.

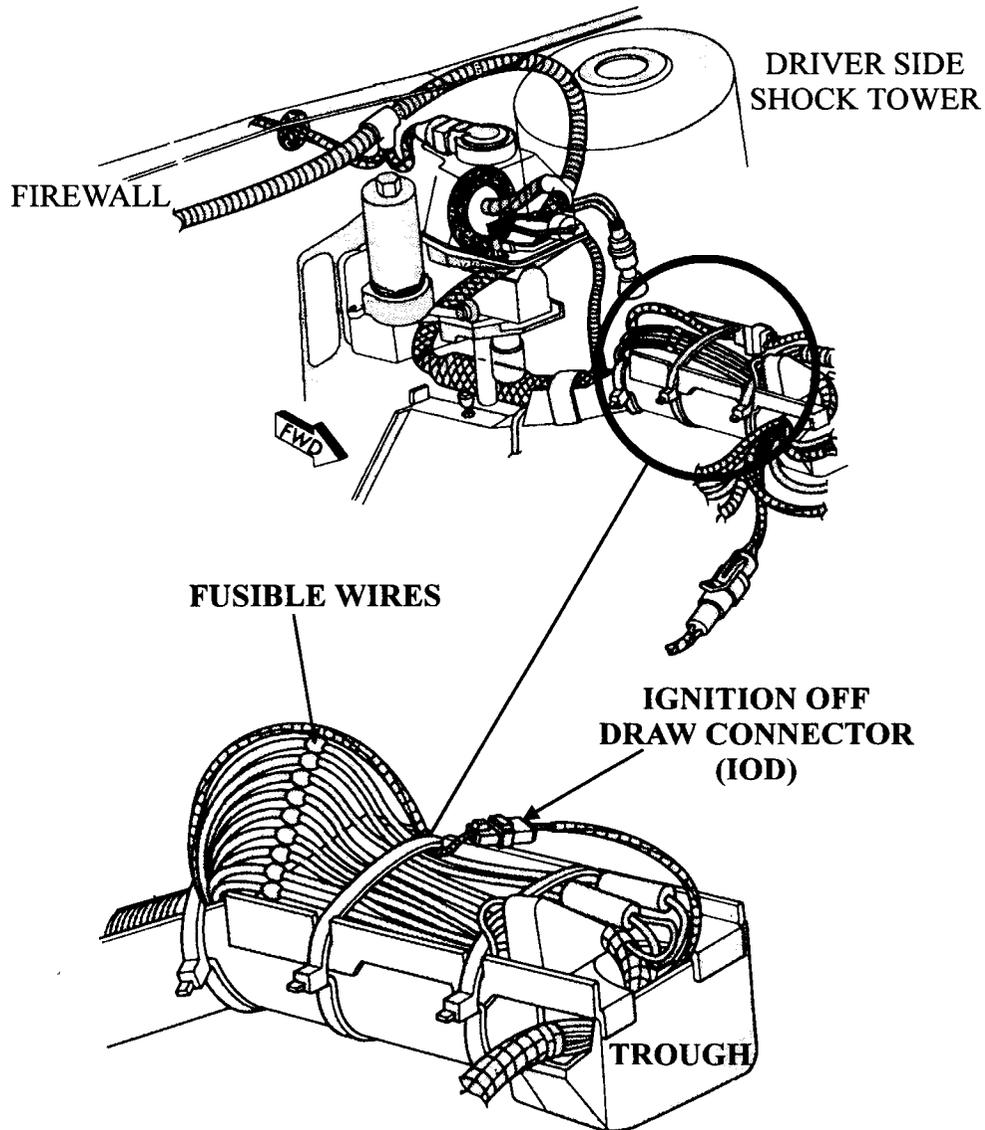
4. If battery voltage is not seen, a fuse or a fusible wire may be blown. Fusible wires are color coded and can usually be found below and between the battery and driver side spring tower as shown in Figure 8. Refer to Figures 9 and 10 for fusible wire color or fuse number.

Typical view of both fusible link and IOD connector location. Not all vehicles have an IOD connector or a trough that the fusible links sit into. All fusible links are located behind and below the battery tray towards the driver side shock tower.

- With the connector unplugged, check cavity # 56 for battery voltage (See Figure 13). While checking for voltage, wiggle the main wiring from the battery to the controller. If battery voltage is lost during this wiggle test, a bad fusible link or a break in the wire has occurred (See Figure 8 for fusible wire location). In Figures 9 and 10 a Fusible Wire Chart can be found showing vehicle application and fusible wire color. In some applications a typical fuse is used and is noted. If a broken wire is in the harness, a continuity check is required at different points across the wire to locate the break.

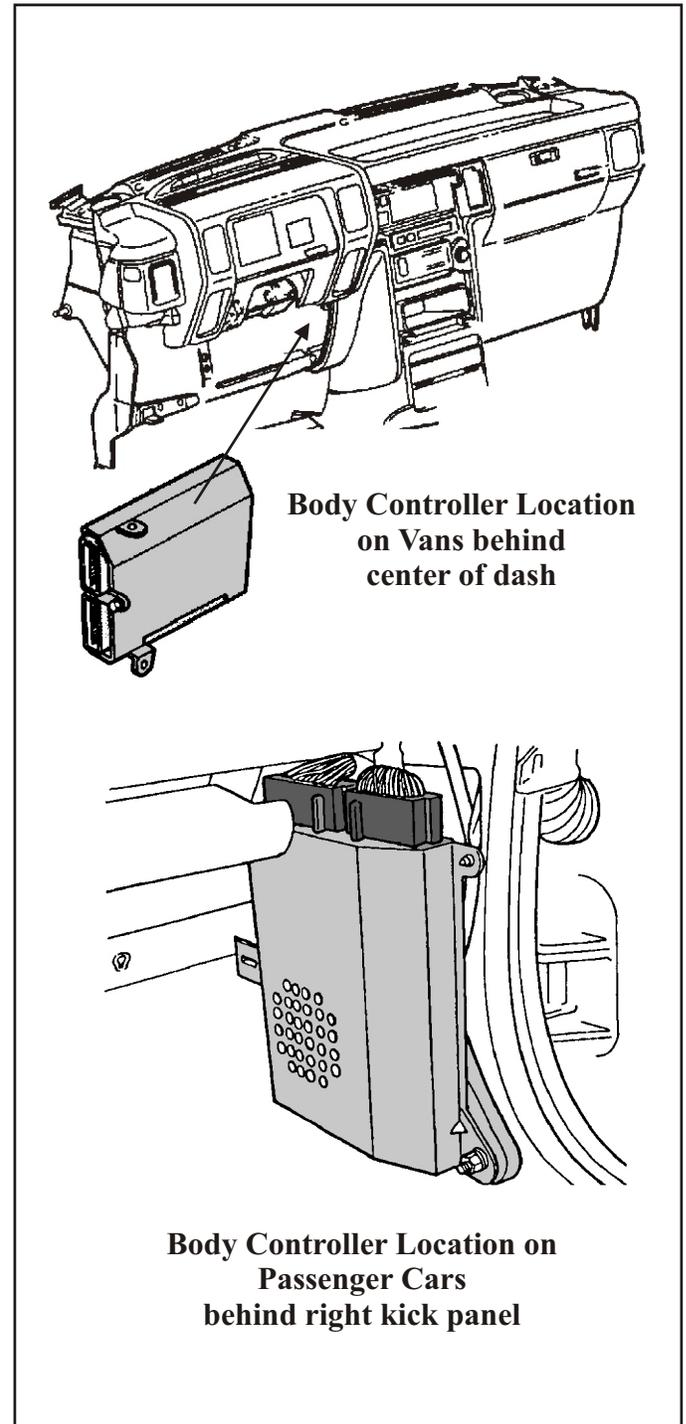
The body controllers in vans is located behind the center of the dash left of the steering column. Passenger cars have the body controller located behind the passenger side kick panel (See Figure 11).

If the vehicle is equipped with a body computer (See Figure 11 for body controller location), unplug and clean its connector. After plugging it back in, verify scanner communication. If a BUS failure still remains, the body computer may need to be replaced. There is not a sure method in determining which controller is causing the BUS failure. When a vehicle is not equipped with a body computer, it is safe to determine that the TCM is bad causing the concern. If it is equipped with a body computer, it could be either controller. However, the body computer would be the most likely cause of the problem. The reason is that the body controller is the computer controlling the voltage in the BUS system. So if there is a BUS failure, the most likely candidate would be the controller responsible for putting the voltage into the BUS system.

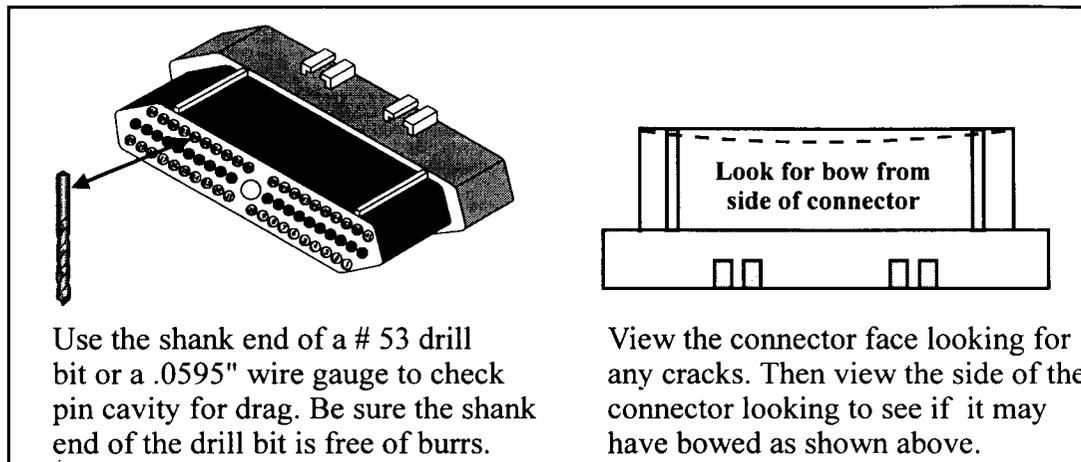
Figure 12

- Unplug the 60 way connector and check for pin drag at the # 56 cavity using the shank end of a # 53 drill bit or .0595" wire gauge as shown in Figure 12. Repair if necessary.

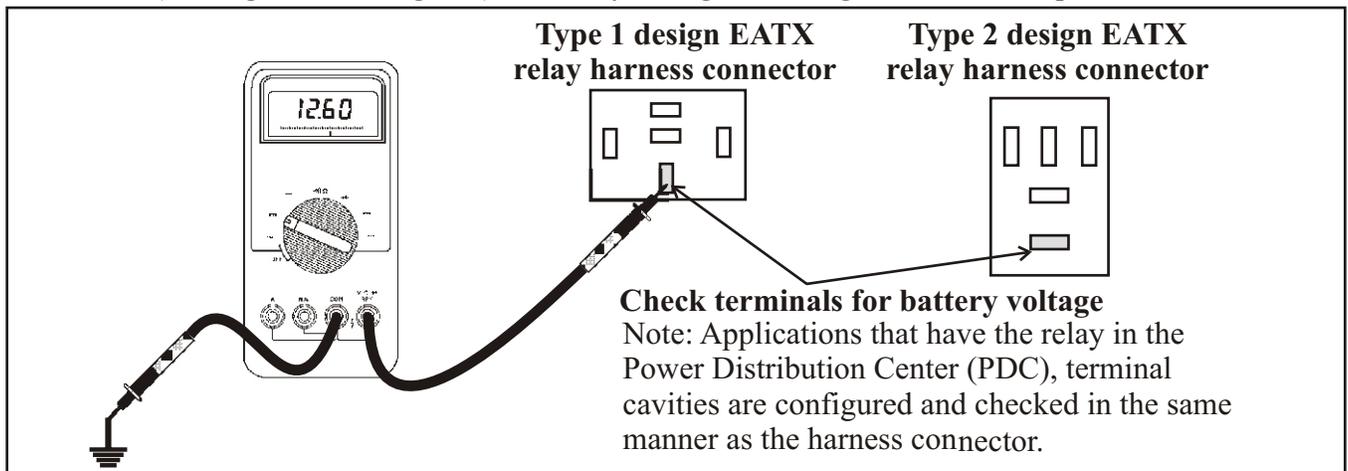
Figure 15

- Replace the EATX relay, refer to pages 8 through 10 for location. If the problem remains, move to the next step. **Tip:** *The reverse lamp relay and EATX relay are the same and can be interchanged. As a quick check, swap the relays. You must keep the selector lever in Reverse for 5 to 10 minutes. If the lights go out, the relay is bad or the contacts need to be cleaned. If the transaxle system works well while the reverse lights exhibits a problem, replace the relay.*
- Unplug the EATX relay. Using a volt meter set to DC volts, verify that direct battery feed is present in the connector as shown in Figure 15. If battery voltage is not seen, a severed wire, a blown fuse or fusible wire may need to be repaired (See Figures 8 through 10). If battery voltage is seen, go to the next step.

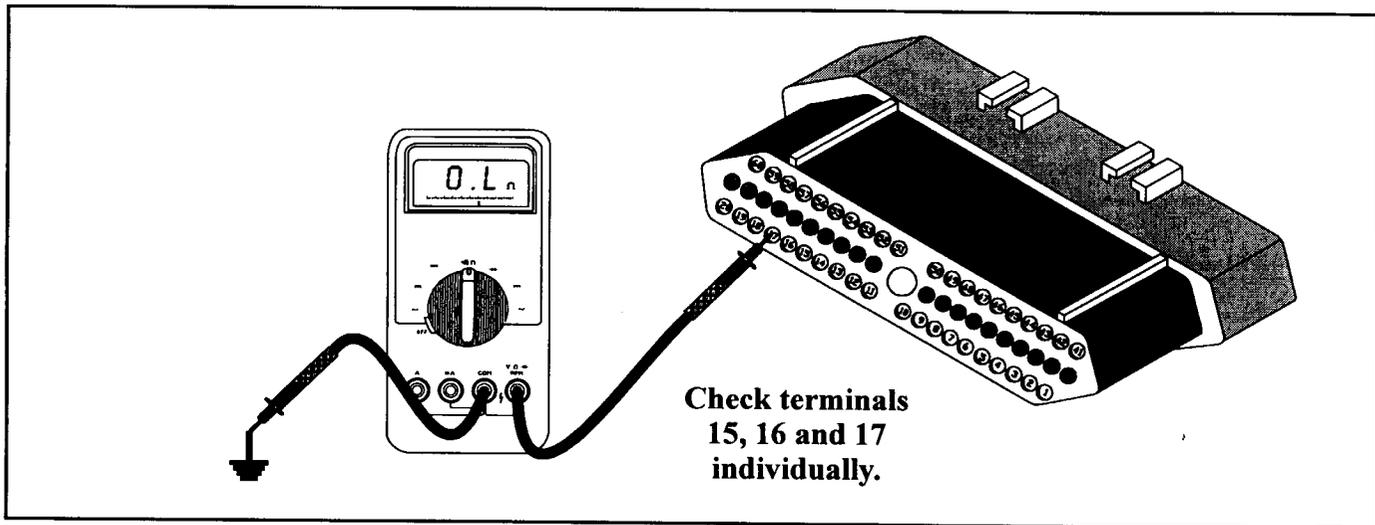
Figure 16

- Keep the EATX relay unplugged. Unplug both the TCM and solenoid body connector. Place the DVOM to an ohm setting. Maintain the negative meter lead to a good known ground. With the positive meter lead carefully probe terminals 15, 16 and 17 in the controller connector as shown in Figure 16. An open circuit should be seen on all three wires. If an ohm reading is seen, a short to ground has occurred on the wire revealing the reading and will need to be repaired. If an open circuit is seen on all three wires, go to the next step.
- Check for continuity between the EATX relay connector and terminal 15 in the TCM connector as shown in Figure 17. If an open is seen, repair the break in the wire. If continuity is seen, go to the next step.

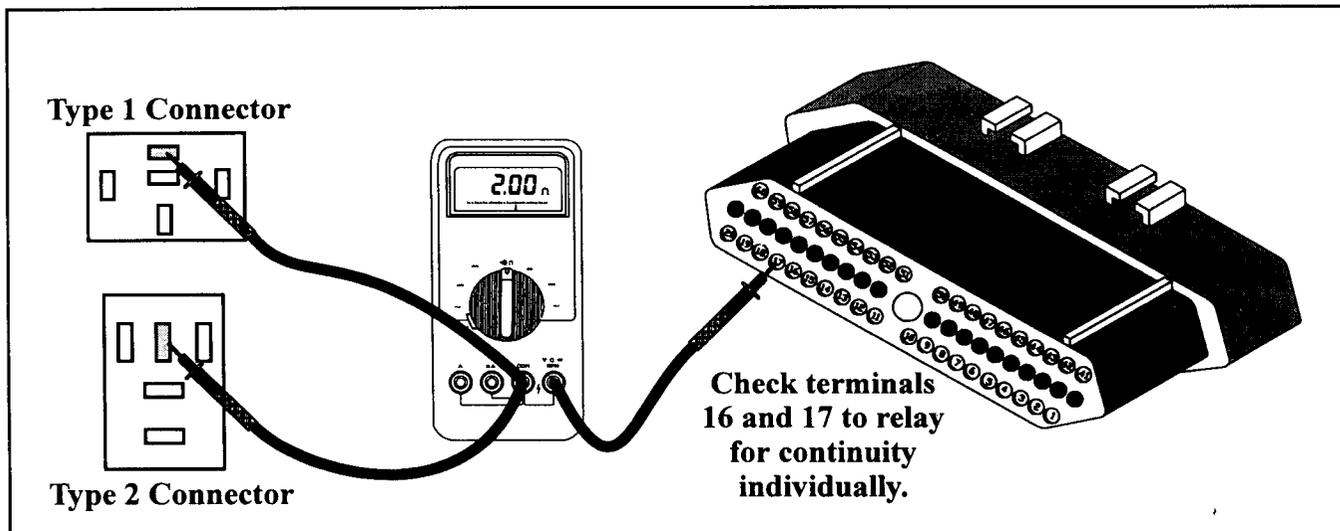
Figure 18

- Check for continuity between the relay connector and terminals 16 and 17 in the controller connector as shown in Figure 18. If an open is seen, repair the break in the wire that shows the open circuit. If continuity is seen, go to the next step.
- Check for continuity between the ground terminal on the battery to the terminal in the relay connector as shown in Figure 19. If an open is seen, repair the wire. If an open is not seen, go to the next step.
- Replace the TCM.

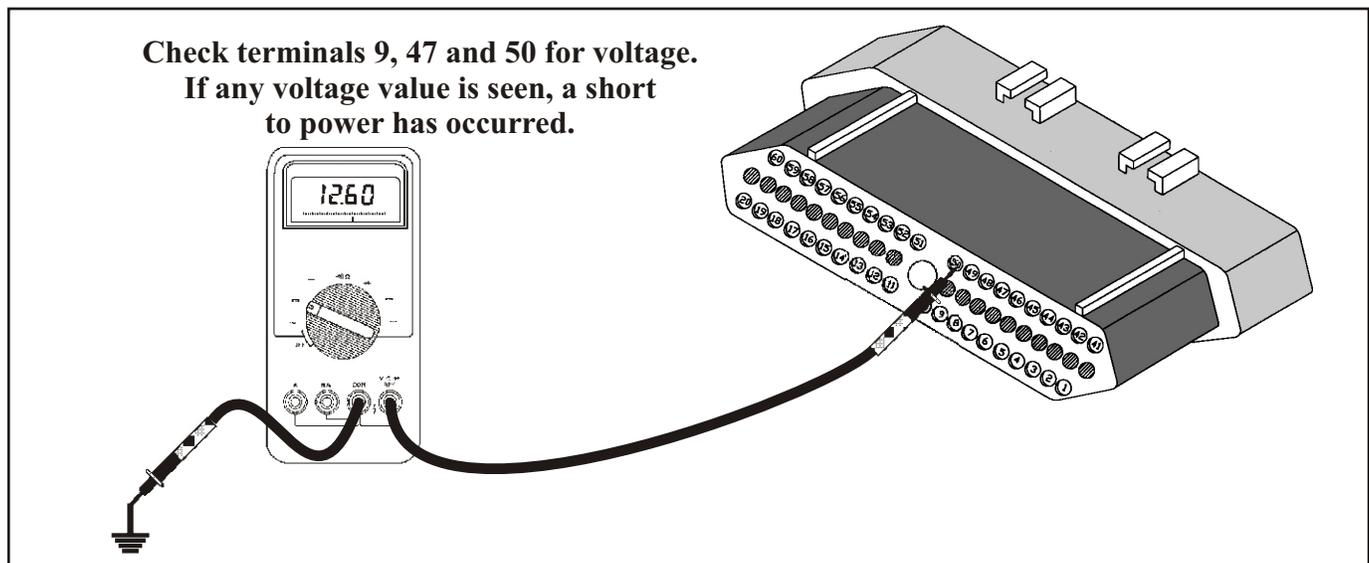
Figure 20

- Unplug the controller and place the DVOM to a DC volt setting. With the negative lead place to a good known ground, carefully inspect terminals 9, 47 and 50 with the positive meter lead (See Figure 20). If a volt reading is seen on any one of these three terminals, a short to power has occurred somewhere in the harness from the solenoid body connector to the controller. Repair the short to power or run a new wire or wires from the solenoid body to the controller. Terminal 9 in the controller goes to terminal 3 in the solenoid body connector. Terminal 47 in the controller goes to terminal 1 in the solenoid body connector. Terminal 50 in the controller goes to terminal 2 in the solenoid body connector. If no volts is seen, go to the next step.

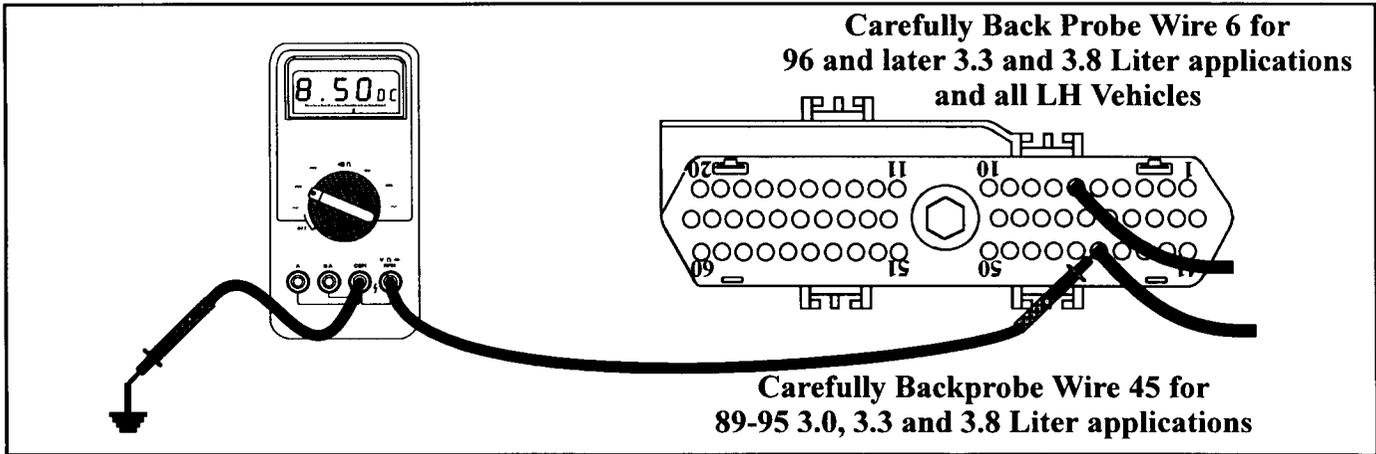
Figure 21

- With a DVOM set to DC volts, carefully back probe wire 45 at the TCM with the positive meter lead and place the negative meter lead to a good known ground (See Figure 21). With the key on and engine off, an 8 to 9 volt pulse should be seen as the crank shaft is turned by hand. If a voltage pulse is observed, the TCM needs to be replaced. If no volts are observed, go to the next step. *Note:* A square wave form is shown in Figure 22 for those that have oscilloscope testing capabilities (Test is performed with vehicle running).

- With a DVOM set to DC volts, using the positive meter lead carefully back probe wire 45 at the TCM for **89-95** 3.3 and 3.8L applications. For all LH vehicles and 96 and later 3.3 and 3.8L applications, back probe wire 6 at the TCM. Place the negative meter lead to a good known ground (See Figure 21). With the key on and engine off, approximately an 5 to 9 volt pulse should be seen as the crank shaft is turned by hand. If a voltage pulse is observed, the TCM needs to be replaced. If no volts are observed, go to the next step.

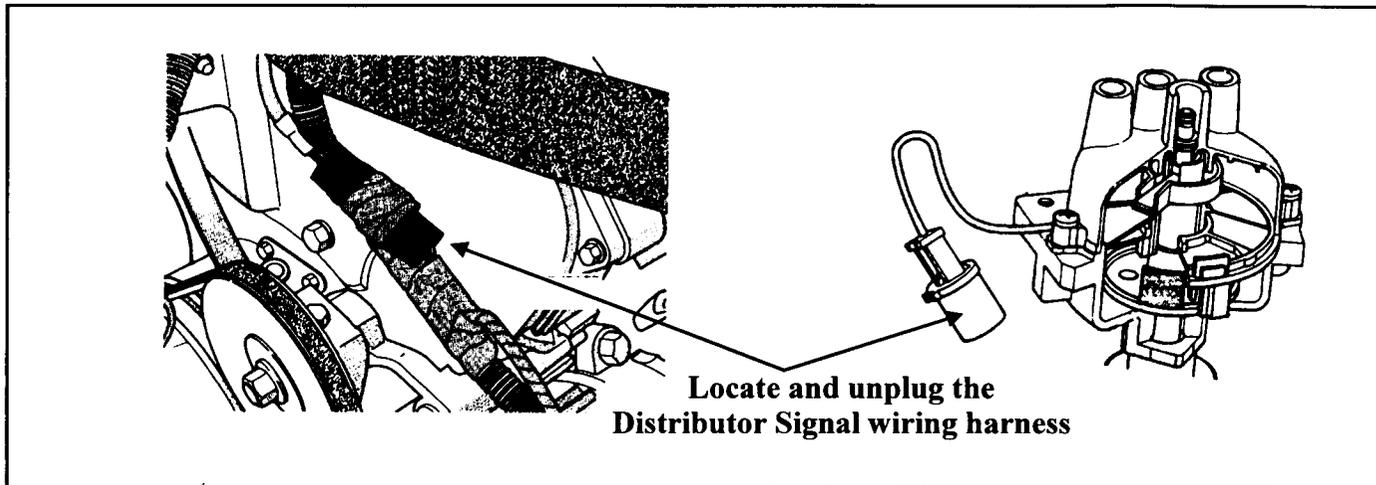
Figure 23

- Go to the distributor and locate a wiring harness coming out from the bottom of the distributor. Trace the harness downstream away from the distributor until you locate the round 4 wire plug as shown in Figure 23. Unplug this 4 way connector and the TCM connector. Perform a continuity check across terminal 2 in the distributor vehicle harness connector to the number 51 wire in the TCM connector as indicated in Figure 24. If there is no continuity, repair or replace the wire. If continuity is seen, go to the next step.

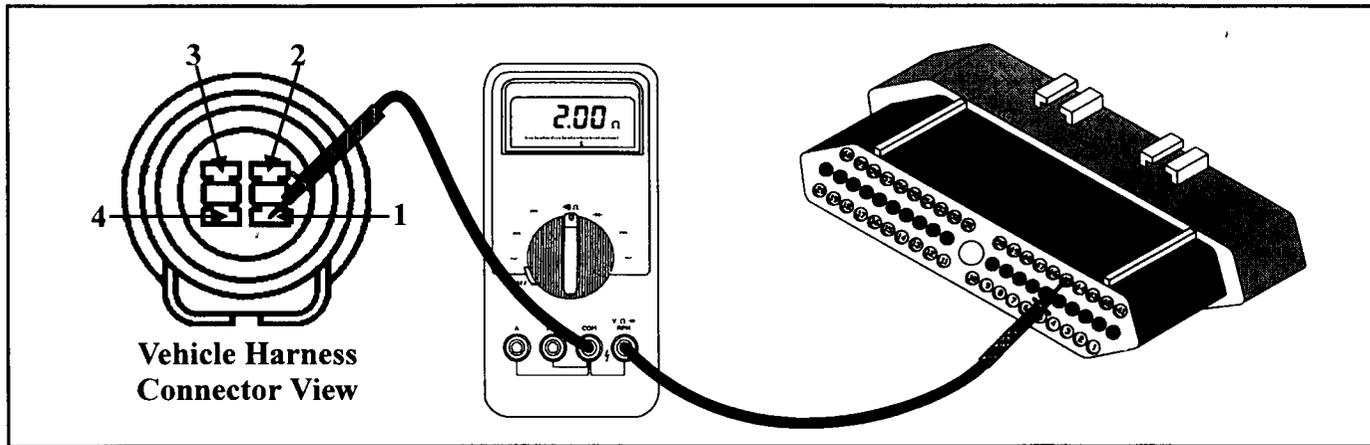
Figure 25

- Perform a continuity check across terminal 1 in the distributor vehicle harness connector to the number 45 wire in the TCM connector as indicated in Figure 25. If there is no continuity, repair or replace the wire.

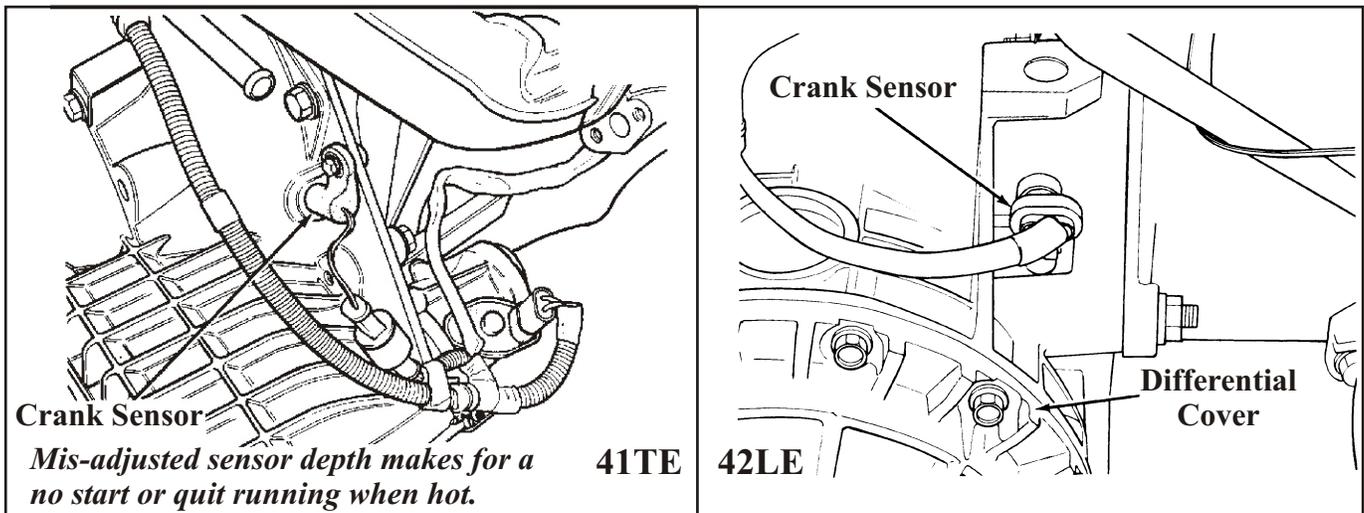
Figure 26

- Locate the crank sensor as shown in Figure 26. Unplug both the crank sensor and the TCM. For **89-95** 3.3 and 3.8L applications perform a continuity check across terminal 1 in the crank sensor connector to terminal 45 in the TCM connector. For all LH vehicles and 96 and later 3.3 and 3.8L, check across terminal 3 in the crank sensor connector to terminal 6 in the TCM connector (See Figure 27). If there is no continuity, repair or replace the wire.

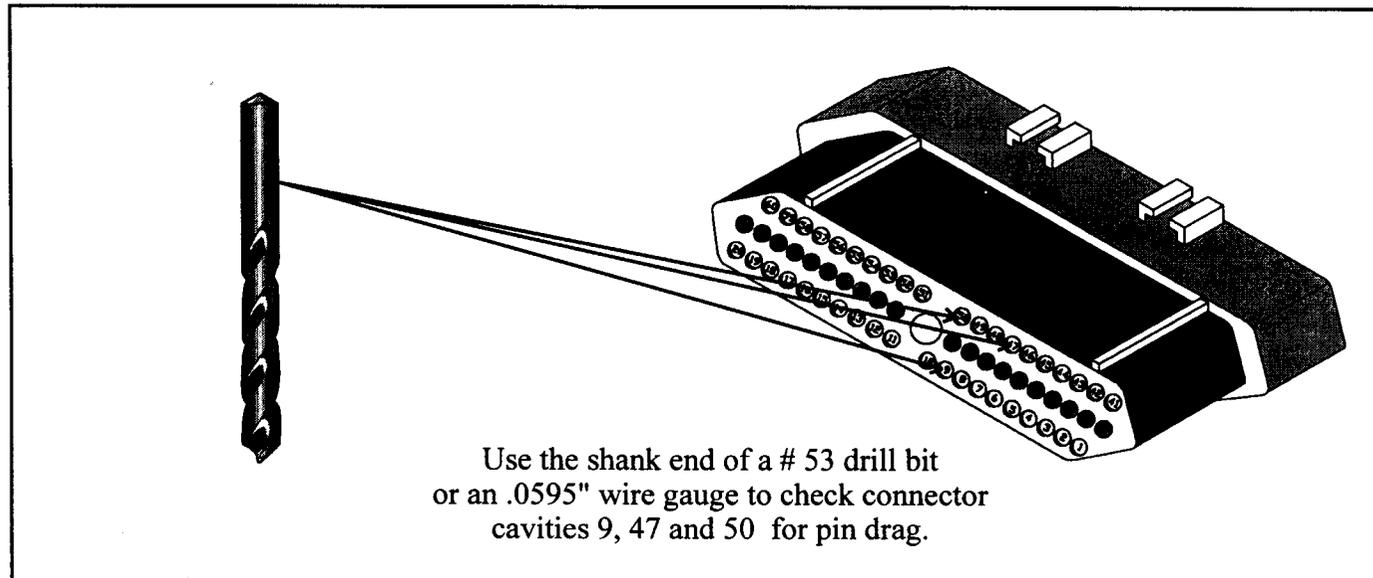
Figure 30

- Inspect cavities 9, 47 and 50 in the TCM 60 way connector for being spread, corroded or pushed back to far. Use the shank end of a # 53 drill bit or a .0595" wire gauge to check the terminal for pin drag (See Figure 30). A connector repair kit available from Chrysler under part number 4419479 if connector replacement is needed.
- If the 60 way connector is good, go to the next step.

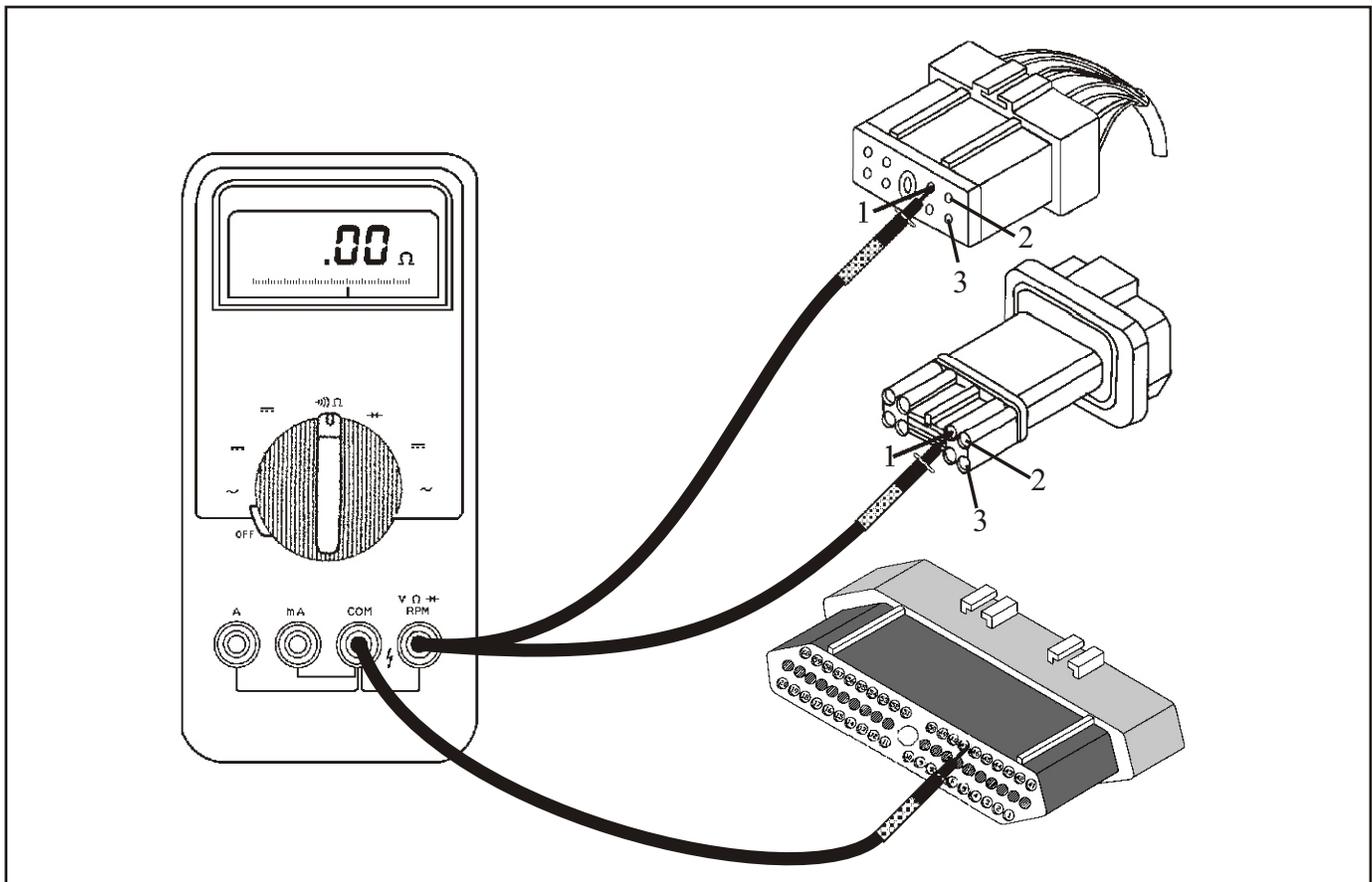
Figure 31

- A continuity check should be made across the following appropriate wire from the solenoid connector to the TCM connector (See Figure 31):

PRESSURE SWITCH	SOLENOID BODY CONNECTOR	TCM CONNECTOR
Low/Reverse Pressure Switch Wire -	2	50
2/4 Pressure Switch Wire -	1	47
Overdrive Pressure Switch Wire -	3	9

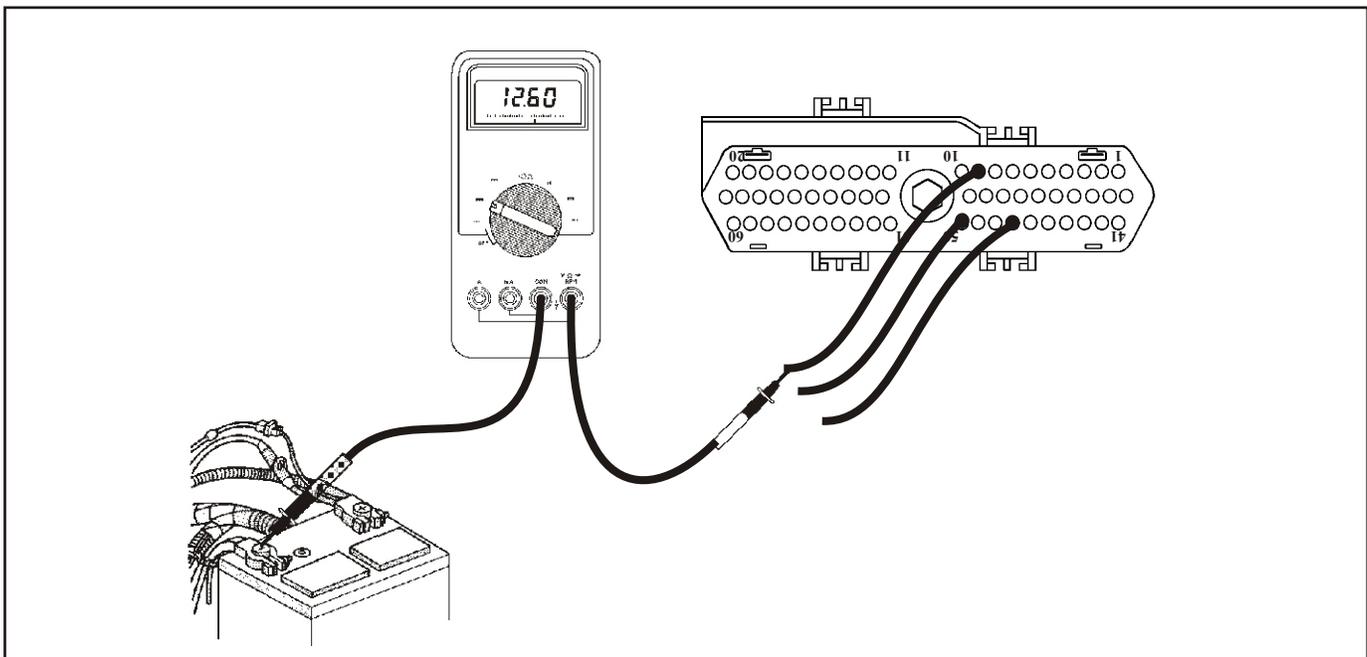
Figure 32

- Place the ignition to the ON position. Do not start the vehicle.
- With a DVOM set to DC volts, place the negative meter lead to the negative battery post. With the positive meter lead, carefully back probe wires 9, 47 and 50 (See Figure 32). Each wire should show battery voltage. ***Special Note: This method should only be employed when pressure switch codes alone are present. Other codes such as a solenoid code may cause the control to default to a limp mode status with just the ignition turned ON. Voltage would then not be observed at pins 9, 47 and 50 providing a false test.***

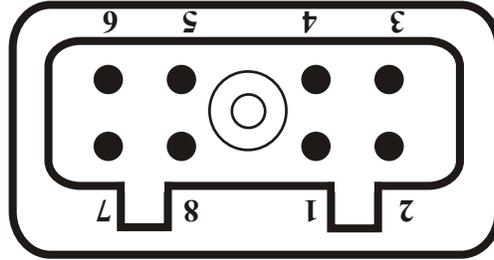
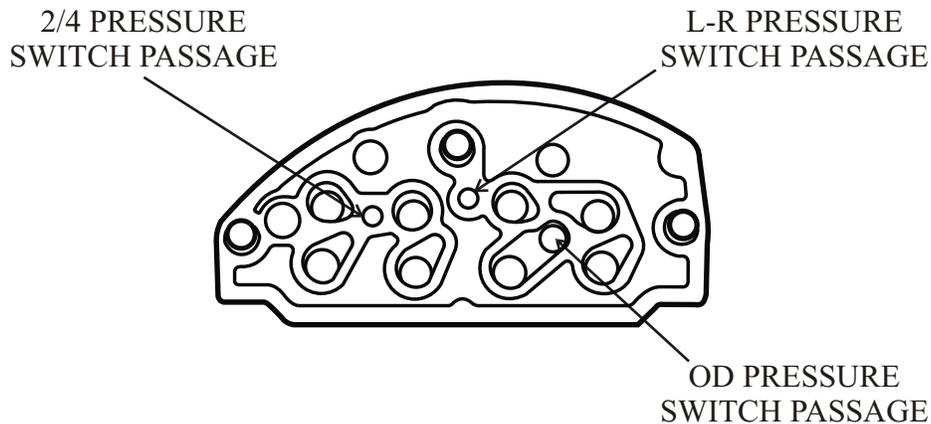
Figure 33

## 41TE SOLENOID BODY RESISTOR AND PRESSURE SWITCH CHECK

EACH PRESSURE SWITCH HAS ITS OWN RESISTOR IN THE CIRCUIT WHICH RANGE BETWEEN APPROXIMATELY 270-330 OHMS @ 68° F EACH RESISTOR SIMILAR IN RESISTANCE. FOR EXAMPLE:  
2 MEASURE 270 AND 1 MEASURES 330 - NO GOOD

RESISTOR	CONNECT OHMMETER LEADS TO PINS
2-4	4 & 1
L-R	4 & 2
O.D.	4 & 3

PRESSURE SWITCH	CONNECT OHMMETER LEADS TO PIN
O.D.	1 & GROUND (Body Base)
L-R	2 & GROUND (Body Base)
2-4	3 & GROUND (Body Base)

OHM METER SHOULD READ "NO CONTINUITY" WITH NO AIR APPLIED TO THE PRESSURE SWITCH. OHM METER SHOULD READ LESS THAN "3" OHMS . WITH 50 PSI OF AIR PRESSURE APPLIED TO THE PRESSURE SWITCH.

- If any one of the wires do not show voltage during this test, there is a break in that wire from the solenoid body to the TCM. Repair the wire.
- If voltage is seen on all three wires, inspect the solenoid body. To check the solenoid body for a 41TE see Figure 33. To inspect a 42LE solenoid body, see Figure 34.

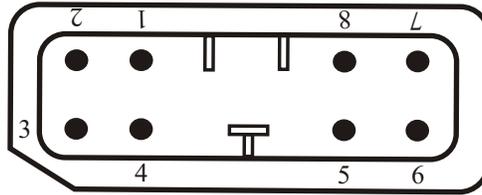
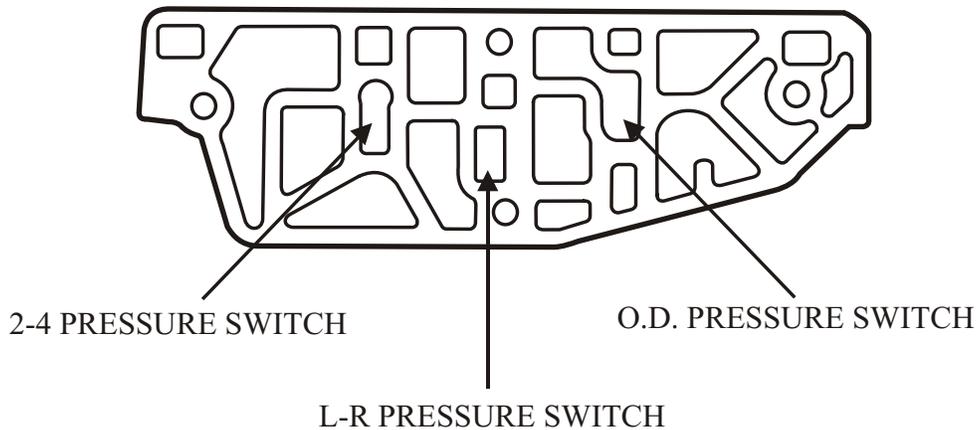
## 42LE SOLENOID BODY RESISTOR AND PRESSURE SWITCH CHECK

EACH PRESSURE SWITCH HAS ITS OWN RESISTOR IN THE CIRCUIT WHICH RANGE BETWEEN APPROXIMATELY 270-330 OHMS @ 68° F EACH RESISTOR SIMILAR IN RESISTANCE. FOR EXAMPLE:  
2 MEASURE 270 AND 1 MEASURES 330 - NO GOOD

RESISTOR	CONNECT OHMMETER LEADS TO PINS
2-4	4 & 1
L-R	4 & 2
O.D.	4 & 3

PRESSURE SWITCH	CONNECT OHMMETER LEADS TO PIN
O.D.	1 & GROUND (Body Base)
L-R	2 & GROUND (Body Base)
2-4	3 & GROUND (Body Base)

OHM METER SHOULD READ "NO CONTINUITY" WITH NO AIR APPLIED TO THE PRESSURE SWITCH. OHM METER SHOULD READ LESS THAN "3" OHMS . WITH 50 PSI OF AIR PRESSURE APPLIED TO THE PRESSURE SWITCH.

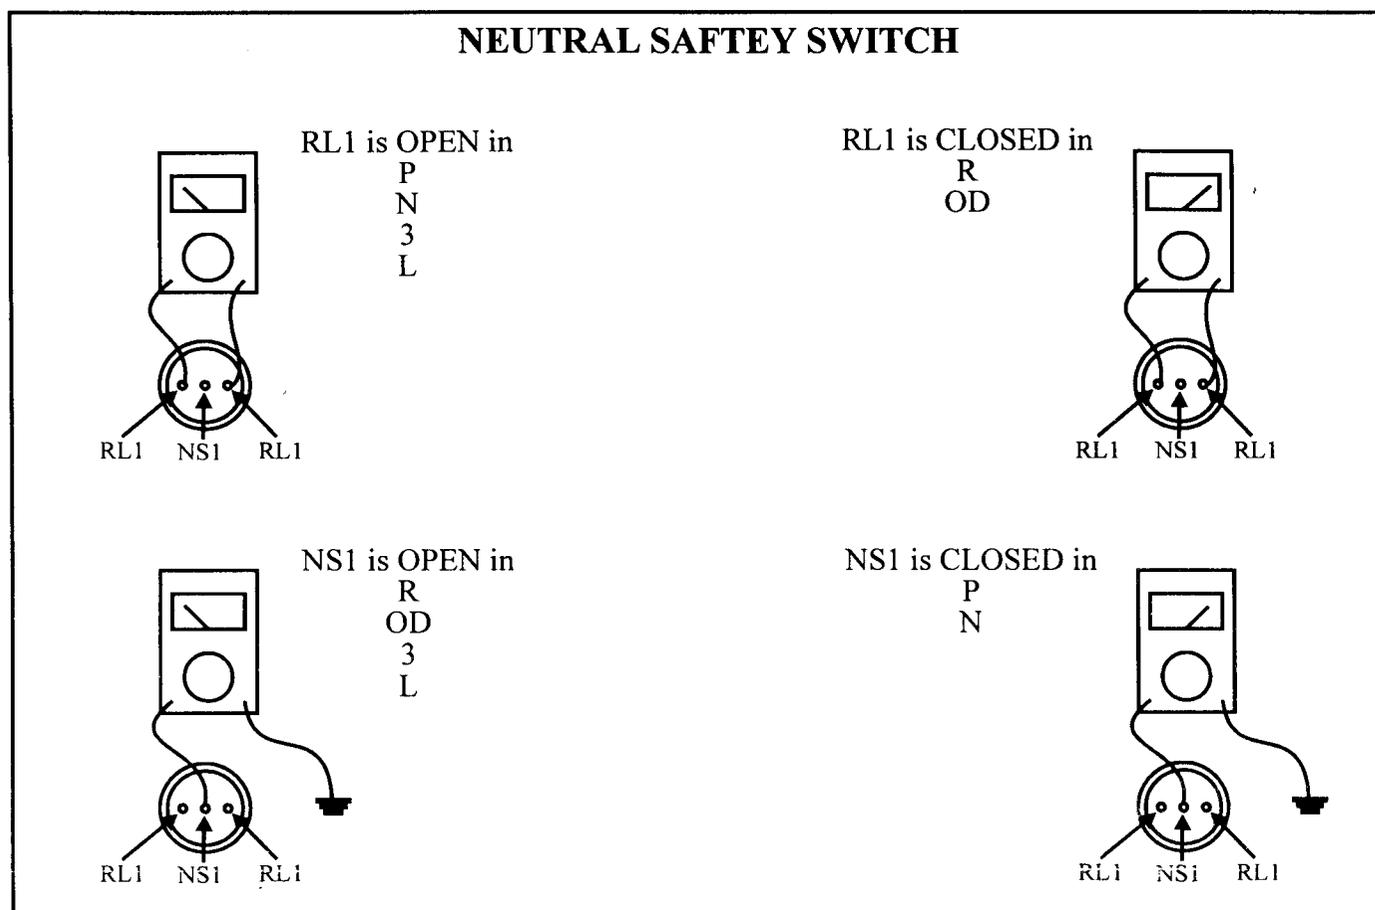
- Once the circuit which malfunctioned has been identified, a check needs to be made on that specific circuit. The first step is to check the PRONDL & Neutral switch operation with the use of a ohm meter. This will check the integrity of the switch as well as the plastic cam located on the manual valve detent assembly. Use Figure 36 to check the specific circuit in question for the Neutral Safety switch or Figure 37 for the PRNODL switch.

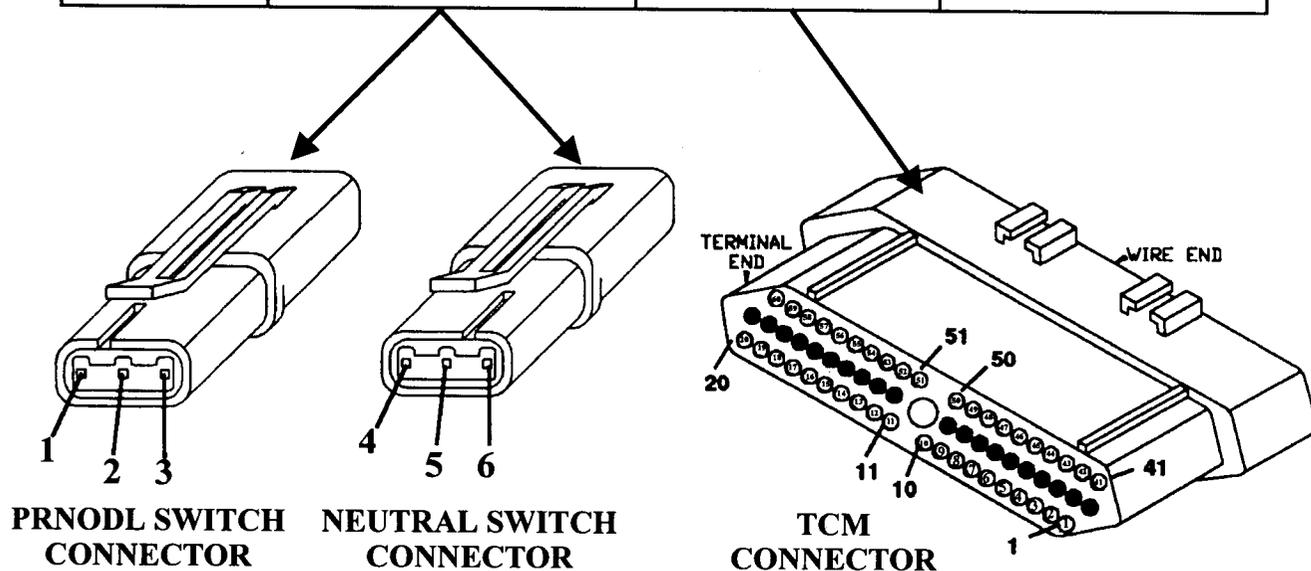
- If a code 28 comes up due to a bad shift lever position signal and both the PRNODL and Neutral switch are known to be good, then a circuit check will have to be performed. This will require the use of an ohmmeter in order to check for continuity across each individual wire going from the switch to the controller. Use the chart and illustrations below to assist you in making the check. It has been ATSG's experience that the majority of open circuits have been traced down to bad connectors. Chrysler has a connector repair kit available for the PRNODL and Neutral Switches under part number 4638996

CIRCUIT NAME	PRNODL SWITCH	CONTROLLER TERMINAL #	POSSIBLE CODES
RL2/T01	1	1	28
NS2/T42	2	42	28
RL2/Z13	3	GROUND	28
CIRCUIT NAME	NEUTRAL SWITCH	CONTROLLER TERMINAL #	POSSIBLE CODES
RL1/A21	4	IGNITION FEED	28
NS1/T41	5	41	28
RL1/T03	6	3	28

- If the connectors check good, use the chart found in Figure 38 to perform continuity checks across each individual circuit.
- If all circuits have continuity, the TCM may need to be replaced. Before doing so, refer to a bulletin found on page 49.
