# 41TE & 42LE CODE BOOK

## **41TE & 42LE DIAGNOSTIC CODE BOOK**

### **INTRODUCTION**

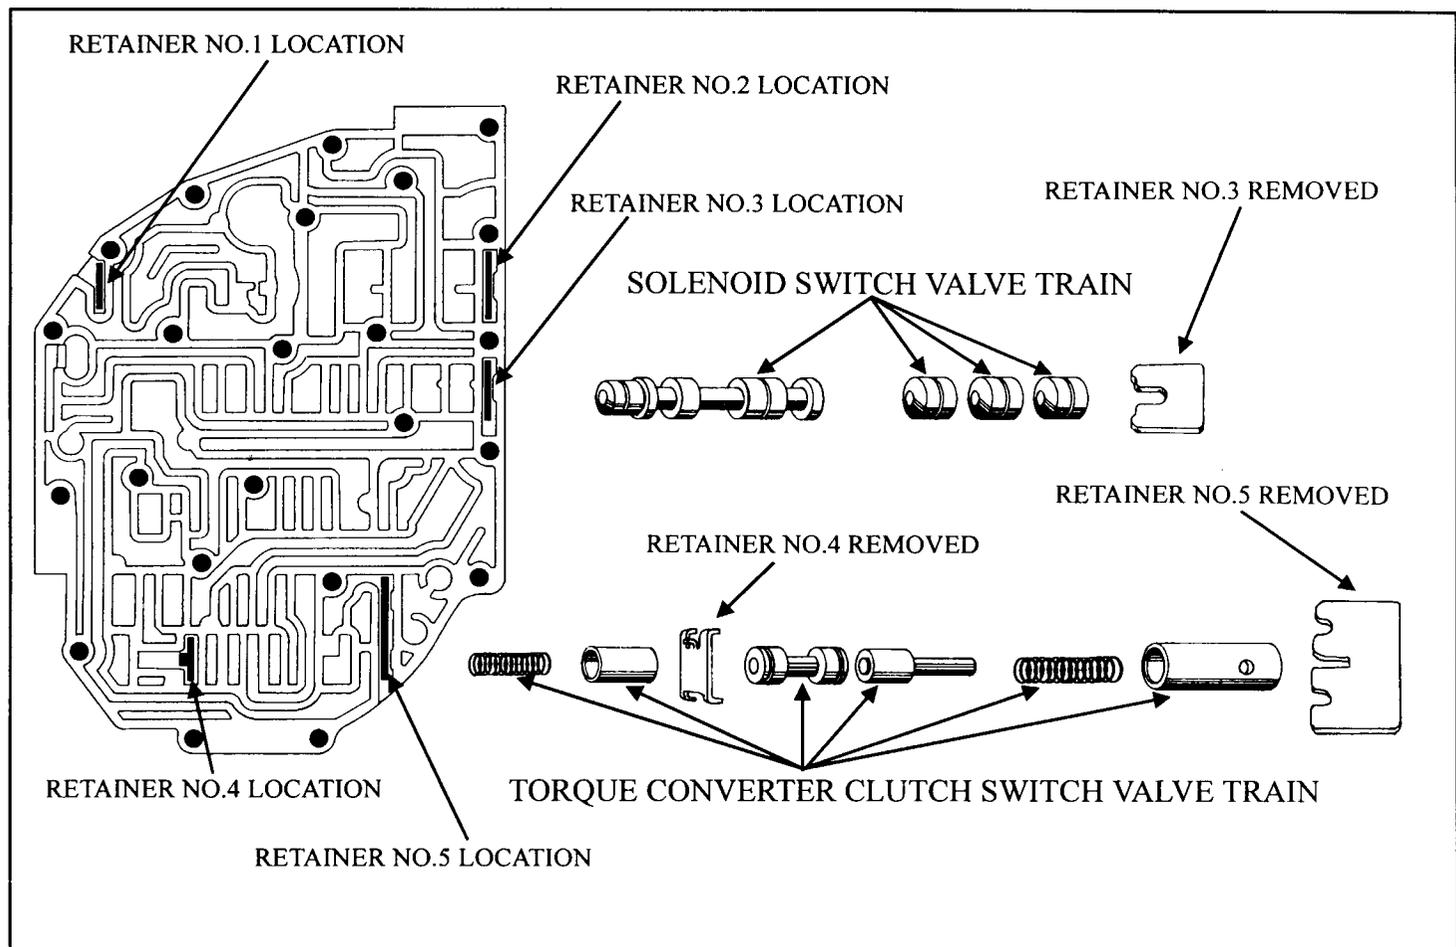
**CORRECTION:** Install the solenoid switch valve train and retainer No.3 as shown in Figure 39.  
**NOTE:** Retainer location No.4 and Torque Converter Clutch Switch Valve Train shown in Figure 39 are for "92" and later only!

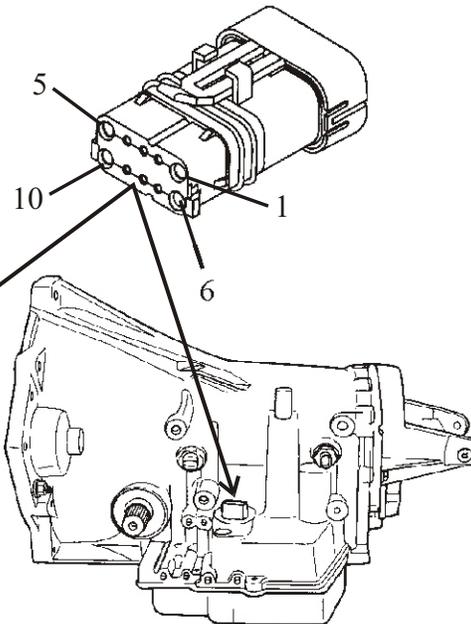
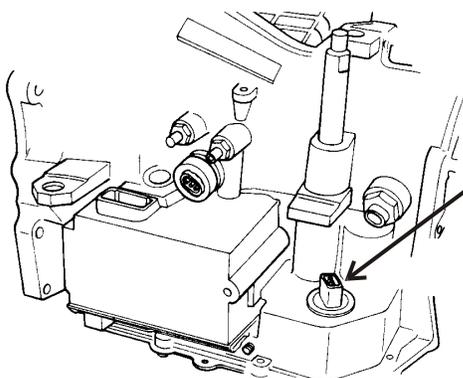
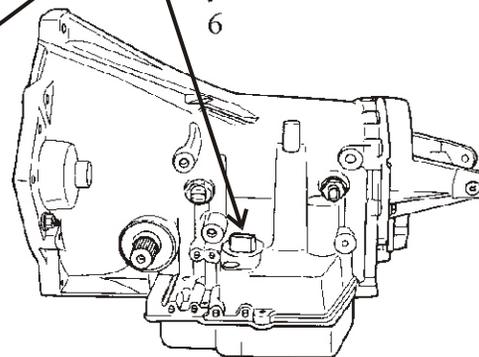
- A scanner can be used to observe the OPEN/CLOSED state of the C1/T41, C2/T42, C3/T3 and the C4/T1 circuits. This can be especially helpful in determining which exact circuit is malfunctioning. Refer to Figure 40 for the OPEN/CLOSED status chart and circuit identification.

RANGE	T42 (C2)	T41 (C1)	T3 (C3)	T1 (C4)
P	P	CL	CL	OP
R	R	CL	OP	OP
N	N	CL	CL	OP
OD	D	OP	OP	CL
3	2	OP	OP	CL
1	1	CL	OP	CL

OP = SWITCH IS OPEN  
CL = SWITCH IS CLOSED

### TRANSMISSION RANGE SENSOR TRS

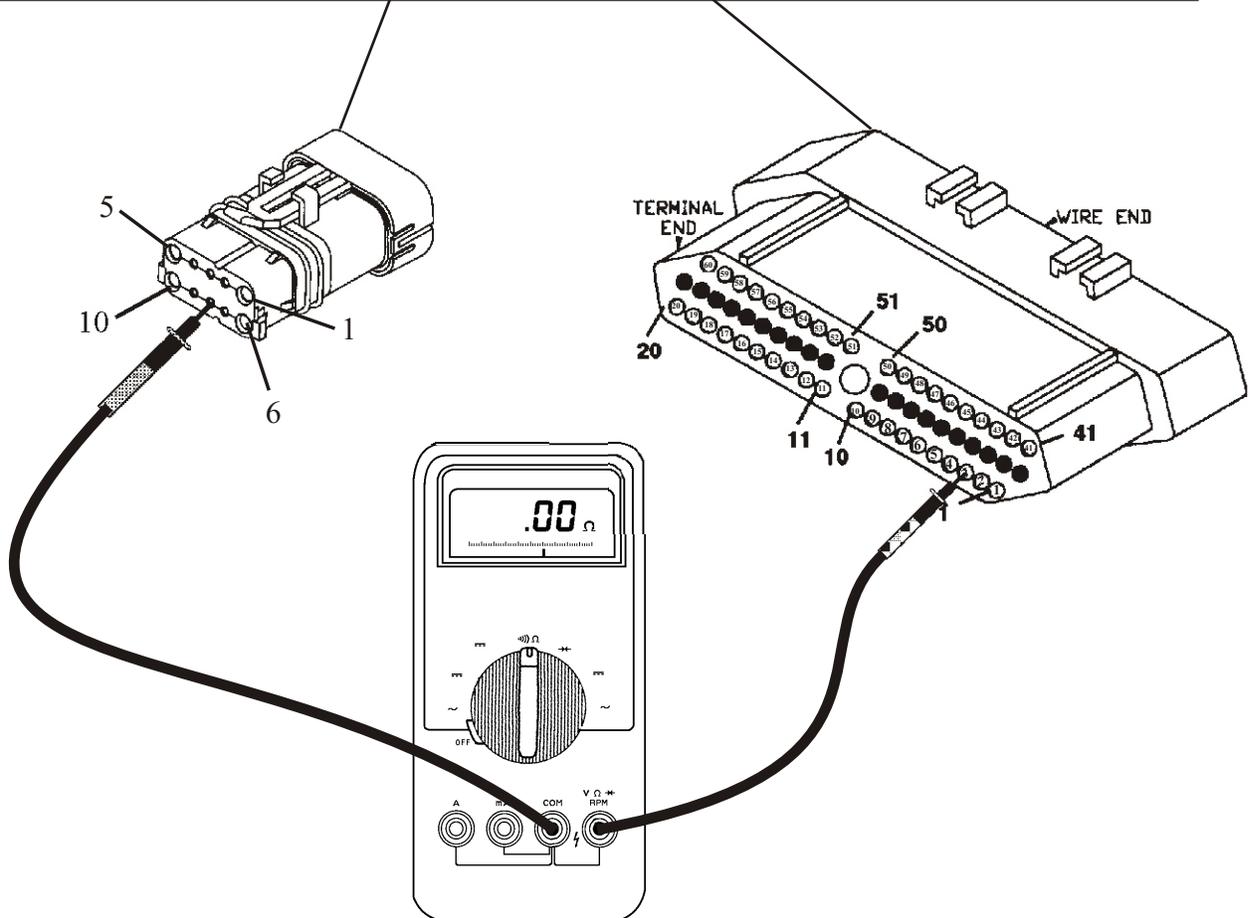
- Once the circuit which malfunctioned has been identified, a continuity check should be made on that circuit. Use the chart found in Figure 41 to assist in identifying the specific circuit or circuits in question. For example, if the scanner reveals that the T3 (C3) circuit does not close when the selector lever is placed in Park, 3 or 1, that specific circuit will need to be checked. In the chart below circuit T3 is the wire which runs from the number eight cavity in the TRS connector to the number three cavity in the TCM connector.

CIRCUIT NAME	TRANSMISSION RANGE SENSOR	CONTROLLER TERMINAL #	POSSIBLE CODES
C1/T41	5	41	28
C2/T42	9	42	28
C3/T03	8	3	28
C4/T01	7	1	28

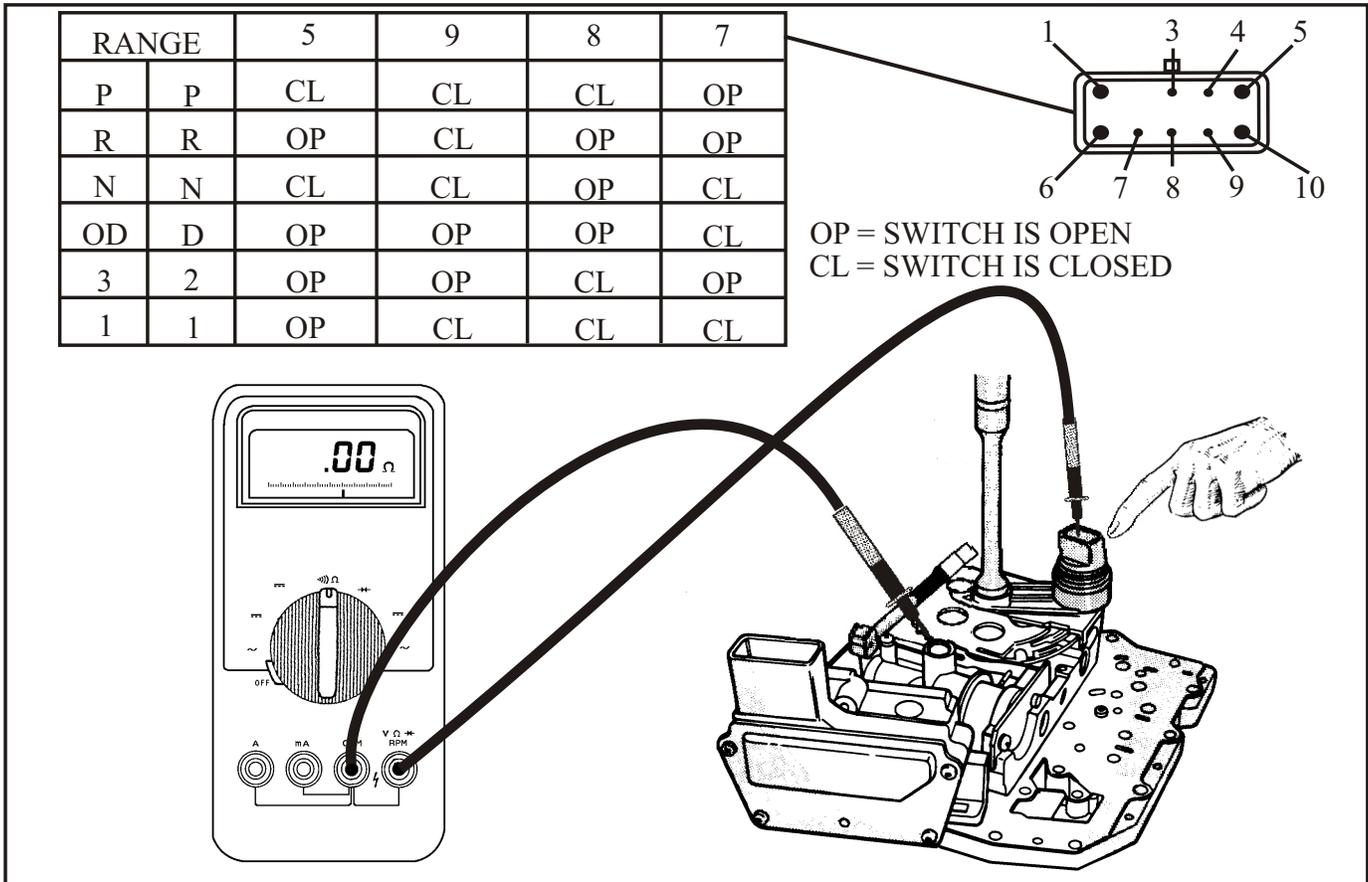
- Remove the valve body from the transmission. With the TRS still mounted to the valve body, place the manual valve in the park position. Fasten the negative meter lead to the metal portion of the rooster comb (See Figure 42). While pushing the switch down onto the rooster comb with one hand, use the positive meter lead to make contact with pins 7, 8, 9 and 10 individually. Approximately .5 to 1.5 ohms should be seen on each pin except # 7, it should read open. Use the chart in Figure 42 to check the TRS in each manual valve selection. Replace the TRS sensor if necessary. If all ranges test good, go to the next step.

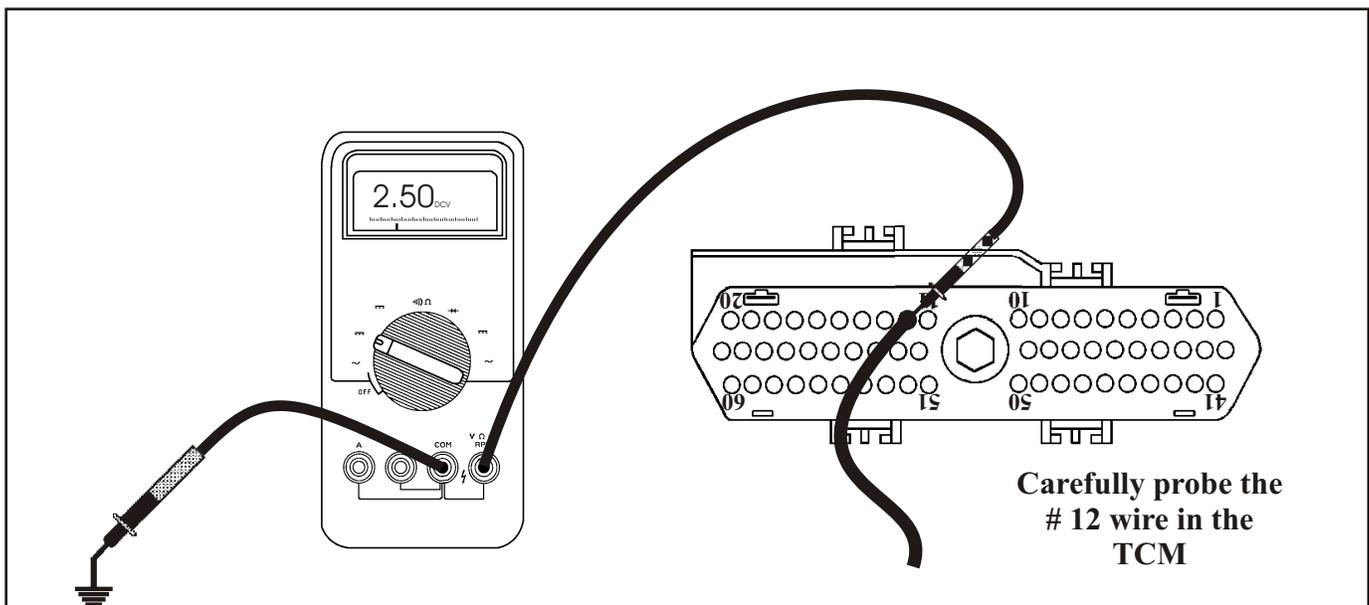
Figure 43

- Compare the TPS voltage seen through a scanner display to a volt meter attached to the number 12 TPS signal wire at the TCM (See Figure 43). With the engine off, place the ignition to the “ON” position. At closed throttle, approximately .50 to .78 volts should be observed. As the throttle is opened the voltage should increase proportionally. When wide open throttle is reached, approximately 3.8 to 4.0 volts should be seen. **NOTE: Both readings should be relatively the same however, the TPS voltage change observed through the scanner will be slightly delayed to that seen on the volt meter.** If the voltage change observed through the volt meter is correct while the scanner provides unusual and incorrect readings, the TCM will need to be replaced. If both the scanner and volt meter reveal a no volt reading, a fixed volt reading, an erratic or incorrect volt reading, go to the next step.

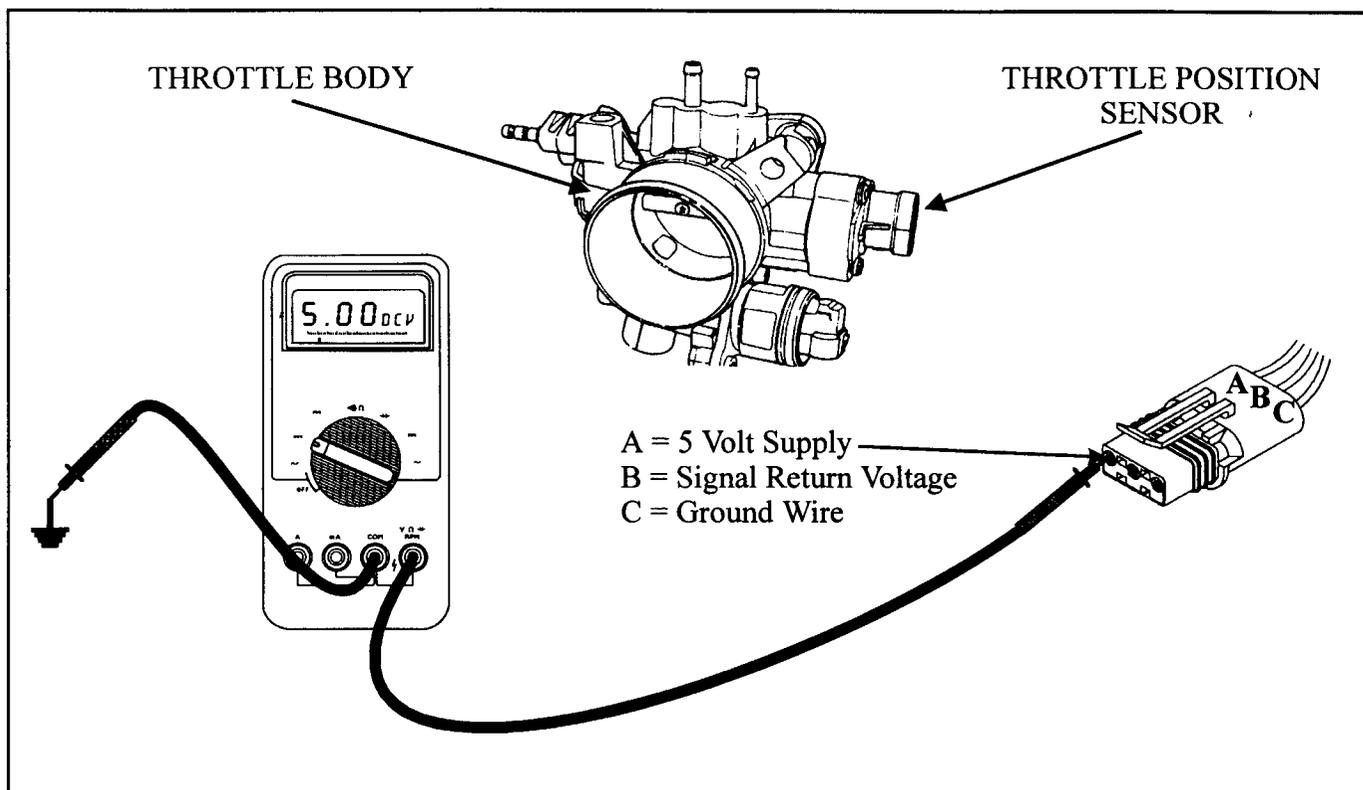
Figure 44

- Locate and unplug the TPS on the throttle body as shown in Figure 44. With the engine off, turn the ignition to the "ON" position. Set the meter to DC volts and place the negative lead to the negative battery post. With the positive lead check terminal A in the harness connector for approximately 5 volts as seen in Figure 44. If voltage is not seen, a bad PCM (Engine Computer) may be the problem as it supplies the 5 volt feed to the TPS. It would be wise to first verify that the wire itself is not severed from the PCM to the TPS by performing a continuity check across the wire. All vehicles up to and including model year 1995 the check should be made from terminal 6 in the PCM connector to terminal A in the TPS connector. For 1996 and later vehicles the check should be made from terminal 61 at the PCM to terminal A in the TPS connector. If continuity is seen across the wire and there is not 5 volts going to the TPS, the PCM will need to be replaced. If 5 volts is seen at the TPS connector, go to the next step.

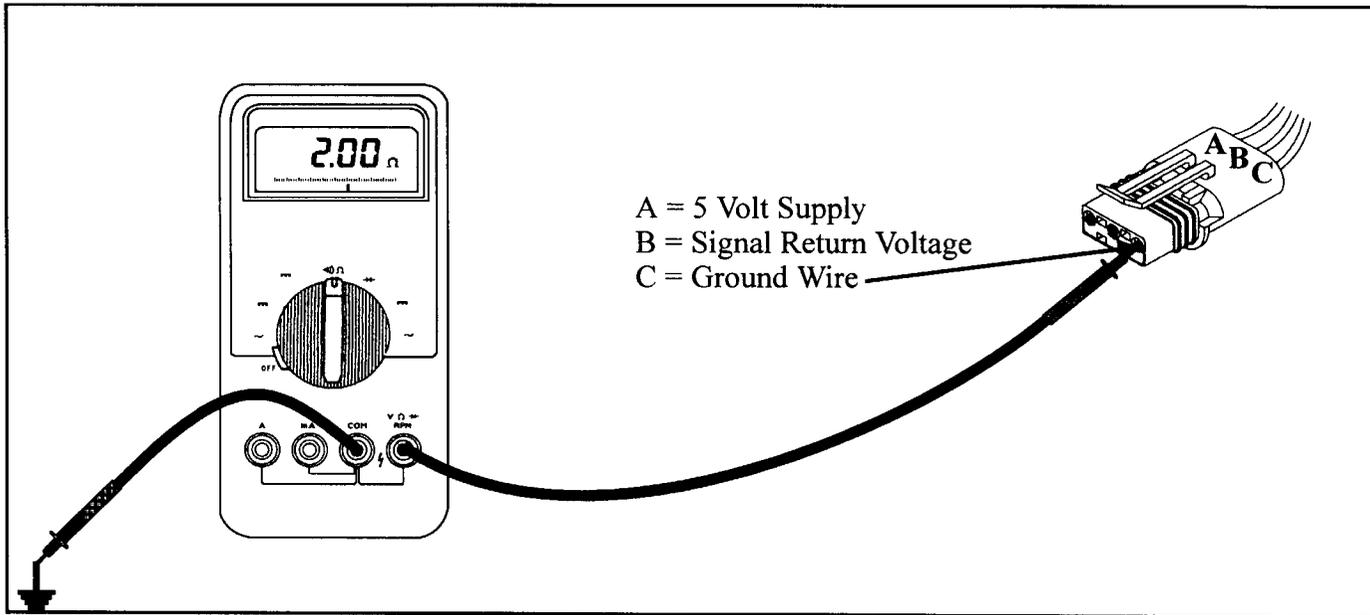
Figure 45

- With a meter set to ohms, place the negative lead to the negative post of the battery and the positive lead to terminal C in the TPS connector (See Figure 45). Approximately 0 to 5 ohms should be seen. If the resistance is greater than 5 ohms or the meter displayed an open circuit, the ground wire will need to be repaired. A quick and simple method would be to splice into the wire with another wire and run it to a good known ground (See Figure 46). If the ground wire is good and the TPS is still malfunctioning, go to the next step.

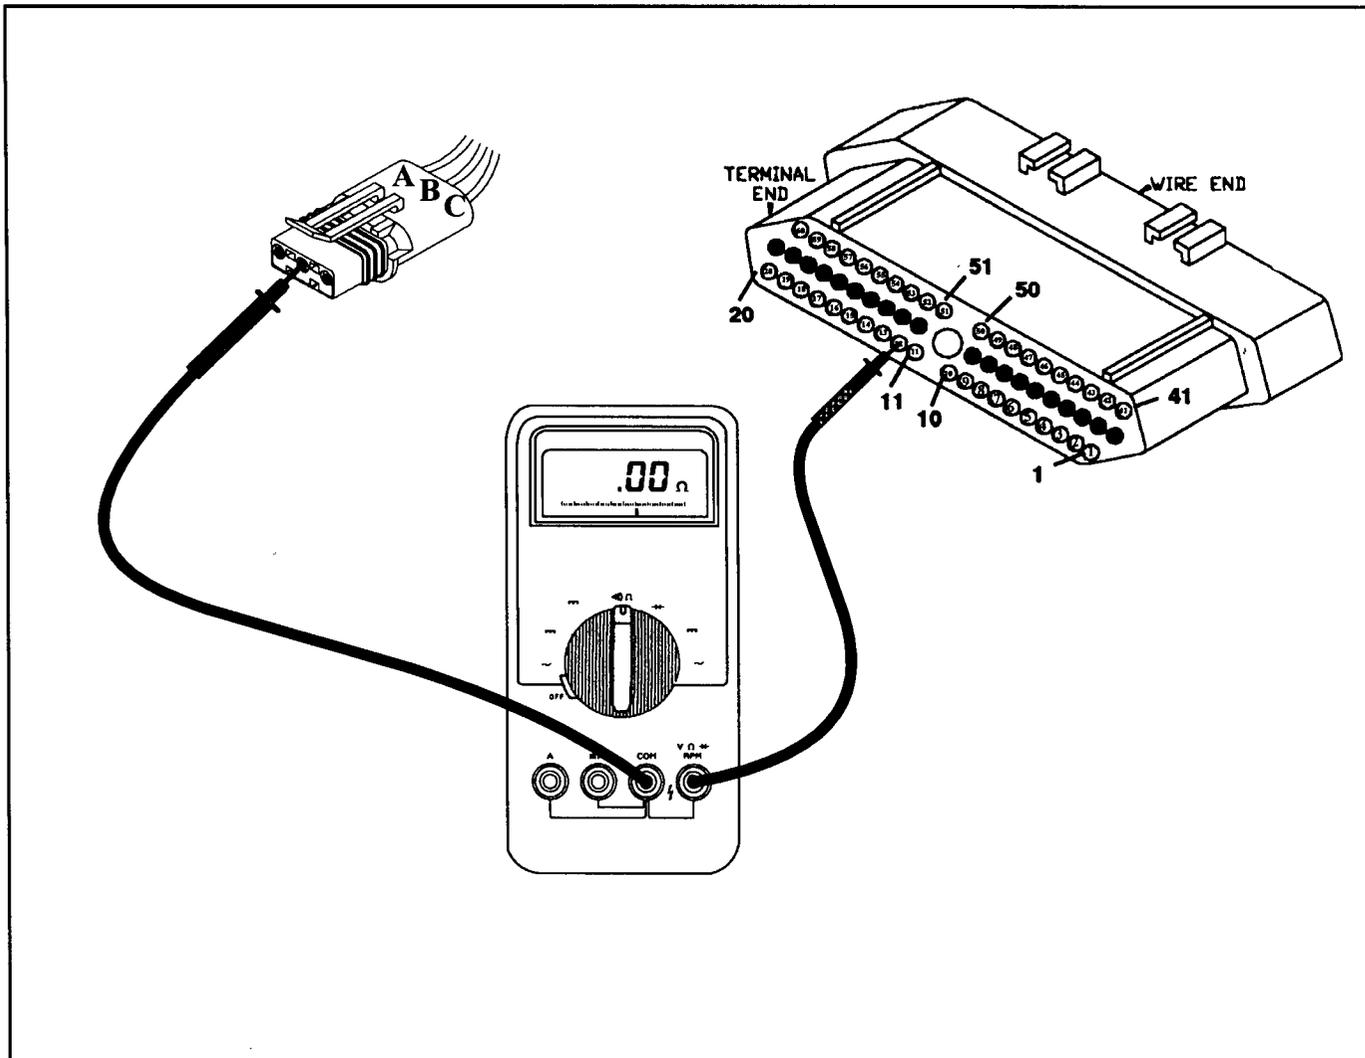
Figure 47

- Unplug both the TCM and TPS. Perform a continuity check from terminal B in the TPS connector to terminal 12 in the TCM connector (See Figure 47). If continuity is not seen, repair the severed wire. If continuity is seen, replace the TPS.

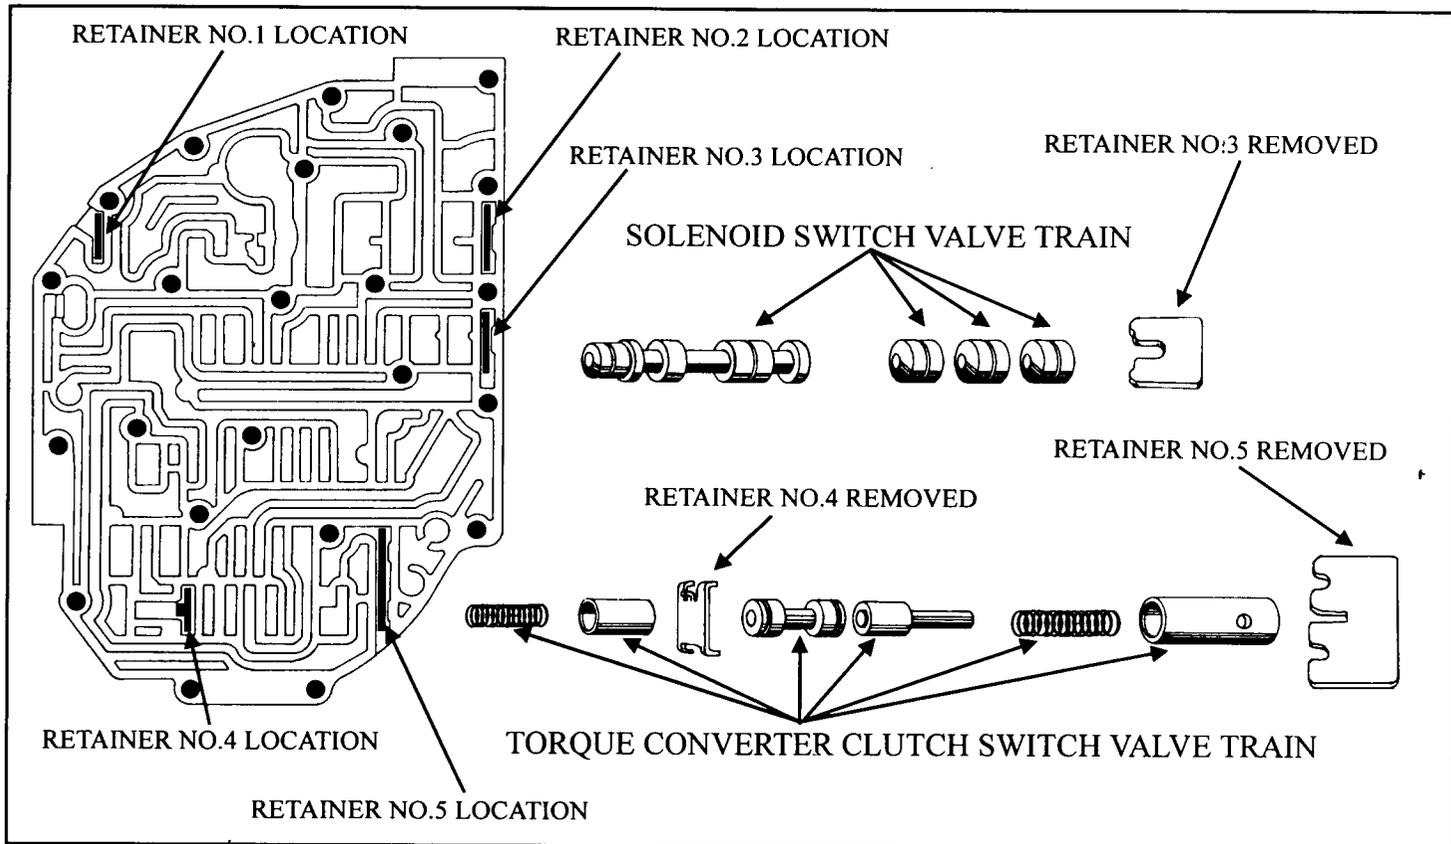
Figure 48

- Use a scanner to observe the Shift Lever Position. If OD is displayed while in the Reverse position the PRNODL switch may be defective. Refer to pages 45 to 52 for step by step diagnosis.
- Inspect the valve body for a stuck Solenoid Switch Valve or a missing # 3 retainer (See Figure 48).

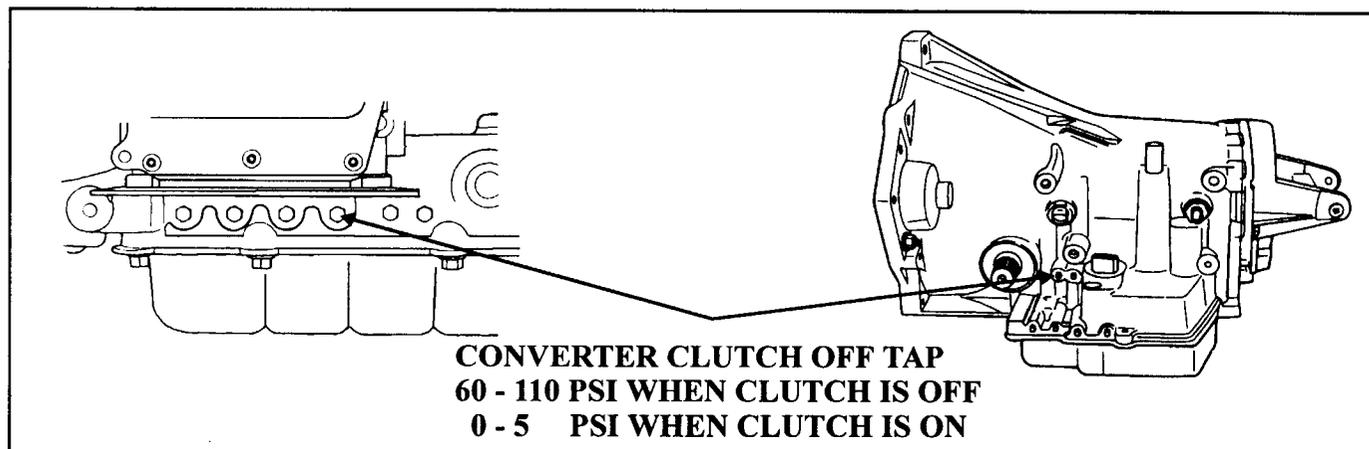
Figure 50

- Record and clear all codes with a scanner via the diagnostic BUS connector. Use the scanner to then observe both engine RPM and Turbine Shaft RPM. Install a pressure gauge onto the converter clutch off tap (See Figure 50). Take the vehicle for a road test. When the scanner indicates full lock up, both the engine RPM and Turbine Shaft RPM should read the same. The pressure gauge should also drop to 5 psi or less. The following results would indicate the different possibilities.

- The Engine and Turbine Shaft RPM's are considerably different but the pressure gauge dropped to 0 psi. The Torque Converter Clutch is slipping or there is low converter clutch apply pressure due to the primary use of an auxiliary cooler or or a defective valve body. Low apply pressure can be determined by observing converter clutch off pressure before lock up. It should be between 60 to 110 psi.

- If full lock up is commanded and pressure drops slightly, inspect the valve body, pump bushing, pump stator and turbine shaft sealing rings for excessive wear or damage.

- If both the Engine RPM and Turbine RPM are the same with a pressure gauge reading 0 psi, the converter clutch is fully locked up. If a code is stored under these conditions, the TCM would be misinterpreting information producing a false code. Replace the TCM.

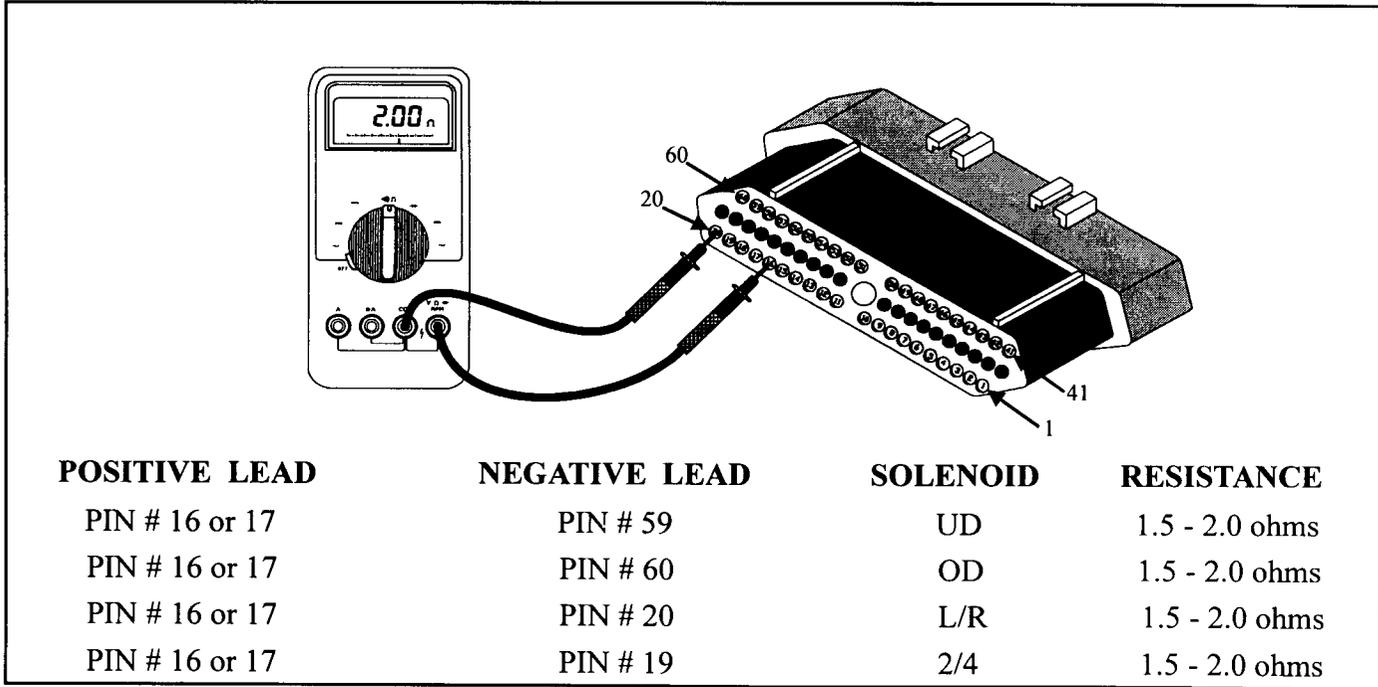
Figure 51

- Unplug the TCM's 60 way connector. Using a DVOM check the resistance of all four solenoid circuits by placing the positive lead onto pin 16 or 17 as seen in Figure 51. With the negative lead, carefully touch pins 19, 20, 59 and 60 one at a time. Each solenoid should measure approximately 1.5 to 2.0 ohms. If the solenoid providing the code reads considerably higher or lower from the other three solenoids, change the solenoid body. If all the readings are the same, wiggle the solenoid wires with the meter still attached and see if the readings behave erratic. If so, the solenoid connector is bad and will need to be replaced with part 4419476.

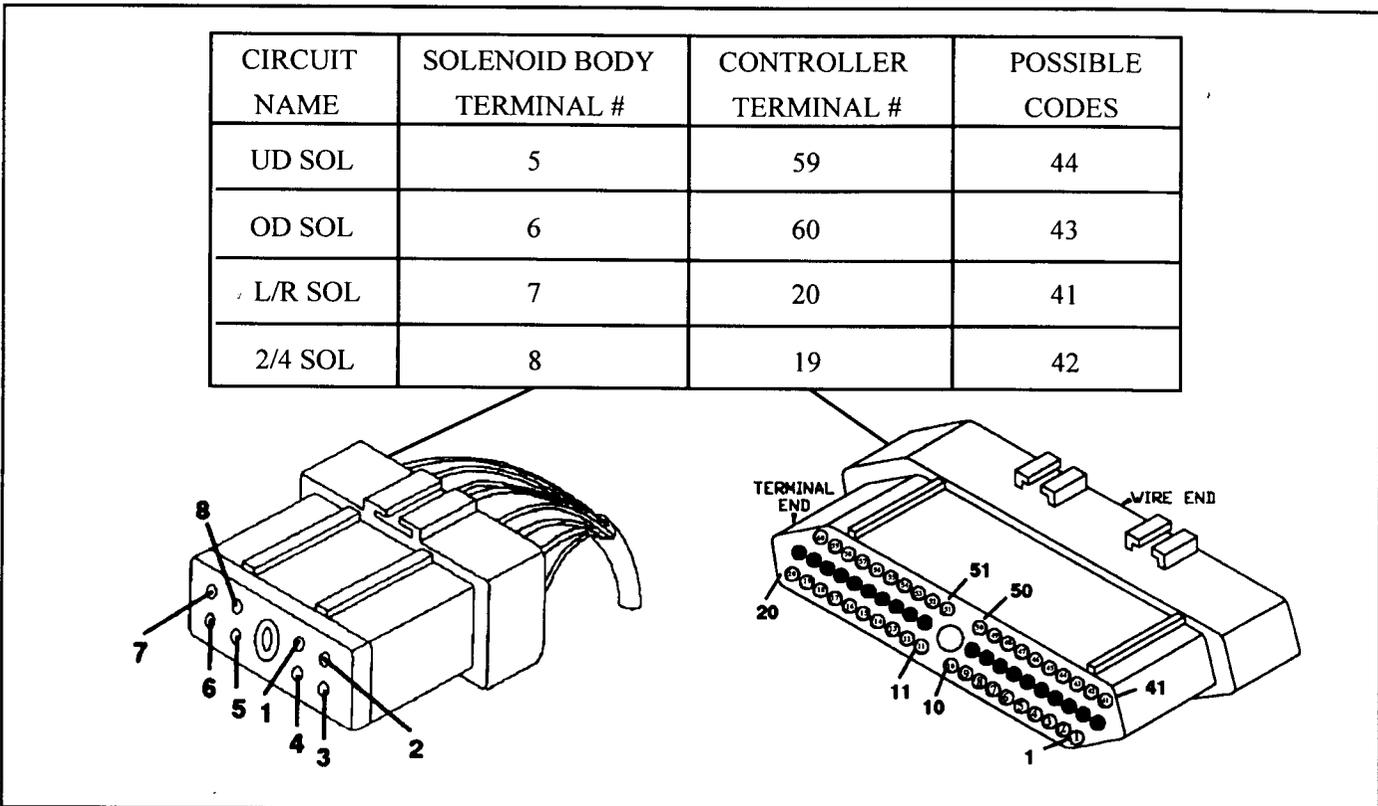
- If when performing the above check an open is seen on one of the solenoid wires, use Figure 52 to perform a continuity check on the wire in question. If it is determined that the wire is severed, a new wire can be run and spliced in outside the harness.

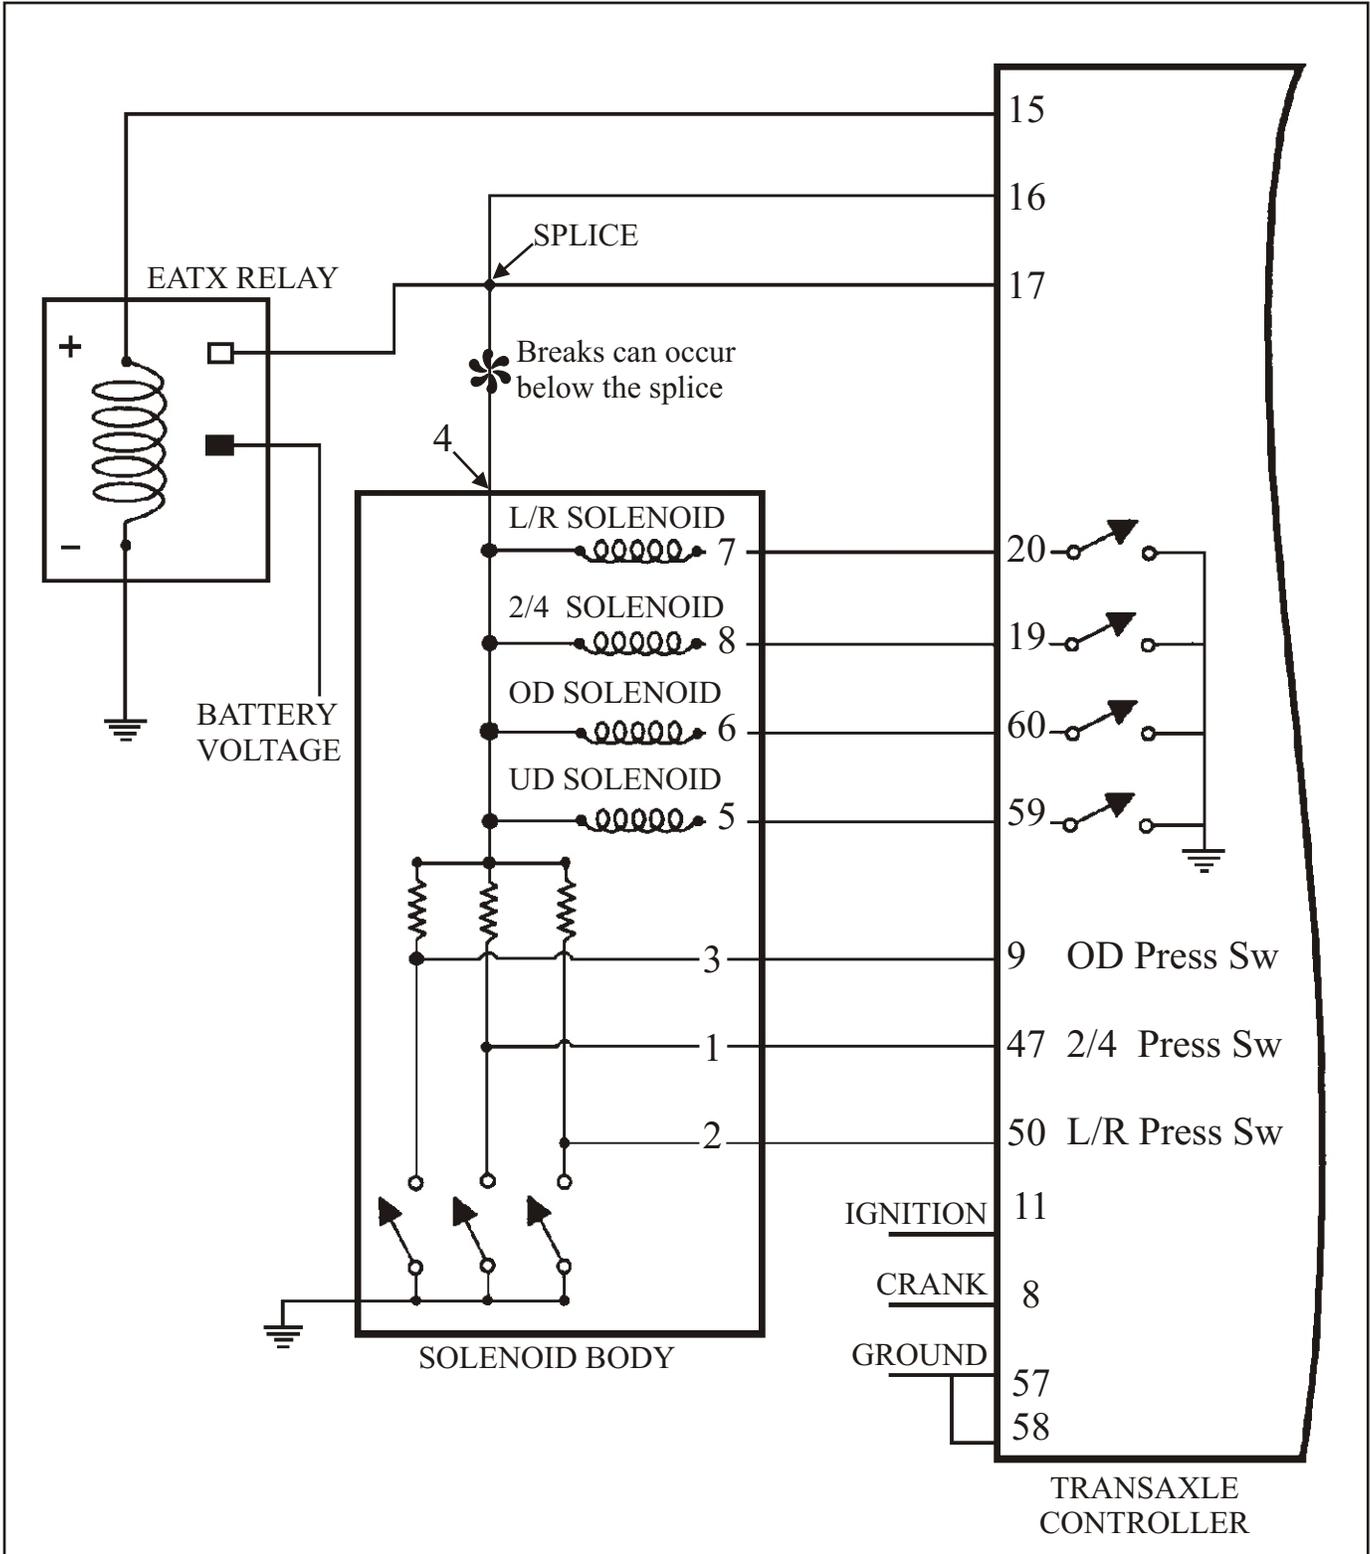
Figure 53

- If when making the above checks and the meter reads infinite on all solenoids, the power wire going to the # 4 pin in the solenoid body has been known to break below the splice as shown in Figure 53. Check for continuity between terminal 16 in the TCM connector to terminal 4 in the solenoid body connector.

- Repeat the test but from terminal 17 to terminal 4. If an open is found, either the harness will need to be replaced or the break has to be located and repaired. This will require peeling back the harness from the solenoid body connector until the break is located.

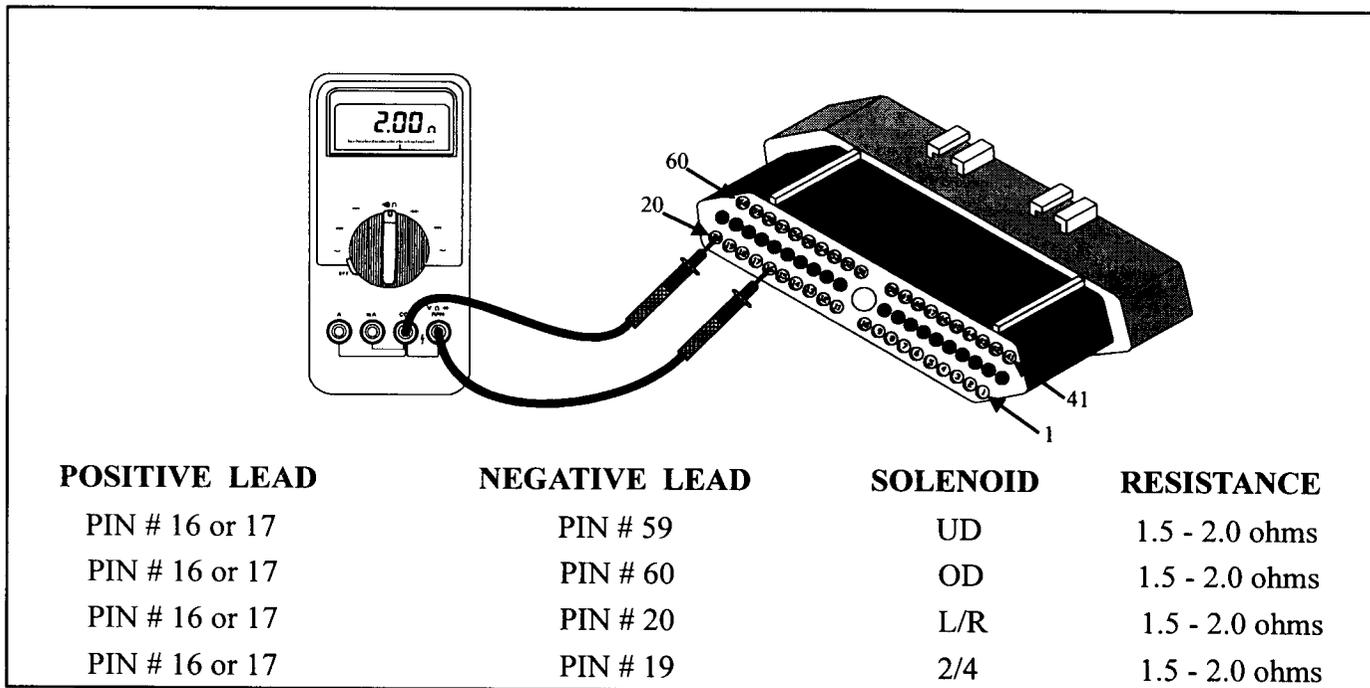
Figure 54

- Unplug the TCM's 60 way connector. Using a DVOM check the resistance of all four solenoid circuits by placing the positive lead onto pin 16 or 17 as seen in Figure 54. With the negative lead, carefully touch pins 19, 20, 59 and 60 one at a time. Each solenoid should measure approximately 1.5 to 2.0 ohms. If the solenoid providing the code reads considerably higher or lower from the other three solenoids, change the solenoid body. If all the readings are the same, wiggle the solenoid wires with the meter still attached and see if the readings behave erratic. If so, the solenoid connector is bad and will need to be repaired.

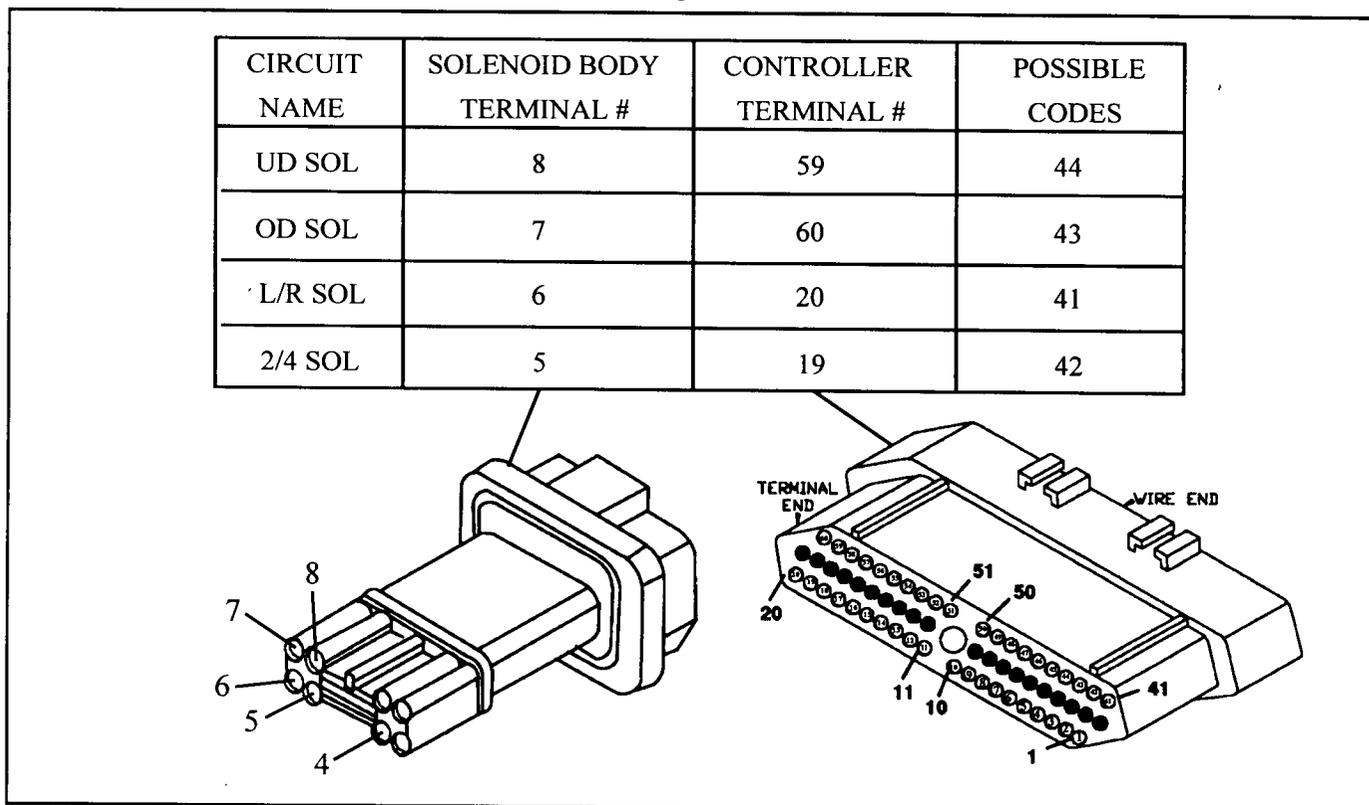
- If when performing the above check an open is seen on one of the solenoid wires, use Figure 55 to perform a continuity check on the wire in question. If it is determined that the wire is severed, a new wire can be run and spliced in outside the harness.

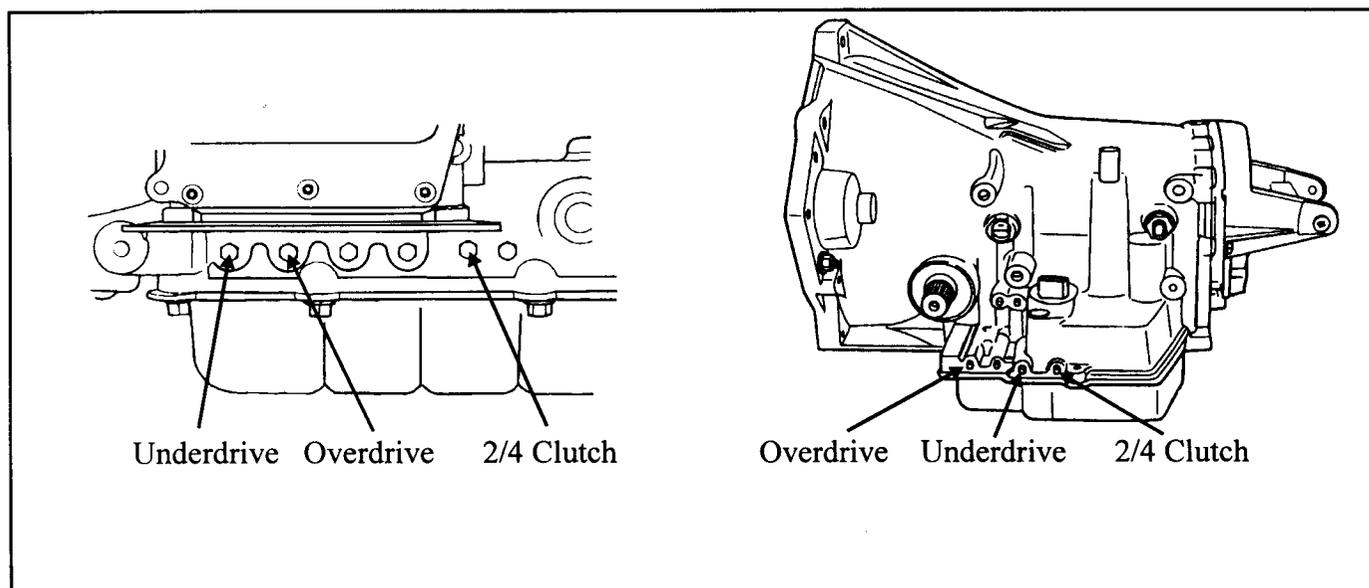
Figure 56

- With the pressure specifications given on page 65, the UD, OD and 2/4 hydraulic circuits should be checked with a pressure gauge (See Figure 56). The 2/4 clutch pressure should be checked in 2nd gear. 120-145 psi should be seen and 0 psi in first and third. Since the transaxle is experiencing a 3-4 shift abort, the full 75-95 psi may not be seen at the 2/4 tap when attempting to go to fourth and should be considered as normal. If the pressure in the 2/4 clutch circuit is substantially low in second gear or pressure is seen in first or third, this hydraulic circuit needs to be investigated.

- The UD clutch circuit is next and can be the most likely hydraulic problem causing the 3-4 shift abort. This clutch circuit should show 120-145 psi in first and second and 75-95 in third. There should be 0 psi in this circuit when in 4th gear. Since the transaxle will not fully go into 4th gear, a 0 psi reading may be hard to detect. To get around this problem, when the transaxle is in third gear, step heavy into the throttle and bring the vehicle up to speed so as to be able to do an OFF throttle upshift into 4th gear. If a 3-4 shift takes place without being on the throttle, the controller will allow a 3-4 shift to take place. While in 4th gear, read the UD pressure gauge. If pressure is seen, this hydraulic circuit needs to be investigated. A bad solenoid body, valve body or pump can cause this type of cross leak.

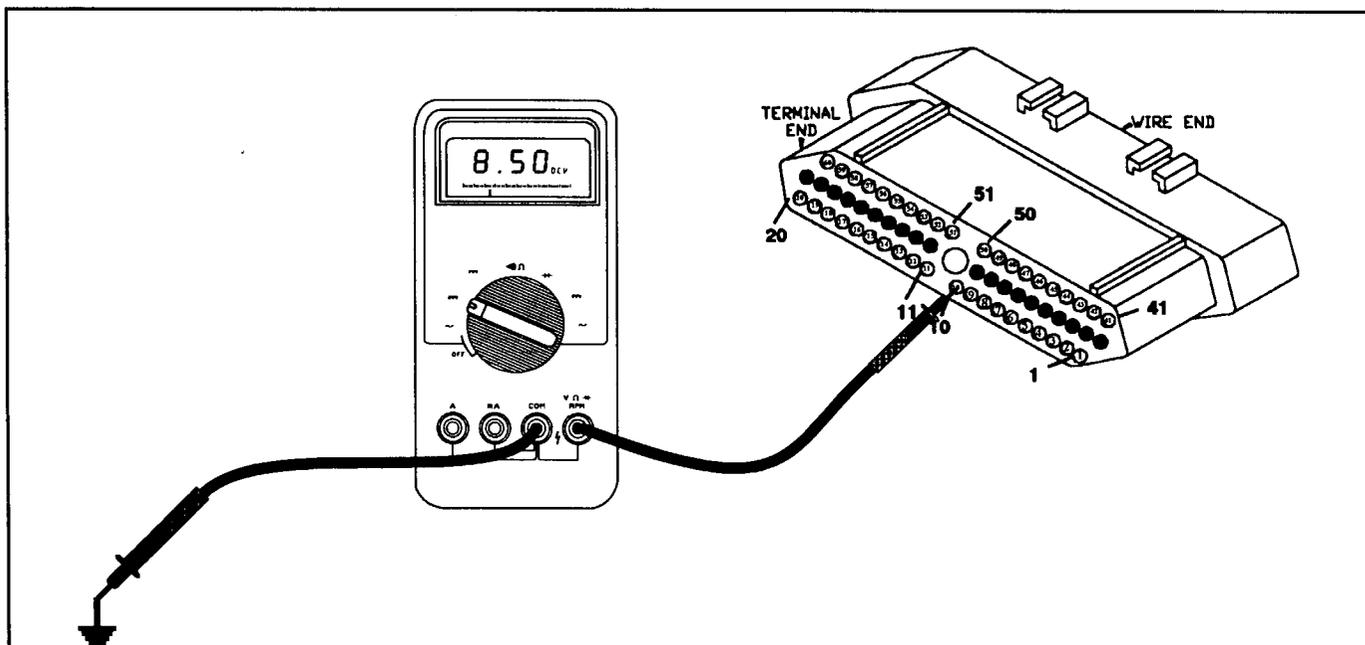
Figure 57

- Unplug the TCM connector with the ignition off. Once disconnected, turn the ignition on and check terminal 10 for 7 to 10 DC volts (See Figure 57). If 7 to 10 volts is observed, replace the TCM. If there is not, go to the next step.

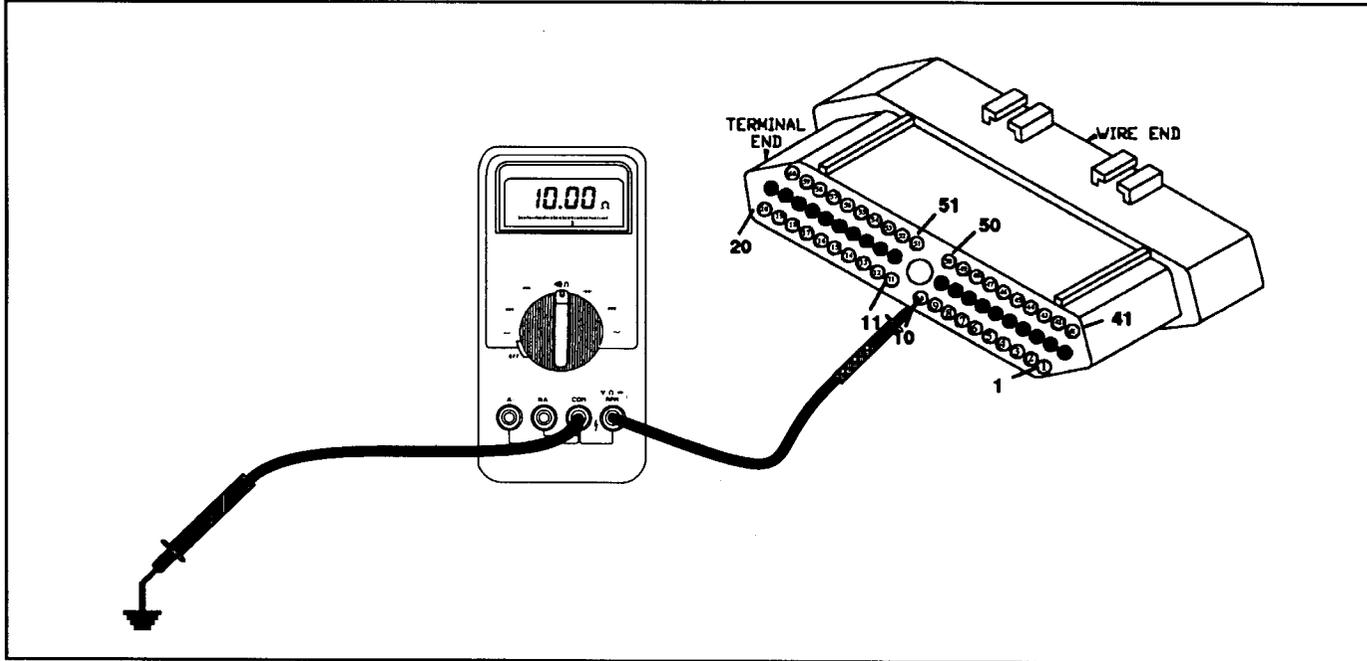
Figure 58

- Turn the ignition off. With the meter still on terminal 10, change to an ohms setting (See Figure 58). If the resistance is below 5 ohms, the wire is shorted to ground and will need to be repaired or replaced. If resistance is above 5 ohms, go to the next step.
