# 41TE & 42LE CODE BOOK

## **41TE & 42LE DIAGNOSTIC CODE BOOK**

### **INTRODUCTION**

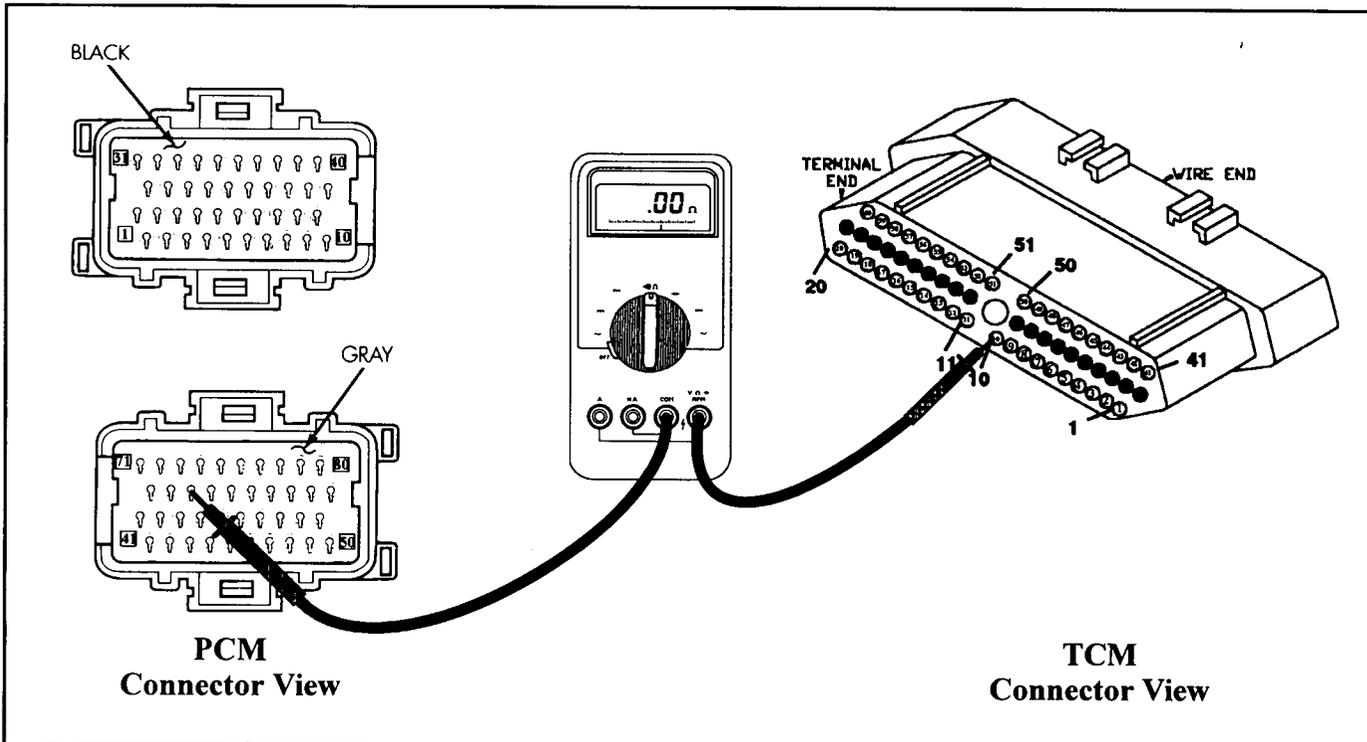
Figure 59

- Keep the ignition off and unplug the PCM and perform a continuity check across the wire. Place one meter lead to cavity 63 in the PCM connector and 10 in the TCM connector (See Figure 59). If resistance is below 5 ohms change the PCM. If an open is seen, repair or replace the severed wire.

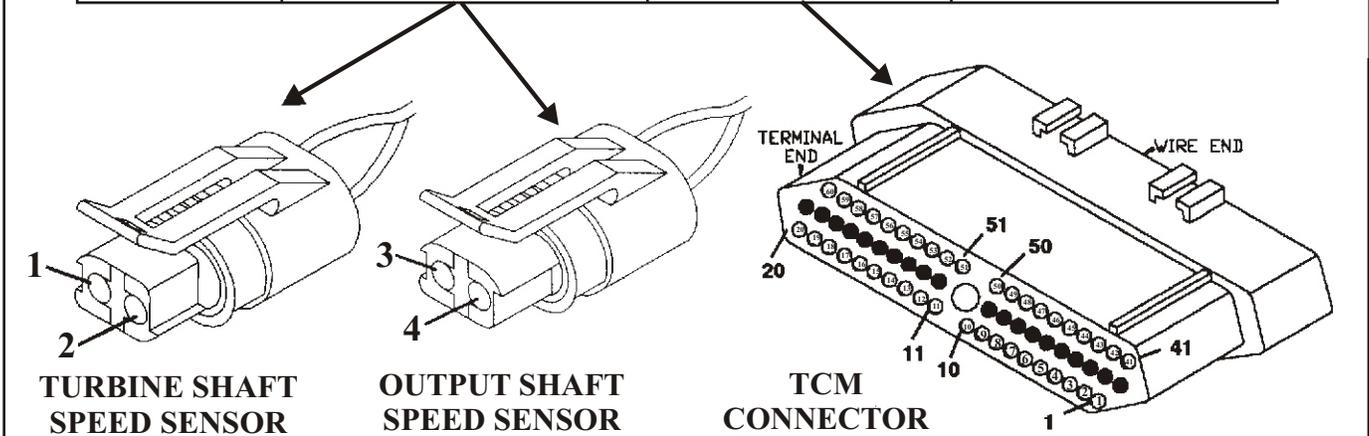
- If an open is observed, use Figure 61 to perform individual continuity checks on each wire. Repair the open wire if necessary. If continuity is seen on each wire, check connector cavities. RPM Sensor Connector repair kit part number is 4419478. See page 25 for the TCM connector check. If connectors are good,

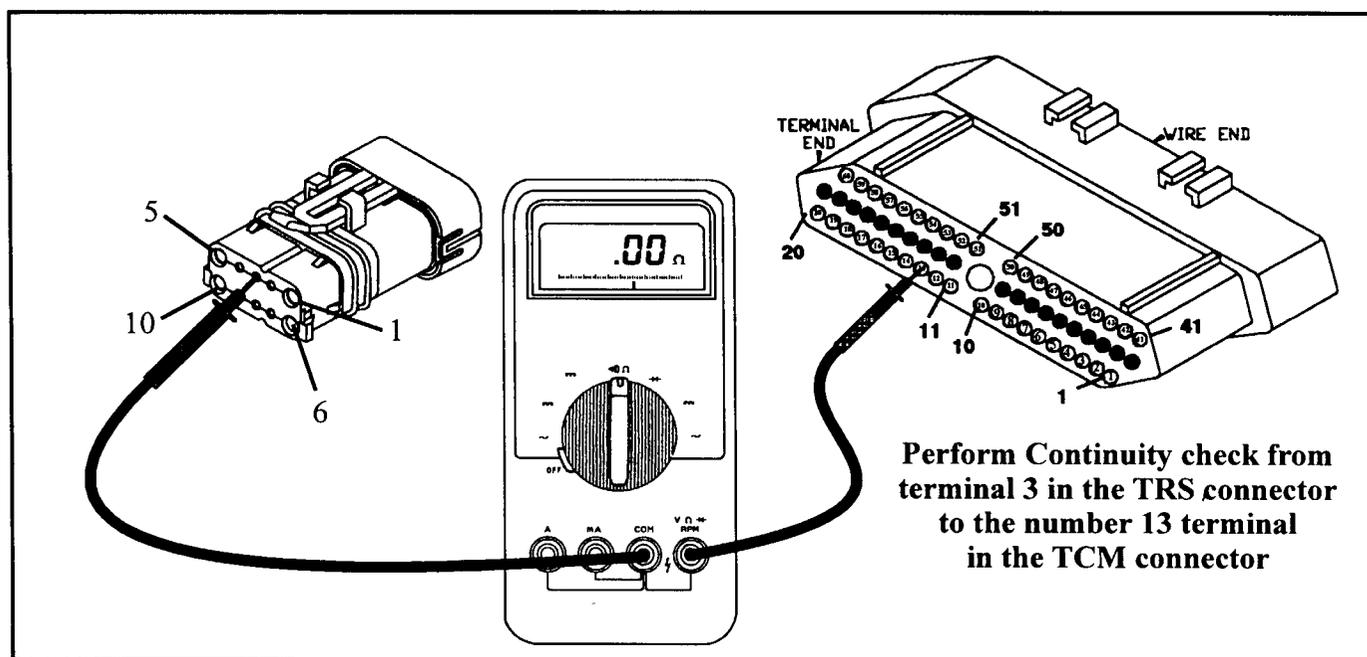
Figure 62

- 1996 and later vehicles have a Transmission Fluid Temperature Sensor built into the Transmission Range Sensor. The ground wire for this sensor is shared with the Turbine and Output RPM sensor at pin 13 in the TCM connector. Should this ground wire become severed, a code 58 and 72 may be set. A continuity check can be performed by placing one meter lead to terminal 3 in the TRS connector and terminal 13 in the TCM (See Figure 62). For further TFT sensor checks, refer to page 84.

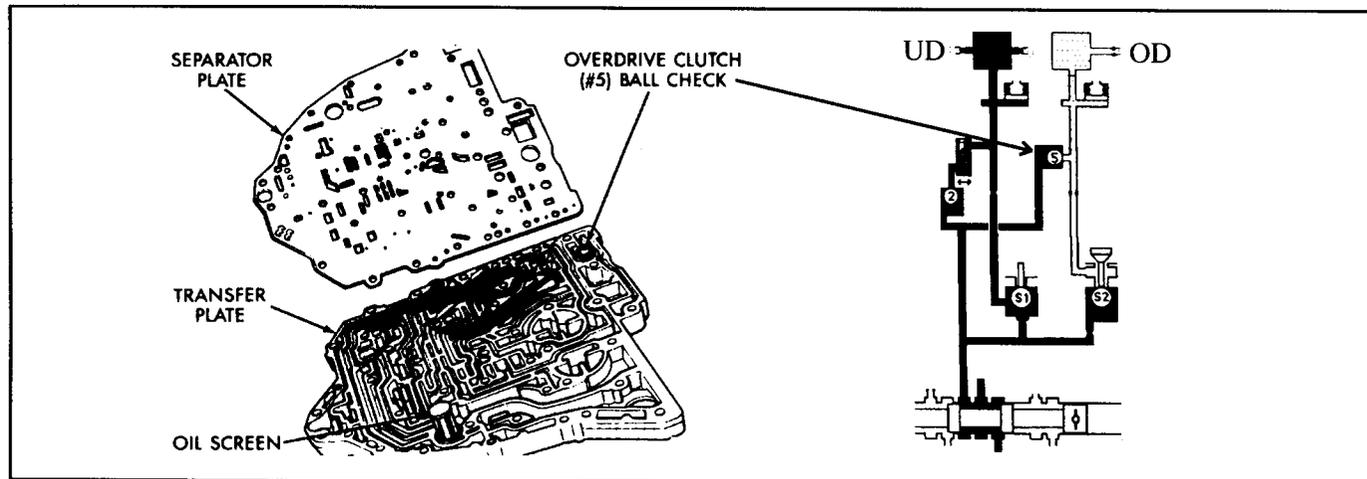
Figure 64

• A low clutch volume reading in just the OD clutch circuit has been commonly caused by a defective O ring on the # 5 check ball capsule in the transfer plate as shown in Figure 64. This blocks controlled line pressure from entering the OD clutch circuit. If the O ring or the capsule itself fails to hold back this pressure, the low OD clutch volume reading will vary depending upon the severity of the leak. If the leak is slight, most of the oil will exhaust past the OD solenoid and the OD clutch volume may appear to be normal. As the leak gets worse, the OD solenoid is flooded and the OD circuit becomes charged with oil causing below minimum CVI. *Note: The # 5 check ball capsule has been eliminated in late model 41TE's and all 42LE's.*

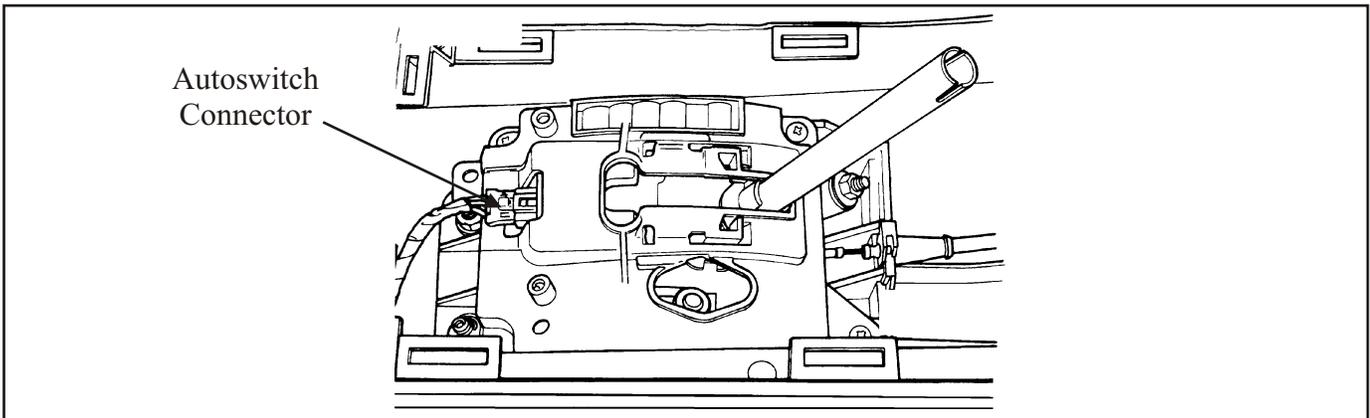
Figure 66

- Locate and unplug the Autostick Switch in the center console (See Figure 66). Using a volt meter, turn the ignition ON and place the negative lead to ground. With the positive lead check for battery voltage at pin 1 in the Autostick connector (See Figure 67). If voltage is seen go to the next step. If voltage is not seen, check for a blown fuse. LH vehicles check fuse # 17, all others check fuse # 11. If the fuse is good, the wire from the fuse to pin 1 is severed and will need to be repaired or replaced.

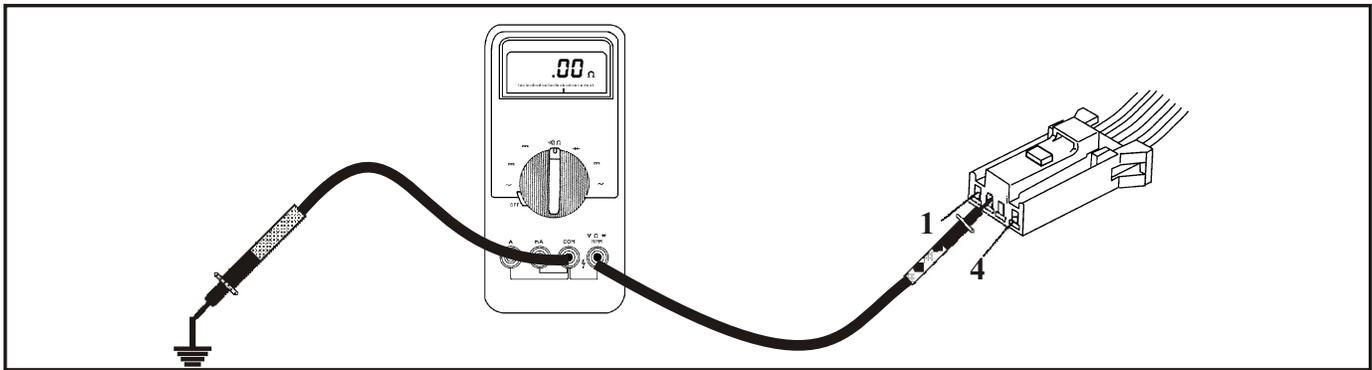
Figure 68

- Turn the ignition off and change the meter to read ohms. Keep the negative lead to ground and place the positive lead into terminal 2 of the Autostick connector (See Figure 68). If continuity (5 ohms or less) is observed, go to the next step. If continuity is not seen, the ground wire is severed or corroded. Repair or replace the wire.
- Unplug the TCM and perform a continuity check from terminal 3 in the Autostick connector to terminal 5 in the TCM (See Figure 69). If continuity is seen, move to the next step. If continuity is not seen, the wire is severed. Repair or replace the wire.
- Perform a continuity check from terminal 4 in the Autostick connector to terminal 44 in the TCM (See Figure 70). If continuity is seen, move to the next step. If continuity is not seen, the wire is severed. Repair or replace the wire.

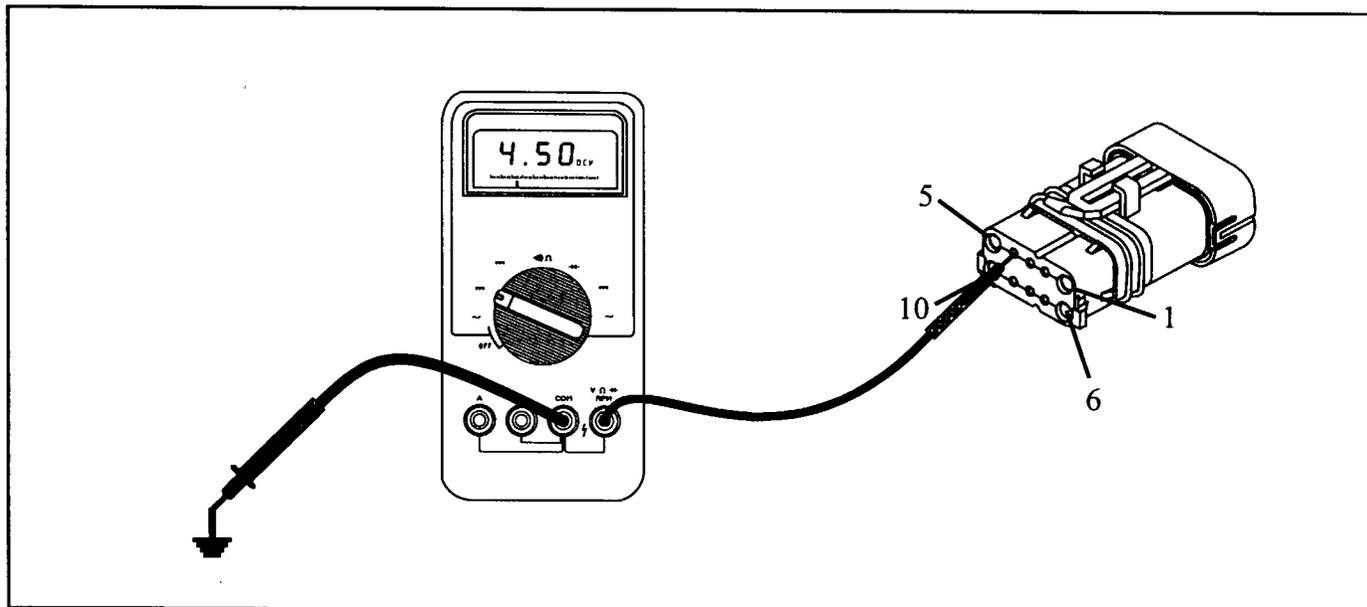
Figure 73

- Unplug the TRS connector. Place the ignition to the "ON" position. With a volt meter placed to DC volts, put the negative lead to a good known ground. With the positive lead, check terminal 4 for voltage (See Figure 73). If voltage is above 4.5 volts move to the next step. If less than 4.5 volts is observed, turn the ignition off and unplug the TCM. Change the meter to an ohms setting and check for continuity between terminal 54 in the TCM connector to terminal 4 in the TRS connector (See Figure 74). If continuity (5 ohms or less) is seen, replace the TCM. If continuity is not seen, repair or replace the wire.

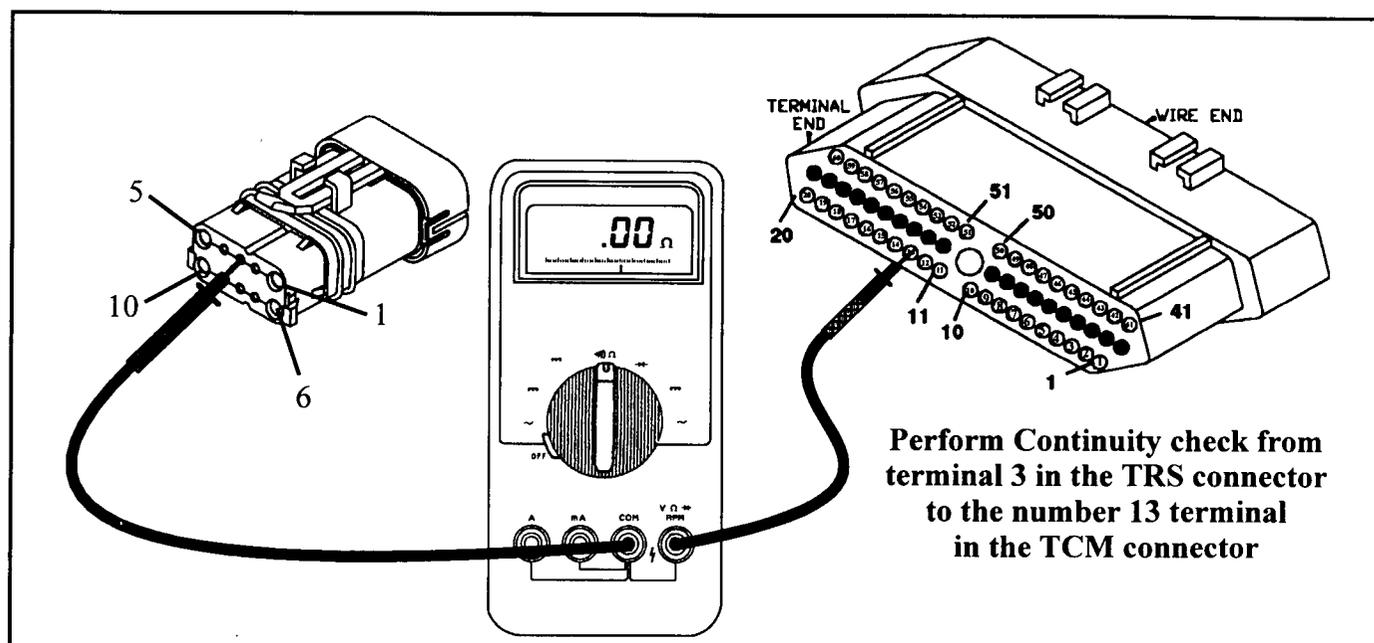
Figure 75

- Perform a continuity check on the TFT's ground wire by placing one meter lead to terminal 3 in the TRS connector and terminal 13 in the TCM as shown in Figure 75. If continuity is seen, go to the next step. If continuity is not seen, repair or replace wire. If the wire is to be replaced, the turbine and output RPM sensor also uses this wire for ground. Be sure to include them in the new wire (See Page 74).

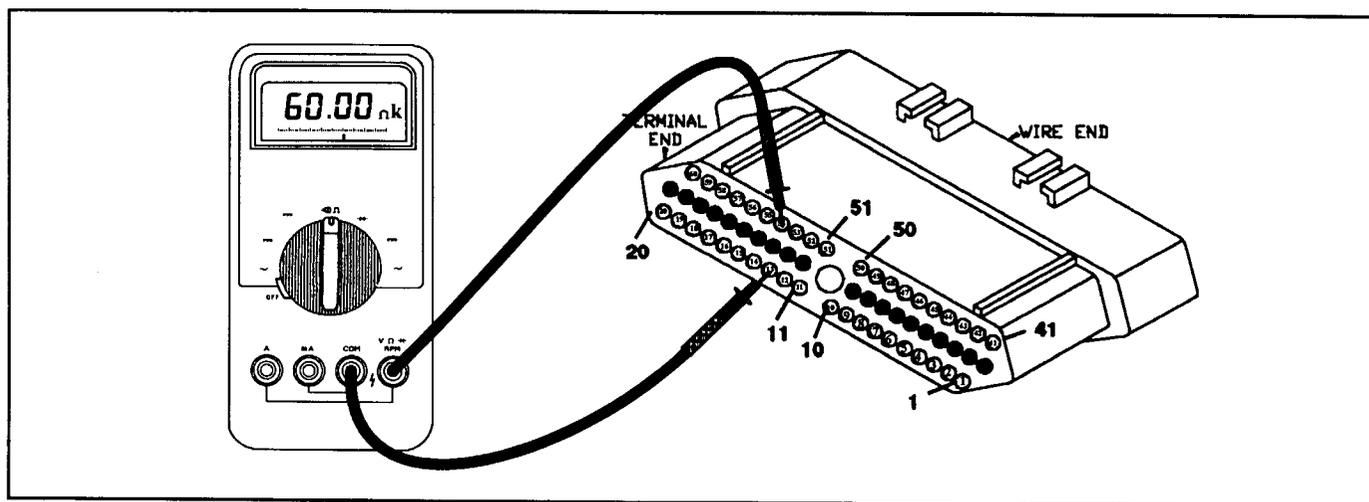
Figure 76

- Re-connect the TRS sensor and perform a resistance check on the TFT sensor from the TCM connector. Place one meter lead into terminal 13 and the other meter lead into terminal 54 (See Figure 76). The range for the sensor from cold to hot is 100,000 ohms to 150 ohms (See Table Below). If the change in resistance is proportional to the change in the transmission fluid temperature and the resistance remains within specification, change the TCM. If the resistance is out of specification or does not change in resistance proportional to temperature, change the TRS.

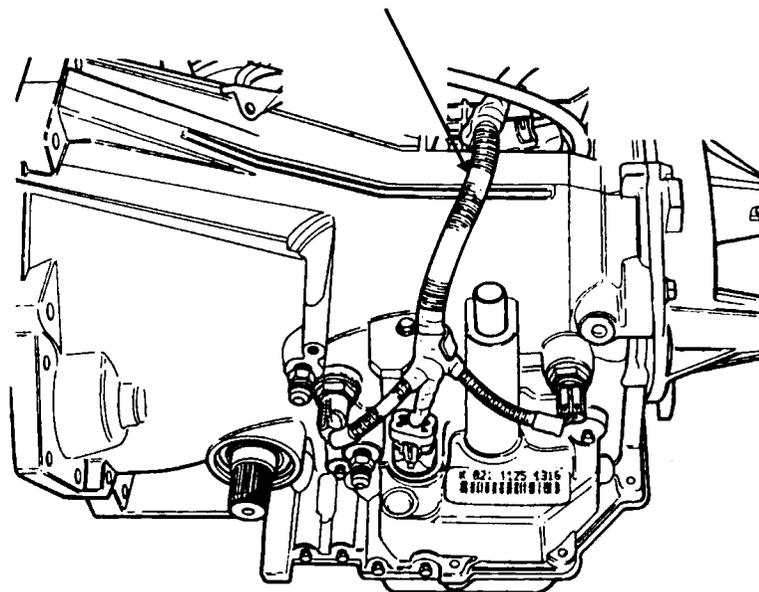
Figure 77

The 42LE transaxle has both the solenoid body and transmission range sensor mounted on the valve body. Each have their own connector coming through the case both of which are not easily accessible with the unit installed in the vehicle. To perform resistance checks of the solenoids, voltage checks on the pressure switches, resistance or volt checks on the Transmission Range Sensor (TRS) is near impossible at the case connector. The harness plugging into the solenoid body and the Transmission Range Sensor runs up to the top of the case above the bell housing where it plugs into the main vehicle harness (See Figure 77). This short wiring harness from the bell housing down to the solenoid body and TRS will allow for checks to be performed with ease. Figure 78 shows the top two connectors in this short pig tail harness. Each pin in these two connectors are numbered and identified. Should a resistance check need to be made on the solenoid body, rather than unplugging the solenoid body at the case (which could fill up with fluid if the unit is full), locate the 8 pin connector above the bell housing and unplug it. Place the positive meter lead of an ohm meter to pin 7. With the negative lead, touch pins 1, 2, 3 and 8 to obtain all 4 solenoid resistance values (See Figure 79). The chart in Figure 79 also provides checks that can be made through the 12 pin connector on the Turbine Shaft RPM sensor, the Output RPM sensor and the Transmission Fluid Temperature sensor.

SHORT HARNESS

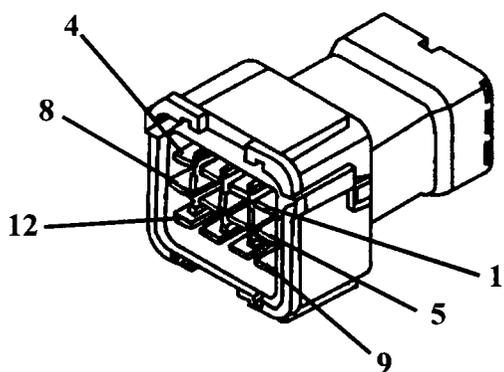
**12 PIN CONNECTOR  
(TRANSMISSION SIDE)**

CAVITY	COLOR	FUNCTION
1	RD/BK	INPUT SPEED SENSOR SIGNAL
2	DB/BK	SPEED SENSOR GROUND
3	LG/WT	OUTPUT SPEED SENSOR SIGNAL
4	BR/YL	TRS-T1 SENSE
5	VT/WT	TRS-T2 SENSE
6	VT	TRS-T3 SENSE
7	LG/BK	TRS-T4 SENSE
8	VT *	TRANS TEMP. SENSOR SIGNAL
9	DG/OR *	AUTOMATIC SHUT DOWN RELAY
10	VT/BK	REVERSE LAMP SENSE
11	WT	FUSED IGNITION SWITCH OUTPUT
12	BK/LG	FUSED IGNITION SWITCH OUTPUT

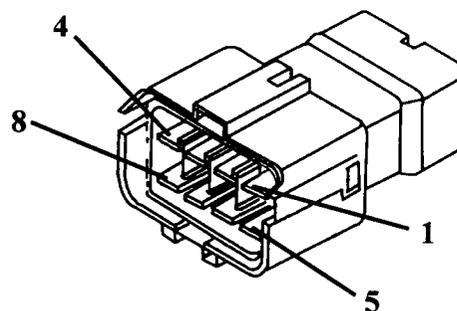
**8 PIN CONNECTOR  
(TRANSMISSION SIDE)**

CAVITY	COLOR	FUNCTION
1	BR	O.D. SOLENOID
2	WT	2-4 SOLENOID
3	PK	U.D. SOLENOID
4	DG	L-R PRESSURE SWITCH
5	YL/BK	2-4 PRESSURE SWITCH
6	OR/BK	O.D. PRESSURE SWITCH
7	RD	TRANS CONTROL RELAY OUTPUT
8	LB	L-R SOLENOID

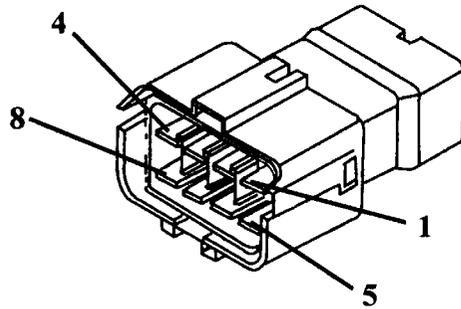
<u>TEST</u>	<u>POSITIVE LEAD</u>	<u>NEGATIVE LEAD</u>	<u>RESISTANCE</u>
L/R SOLENOID		8	1.5-2.0 OHMS
2-4 SOLENOID	7	2	1.5-2.0 OHMS
UD SOLENOID		3	1.5-2.0 OHMS
OD SOLENOID		1	1.5-2.0 OHMS

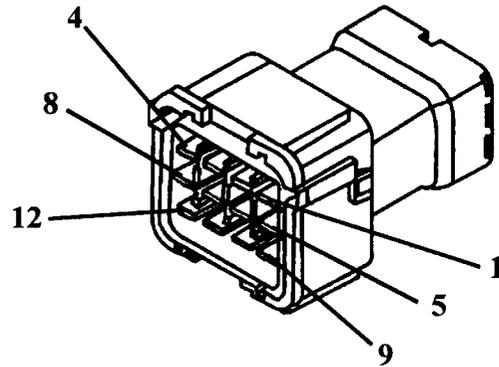
<u>TEST</u>	<u>POSITIVE LEAD</u>	<u>NEGATIVE LEAD</u>	<u>RESISTANCE</u>
TURBINE RPM	1		300-1200 OHMS
OUTPUT RPM	3	2	300-1200 OHMS
TEMP. SENSOR	8		VARIES (See Page 86)

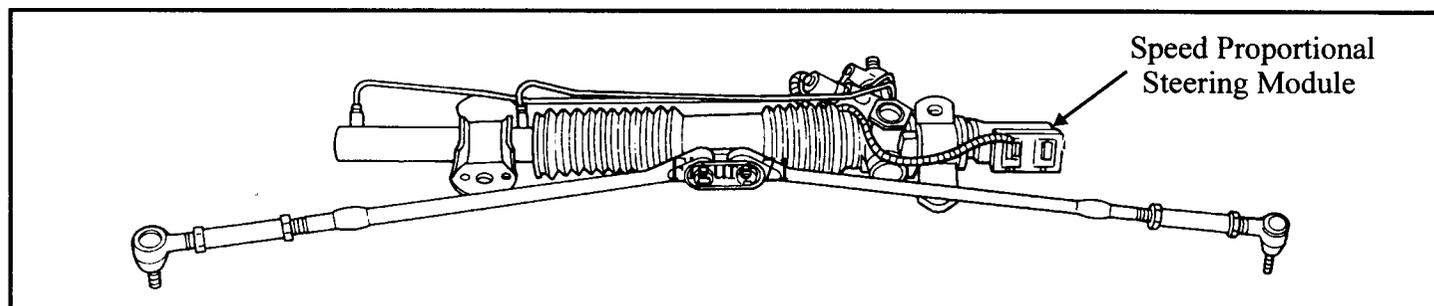
- Locate the Speed Proportional Steering Module on the steering rack as shown in Figure 80 and unplug it. Terminal 1 is battery feed from the ignition switch through either fuse 6 or 20. If battery voltage is not seen with the ignition ON, repair or replace fuse, ignition switch or severed wire. If voltage is seen go to the next step.

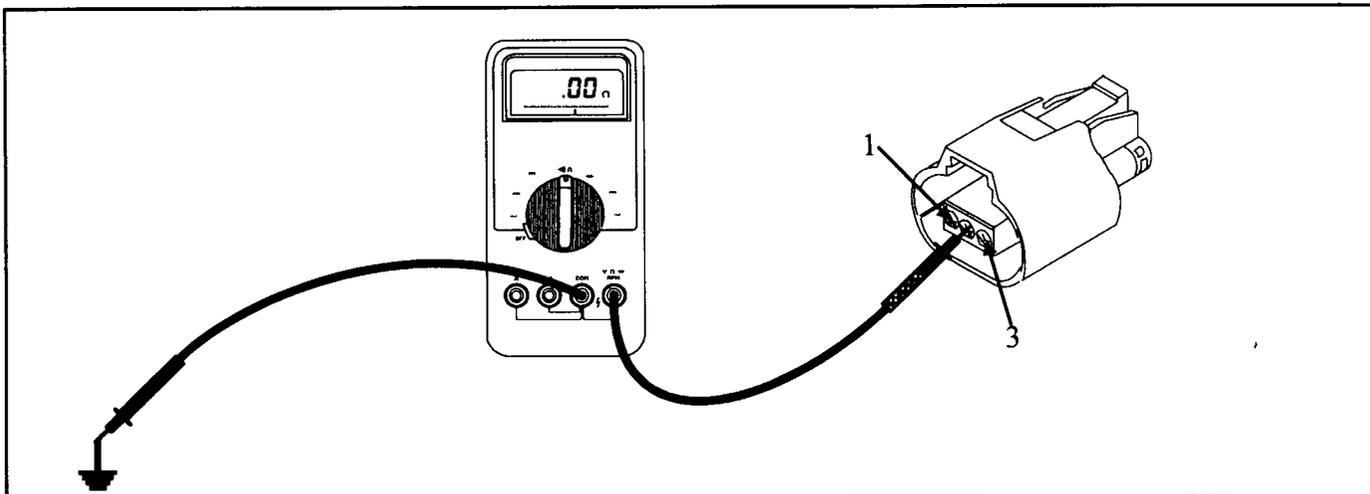
Figure 82

- Set meter to ohms and check the middle terminal for continuity as the middle wire goes to ground (See Figure 82). If continuity is seen (5 ohms or less), go to the next step. If continuity is not seen, repair or replace the wire.
- Perform a continuity check from terminal 3 in the Speed Proportional Steering Module connector to terminal 58 in the TCM connector (See Figure 83). If continuity is seen, go to the next step. If an open is seen repair or replace the wire.
- Plug the module and TCM back in and carefully back probe the # 3 wire with the meter set to DC volts. Start the vehicle and allow to the wheel to spin slowly. A 5 volts pulse should be seen. If there is, replace the Speed Proportional Steering Module. If there is not, either the TCM has not been flash with pinion factor information or the TCM is defective. Flash or replace the TCM.
