41TE & 42LE CODE BOOK

41TE & 42LE DIAGNOSTIC CODE BOOK INTRODUCTION

The Chrysler 41TE and 42LE Diagnostic Code Book is designed to provide the technician with a step by step diagnostic approach to each and every transaxle code available from 1989 to 1998 model year. This manual can be used in companion with any type of scanner utilized in retrieving these codes from the controller. As an aid to the technician, component location is recognized throughout the manual.

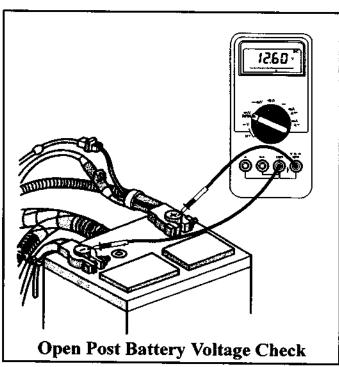
Figure 1

Using a DVOM set to DC volts, measure the open post battery voltage by placing the negative lead to the negative battery post and the positive meter lead to the positive battery post as shown in Figure 1.

With the volt meter connected to the battery as shown in Figure 1, start the vehicle. Turn on the headlights and blower motor to put a load on the voltage system. Approximately 13.5 to 14.4 volts should be seen (See Figure 3). If 15 volts or higher is seen, this may indicate an overcharging alternator which may result in erratic computer behaviour. This problem needs to be rectified before going to the next step.

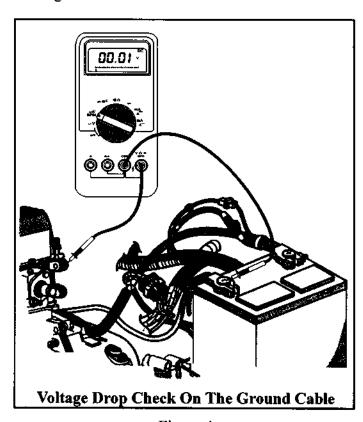
Figure 4

The next step is to perform a voltage drop test across the ground cable. This checks for corrosion or bad connections with the main ground cable itself. To do this, keep the vehicle running and turn on as many accessories as possible, i.e. headlights, AC, radio, etc. With the meter set to DC volts, place the negative lead of the meter to the negative post of the battery. Place the positive lead of the meter to either the body or engine block (See Figure 4). No more than 0.10 volts should be seen. A good ground will usually show 0.00 or 0.01 volts. If 0.20 or more is seen, clean and/or replace the main ground cable to obtain a 0.00 or 0.01 reading.

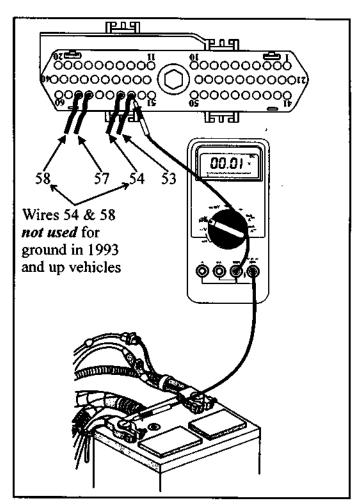
Figure 5

Locate the transaxle controller (See Pages 6 and 7). Once the controller is located, pop the plastic harness cover away from the wires going into the connector (Do not remove the center bolt). Once the cover is removed and the 60 way connector can be viewed from the wire side, locate the ground wires. 1989 to 1992 use wires 53, 54, 57 and 58 for ground (See Figure 5).

Start the vehicle and turn on several accessories. Set the meter to DC volts and place the positive lead of the meter to the negative battery post. Using the negative lead, carefully back probe each ground wire as shown in Figure 5. No more than 0.10 volts can be seen. If more than 0.10 volts is seen, that ground wire is bad.

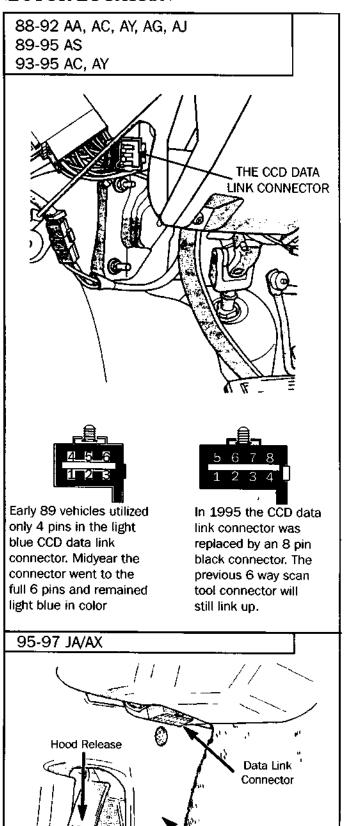
Drivers side kick panel

CCD DATA LINK CONNECTOR

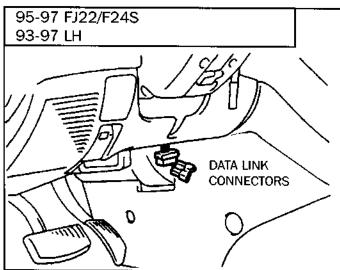
4 & 6 WAY DATA LINK TERMINAL I.D.

- 1....SCI Receive (Vehicle with ABS)
- 2....Battery (12V)

- 3....Serial Data Bus (-) (2.5 V)
- 4....Serial Data Bus (+) (2.5 V)
- 5....SCI Transmit (Vehicle with ABS)
- 6....Ground (0.1 V or less)

- 3. If battery voltage is present, check the ground wire by placing the negative meter lead to the appropriate terminal (See pages 11 and 12 for data link terminal identification). Place the positive meter lead to a good known ground. There should be 0.1 volt or less. If a higher voltage value is seen, clean or repair the ground wire.

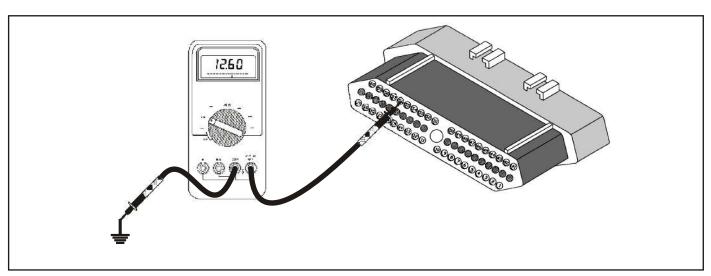
Figure 7

- 1. Locate the TCM (See pages 6 and 7) and carefully unplug the 60 way connector.
- 2. With a DVOM set to DC volts, check for battery voltage on the J11 circuit at pin 56 as shown in Figure 7. If battery voltage is seen, go to the next step. If battery voltage is not seen, go to step 4.

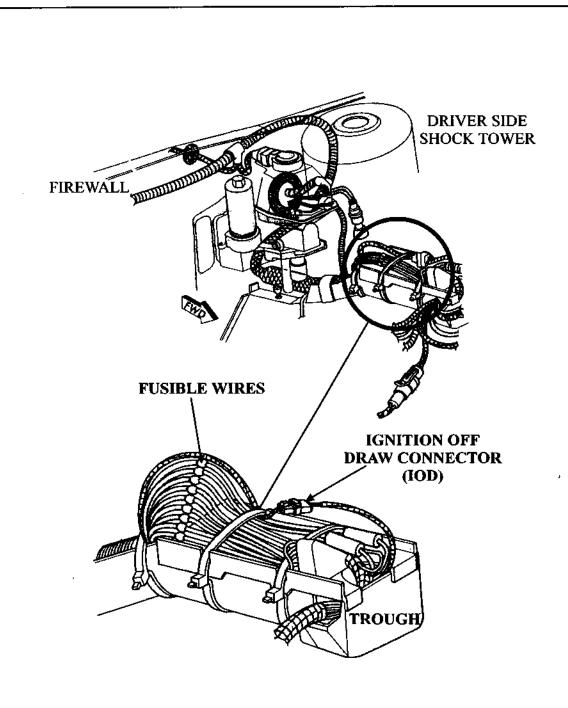
- 4. If battery voltage is not seen, a fuse or a fusible wire may be blown. Fusible wires are color coded and can usually be found below and between the battery and driver side spring tower as shown in Figure 8. Refer to Figures 9 and 10 for fusible wire color or fuse number.

Typical view of both fusible link and IOD connector location. Not all vehicles have an IOD connector or a trough that the fusible links sit into. All fusible links are located behind and below the battery tray towards the driver side shock tower.

- With the connector unplugged, check cavity # 56 for battery voltage (See Figure 13). While checking for voltage, wiggle the main wiring from the battery to the controller. If battery voltage is lost during this wiggle test, a bad fusible link or a break in the wire has occured (See Figure 8 for fusible wire location). In Figures 9 and 10 a Fusible Wire Chart can be found showing vehicle application and fusible wire color. In some applications a typical fuse is used and is noted. If a broken wire is in the harness, a continuity check is required at different points across the wire to locate the break.

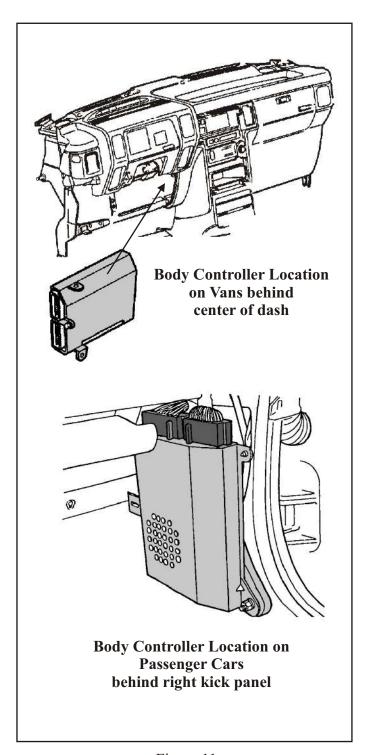
The body controllers in vans is located behind the center of the dash left of the steering column. Passenger cars have the body controller located behind the passenger side kick panel (See Figure 11).

If the vehicle is equipped with a body computer (See Figure 11 for body controller location), unplug and clean its connector. After plugging it back in, verify scanner communication. If a BUS failure still remains, the body computer may need to be replaced. There is not a sure method in determining which controller is causing the BUS failure. When a vehicle is not equipped with a body computer, it is safe to determine that the TCM is bad causing the concern. If it is equipped with a body computer, it could be either controller. However, the body computer would be the most likely cause of the problem. The reason is that the body controller is the computer controlling the voltage in the BUS system. So if there is a BUS failure, the most likely candidate would be the controller responsible for putting the voltage into the BUS system.

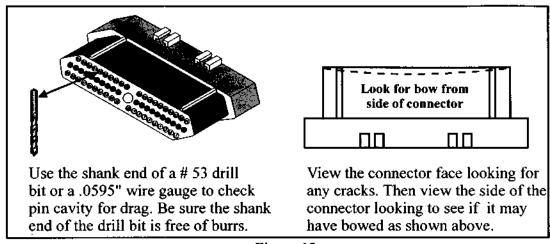
Figure 12

- Perform the *Preliminary Electrical Checks* outlined starting on page 3. Be sure to use the chart on page 5 when testing the controller's main ground wires.
 - Inspect the 60 way controller connector for corrosion, distortion and/or cracks in the connector, pushed back or spread pin cavities. Particularly the power and ground wire pins (See Figure 12).
 - If the above checks prove good, the controller will need to be replaced.

- Unplug the 60 way connector and check for pin drag at the # 56 cavity using the shank end of a # 53 drill bit or .0595" wire gauge as shown in Figure 12. Repair if necessary.

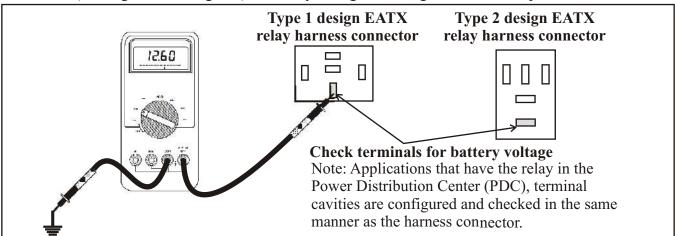
Figure 15

- Replace the EATX relay, refer to pages 8 through 10 for location. If the problem remains, move to the next step. Tip: The reverse lamp relay and EATX relay are the same and can be interchanged. As a quick check, swap the relays. You must keep the selector lever in Reverse for 5 to 10 minutes. If the lights go out, the relay is bad or the contacts need to be cleaned. If the transaxle system works well while the reverse lights exhibits a problem, replace the relay.
 - Unplug the EATX relay. Using a volt meter set to DC volts, verify that direct battery feed is present in the connector as shown in Figure 15. If battery voltage is not seen, a severed wire, a blown fuse or fusible wire may need to be repaired (See Figures 8 through 10). If battery voltage is seen, go to the next step.

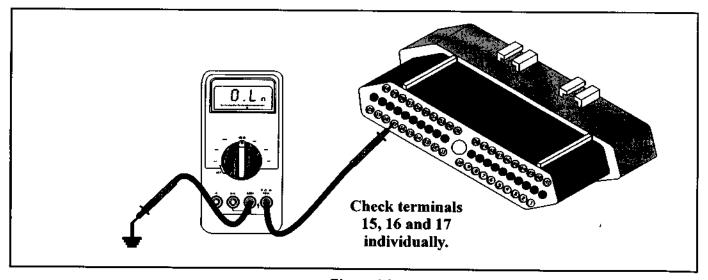
Figure 16

- Keep the EATX relay unplugged. Unplug both the TCM and solenoid body connector. Place the DVOM to an ohm setting. Maintain the negative meter lead to a good known ground. With the positive meter lead carefully probe terminals 15, 16 and 17 in the controller connector as shown in Figure 16. An open circuit should be seen on all three wires. If an ohm reading is seen, a short to ground has occurred on the wire revealing the reading and will need to be repaired. If an open circuit is seen on all three wires, go to the next step.
 - Check for continuity between the EATX relay connector and terminal 15 in the TCM connector as shown in Figure 17. If an open is seen, repair the break in the wire. If continuity is seen, go to the next step.

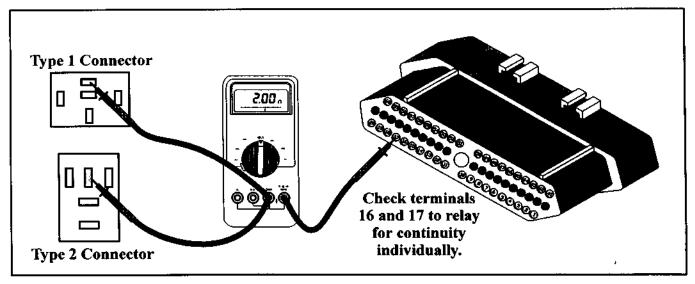
Figure 18

- Check for continuity between the relay connector and terminals 16 and 17 in the controller connector as shown in Figure 18. If controller connector as shown in Figure 18. If an open is seen, repair the break in the wire that shows the open circuit. If continuity is seen, go to the next step.
 - Check for continuity between the ground terminal on the battery to the terminal in the relay connector as shown in Figure 19. If an open is seen, repair the wire. If an open is not seen, go to the next step.
 - Replace the TCM.

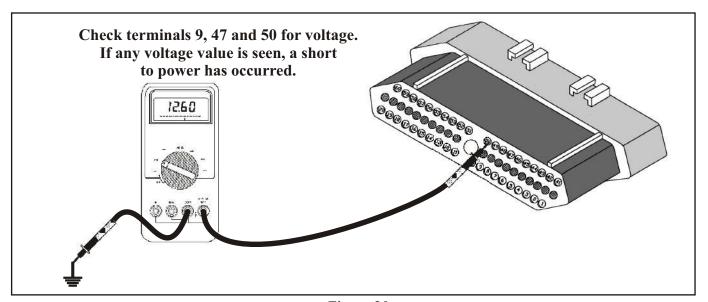
Figure 20

- Unplug the controller and place the DVOM to a DC volt setting. With the negative lead place to a good known ground, carefully inspect terminals 9, 47 and 50 with the positive meter lead (See Figure 20). If a volt reading is seen on any one of these three terminals, a short to power has occurred somewhere in the harness from the solenoid body connector to the controller. Repair the short to power or run a new wire or wires from the solenoid body to the controller. Terminal 9 in the controller goes to terminal 3 in the solenoid body connector. Terminal 47 in the controller goes to terminal 1 in the solenoid body connector. Terminal 50 in the controller goes to terminal 2 in the solenoid body connector. If no volts is seen, go to the next step.

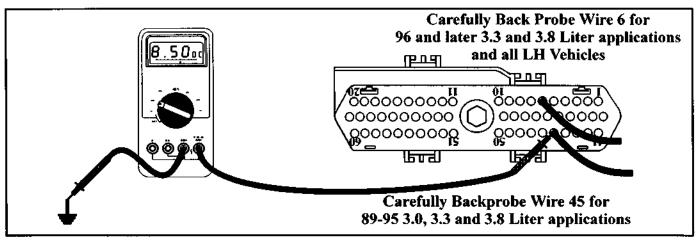
Figure 21

- With a DVOM set to DC volts, carefully back probe wire 45 at the TCM with the positive meter lead and place the negative meter lead to a good known ground (See Figure 21). With the key on and engine off, an 8 to 9 volt pulse should be seen as the crank shaft is turned by hand. If a voltage pulse is observed, the TCM needs to be replaced. If no volts are observed, go to the next step. Note: A square wave form is shown in Figure 22 for those that have oscilloscope testing capabilities (Test is performed with vehicle running).

- With a DVOM set to DC volts, using the positive meter lead carefully back probe wire 45 at the TCM for **89-95** 3.3 and 3.8L applications. For all LH vehicles and 96 and later 3.3 and 3.8L applications, back probe wire 6 at the TCM. Place the negative meter lead to a good known ground (See Figure 21). With the key on and engine off, approximately an 5 to 9 volt pulse should be seen as the crank shaft is turned by hand. If a voltage pulse is observed, the TCM needs to be replaced. If no volts are observed, go to the next step.

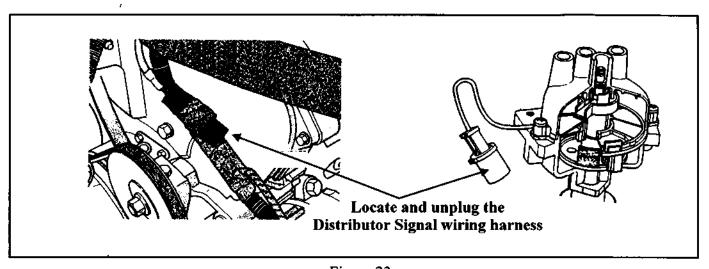
Figure 23

- Go to the distributor and locate a wiring harness coming out from the bottom of the distributor. Trace the harness downstream away from the distributor until you locate the round 4 wire plug as shown in Figure 23. Unplug this 4 way connector and the TCM connector. Perform a continuity check across terminal 2 in the distributor vehicle harness connector to the number 51 wire in the TCM connector as indicated in Figure 24. If there is no continuity, repair or replace the wire. If continuity is seen, go to the next step.

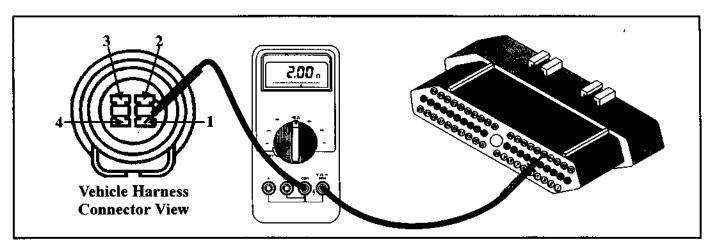
Figure 25

Perform a continuity check across terminal 1 in the distributor vehicle harness connector to the number 45 wire in the TCM connector as indicated in Figure 25. If there is no continuity, repair or replace the wire.

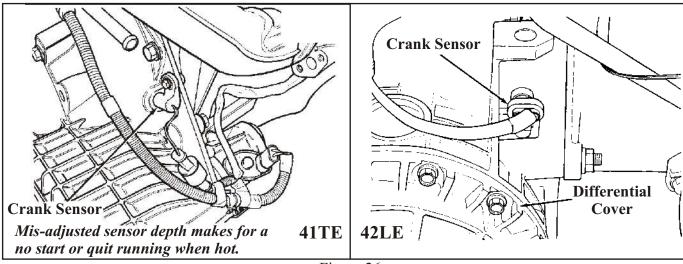
Figure 26

- Locate the crank sensor as shown in Figure 26. Unplug both the crank sensor and the TCM. For **89-95** 3.3 and 3.8L applications perform a continuity check across terminal 1 in the crank sensor connector to terminal 45 in the TCM connector. For all LH vehicles and 96 and later 3.3 and 3.8L, check across terminal 3 in the crank sensor connector to terminal 6 in the TCM connector (See Figure 27). If there is no continuity, repair or replace the wire.

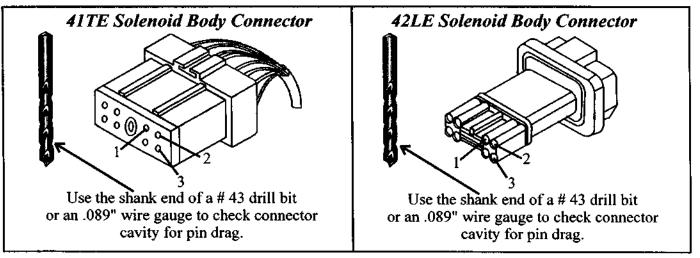
Figure 29

- If any of the above pressure switch codes are present before overhaul, it is possible that a low fluid level or restricted filter may be the cause. It is suggested to inspect both the fluid level as well as the filter and filter O ring. Correct or replace if necessary. Obviously if the filter is loaded with converter clutch material, the unit would need to come out for other repairs. For codes 21, 22 or 24, refer to pages 44 and 49 before performing the following diagnostic steps.
- Inspect cavities 1, 2 and 3 in the solenoid body 8 way connector for being spread, corroded or pushed back to far. Use the shank end of a # 43 drill bit or a .089" wire gauge to check the terminal for pin drag (See Figure 29). Vehicles equipped with the 41TE transaxle have a connector repair kit available from Chrysler under part number 4419476 if connector replacement is needed.

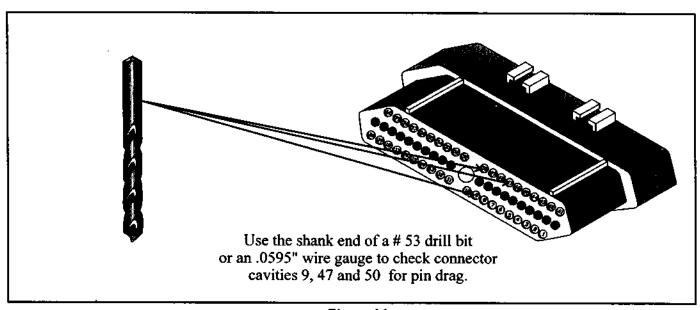
Figure 30

- Inspect cavities 9, 47 and 50 in the TCM 60 way connector for being spread, corroded or pushed back to far. Use the shank end of a # 53 drill bit or a .0595" wire gauge to check the terminal for pin drag (See Figure 30). A connector repair kit available from Chrysler under part number 4419479 if connector replacement is needed.
- If the 60 way connector is good, go to the next step.

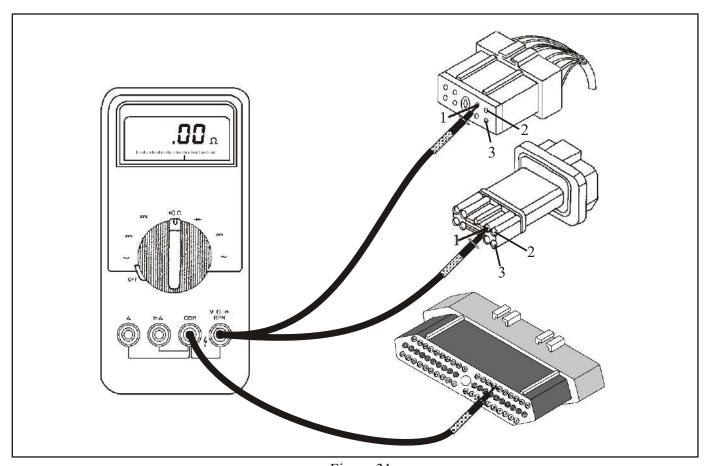
Figure 31

• A continuity check should be made across the following appropriate wire from the solenoid connector to the TCM connector (See Figure 31):

PRESSURE SWITCH	SOLENOID BODY CONNECTOR	TCM CONNECTOR
Low/Reverse Pressure Switch Wire - 2/4 Pressure Switch Wire - Overdirve Pressure Switch Wire -	2 1 3	50 47 9

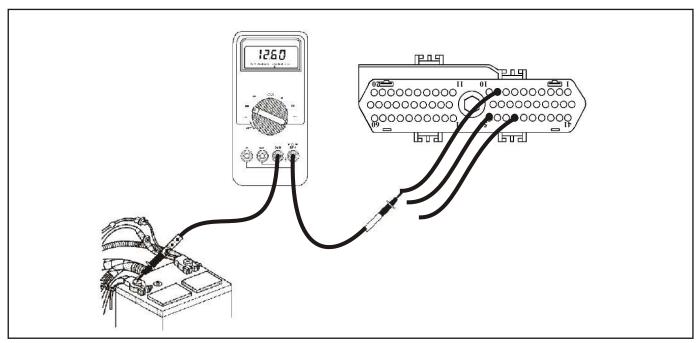
Figure 32

- Place the ignition to the ON position. Do not start the vehicle.
- With a DVOM set to DC volts, place the negative meter lead to the negative battery post. With the positive meter lead, carefully back probe wires 9, 47 and 50 (See Figure 32). Each wire should show battery voltage. Special Note: This method should only be employed when pressure switch codes alone are present. Other codes such as a solenoid code may cause the control to default to a limp mode status with just the ignition turned ON. Voltage would then not be observed at pins 9, 47 and 50 providing a false test.

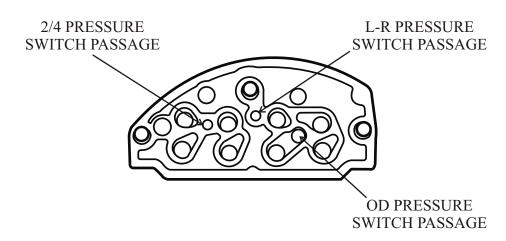
RESISTOR	CONNECT OHMMETER LEADS TO PINS
2-4	4 & 1
L-R	4 & 2
O.D.	4 & 3

PRESSURE SWITCH TEST

PRESSURE SWITCH	CONNECT OHMMETER LEADS TO PIN
O.D.	1 & GROUND (Body Base)
L-R	2 & GROUND (Body Base)
2-4	3 & GROUND (Body Base)

OHM METER SHOULD READ "NO CONTINUITY" WITH NO AIR APPLIED TO THE PRESSURE SWITCH. OHM METER SHOULD READ LESS THAN "3" OHMS . WITH 50 PSI OF AIR PRESSURE APPLIED TO THE PRESSURE SWITCH.

- If any one of the wires do not show voltage during this test, there is a break in that wire from the solenoid body to the TCM. Repair the wire.
- If voltage is seen on all three wires, inspect the solenoid body. To check the solenoid body for a 41TE see Figure 33. To inspect a 42LE solenoid body, see Figure 34.

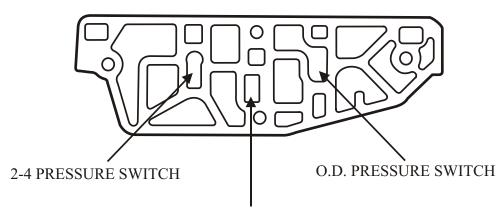
RESISTOR	CONNECT OHMMETER LEADS TO PINS
2-4	4 & 1
L-R	4 & 2
O.D.	4 & 3

PRESSURE SWITCH TEST

L-R PRESSURE SWITCH

PRESSURE SWITCH	CONNECT OHMMETER LEADS TO PIN
O.D.	1 & GROUND (Body Base)
L-R	2 & GROUND (Body Base)
2-4	3 & GROUND (Body Base)

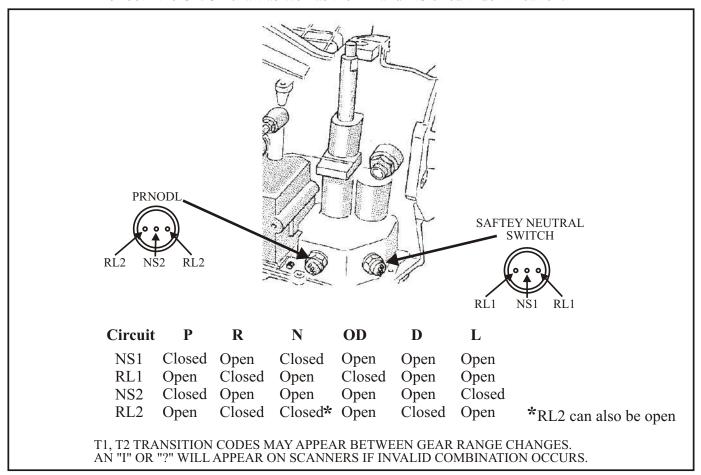
• A scanner can be used to observe the OPEN/CLOSED state of both the Reverse Light 1 & 2 and the Neutral Switch 1 & 2 circuits. This can be especially helpful in determining which exact circuit is malfunctioning. Refer to Figure 35 for both the OP/CL chart as well as the RL and NS circuit identification.

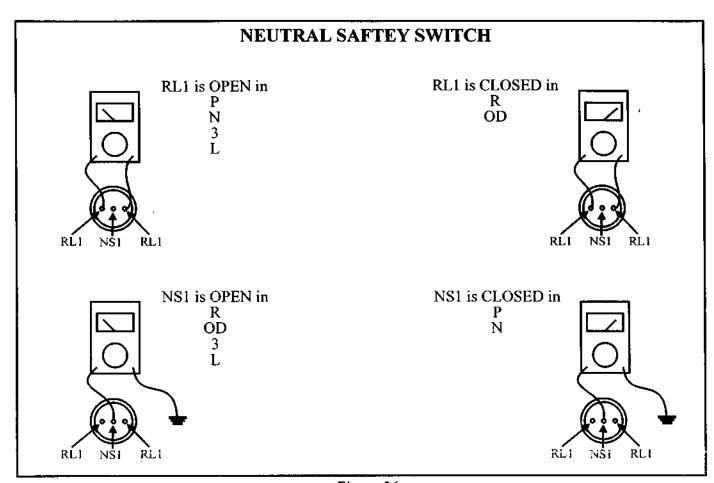
- Once the circuit which malfunctioned has been identified, a check needs to be made on that specific circuit. The first step is to check the PRONDL & Neutral switch operation with the use of a ohm meter. This will check the integrity of the switch as well as the plastic cam located on the manual valve detent assembly. Use Figure 36 to check the specific circuit in question for the Neutral Safety switch or Figure 37 for the PRNODL switch.

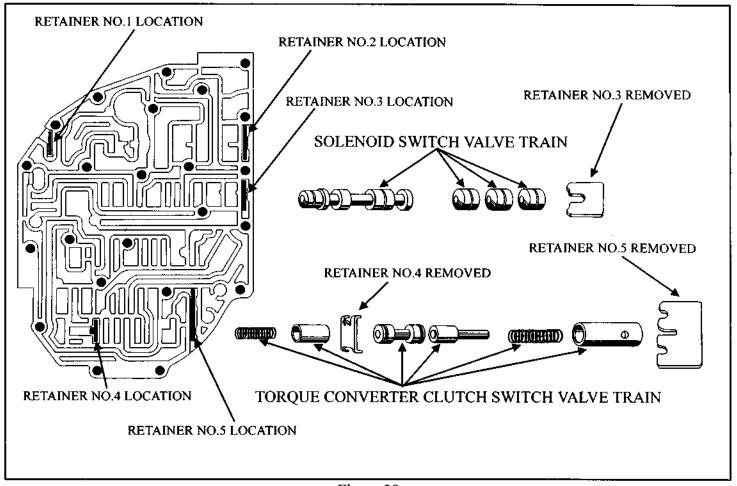
Install the solenoid switch valve train and retainer No.3 as shown in Figure 39.

NOTE: Retainer location No.4 and Torque Converter Clutch Switch Valve Train shown in

Figure 39 are for "92" and later only!

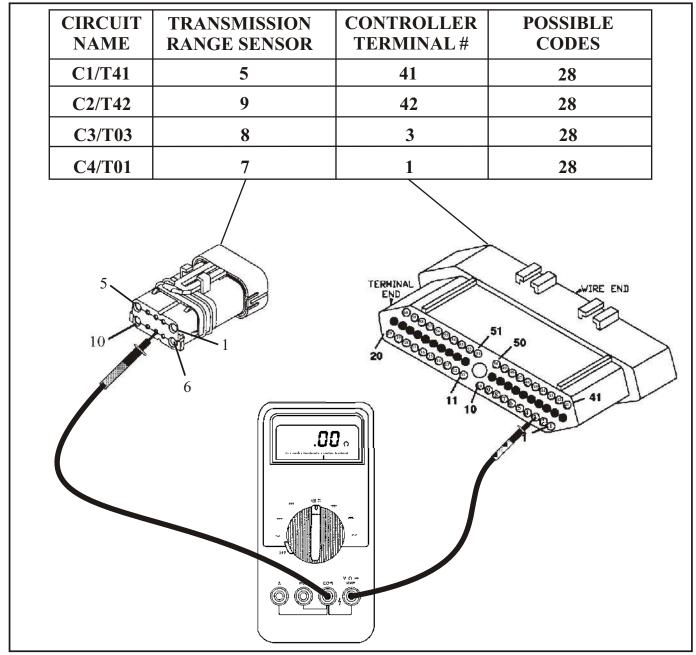
• Once the circuit which malfunctioned has been identified, a continuity check should be made on that circuit. Use the chart found in Figure 41 to assist in identifying the specific circuit or circuits in question. For example, if the scanner reveals that the T3 (C3) circuit does not close when the selector lever is placed in Park, 3 or 1, that specific circuit will need to be checked. In the chart below circuit T3 is the wire which runs from the number eight cavity in the TRS connector to the number three cavity in the TCM connector.

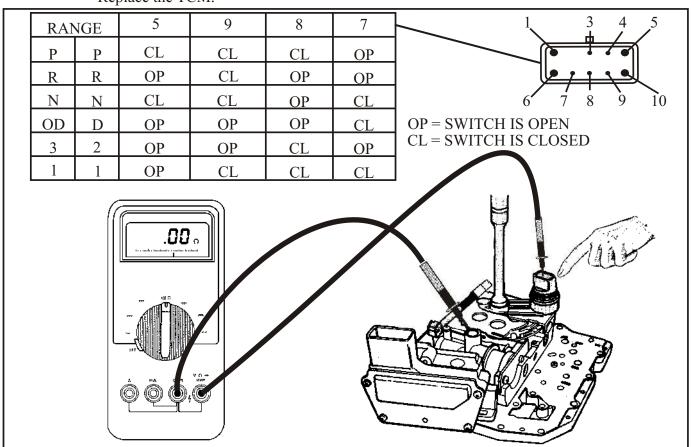
- Remove the valve body from the transmission. With the TRS still mounted to the valve body, place the manual valve in the park position. Fasten the negative meter lead to the metal portion of the rooster comb (See Figure 42). While pushing the switch down onto the rooster comb with one hand, use the positive meter lead to make contact with pins 7, 8, 9 and 10 individually. Approximately .5 to 1.5 ohms should be seen on each pin except #7, it should read open. Use the chart in Figure 42 to check the TRS in each manual valve selection. Replace the TRS sensor if necessary. If all ranges test good, go to the next step.

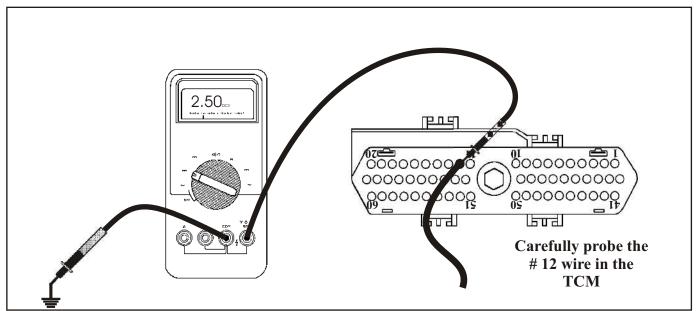
Figure 43

• Compare the TPS voltage seen through a scanner display to a volt meter attached to the number 12 TPS signal wire at the TCM (See Figure 43). With the engine off, place the ignition to the "ON" position. At closed throttle, approximately .50 to .78 volts should be observed. As the throttle is opened the voltage should increase proportionally. When wide open throttle is reached, approximately 3.8 to 4.0 volts should be seen. NOTE: Both readings should be relatively the same however, the TPS voltage change observed through the scanner will be slightly delayed to that seen on the volt meter.

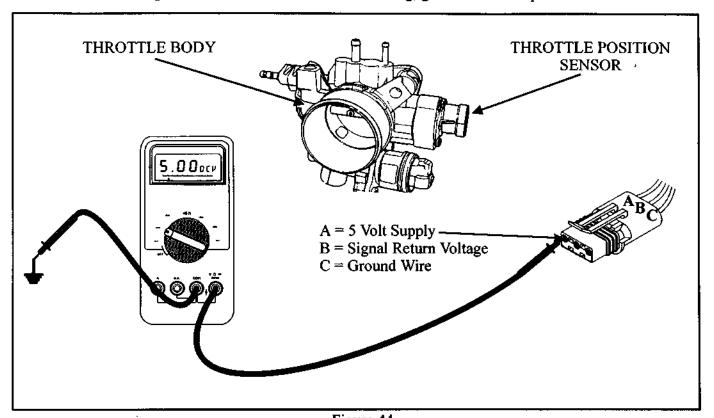
Figure 44

- Locate and unplug the TPS on the throttle body as shown in Figure 44. With the engine off, turn the ignition to the "ON" position. Set the meter to DC volts and place the negative lead to the negative battery post. With the positive lead check terminal A in the harness connector for approximately 5 volts as seen in Figure 44. If voltage is not seen, a bad PCM (Engine Computer) may be the problem as it supplies the 5 volt feed to the TPS. It would be wise to first verify that the wire itself is not severed from the PCM to the TPS by performing a continuity check across the wire. All vehicles up to and including model year 1995 the check should be made from terminal 6 in the PCM connector to terminal A in the TPS connector. For 1996 and later vehicles the check should be made from terminal 61 at the PCM to terminal A in the TPS connector. If continuity is seen across the wire and there is not 5 volts going to the TPS, the PCM will need to be replaced. If 5 volts is seen at the TPS connector, go to the next step.

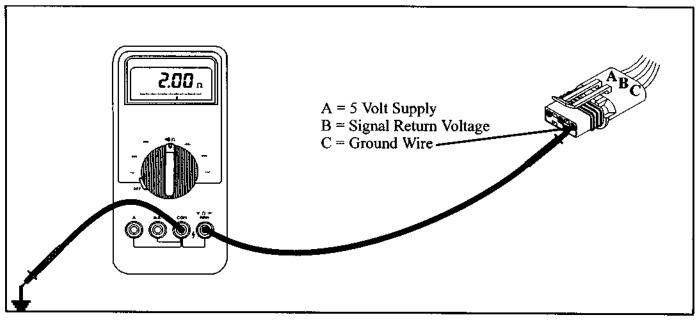
Figure 45

- With a meter set to ohms, place the negative lead to the negative post of the battery and the positive lead to terminal C in the TPS connector (See Figure 45). Approximately 0 to 5 ohms should be seen. If the resistance is greater than 5 ohms or the meter displayed an open circuit, the ground wire will need to be repaired. A quick and simple method would be to splice into the wire with another wire and run it to a good known ground (See Figure 46). If the ground wire is good and the TPS is still malfunctioning, go to the next step.

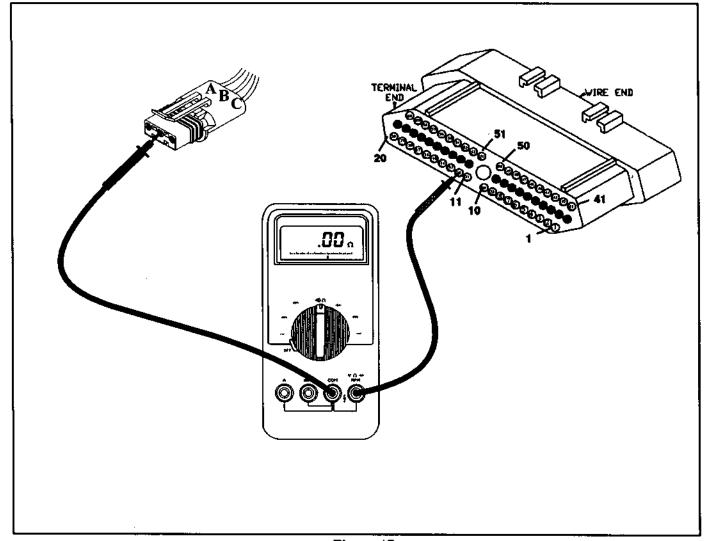
Figure 47

Unplug both the TCM and TPS. Perform a continuity check from terminal B in the TPS connector to terminal 12 in the TCM connector (See Figure 47). If continuity is not seen, repair the severed wire. If continuity is seen, replace the TPS.

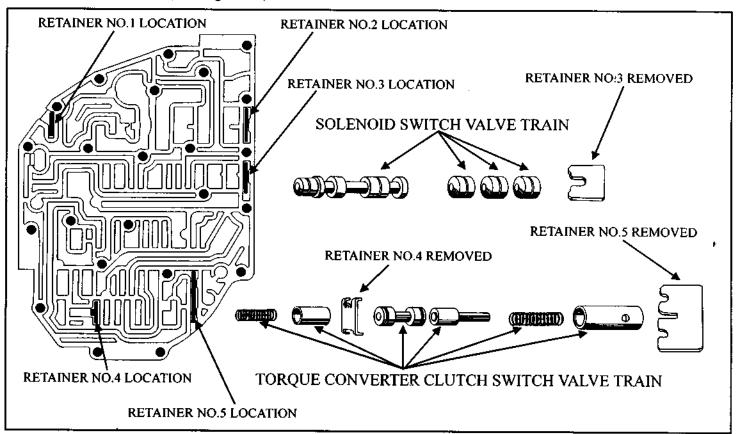
- Use a scanner to observe the Shift Lever Position. If OD is displayed while in the Reverse position the PRNODL switch may be defective. Refer to pages 45 to 52 for step by step diagnosis.
- Inspect the valve body for a stuck Solenoid Switch Valve or a missing # 3 retainer (See Figure 48).

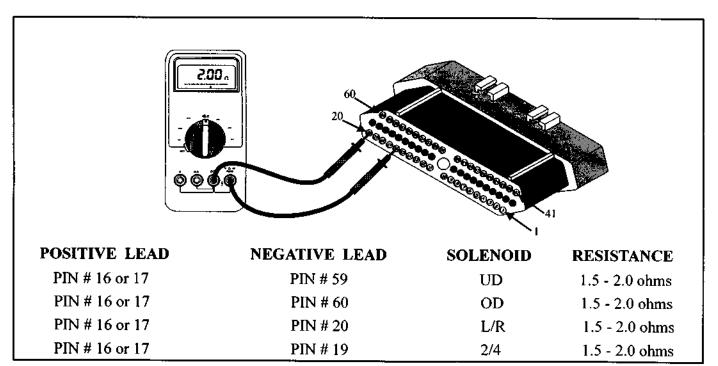
Fig:	ure 51		
CIRCUIT NAME	SOLENOID BODY TERMINAL #	CONTROLLER TERMINAL #	POSSIBLE CODES	,
UD SOL	5	59	44	
OD SOL	6	60	43	
L/R SOL	7	20	41	
2/4 SOL	8	19	42	
	2	TERNINAL END CO.	51 50 900000000000000000000000000000000000	EN EN
	NAME JD SOL DD SOL L/R SOL	SIRCUIT SOLENOID BODY TERMINAL # UD SOL 5 OD SOL 6 L/R SOL 7 2/4 SOL 8	NAME TERMINAL # TERMINAL # JD SOL 5 59 DD SOL 6 60 L/R SOL 7 20 2/4 SOL 8 19	SOLENOID BODY CONTROLLER POSSIBLE CODES

- If when performing the above check an open is seen on one of the solenoid wires, use Figure 52 to perform a continuity check on the wire in question. If it is determined that the wire is severed, a new wire can be run and spliced in outside the harness.

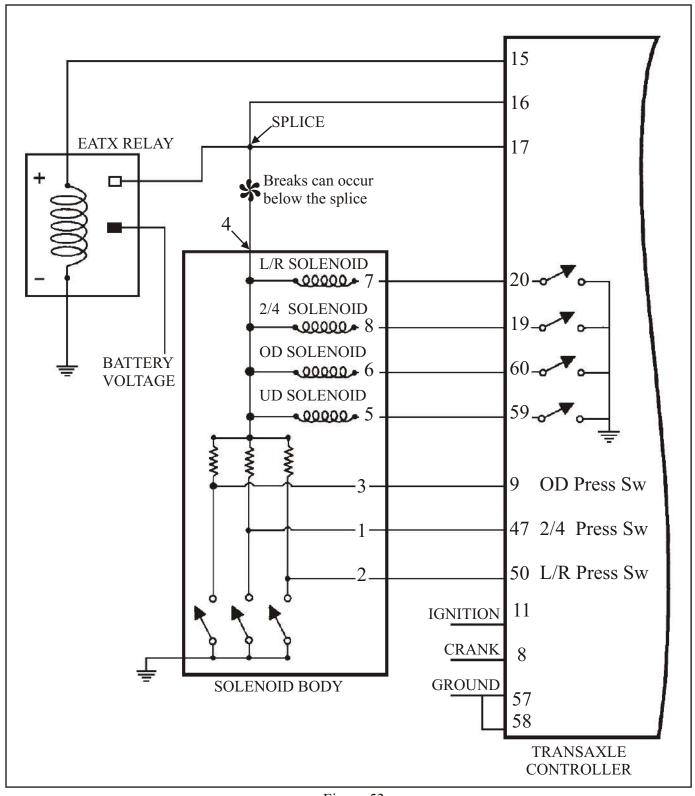
Figure 53

- If when making the above checks and the meter reads infinite on all solenoids, the power wire going to the # 4 pin in the solenoid body has been known to break below the splice as shown in Figure 53. Check for continuity between terminal 16 in the TCM connector to terminal 4 in the solenoid body connector.

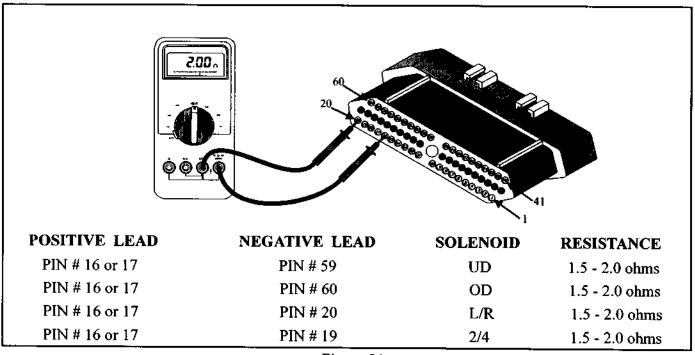
Figure 54

- Unplug the TCM's 60 way connector. Using a DVOM check the resistance of all four solenoid circuits by placing the positive lead onto pin 16 or 17 as seen in Figure 54. With the negative lead, carefully touch pins 19, 20, 59 and 60 one at a time. Each solenoid should measure approximately 1.5 to 2.0 ohms. If the solenoid providing the code reads considerably higher or lower from the other three solenoids, change the solenoid body. If all the readings are the same, wiggle the solenoid wires with the meter still attached and see if the readings behave erratic. If so, the solenoid connector is bad and will need to be repaired.

ure 54						
CIRCUIT NAME	SOLENOID BODY TERMINAL #	CONTROLLER TERMINAL #	POSSIBLE CODES	,				
UD SOL	8	59	44					
OD SOL	7	60	43					
· L/R SOL	6	20	41					
2/4 SOL	5	19	42					
TERMINAL SILVER END AFRE END A

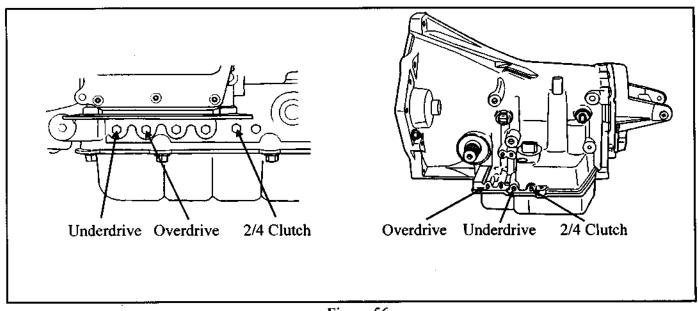
Figure 56

- With the pressure specifications given on page 65, the UD, OD and 2/4 hydraulic circuits should be checked with a pressure gauge (See Figure 56). The 2/4 clutch pressure should be checked in 2nd gear. 120-145 psi should be seen and 0 psi in first and third. Since the transaxle is experiencing a 3-4 shift abort, the full 75-95 psi may not be seen at the 2/4 tap when attempting to go to fourth and should be considered as normal. If the pressure in the 2/4 clutch circuit is substantially low in second gear or pressure is seen in first or third, this hydraulic circuit needs to be investigated.

- The UD clutch circuit is next and can be the most likely hydraulic problem causing the 3-4 shift abort. This clutch circuit should show 120-145 psi in first and second and 75-95 in third. There should be 0 psi in this circuit when in 4th gear. Since the transaxle will not fully go into 4th gear, a 0 psi reading may be hard to detect. To get around this problem, when the transaxle is in third gear, step heavy into the throttle and bring the vehicle up to speed so as to be able to do an OFF throttle upshift into 4th gear. If a 3-4 shift takes place without being on the throttle, the controller will allow a 3-4 shift to take place. While in 4th gear, read the UD pressure gauge. If pressure is seen, this hydraulic circuit needs to be investigated. A bad solenoid body, valve body or pump can cause this type of cross leak.

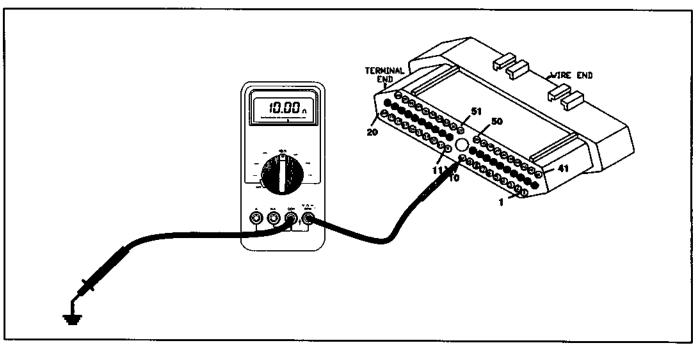
Figure 58

- Turn the ignition off. With the meter still on terminal 10, change to an ohms setting (See Figure 58). If the resistance is below 5 ohms, the wire is shorted to ground and will need to be repaired or replaced. If resistance is above 5 ohms, go to the next step.

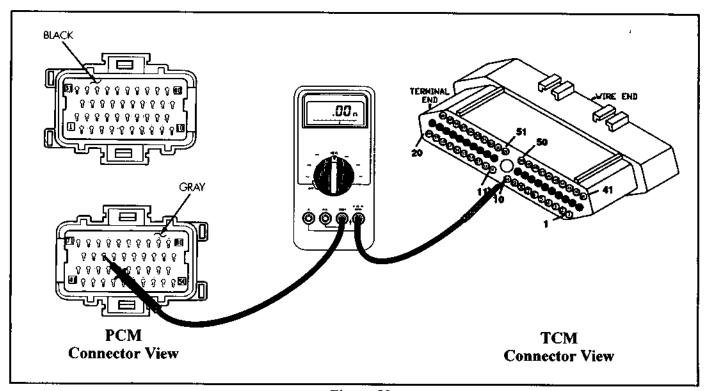
Figure 59

- Keep the ignition off and unplug the PCM and perform a continuity check across the wire. Place one meter lead to cavity 63 in the PCM connector and 10 in the TCM connector (See Figure 59). If resistance is below 5 ohms change the PCM. If an open is seen, repair or replace the severed wire.

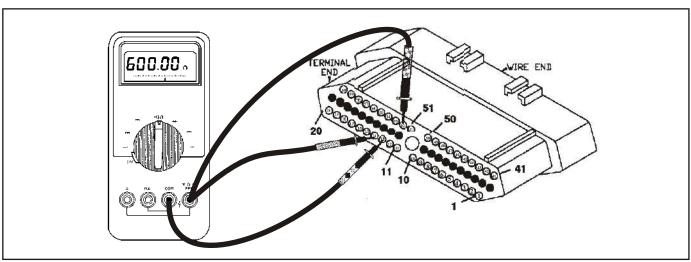
- With the ignition off, unplug the TCM. With an ohm meter, place the negative lead to terminal 13. With the positive lead, the turbine shaft RPM sensor's resistance can be measured by placing the lead onto terminal 52. The output shaft RPM can be measured by placing the positive meter lead to terminal 14. Both RPM sensor should measure between 500 to 600 ohms (See Figure 60). Note: Factory repair manuals specify 300 to 1200 ohms. It has been ATSG's experience that this is to broad of a range. However, if a sensor measures 1200 ohms, the other sensor should be within the same range otherwise it should be determined defective. Replace RPM Sensor or Sensors if necessary.

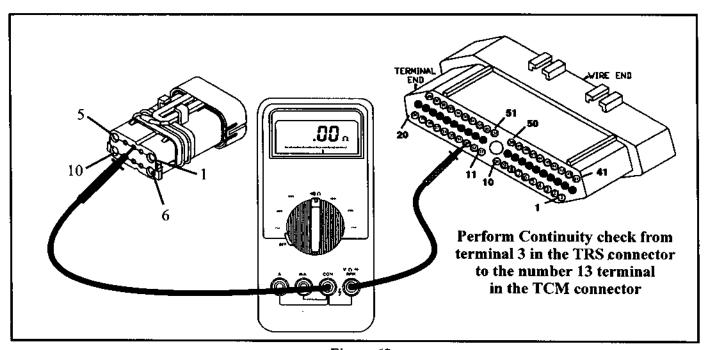
Figure 62

1996 and later vehicles have a Transmission Fluid Temperature Sensor built into the Transmission Range Sensor. The ground wire for this sensor is shared with the Turbine and Output RPM sensor at pin 13 in the TCM connector. Should this ground wire become severed, a code 58 and 72 may be set. A continuity check can be performed by placing one meter lead to terminal 3 in the TRS connector and terminal 13 in the TCM (See Figure 62). For further TFT sensor checks, refer to page 84.

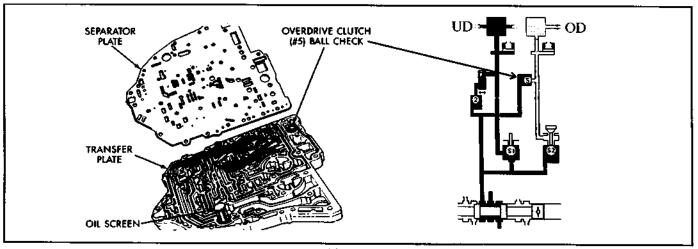
Figure 64

A low clutch volume reading in just the OD clutch circuit has been commonly caused by a defective O ring on the # 5 check ball capsule in the transfer plate as shown in Figure 64. This blocks controlled line pressure from entering the OD clutch circuit. If the O ring or the capsule itself fails to hold back this pressure, the low OD clutch volume reading will vary depending upon the severity of the leak. If the leak is slight, most of the oil will exhaust past the OD solenoid and the OD clutch volume may appear to be normal. As the leak gets worse, the OD solenoid is flooded and the OD circuit becomes charged with oil causing below minimum CVI. Note: The # 5 check ball capsule has been eliminated in late model 41TE's and all 42LE's.

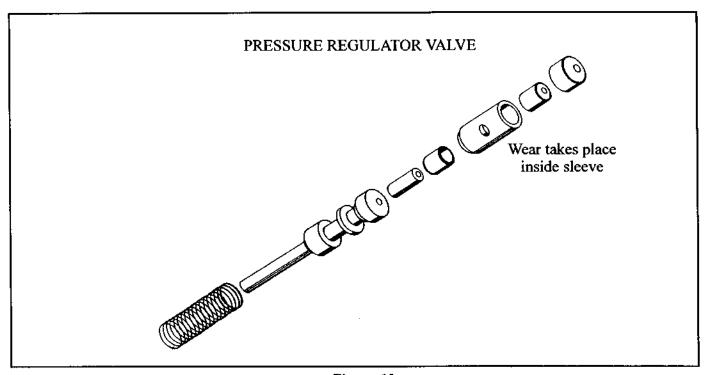
Figure 65

Another cause of low CVI that is often overlooked is high line pressure. There are three predetermined line pressure settings in an A604 transaxle. First and second gears have 120 to 145 psi. Third and fourth have 75 to 95 psi, while reverse is calibrated to have 175 to 235 psi. The controller for the transaxle has no way of knowing or checking what the actual line pressure is in the transaxle. Therefore, the controller controls the solenoid pulse rate based on these predetermined line pressure settings. If a mechanical problem occurs in the valve body causing high line pressure, the controller will be pulsing a clutch on through a solenoid based on a lower value pressure. With line pressure being much higher than what the controller thinks it is, a higher volume of oil is allowed to pass through the solenoid which results in a below minimum CVI reading. One common cause for this is either a worn sleeve in the pressure regulator valve system or a stuck pressure regulator valve (See Figure 65).

Both cross leaks and high line pressure problems causing the below minimum CVI values can be easily checked with a pressure gauge. For example, if you have a below minimum CVI value in the OD clutch circuit, attach a pressure gauge on the OD clutch tap. There should NOT be any pressure in that port in first and second gear. If there is, you have a cross leak. At the same time, when you shift into third and fourth, your OD clutch pressure should be 75 to 95 psi. If you have 110 psi or higher, you have a high line pressure problem most likely caused by a worn sleeve in the pressure regulator valve.

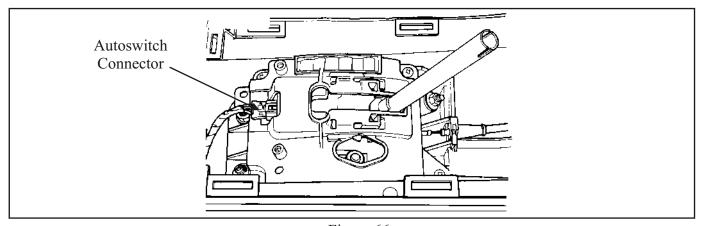
Figure 66

• Locate and unplug the Autostick Switch in the center console (See Figure 66). Using a volt meter, turn the ignition ON and place the negative lead to ground. With the positive lead check for battery voltage at pin 1 in the Autostick connector (See Figure 67). If voltage is seen go to the next step. If voltage is not seen, check for a blown fuse. LH vehicles check fuse # 17, all others check fuse # 11. If the fuse is good, the wire from the fuse to pin 1 is severed and will need to be repaired or replaced.

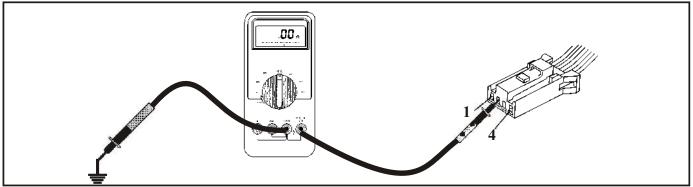
Figure 68

- Turn the ignition off and change the meter to read ohms. Keep the negative lead to ground and place the positive lead into terminal 2 of the Autostick connector (See Figure 68). If continuity (5 ohms or less) is observed, go to the next step. If continuity is not seen, the ground wire is severed or corroded. Repair or replace the wire.
- Unplug the TCM and perform a continuity check from terminal 3 in the Autostick connector to terminal 5 in the TCM (See Figure 69). If continuity is seen, move to the next step. If continuity is not seen, the wire is severed. Repair or replace the wire.
- Perform a continuity check from terminal 4 in the Autostick connector to terminal 44 in the TCM (See Figure 70). If continuity is seen, move to the next step. If continuity is not seen, the wire is severed. Repair or replace the wire.

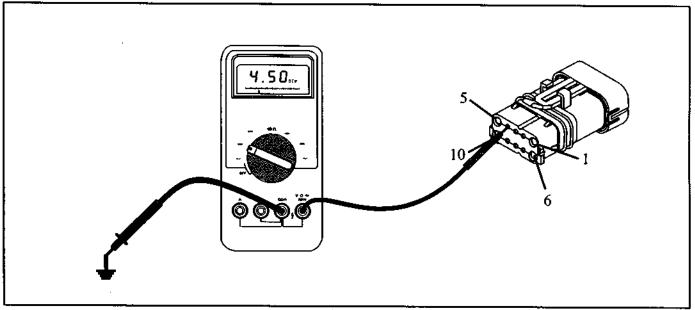
Figure 73

- Unplug the TRS connector. Place the ignition to the "ON" position. With a volt meter placed to DC volts, put the negative lead to a good known ground. With the positive lead, check terminal 4 for voltage (See Figure 73). If voltage is above 4.5 volts move to the next step. If less than 4.5 volts is observed, turn the ignition off and unplug the TCM. Change the meter to an ohms setting and check for continuity between terminal 54 in the TCM connector to terminal 4 in the TRS connector (See Figure 74). If continuity (5 ohms or less) is seen, replace the TCM. If continuity is not seen, repair or replace the wire.

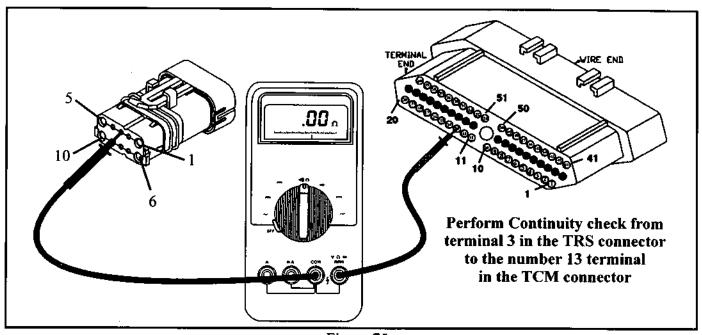
Figure 75

Perform a continuity check on the TFT's ground wire by placing one meter lead to terminal 3 in the TRS connector and terminal 13 in the TCM as shown in Figure 75. If continuity is seen, go to the next step. If continuity is not seen, repair or replace wire. If the wire is to be replaced, the turbine and output RPM sensor also uses this wire for ground. Be sure to include them in the new wire (See Page 74).

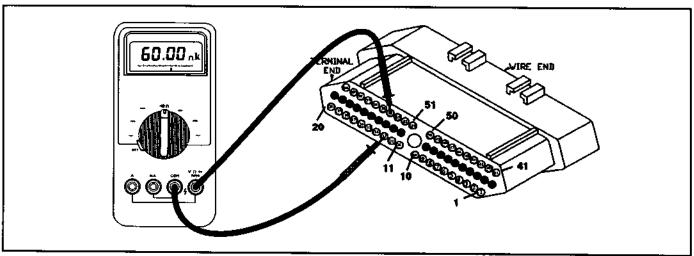
Figure 76

• Re-connect the TRS sensor and perform a resistance check on the TFT sensor from the TCM connector. Place one meter lead into terminal 13 and the other meter lead into terminal 54 (See Figure 76). The range for the sensor from cold to hot is 100,000 ohms to 150 ohms (See Table Below). If the change in resistance is proportional to the change in the transmission fluid temperature and the resistance remains within specification, change the TCM. If the resistance is out of specification or does not change in resistance proportional to temperature, change the TRS.

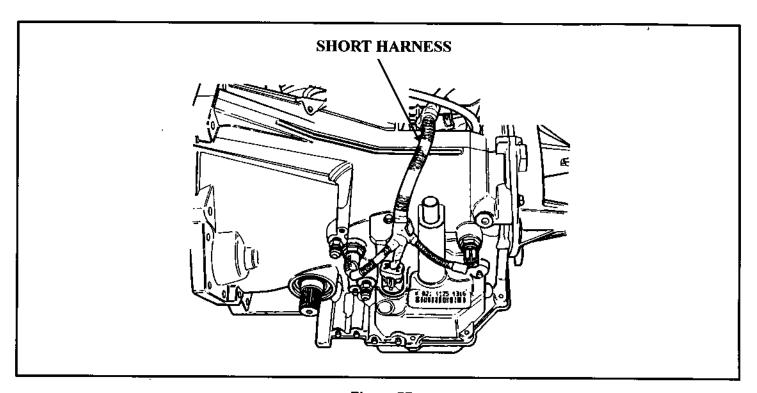
The 42LE transaxle has both the solenoid body and transmission range sensor mounted on the valve body. Each have their own connector coming through the case both of which are not easily accessible with the unit installed in the vehicle. To perform resistance checks of the solenoids, voltage checks on the pressure switches, resistance or volt checks on the Transmission Range Sensor (TRS) is near impossible at the case connector. The harness plugging into the solenoid body and the Transmission Range Sensor runs up to the top of the case above the bell housing where it plugs into the main vehicle harness (See Figure 77). This short wiring harness from the bell housing down to the solenoid body and TRS will allow for checks to be performed with ease. Figure 78 shows the top two connectors in this short pig tail harness. Each pin in these two connectors are numbered and identified. Should a resistance check need to be made on the solenoid body, rather than unplugging the solenoid body at the case (which could fill up with fluid if the unit is full), locate the 8 pin connector above the bell housing and unplug it. Place the positive meter lead of an ohm meter to pin 7. With the negative lead, touch pins 1, 2, 3 and 8 to obtain all 4 solenoid resistance values (See Figure 79). The chart in Figure 79 also provides checks that can be made through the 12 pin connector on the Turbine Shaft RPM sensor, the Output RPM sensor and the Transmission Fluid Temperature sensor.

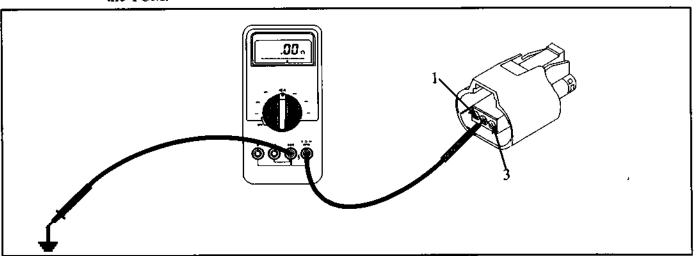
Figure 82

- Set meter to ohms and check the middle terminal for continuity as the middle wire goes to ground (See Figure 82). If continuity is seen (5 ohms or less), go to the next step. If continuity is not seen, repair or replace the wire.
- Perform a continuity check from terminal 3 in the Speed Proportional Steering Module connector to terminal 58 in the TCM connector (See Figure 83). If continuity is seen, go to the next step. If an open is seen repair or replace the wire.
- Plug the module and TCM back in and carefully back probe the # 3 wire with
 the meter set to DC volts. Start the vehicle and allow to the wheel to spin
 slowly. A 5 volts pulse should be seen. If there is, replace the Speed
 Proportional Steering Module. If there is not, either the TCM has not been
 flash with pinion factor information or the TCM is defective. Flash or replace
 the TCM.
