Vehicle: Application and ID

## Engine: Service and Repair

## Camshaft: Service and Repair

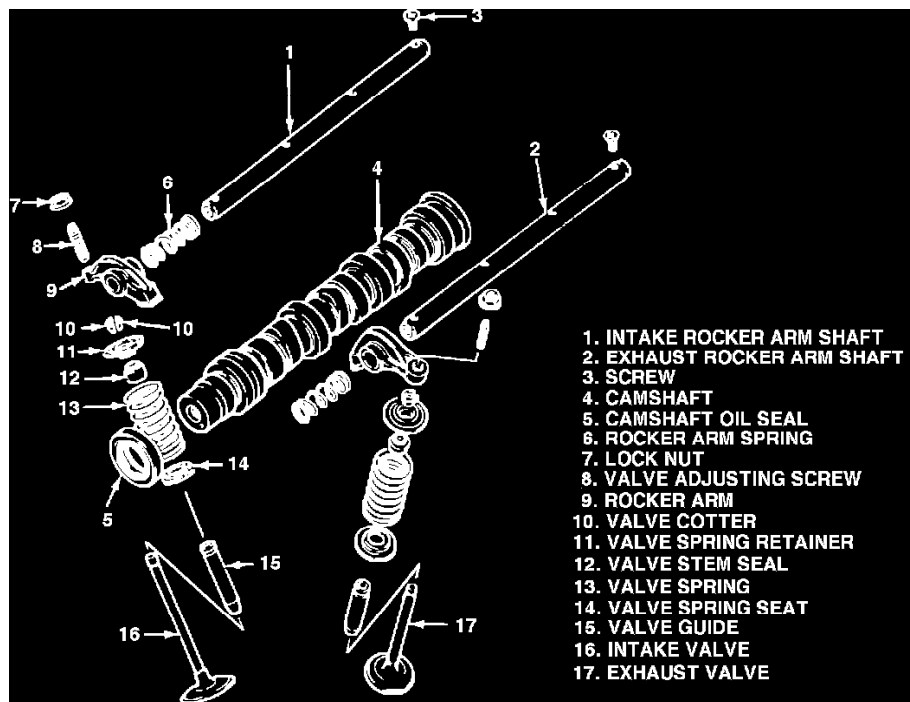
**Fig. 14 Exploded view of valve train assembly**

1. Disconnect battery ground cable.
2. Remove air cleaner and cylinder head cover.
3. Remove distributor and case from cylinder head.
4. Loosen all valve adjusting screw locknuts and turn adjusting screws completely back to allow rocker arms to move freely.
5. Remove rocker arm shaft screws and rocker arm shafts. Then, remove rocker arms and springs, **Fig. 14**.
6. Remove fuel pump and pushrod from cylinder head.
7. Refer to "Timing Belt & Cover, Replace" procedure to remove crankshaft pulley and timing belt outer cover.

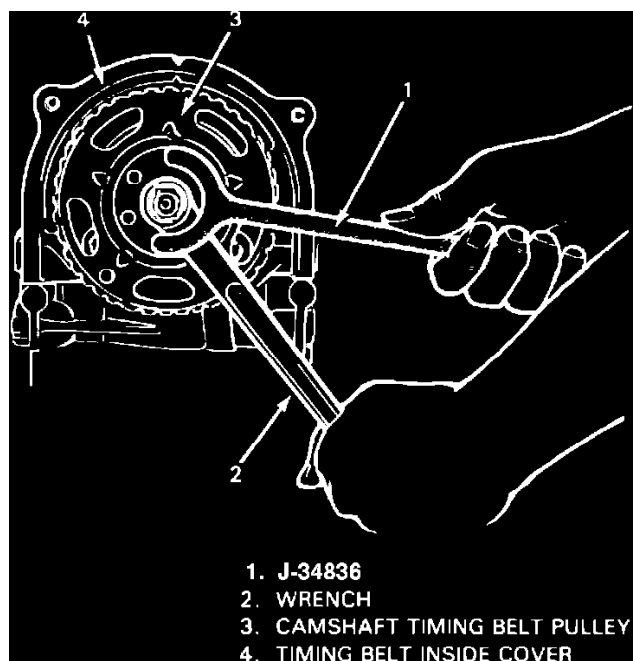
**Fig. 15 Timing belt sprocket removal**

8. Using tool J-34836, remove timing belt sprocket and timing belt inner cover, **Fig. 15**.
9. Remove camshaft from cylinder head.

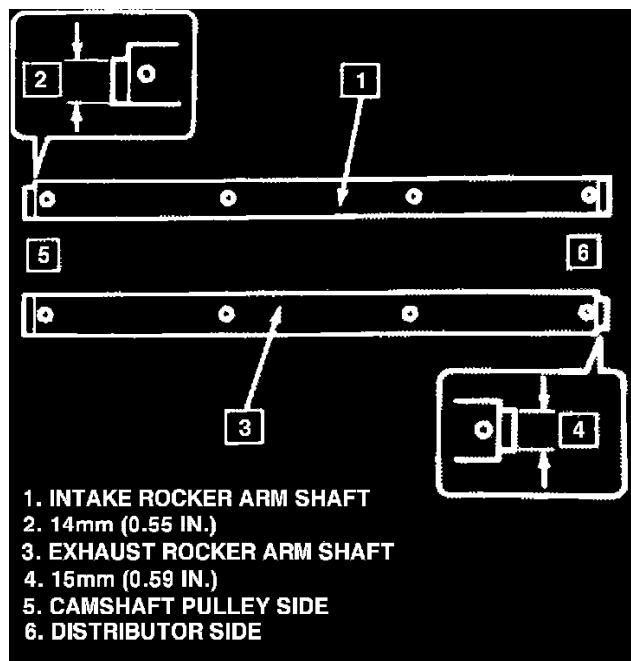
**Fig. 16 Rocker arm shaft identification**

10. Reverse procedure to install. Torque camshaft sprocket to 41-46 ft. lbs. Refer to **Fig. 16** for rocker shaft identification.

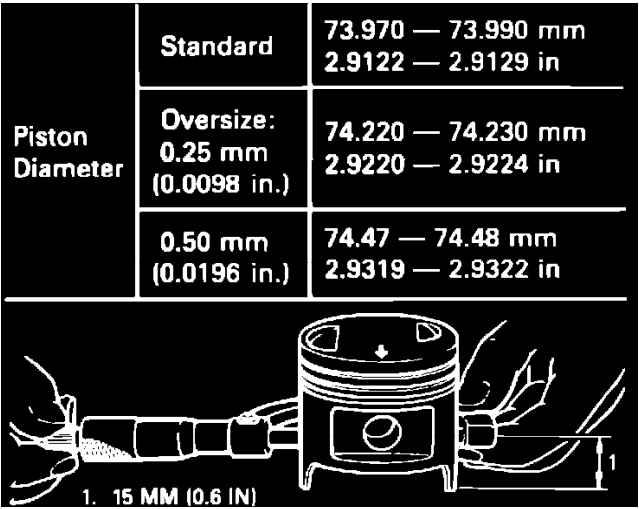
Fig. 17 Measuring piston diameter

- 1. Inspect piston for cracks or other damage. Replace as necessary.
- 2. Measure piston diameter at a height of .59 inches (15 mm) from piston skirt end in perpendicular direction to piston pin, **Fig. 17**.

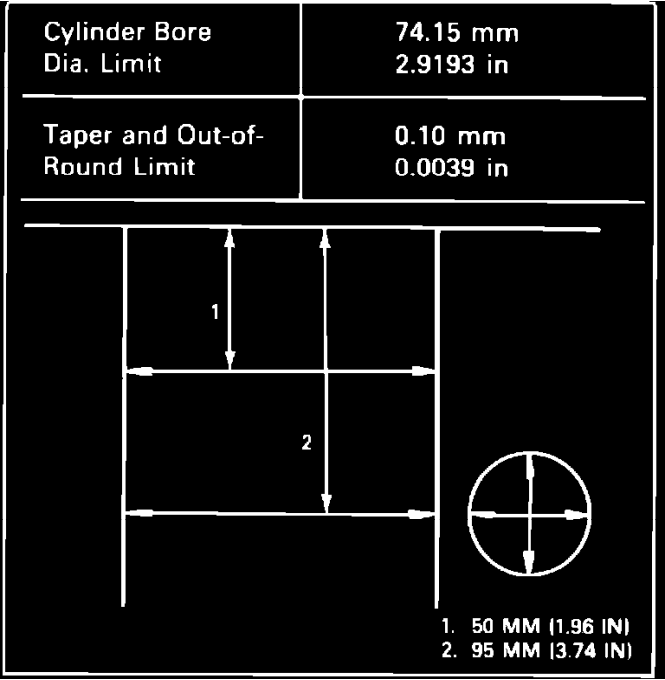
Fig. 18 Measuring piston bore diameter

- 3. Measure cylinder bore diameter, **Fig. 18**, and piston diameter to determine piston clearance. Piston clearance should be .0008-.0015 inch. If clearance is excessive, rebore cylinder and install oversize piston. All cylinders must be overbored to same size to ensure balance.

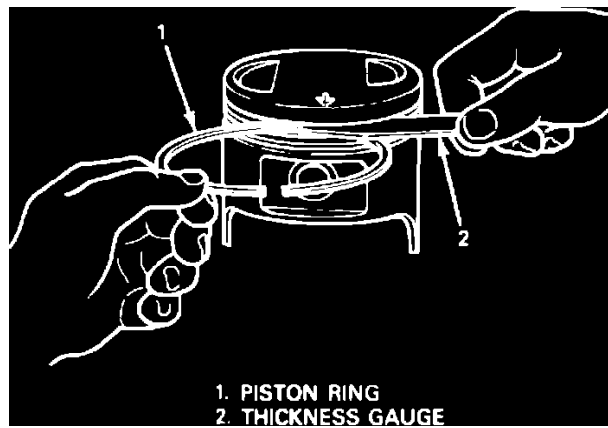
**Fig. 19 Measuring piston ring side clearance**

4. With piston grooves clean, dry and free of carbon, insert piston ring into groove, and measure clearance between ring and ring land with feeler gauge, **Fig. 19**. If clearance is out of specification, replace piston.
5. Piston pin should fit into piston bore with easy finger push at normal room temperature. Check piston pin and piston pin bore for wear or damage. If badly worn or damaged, replace pin or piston as necessary.

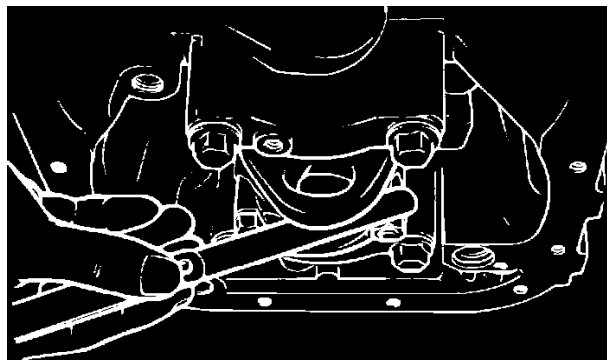
**Fig. 20 Measuring rod bearing side clearance**

6. Install connecting rod on its journal and check that side clearance does not exceed .0137 inch, **Fig. 20**. If so, replace connecting rod.

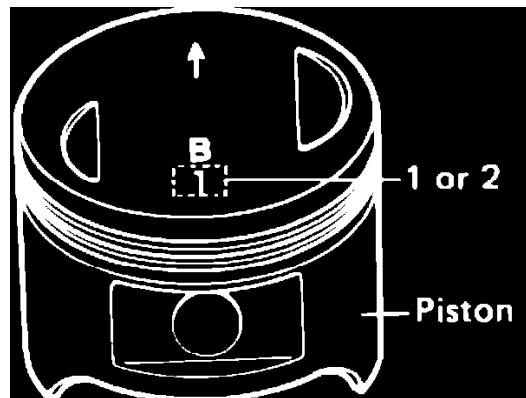
**Fig. 21 Piston identification**

- a. Each piston has number 1 or 2 stamped on top, **Fig. 21**, to indicate its outside diameter.
- b. The engine block is stamped as shown in **Fig. 22**, to indicate size of piston in each bore.

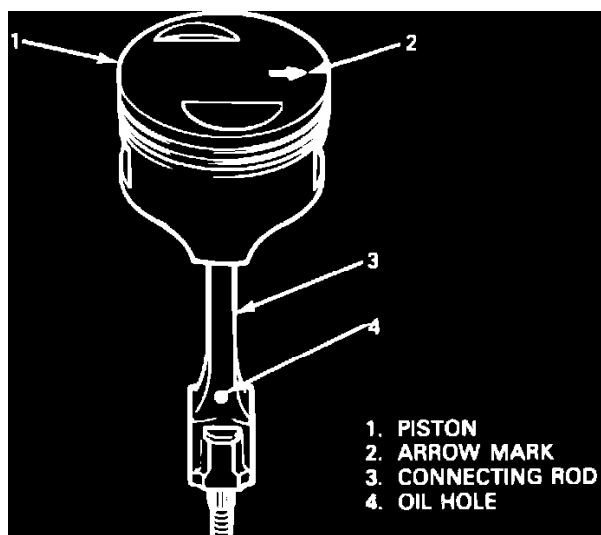
**Fig. 23 Piston to connecting rod installation**

1. Apply engine oil to piston pin bores in piston and rod and fit connecting rod to piston as shown in **Fig. 23**.

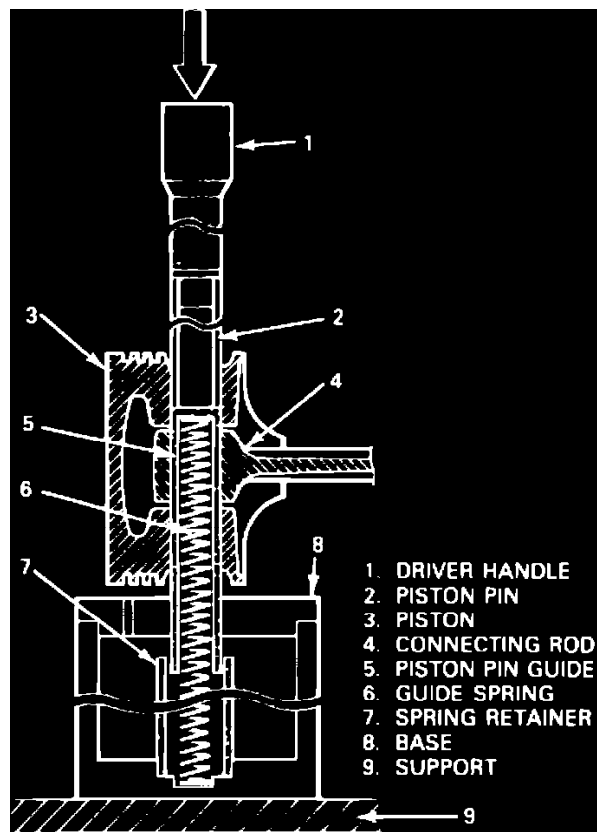
Fig. 24 Piston pin installation

2. Place piston on tool J-34838 so arrow mark on piston head faces up. Press piston pin into piston and connecting rod, **Fig. 24**.

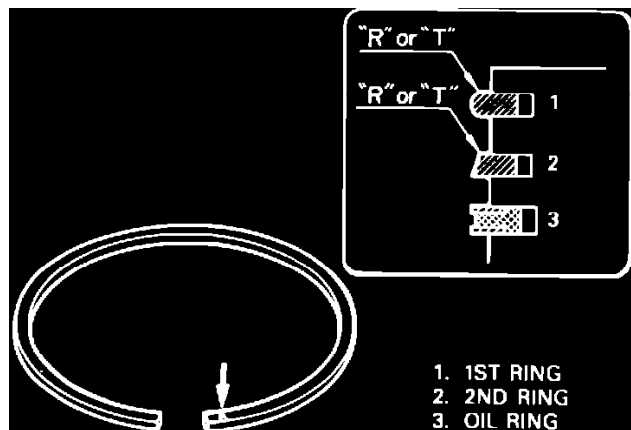
Fig. 25 Piston ring installation

3. Install piston rings so marked side of each ring faces top of piston, **Fig. 25**. Note shape of rings 1 and 2.

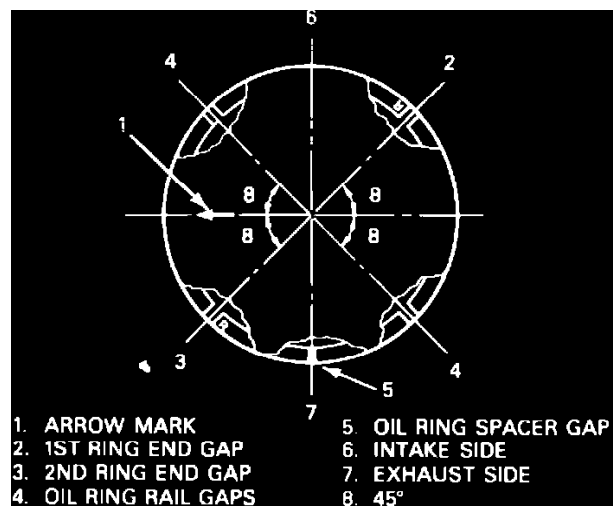
Fig. 26 Ring end gap alignment

4. Install oil ring spacer first, then 2 rails.
5. Align ring end gaps as shown in **Fig. 26**. Pistons and connecting rod assemblies must be installed in block so arrows on pistons face front (pulley end) of engine.

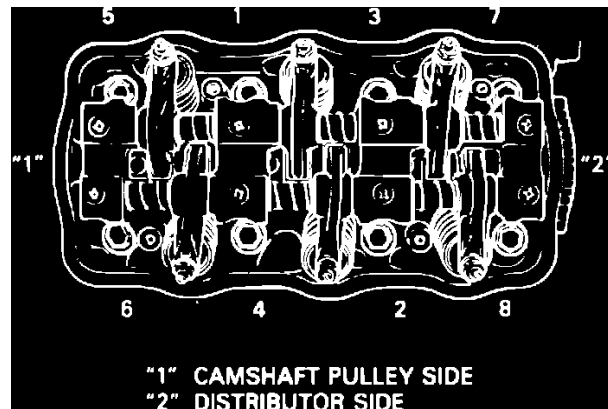
**Fig. 1** Cylinder head bolt tightening sequence

17. Reverse procedure to install. Torque cylinder head bolts to specification sequentially according to pattern shown in **Fig. 1**.

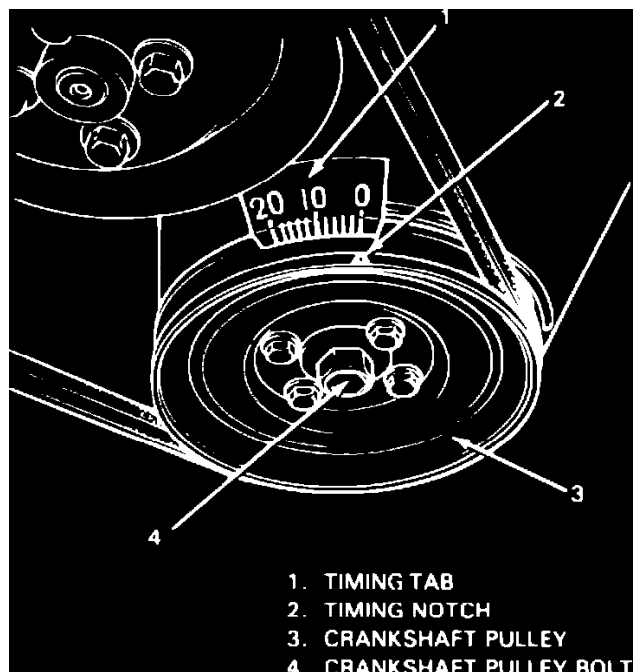
**Fig. 2 Aligning crankshaft pulley**

1. Remove air cleaner and cylinder head cover.
2. Turn crankshaft clockwise and align timing notch on crankshaft pulley with 0 mark on timing tab, **Fig. 2**.

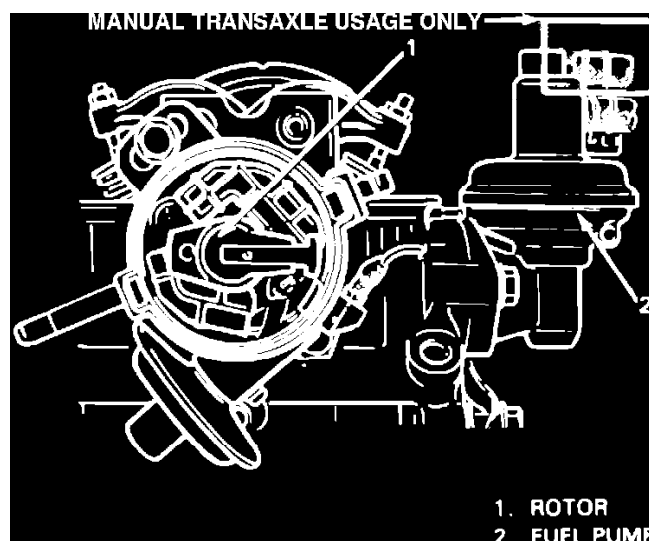
**Fig. 3 Distributor rotor at TDC position**

3. Remove distributor cap. Engine is at TDC when distributor rotor is positioned as shown in **Fig. 3**. If engine is not at TDC, turn crankshaft 360 degrees so timing notch is at 0 mark again.

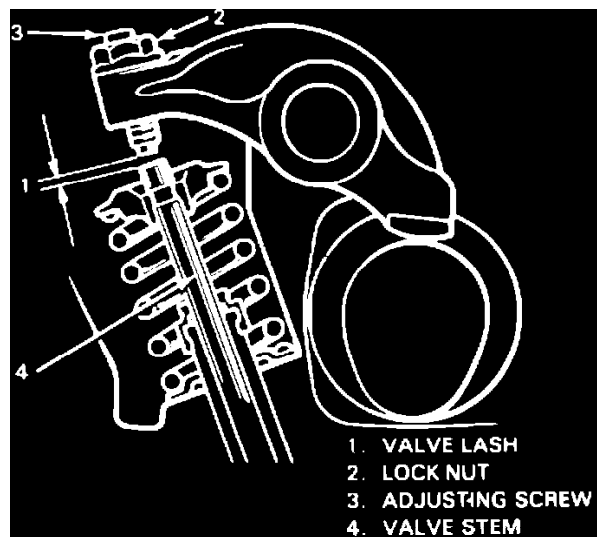
**Fig. 4 Adjusting valve lash**

4. Using feeler gauge, measure No. 1 cylinder intake and exhaust valve clearances at 1 in **Fig. 4**.
5. Adjust valve lash, if necessary, by turning adjusting screw after loosening locknut, **Fig. 4**. After adjustment, tighten locknut to specified torque.

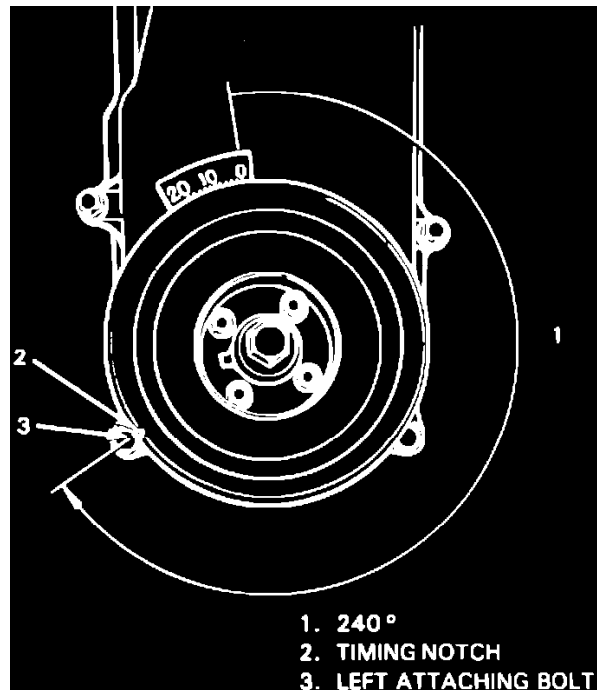
**Fig. 5 Crankshaft pulley alignment w/left side timing belt cover bolt**

6. After checking No. 1 cylinder, turn crankshaft 240 degrees clockwise and align timing notch on pulley with left mounting bolt of timing belt cover, **Fig. 5**. Check and, if necessary, adjust intake and exhaust valves of No. 3 cylinder.

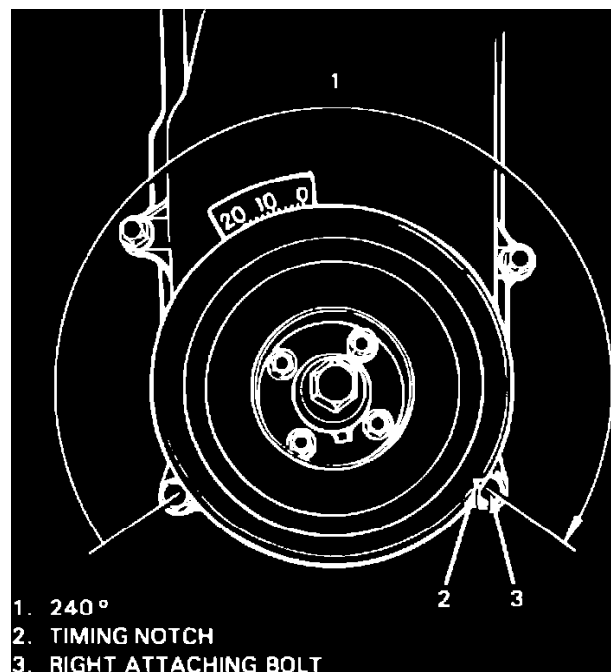
**Fig. 6 Crankshaft pulley alignment w/right side timing belt cover bolt**

7. Rotate crankshaft 240 degrees clockwise from left mounting bolt, and align timing notch with right mounting bolt as shown in **Fig. 6**. Then, check and, if necessary, adjust intake and exhaust valves of No. 2 cylinder.
8. After checking and adjusting valves, install distributor cap, cylinder head cover and air cleaner.

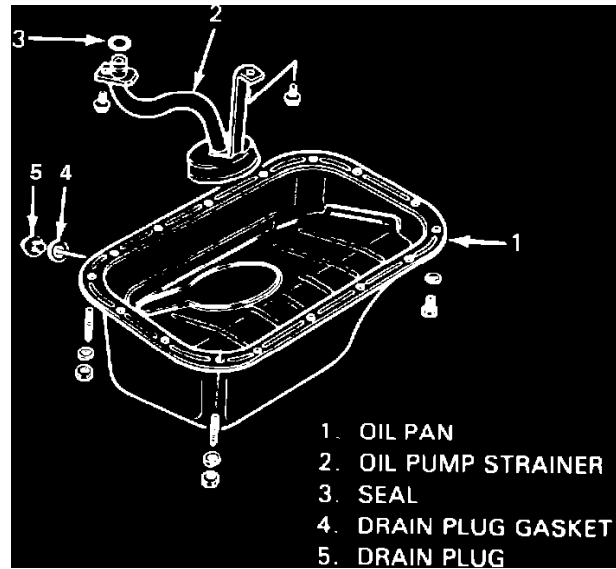
**Fig. 27 Oil pan removal**

1. Disconnect battery ground cable.
2. Raise and support vehicle.
3. Drain oil pan.
4. Remove flywheel dust cover.
5. Disconnect exhaust pipe at manifold.
6. Remove oil pan bolts and pan, **Fig. 27**.
7. Remove oil pump screen.
8. Reverse procedure to install. Apply continuous bead of silicon type sealer to oil pan flange inside bolt holes. Starting at center and working outwards, torque oil pan bolts to 7-9 ft. lbs. Torque drain plug to 22-29 ft. lbs.

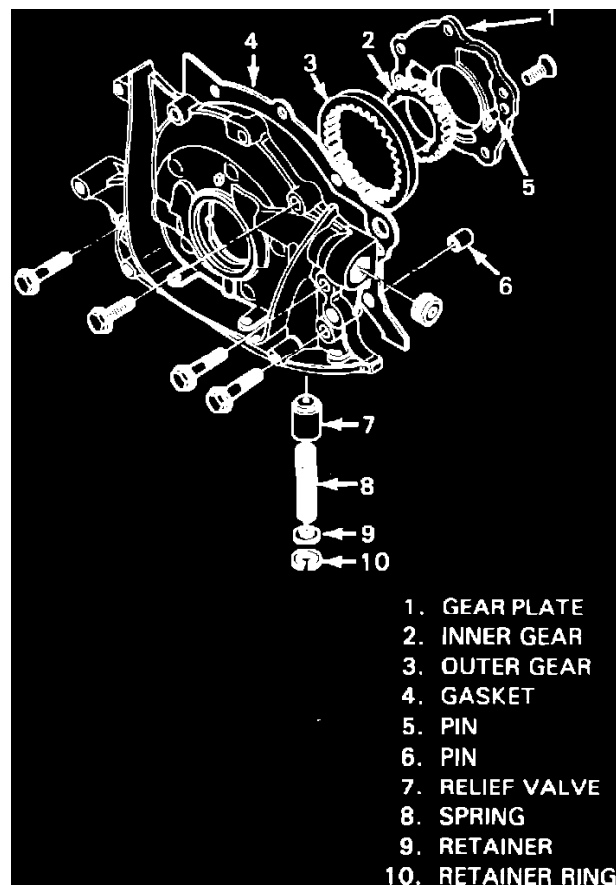
Fig. 28 Oil pump removal 1985-87 Gear Type

3. Remove crankshaft timing belt sprocket.
4. Remove alternator mounting bracket.
5. Remove A/C compressor mounting bracket, if so equipped.
6. Remove alternator adjusting bolt and upper cover bolt.
7. Remove oil pump bolts and pump, **Fig. 28 and 29.**

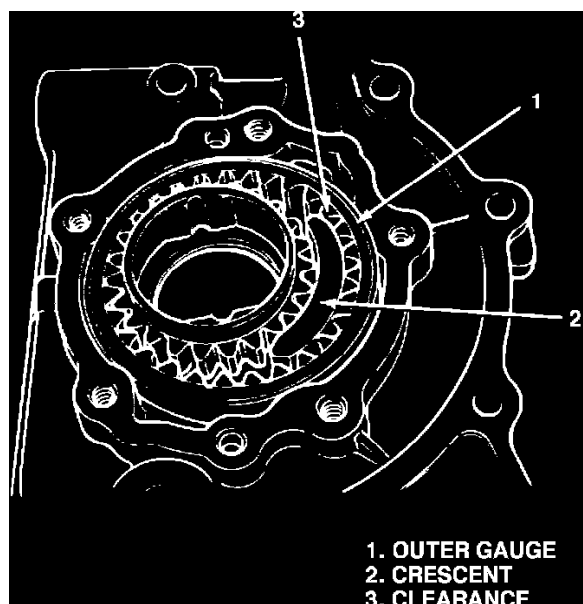
**Fig. 30 Checking oil pump gear radial clearance. Rotory type similar**

1. Remove dipstick tube from oil pump.
2. Remove gear plate screws and gear plate.
3. Remove outer and inner gears and/or rotors.
4. Inspect oil seal lip for damage and replace as necessary.
5. Inspect outer and inner gears and/or rotors, gear plate, and oil pump case for excessive wear or damage.
6. Using feeler gauge, check radial clearance between outer gear and/or rotor and crescent, **Fig. 30.** If clearance exceeds .0122 inch, replace outer gear and/or rotor.

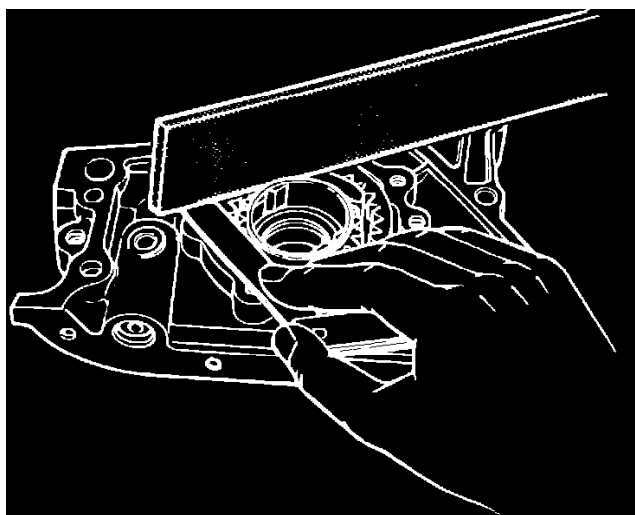
**Fig. 31 Checking oil pump gear side clearance. Rotory type similar**

7. Using straightedge and feeler gauge, measure side clearance which should not exceed .0059 inch, **Fig. 31.**
8. Wash, clean and dry all oil pump parts.
9. Apply light coat of engine oil to inner and outer gears and/or rotors, oil seal lip portion, and inside surfaces of oil pump case and plate.
10. Install outer and inner gears and/or rotors in pump case.
11. Install gear plate and tighten screws securely. Check that gears turn smoothly by hand.
12. Install O-ring in pump case, then dipstick tube.

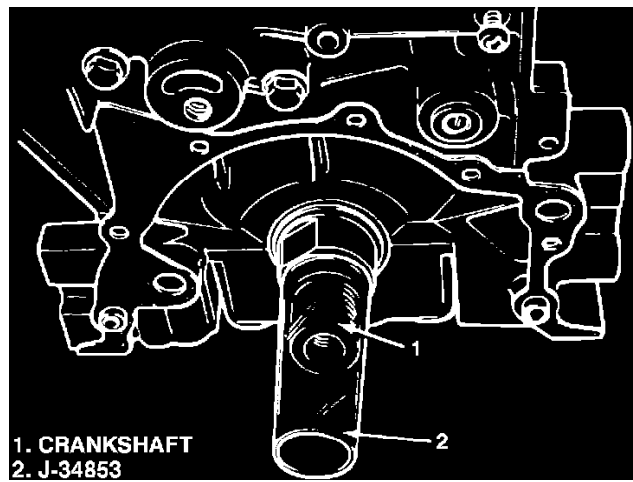
Fig. 32 Tool J-34853 installation

1. Install oil pump pins and gasket on engine block.
2. Install tool J-34853 (oil seal guide) onto crankshaft to prevent damage to oil seal lip, **Fig. 32**. Apply engine oil to special tool.
3. Install oil pump onto crankshaft and engine block. Note location of mounting bolts, **Fig. 33**. **No. 1 bolts are shorter than No. 2 bolts in length. Install bolts as shown in Fig. 33, and torque bolts to 7-9 ft. lbs.**
4. After installing oil pump, check that oil seal lip is not twisted, then remove tool.

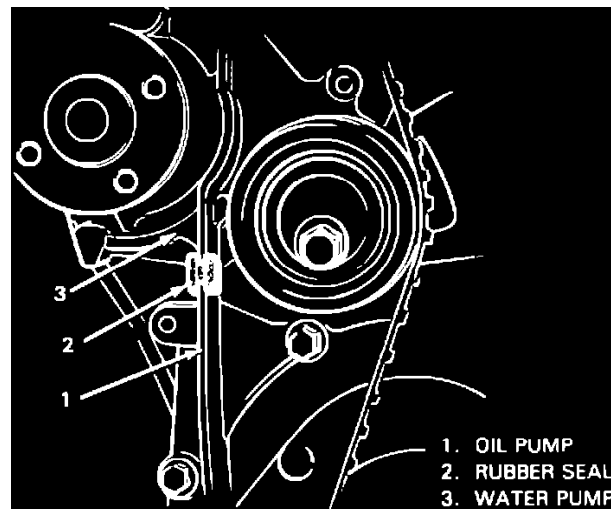
Fig. 34 Rubber seal installation

5. Install rubber seal between oil pump and water pump, **Fig. 34**.
6. If necessary, trim edges of oil pump seal flush with oil pan mating surface.
7. Install timing belt guide, key and crankshaft timing sprocket. Note that timing belt guide must be installed so that curved side faces oil pump.
8. Torque crankshaft timing sprocket bolt to 47-54 ft. lbs.

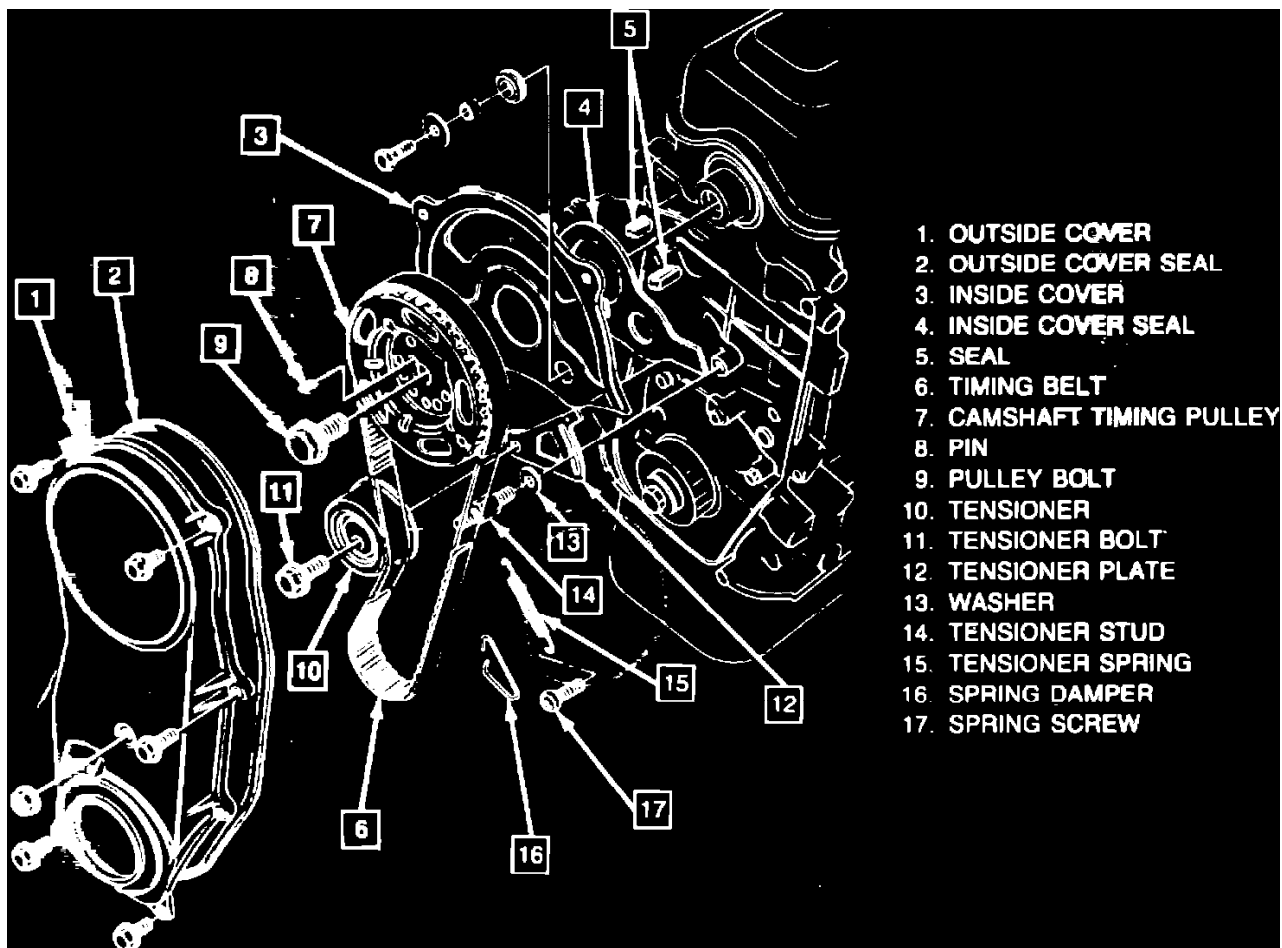
Fig. 7 Timing belt and cover assembly

1. Disconnect battery ground cable.
2. Loosen water pump pulley bolts.
3. Remove A/C compressor adjusting bolt, if equipped.
4. Loosen alternator adjusting bolt.
5. Raise and support vehicle.
6. Remove drive belt splash shield.
7. Remove plug in right fender well.
8. Remove A/C compressor drive belt, if equipped.
9. Remove alternator belt.
10. Remove crankshaft pulley and water pump pulley.
11. Remove bolts at bottom of timing belt cover, Fig. 7.
12. Lower vehicle.

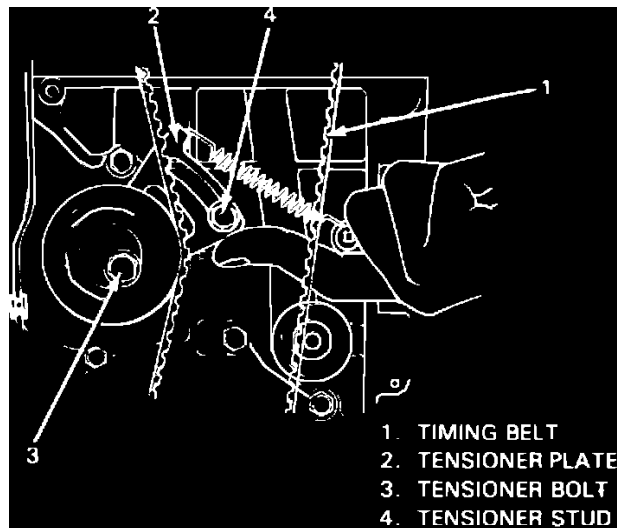
**Fig. 8 Timing belt removal**

13. Remove bolts at top of timing belt cover and cover.
14. Remove cylinder head cover.
15. Loosen rocker arm adjusting screws.
16. Remove distributor cap.
17. Loosen tensioner bolt and stud, and remove belt as shown in **Fig. 8**.
18. Remove tensioner, tensioner plate and tensioner spring.

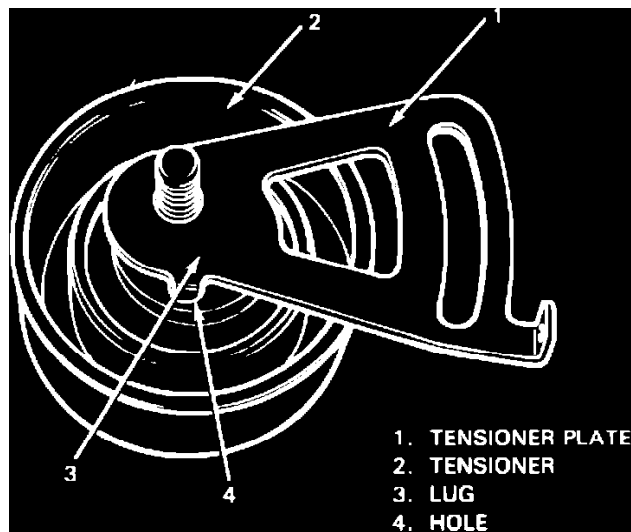
**Fig. 9 Tensioner assembly**

1. Install tensioner plate to tensioner. Insert lug of tensioner plate into hole of tensioner, **Fig. 9**.

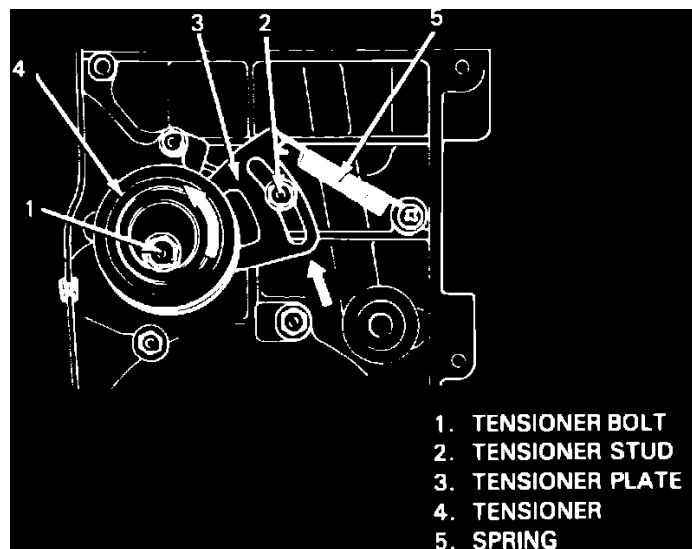
Fig. 10 Checking tensioner plate movement

2. Install tensioner, tensioner plate and spring. Hand tighten tensioner bolt and stud only. Check that plate movement is in direction shown in **Fig. 10**. If no movement occurs between plate and tensioner, remove tensioner and plate and re-insert plate lug into tensioner hole.

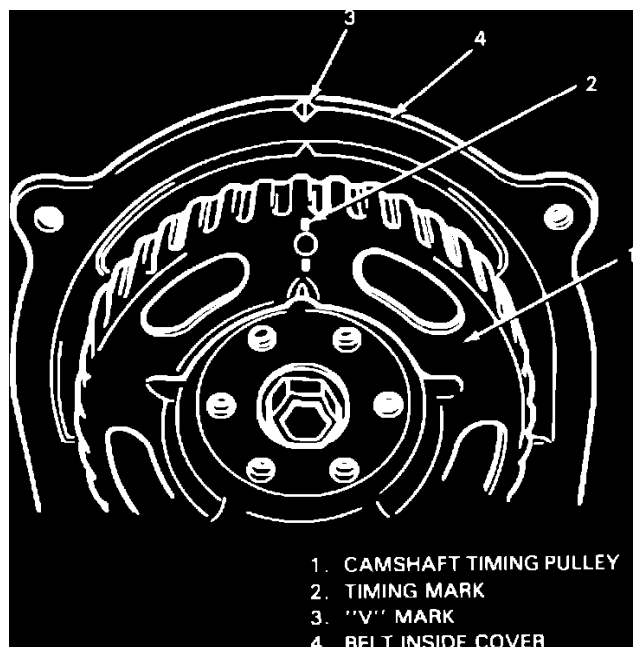
Fig. 11 Camshaft pulley alignment

3. Turn camshaft pulley clockwise and align timing mark on camshaft pulley with V mark on inside belt cover, **Fig. 11**.

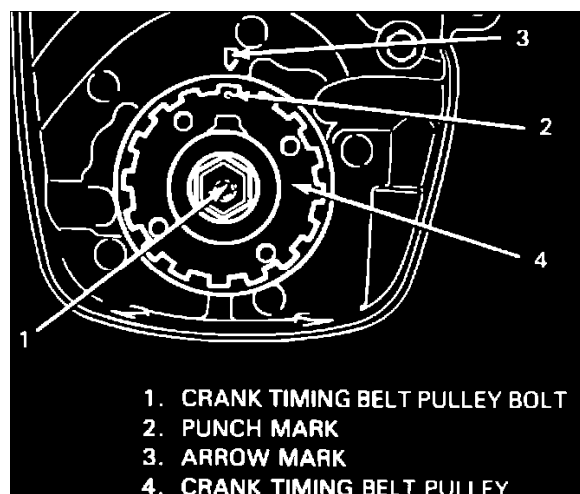
Fig. 12 Aligning timing belt pulley punch mark with oil pump arrow

4. Using 17 mm wrench, turn crankshaft clockwise and align punch mark on timing belt pulley with arrow mark on oil pump, **Fig. 12**.

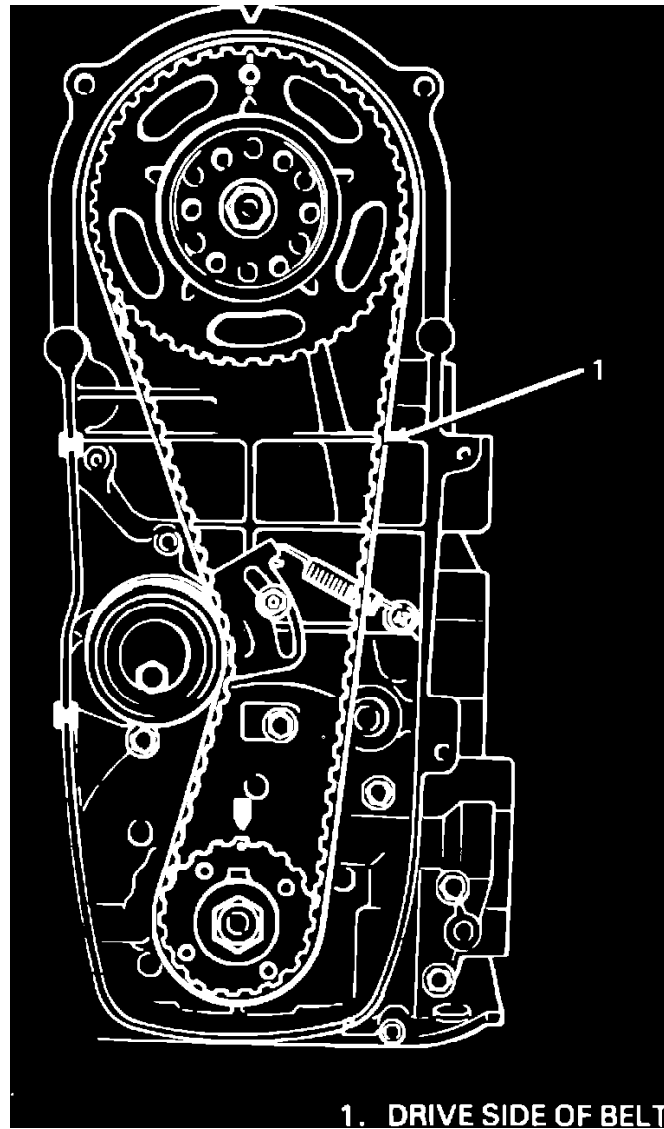
**Fig. 13 Timing belt installation**

5. With all 4 marks aligned, install timing belt on sprockets so that drive side of belt is free of any slack and so tensioner plate is positioned as shown in **Fig. 13**.
6. To ensure timing belt is free of slack, turn crankshaft one rotation clockwise after installing belt. After removing slack, first torque tensioner stud, and then tensioner bolt to 17-21 ft. lbs.
7. Install timing belt outer cover.
8. Install crankshaft pulley and torque 4 bolts to 7-9 ft. lbs.
9. Refer to "Valves, Adjust" procedure and adjust intake and exhaust valves.
10. Install water pump pulley and drive belt.
11. Install cylinder head cover and air cleaner.
12. Connect battery ground cable.

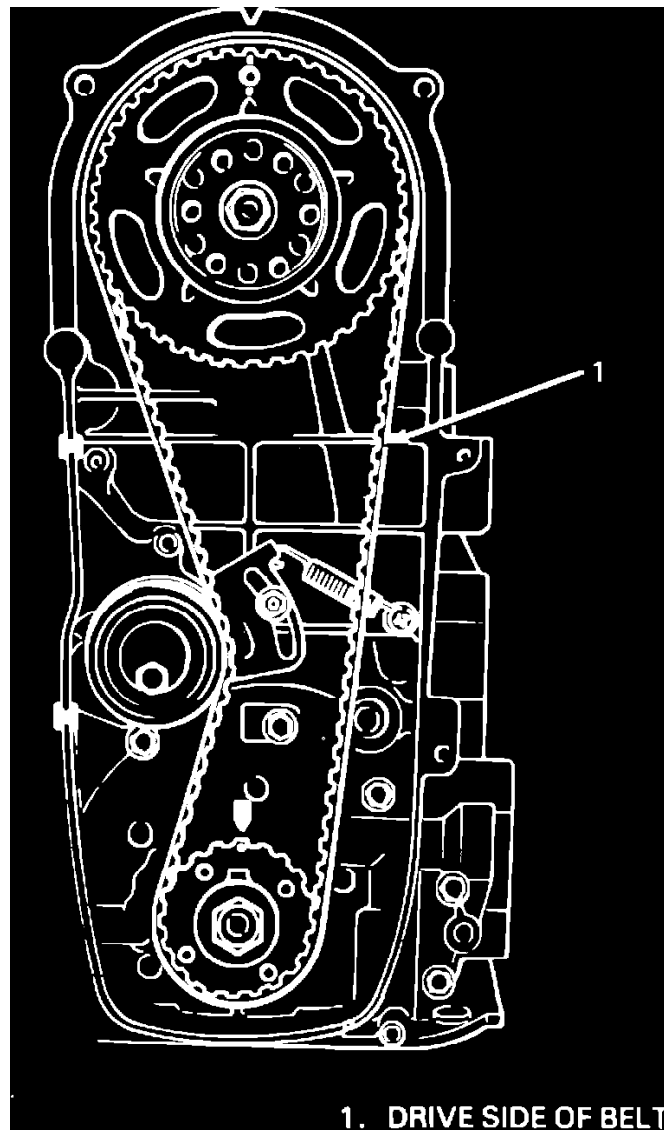
Fig. 13 Timing belt installation

**CAUTION:** Incorrect removal or installation of the timing belt can result in damage to internal engine components.

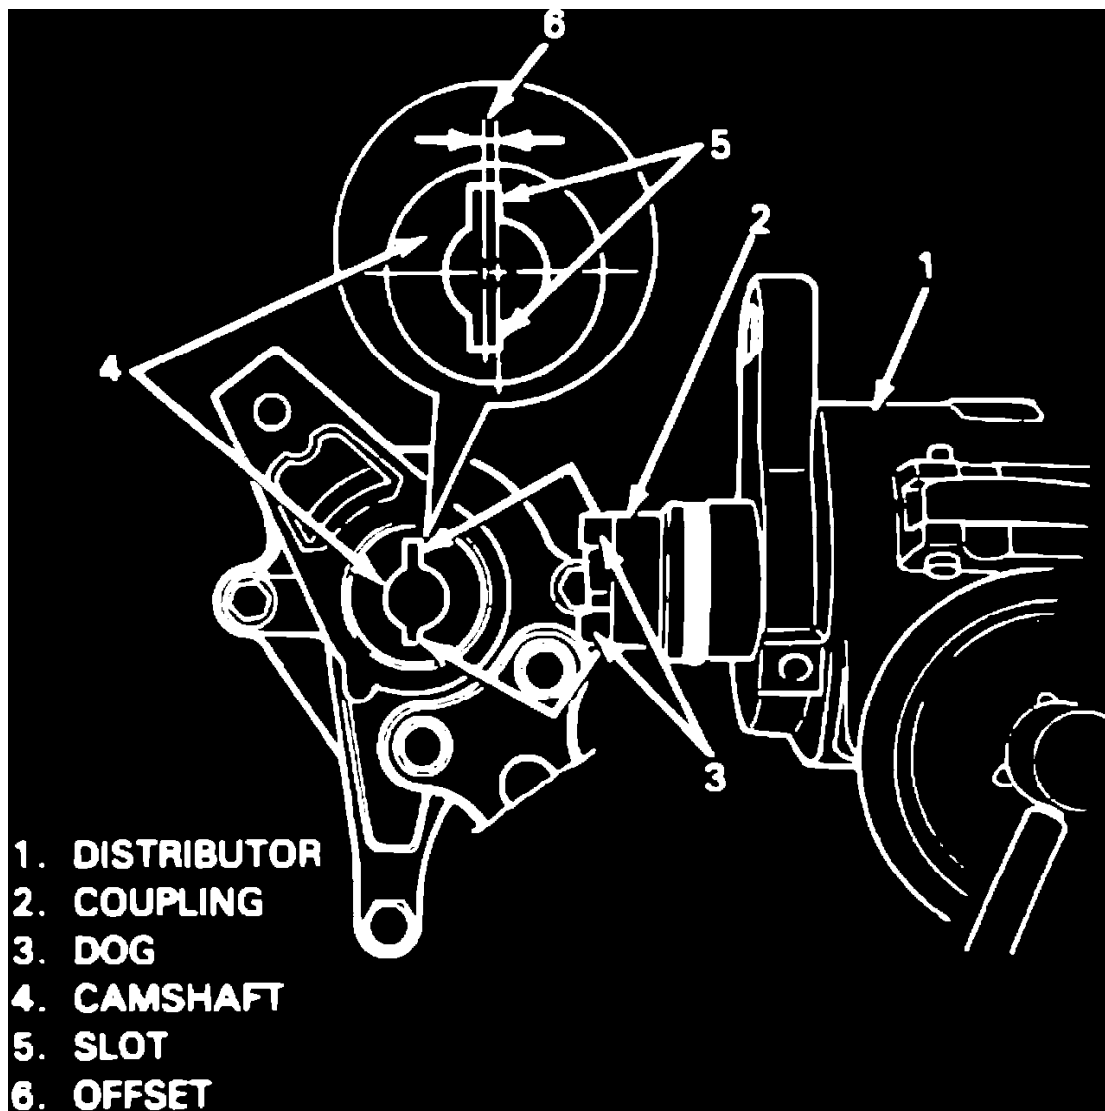
**Fig. 3 Aligning distributor drive tang**

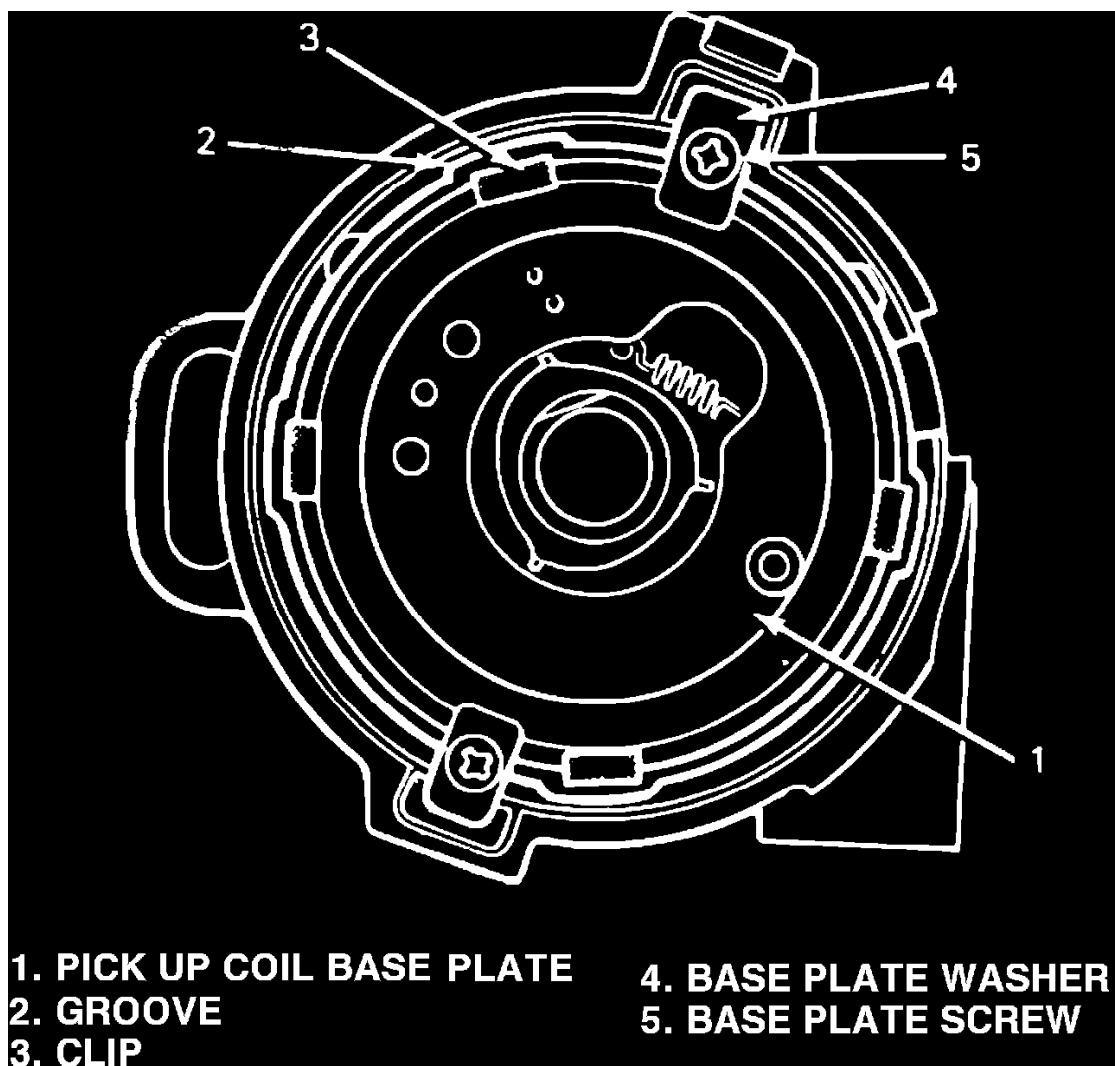
**Fig. 6 Installing pickup coil base plate in distributor housing**

1. Position pickup coil base plate in distributor. Install 4 clips on base plate into 4 grooves of distributor housing, **Fig. 6**.
2. Install vacuum advance unit.
3. Install pickup coil on base plate. Refer to "Air Gap, Adjust" procedure and adjust air gap. Tighten pickup coil screws.
4. Install module in distributor housing.
5. Install distributor rotor, cap and gasket.

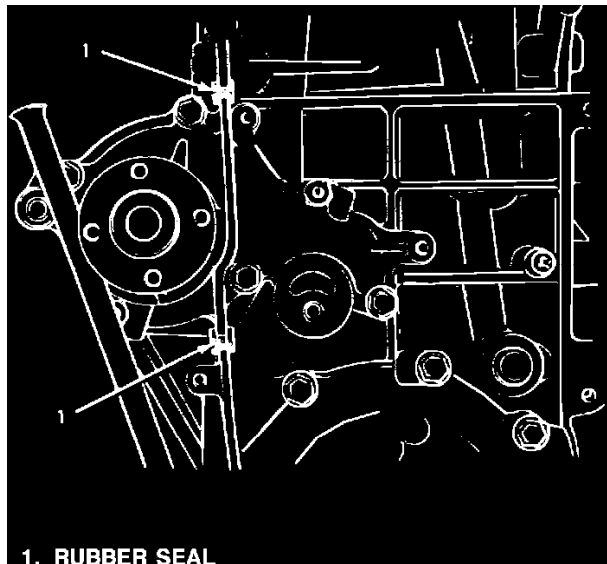
**Fig. 35 Installing rubber seals**

1. Disconnect battery ground cable.
2. Drain cooling system.
3. Remove drive belt, water pump pulley, crankshaft pulley, timing belt outside cover, timing belt and timing belt tensioner.
4. Remove water pump mounting bolts and nuts, and water pump.
5. If pump is defective, it must be replaced.
6. Place new water pump gasket on engine block.
7. Install water pump on engine block.
8. Install rubber seals between water pump and oil pump, and between water pump and cylinder head, **Fig. 35**.
9. Install timing belt tensioner, timing belt, timing belt outside cover, crankshaft pulley, water pump pulley and drive belt.
10. Tighten drive belt so it deflects .25-.35 inch on span between water pump pulley and crankshaft pulley.
11. Adjust intake and exhaust valves. Install valve cover and air cleaner.
12. Fill cooling system.
13. Connect battery ground cable.

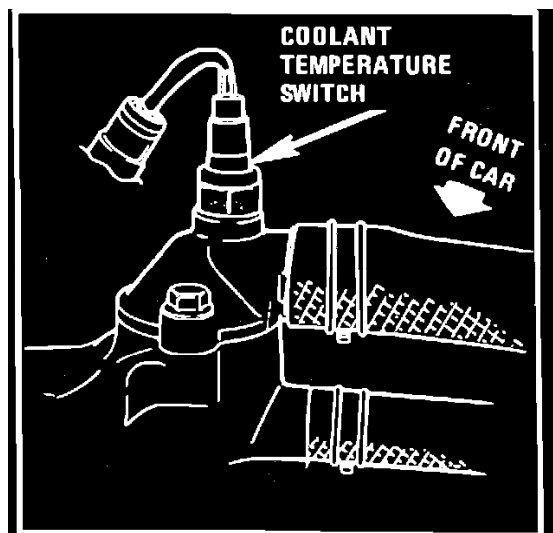
Top Center Of Engine

Mounted To Top Of Thermostat Housing

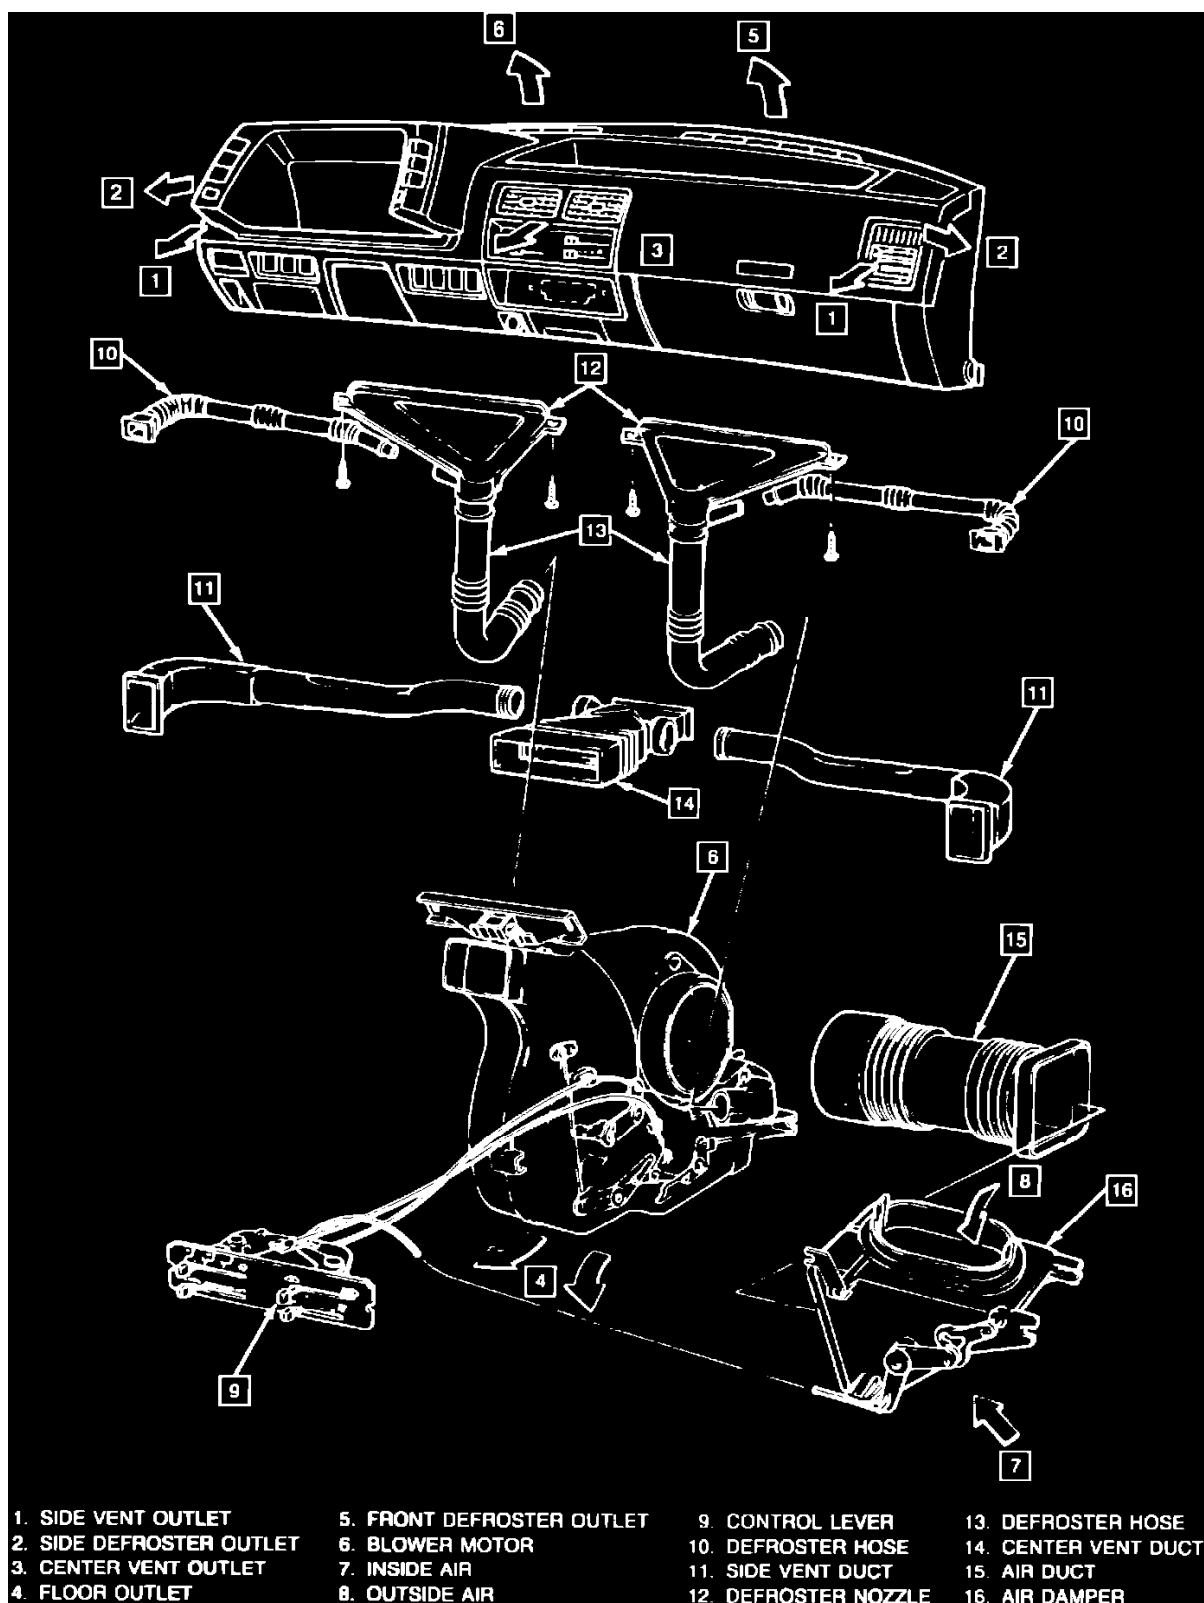
Fig. 8 Heater & defroster assembly

1. Drain cooling system.
2. Disconnect water hoses from heater core.
3. Remove glove box compartment.
4. Disconnect defroster hoses from heater housing, **Fig. 8**.
5. Disconnect connectors from blower motor and heater resistor.
6. Disconnect 3 control cables from heater case side levers.
7. Pull out center vent louvre.
8. Disconnect right and left side vent ducts from center vent duct.
9. Remove center vent duct.
10. Remove ashtray upper plate.
11. Remove instrument member stay.
