Vehicle: Application and ID

## Engine: Service and Repair

## Camshaft: Service and Repair

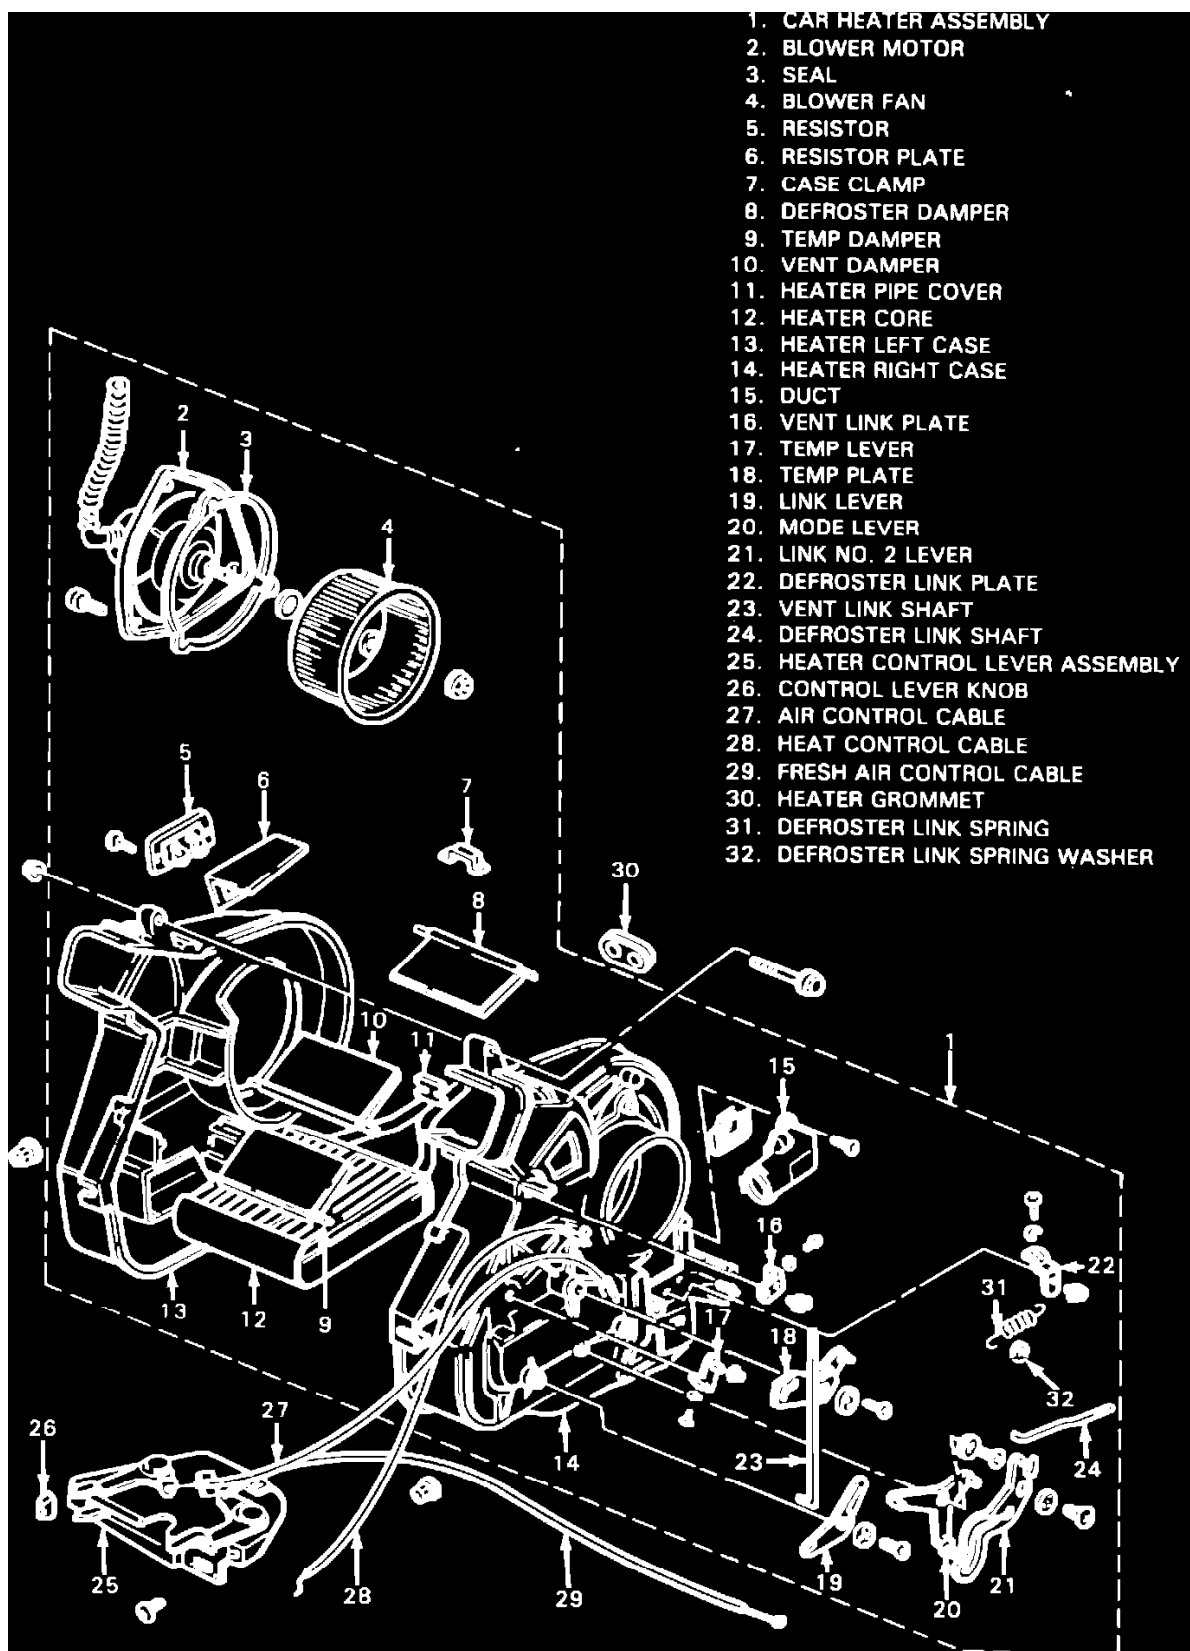
Fig. 9 Heater core case assembly

12. Remove 2 heater assembly mounting nuts.
13. Loosen heater case top side mounting bolts from glove box side.
14. Remove heater control assembly.
15. Remove retaining clips from heater case halves, Fig. 9.
16. Remove heater core from housing.

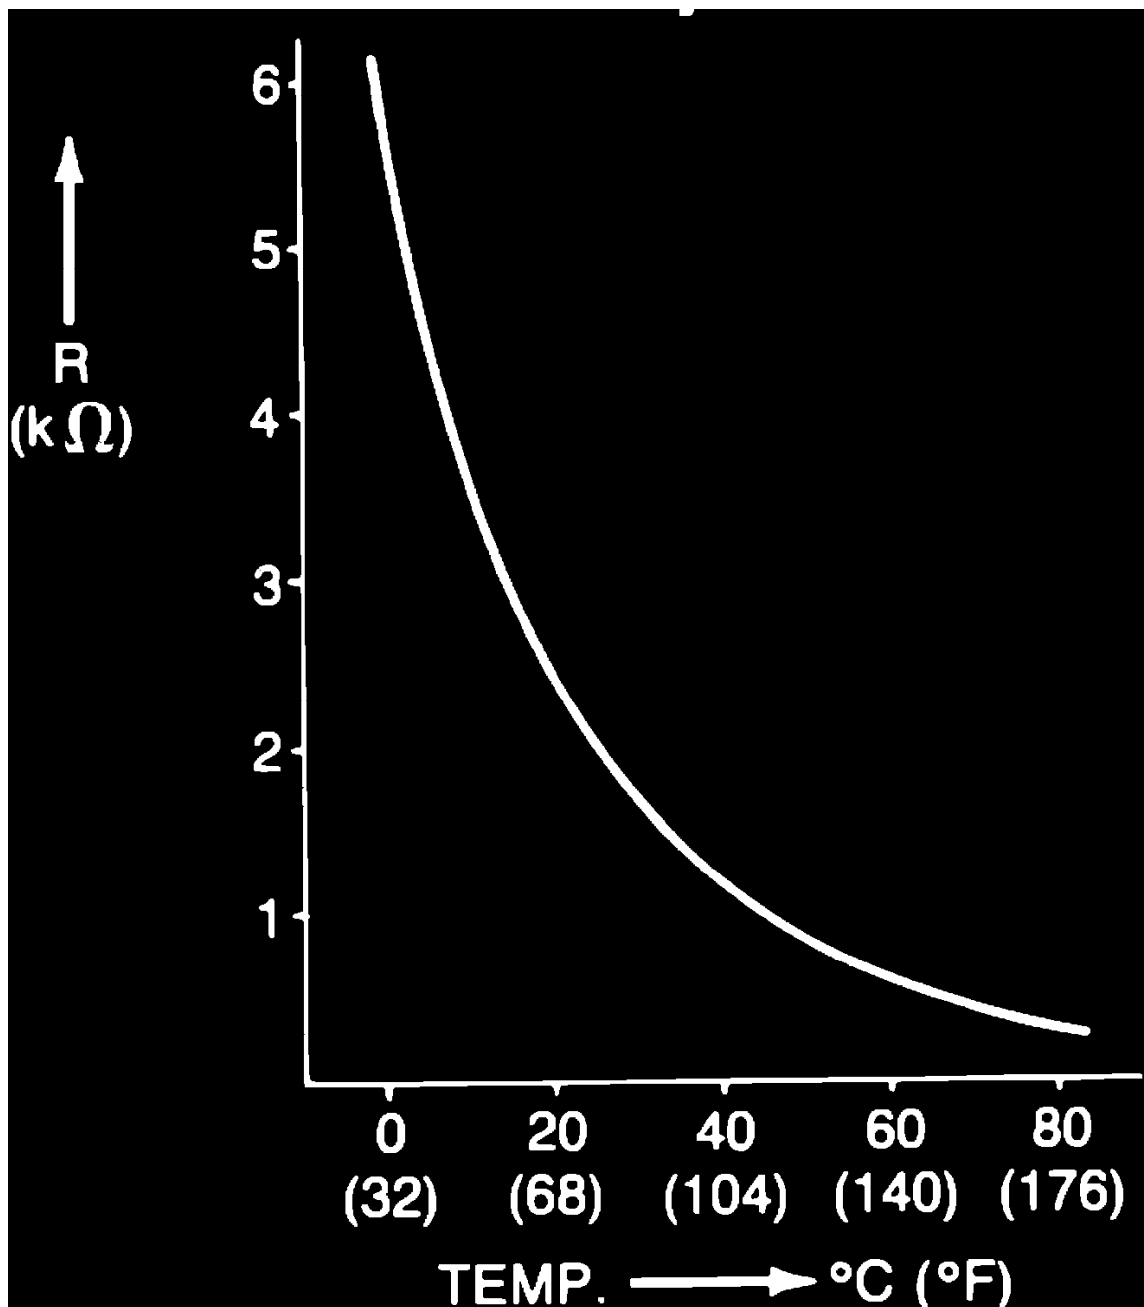
**Fig. 13 Checking coolant temperature sensor**

Warm temperature sensor, then check temperature-to-resistance relationship as shown, **Fig. 13**.

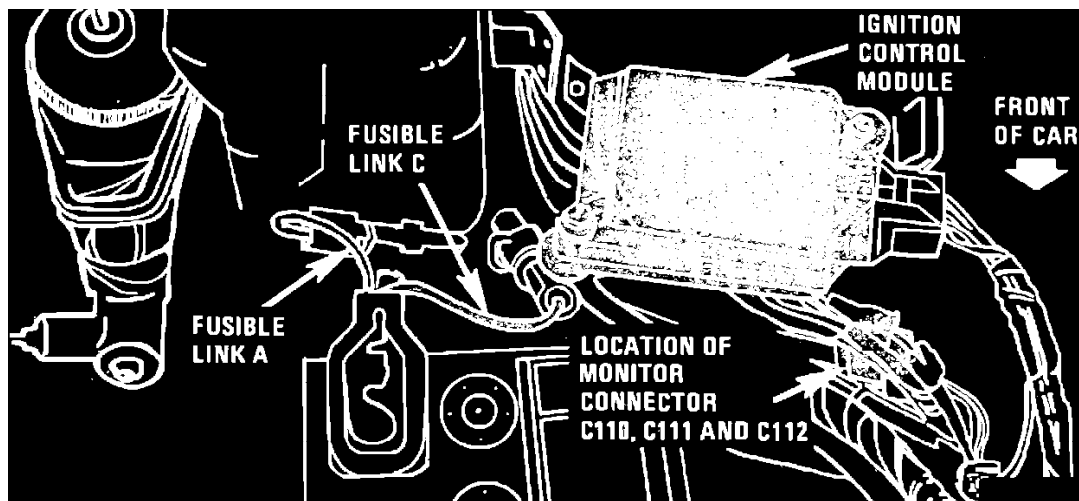
Left Side Of Engine Compartment

Mounted On Left Strut Tower

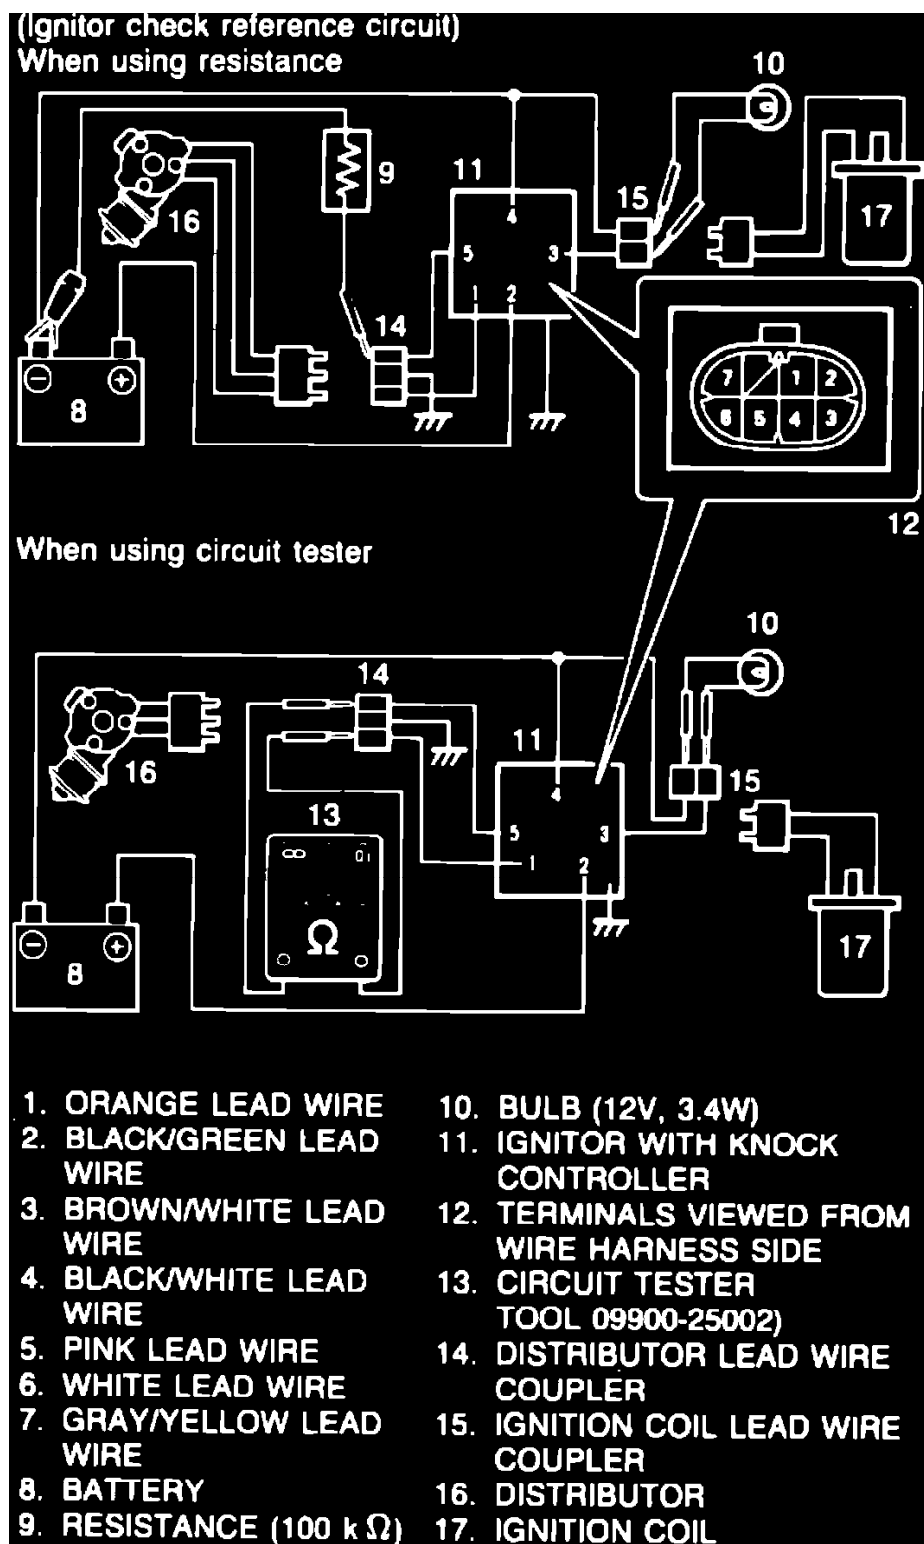
Fig. 8 Testing igniter w/knock controller. 1987 - 88 Models w/EFI & turbocharger

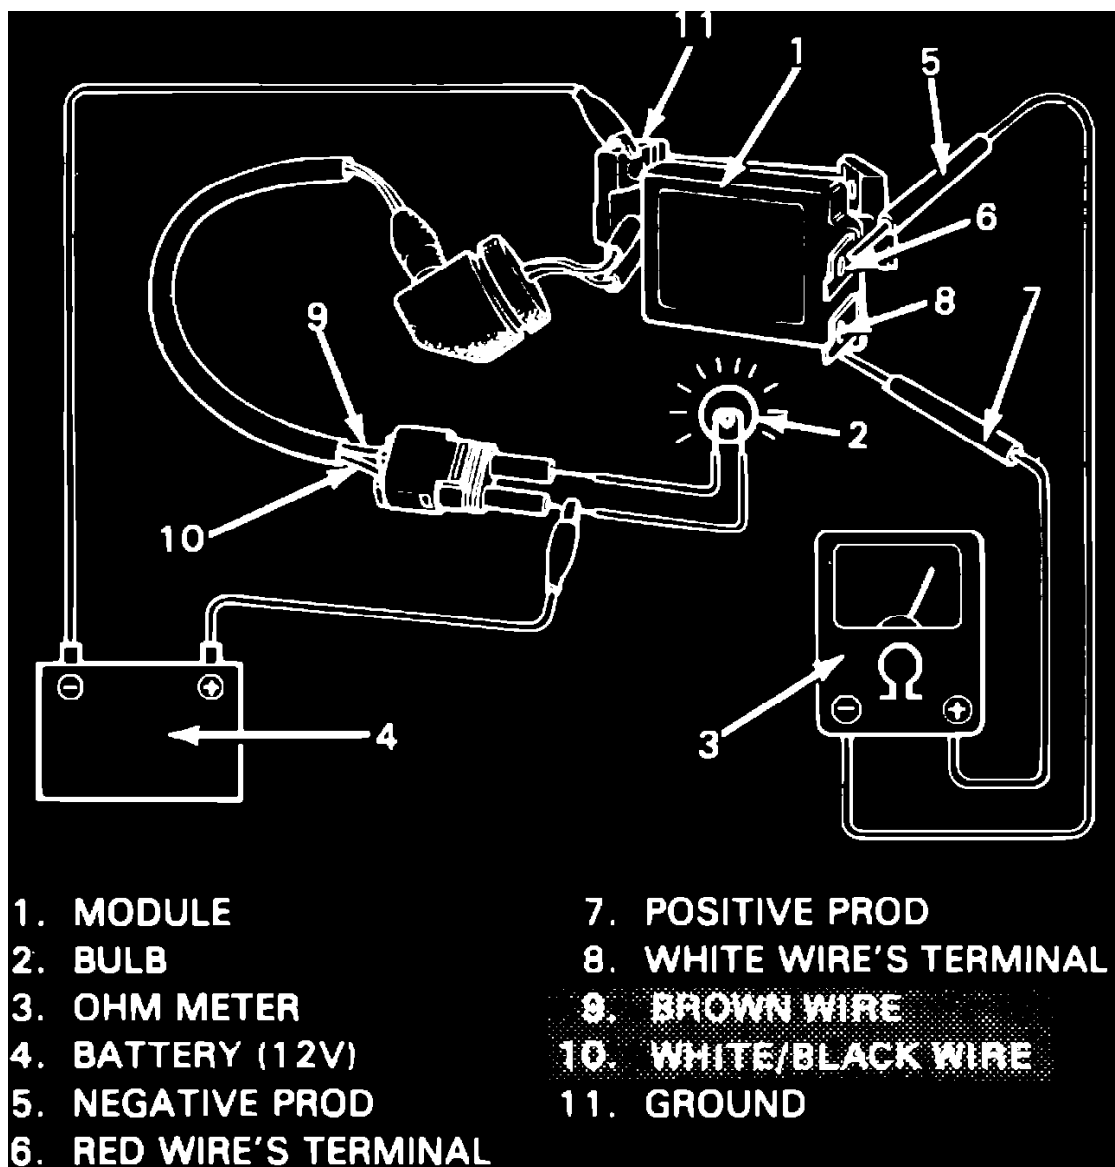
Fig. 5 Checking ignition module

1. Remove dust cover from module and disconnect red and white wires.
2. Connect ohmmeter, test lamp, and 12 volt battery as shown in **Fig. 5**.
3. Set ohmmeter to 1 - 10 ohm range. Connect negative probe to red wire terminal of module and positive probe to white wire terminal. If test lamp illuminates, module is satisfactory. If not, replace module. **Ohmmeter leads should only be connected as outlined above. Reversing leads may cause damage to module.**
4. Connect red and white wires to module and install dust cover.

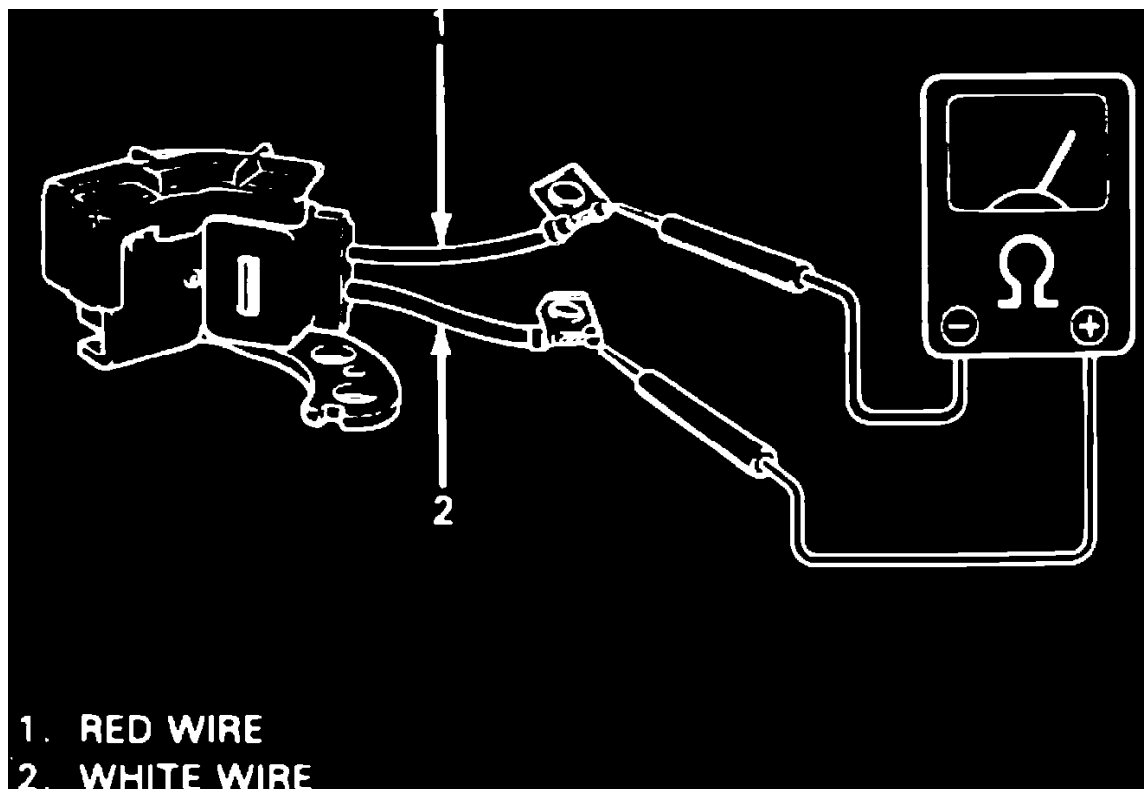
**Fig. 4 Checking pickup coil resistance**

1. Check base plate for smooth rotation. Replace base plate if faulty.
2. Remove dust cover from module and disconnect red and white wires, **Fig. 4**.
3. Connect ohmmeter to red and white wires and measure resistance. Pickup coil resistance should be 130 - 190 ohms. Replace pickup coil if resistance is not within specification.
4. Connect red and white wires to module and install dust cover.

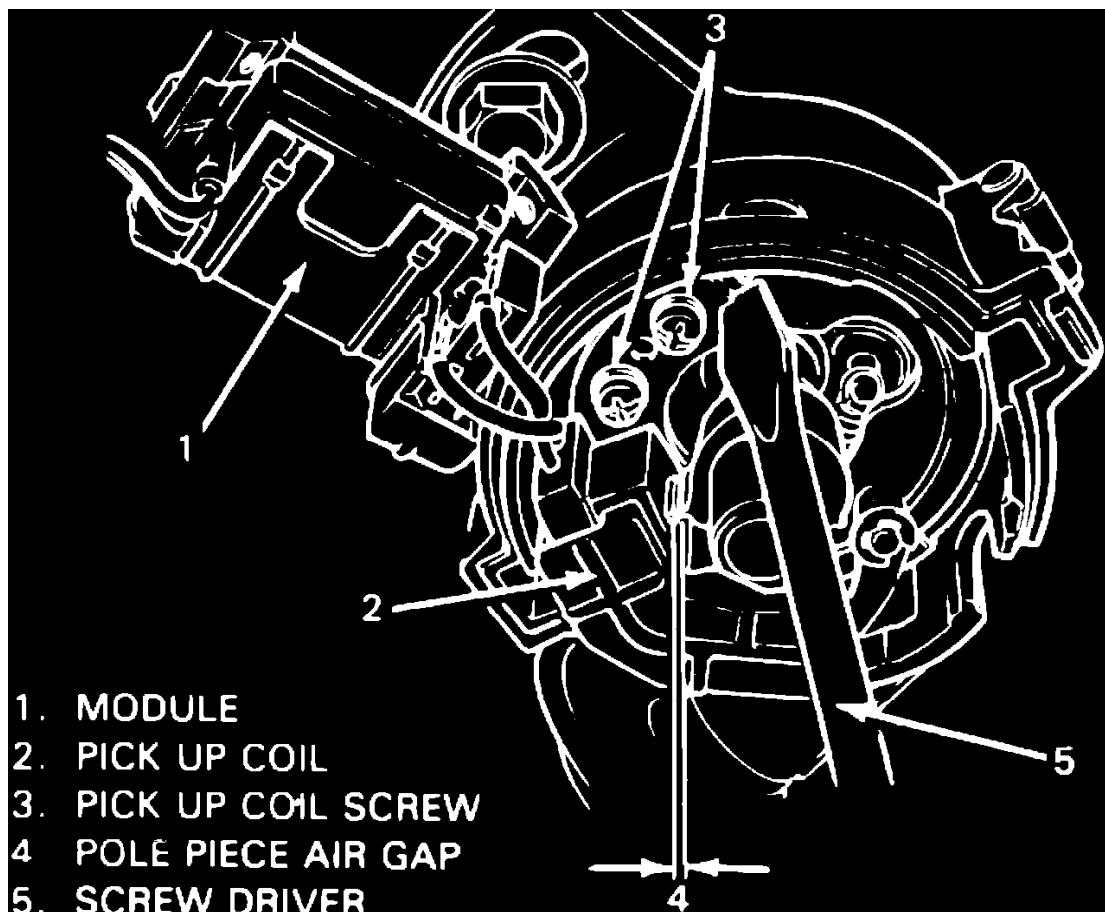
**Fig. 7 Adjusting air gap**

1. Remove distributor cap and rotor.
2. Using feeler gauge, measure air gap between pole piece tooth and pickup coil, **Fig. 7**. Air gap should be .008 - .015 inch (.2 - .4 mm).
3. If gap is incorrect, remove module and loosen 2 screws holding pickup coil.
4. Using screwdriver, move pickup coil to adjust gap to specification.
5. Tighten 2 screws and recheck air gap.
6. Install module, rotor, and distributor cap.

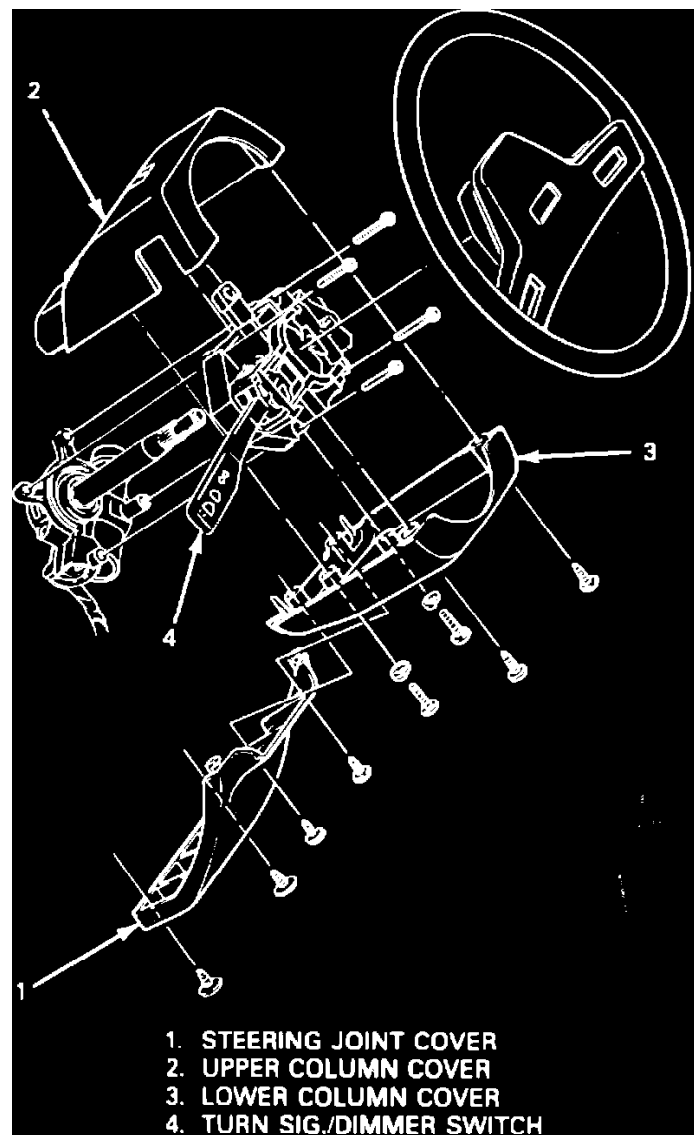
**Fig. 2 Turn signal/dimmer switch removal**

1. Disconnect battery ground cable.
2. Remove steering joint cover.
3. Remove steering wheel pad.
4. Using suitable puller, remove steering wheel.
5. Remove steering column lower cover, **Fig. 2**.
6. Disconnect main switch and turn signal/dimmer switch connectors.
7. Remove turn signal/dimmer switch, **Fig. 2**.

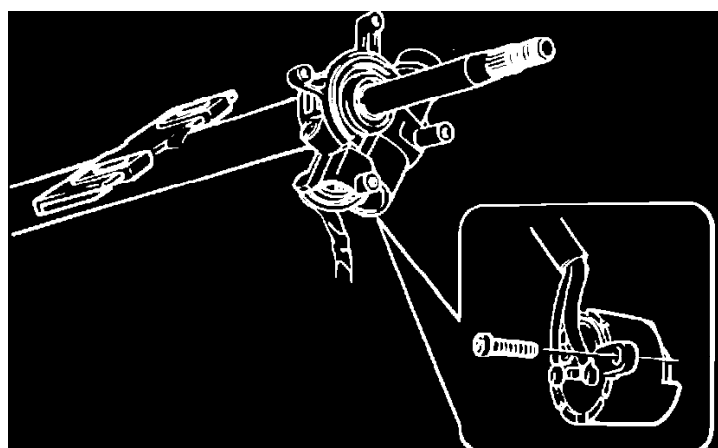
**Fig. 3 Ignition switch removal**

8. Remove ignition switch screws, then switch, **Fig. 3**.

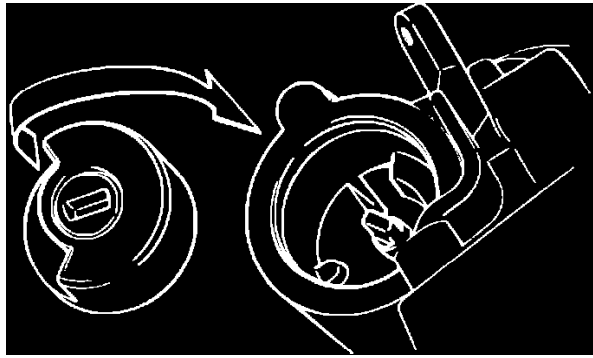
**Fig. 4 Ignition switch installation**

9. Reverse procedure to install. Position ignition switch so recess is mated with tab on bracket, **Fig. 4**.

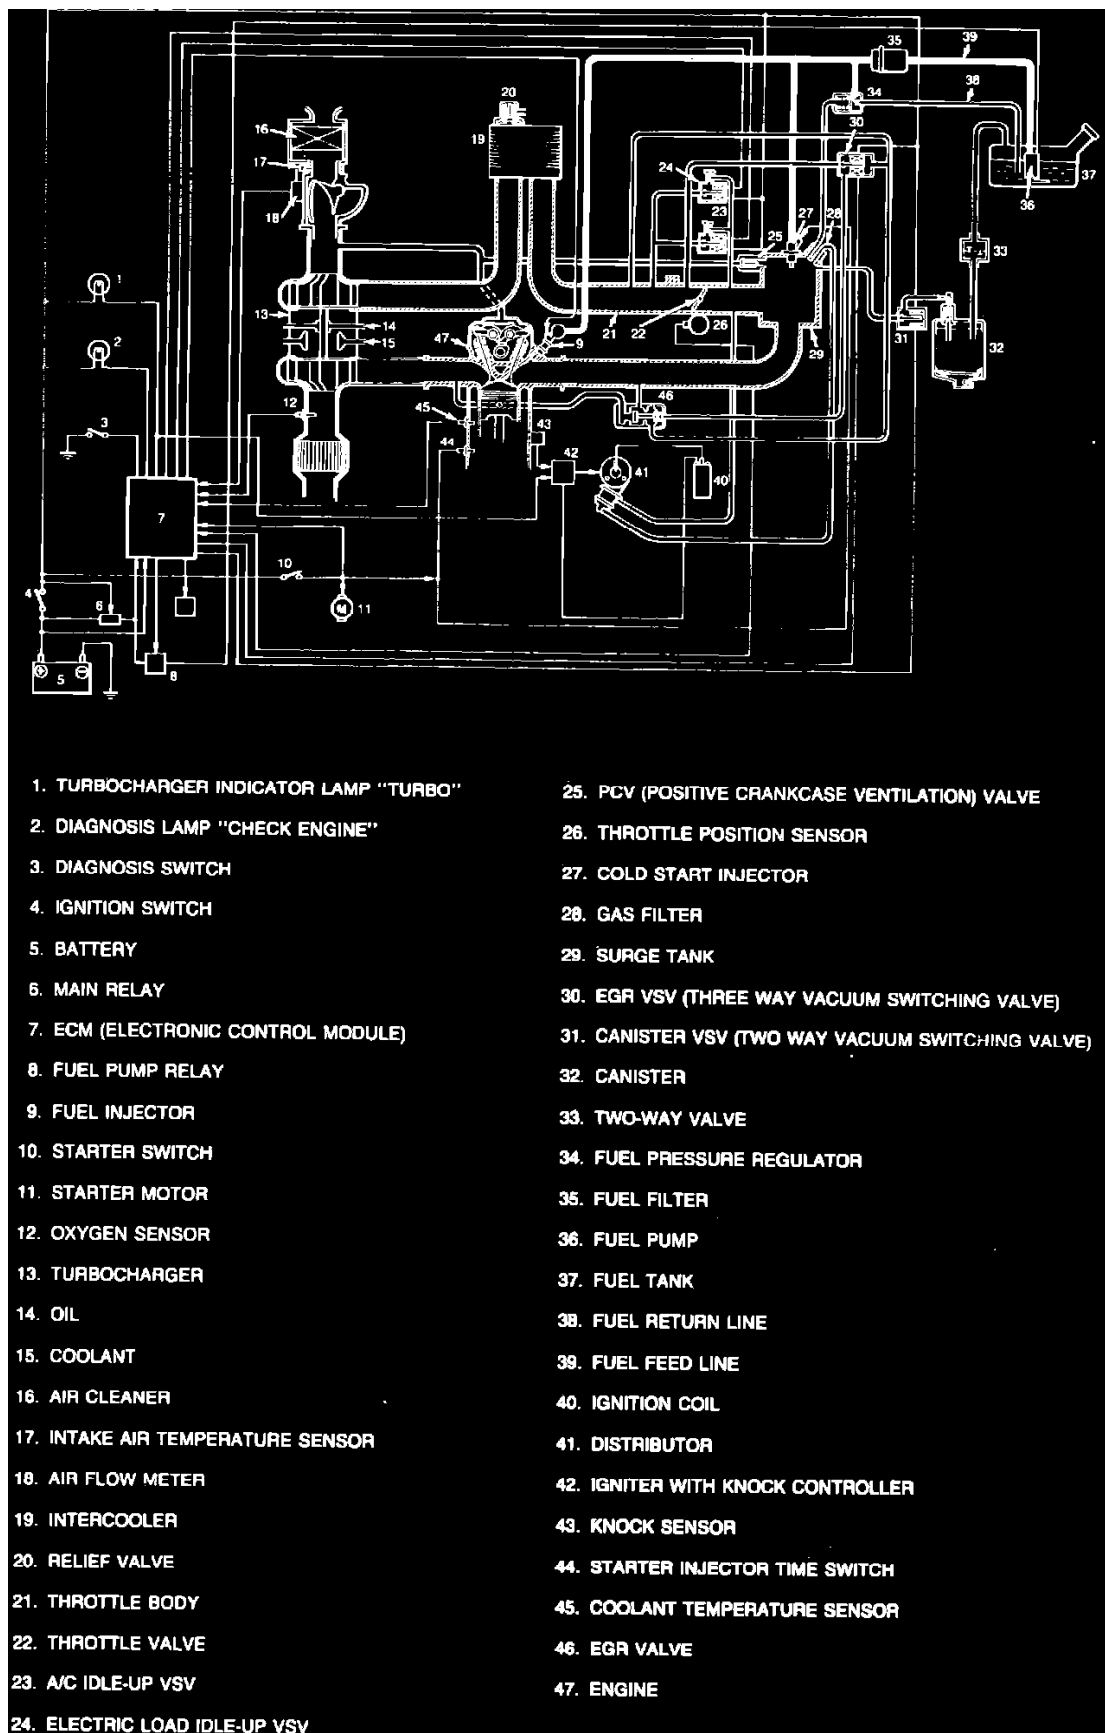
Fig. 1 Electronic fuel injection system

The electronic control type fuel injection system with turbocharger and intercooler, **Figs. 1 through 3**, consists of an ECM (Electronic Control Module), an in-tank electric fuel pump, a pressure regulator, an air flow meter, fuel injectors, a turbocharger, an intercooler, an inlet air temperature sensor, a coolant temperature sensor and various other related components.

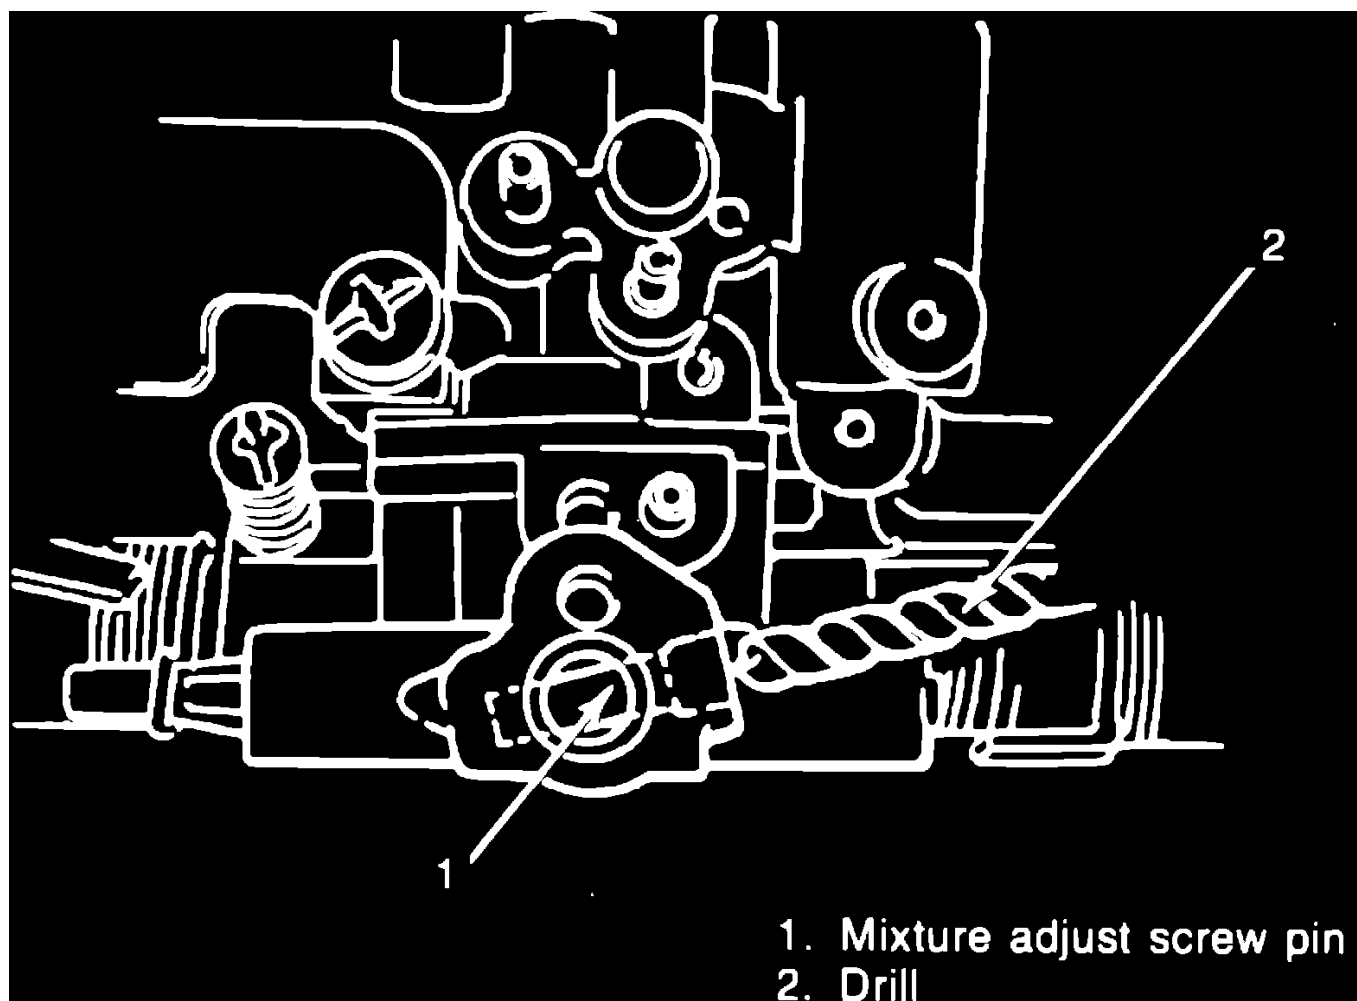
**Fig. 10 Mixture adjusting screw pin removal**

The idle mixture adjusting screw is recessed into the throttle body and blocked by a steel pin to prevent tampering. Idle mixture should not be adjusted unless carburetor is overhauled or diagnosis indicates the carburetor as the cause of driveability or emissions related complaints. If idle mixture adjustment is required, remove pin sealing adjusting screw using the following procedure:

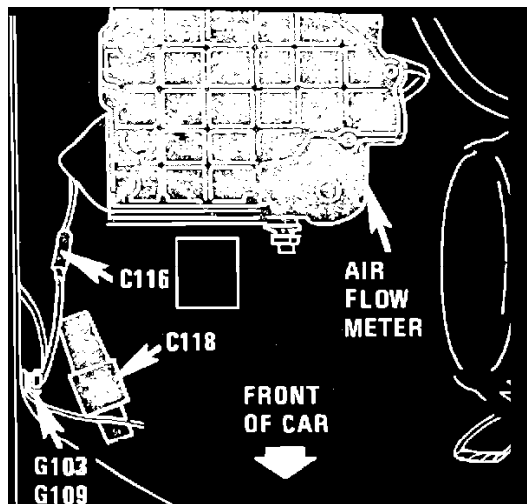
Right Front Corner Of Engine Compartment

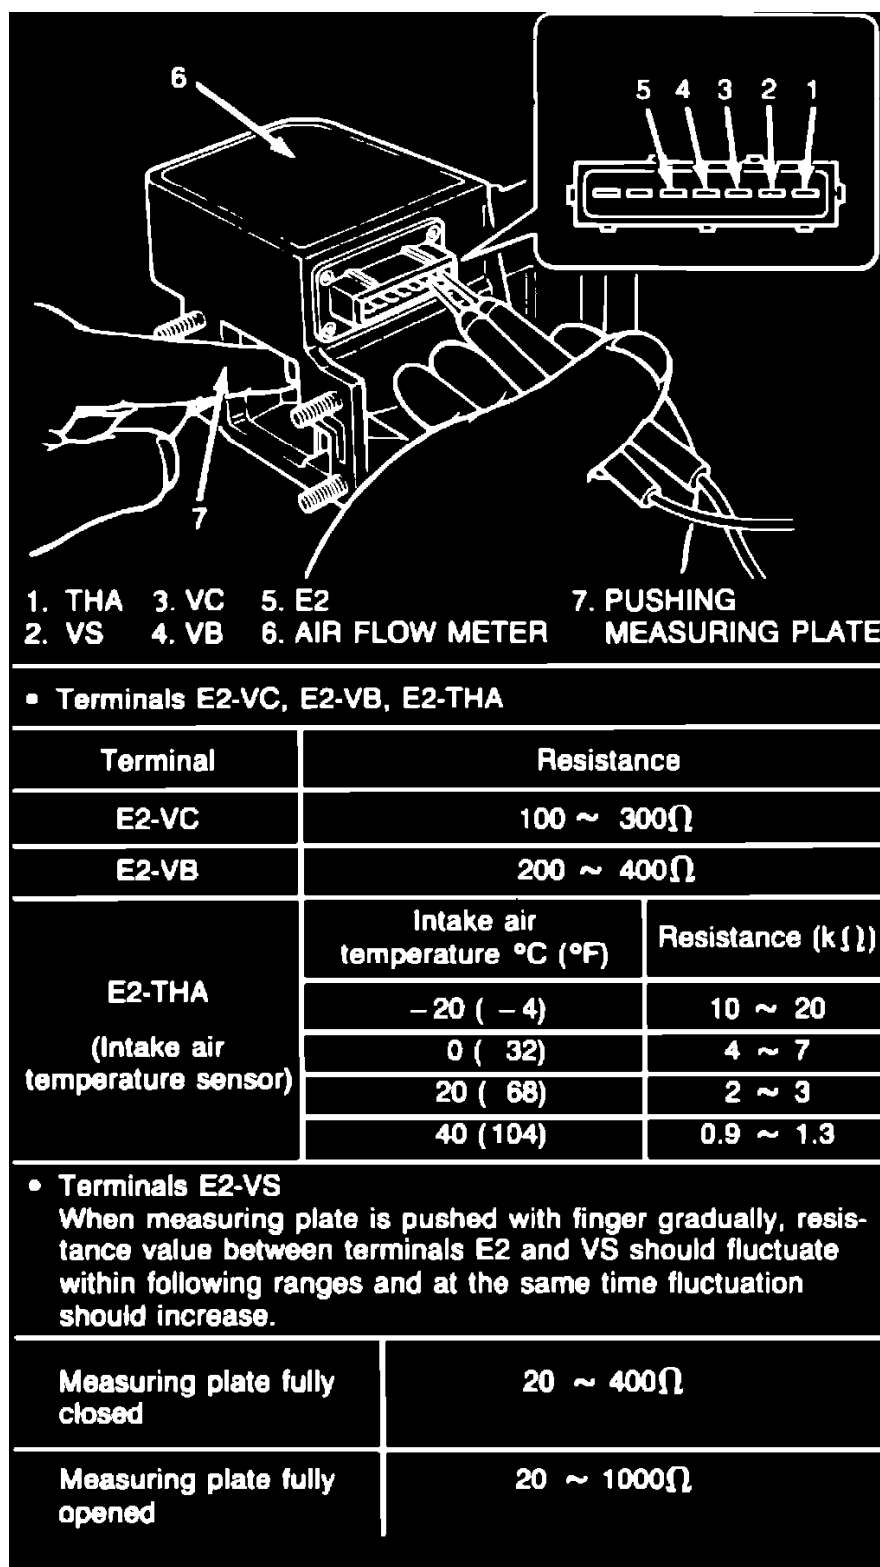
Fig. 10 Checking air flow meter

1. Check resistance between terminals of air flow meter as shown, Fig. 10.

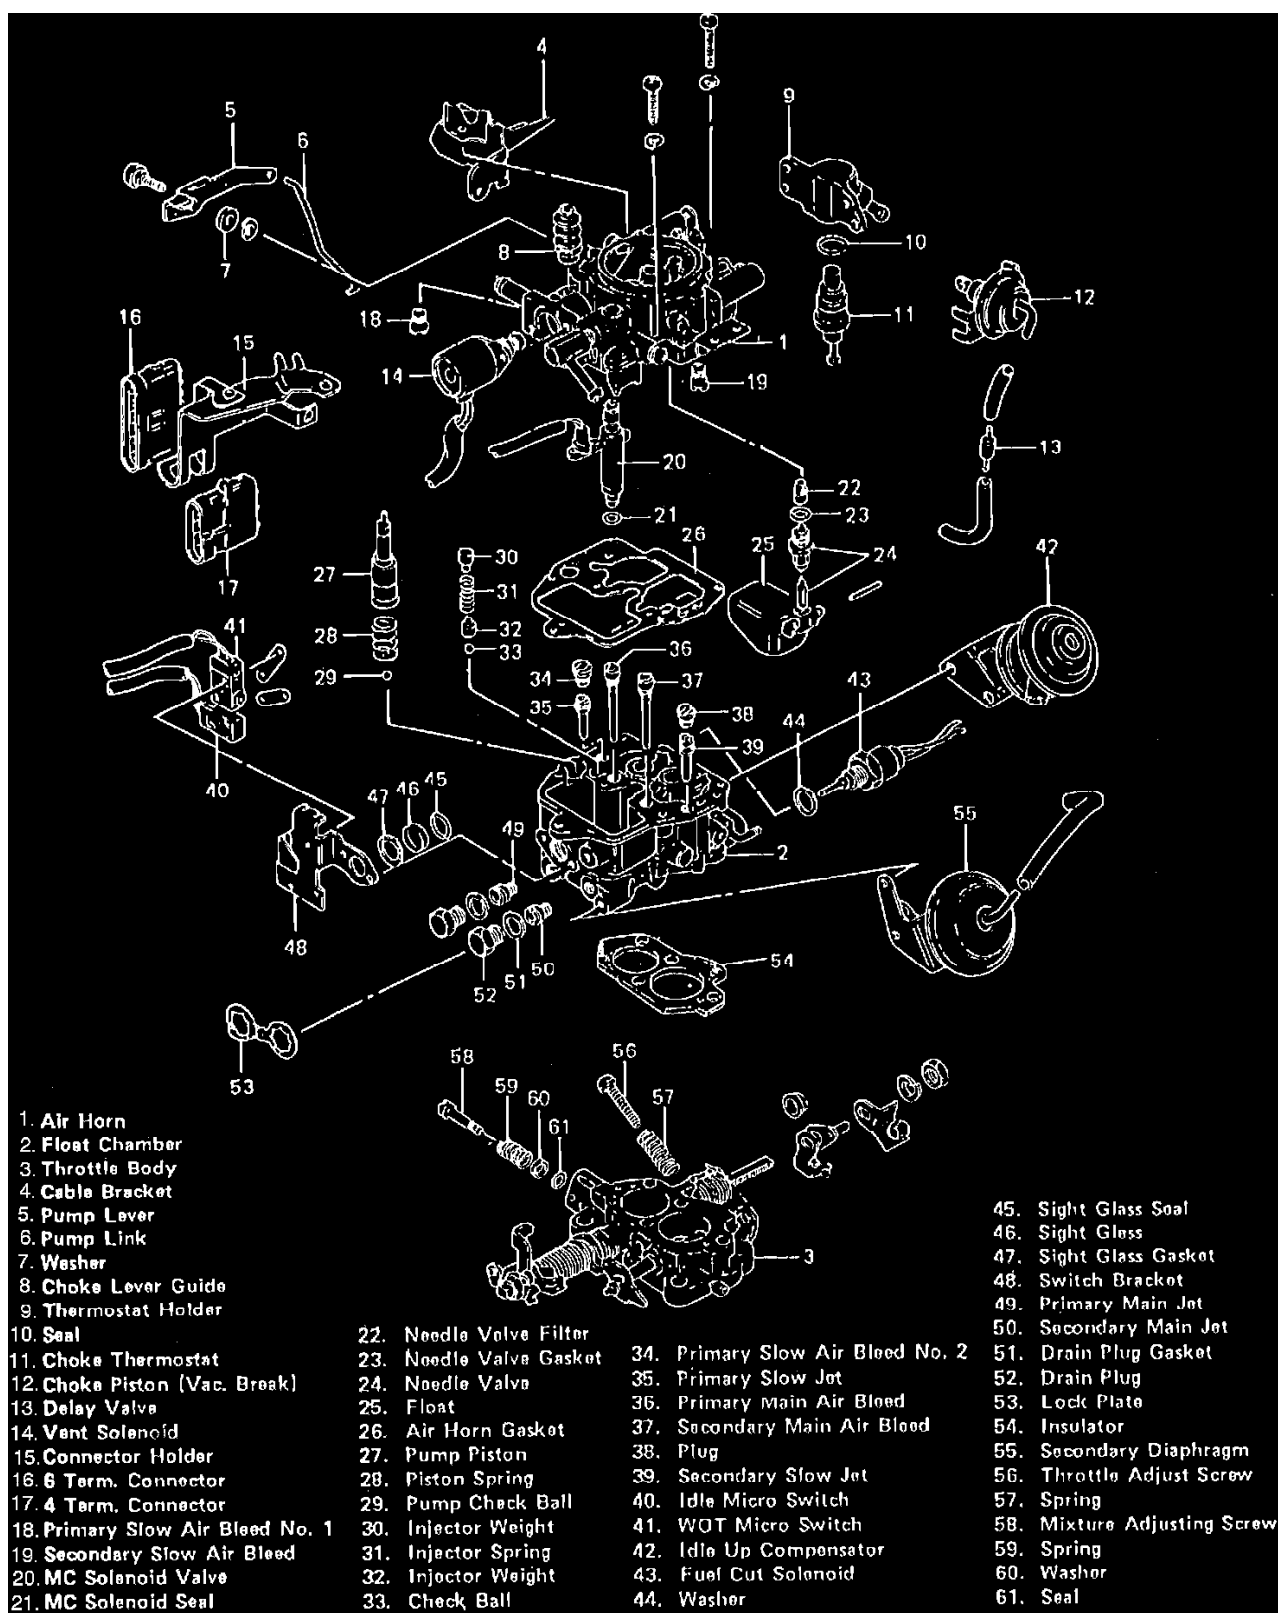
**Fig. 1 Typical Exploded View Of Hitachi MR08 Carburetor**

The Hitachi MR08 carburetor is a staged two barrel downdraft unit with separate primary and secondary metering systems fed from a common float chamber, **Fig. 1**. The primary throttle plate is directly actuated by the accelerator linkage and the primary system functions under all operating conditions. The secondary throttle plate is vacuum operated and opens only during high RPM or high load operation.

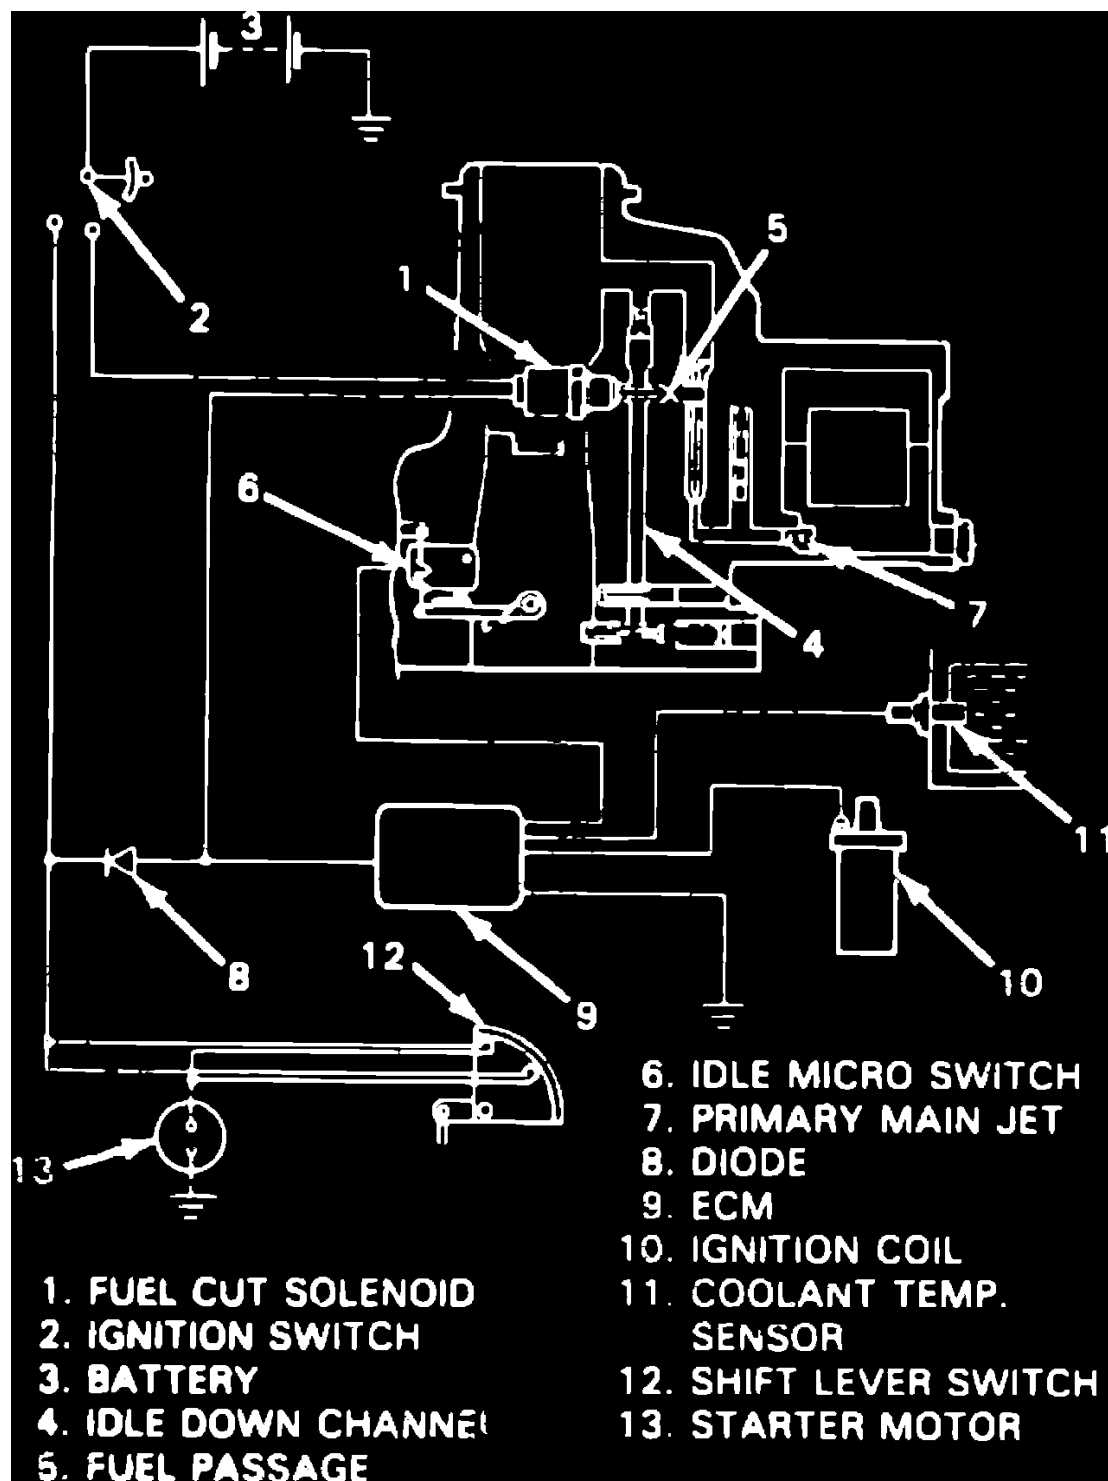
Fig. 20 Fuel cut system schematic. 1987 - 88 Models w/automatic transmission

This system consists of a solenoid valve mounted in the primary idle circuit of the carburetor, **Figs. 19, 20 and 21**. The solenoid valve cuts off fuel supply to prevent dieseling when the ignition is shut off, and to improve fuel economy and reduce catalyst overheating during deceleration.

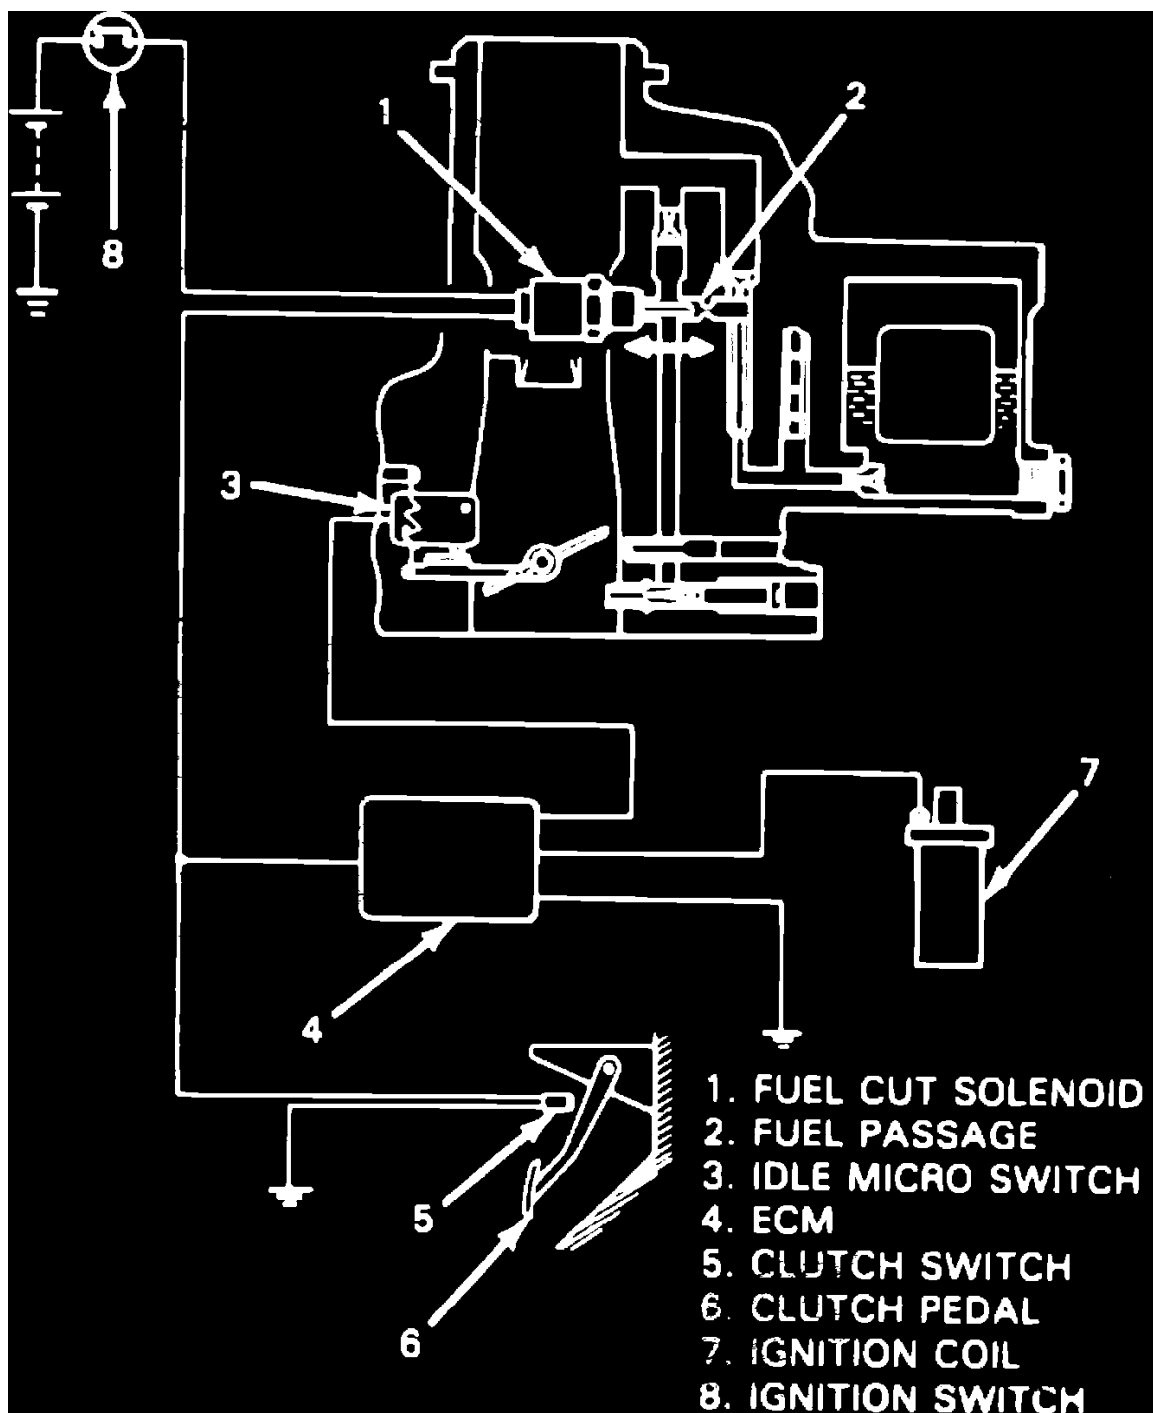
**Fig. 21 Fuel cut system schematic. 1987 - 88 models w/manual transmission**

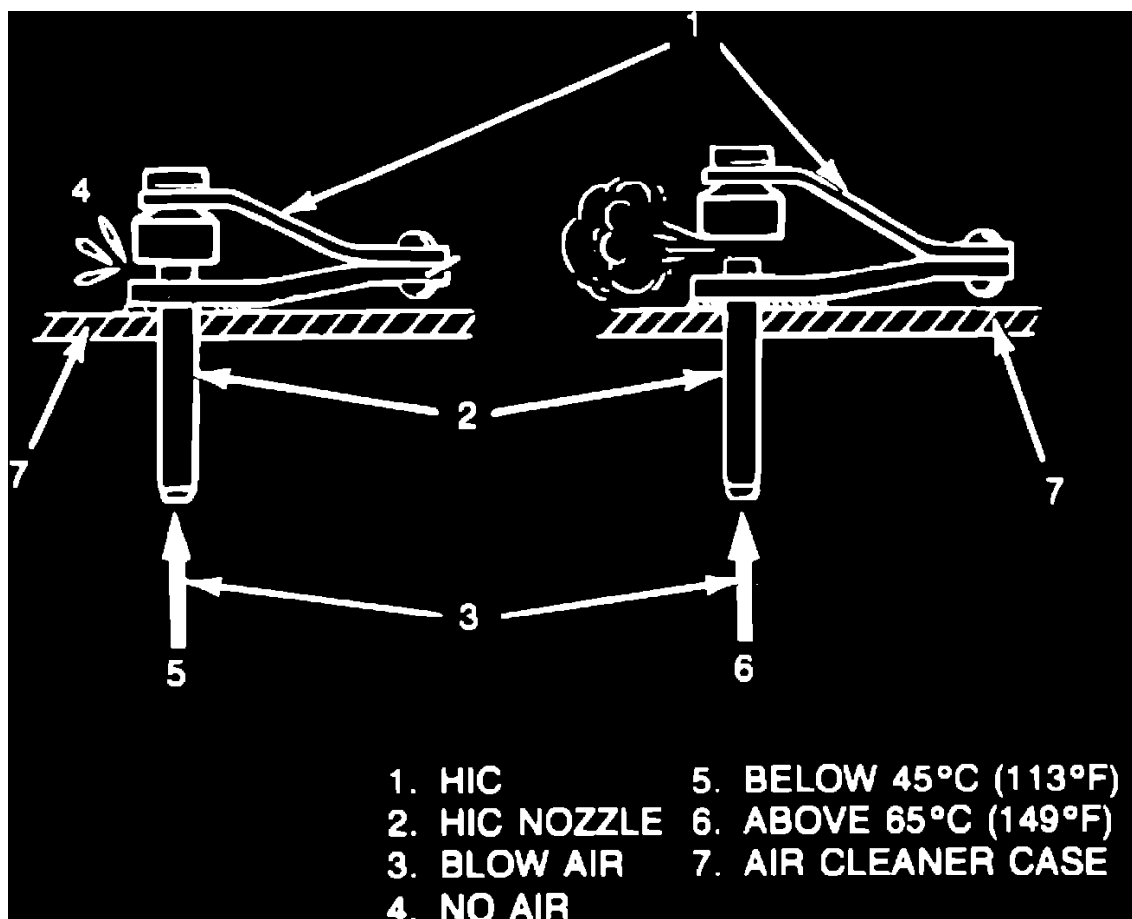
**Fig. 23 Checking hot idle compensator operation**

The HIC, **Fig. 23**, uses a bi-metallic spring to allow additional air flow into the engine during very high engine compartment temperatures. This additional air flow prevents an unstable idle caused by the rich air/fuel mixture that results from these high temperatures.

1. Remove air cleaner.
2. Disconnect vacuum hose from HIC.
3. Check temperature at HIC with thermometer.
4. Blow air into HIC. HIC should be closed at temperatures below 113°F, and open at temperatures above 149°F, **Fig. 23**.
5. Reconnect vacuum hose and reinstall air cleaner.
