Vehicle: Application and ID

## Engine: Service and Repair

## Camshaft: Service and Repair

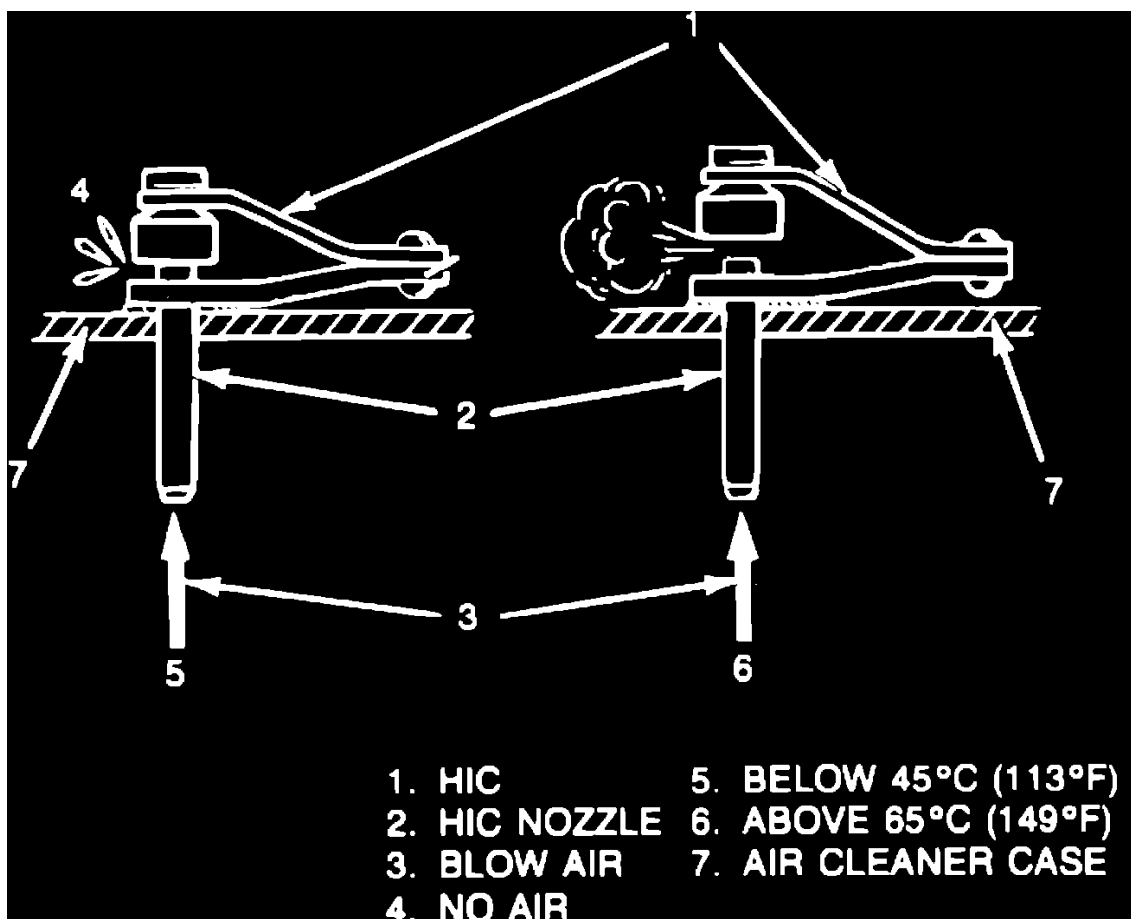
**Fig. 23 Checking hot idle compensator operation**

The HIC, **Fig. 23**, uses a bi-metallic spring to allow additional air flow into the engine during very high engine compartment temperatures. This additional air flow prevents an unstable idle caused by the rich air/fuel mixture that results from these high temperatures.

1. Remove air cleaner.
2. Disconnect vacuum hose from HIC.
3. Check temperature at HIC with thermometer.
4. Blow air into HIC. HIC should be closed at temperatures below 113°F, and open at temperatures above 149°F, **Fig. 23**.
5. Reconnect vacuum hose and reinstall air cleaner.

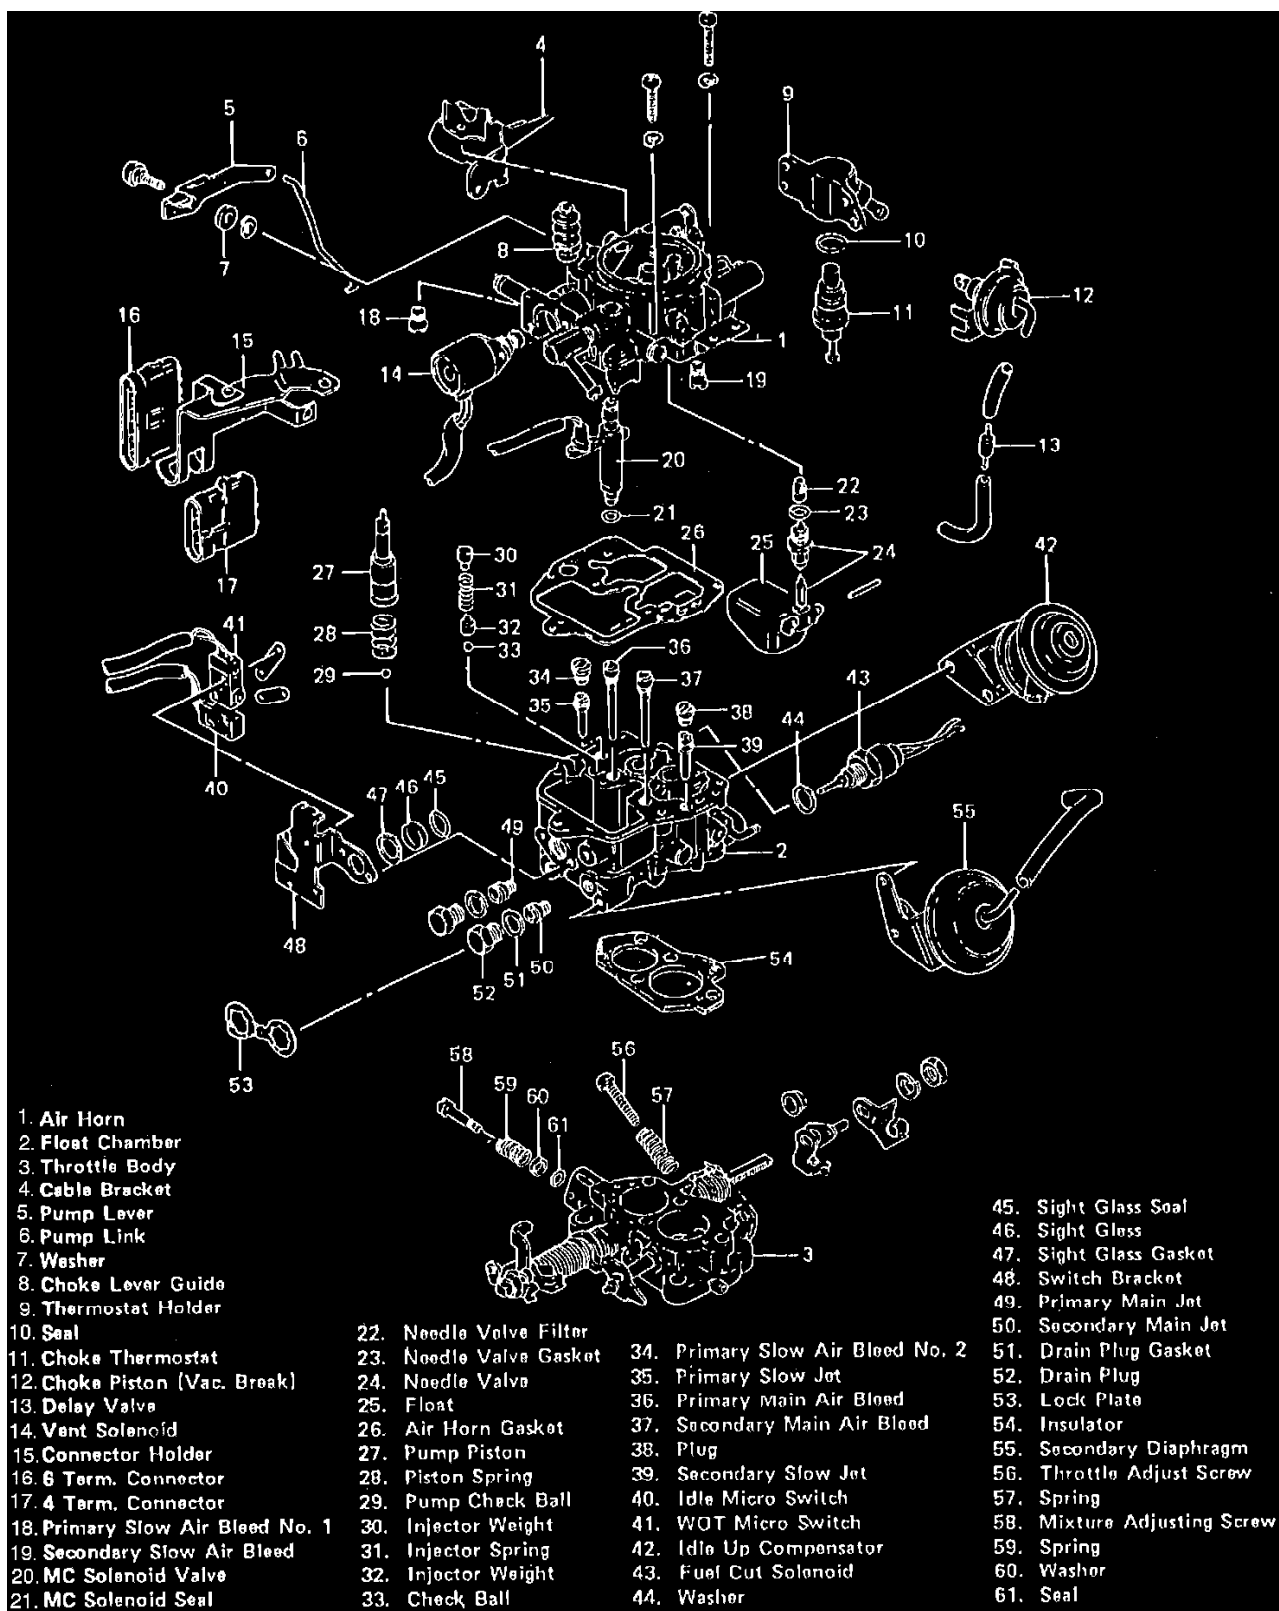
Fig. 1 Typical Exploded View Of Hitachi MR08 Carburetor

Keep all components in order by sub-system to aid assembly. Note installation position of all calibrated components, keeping primary and secondary system components separate, so that they can be installed in proper position.

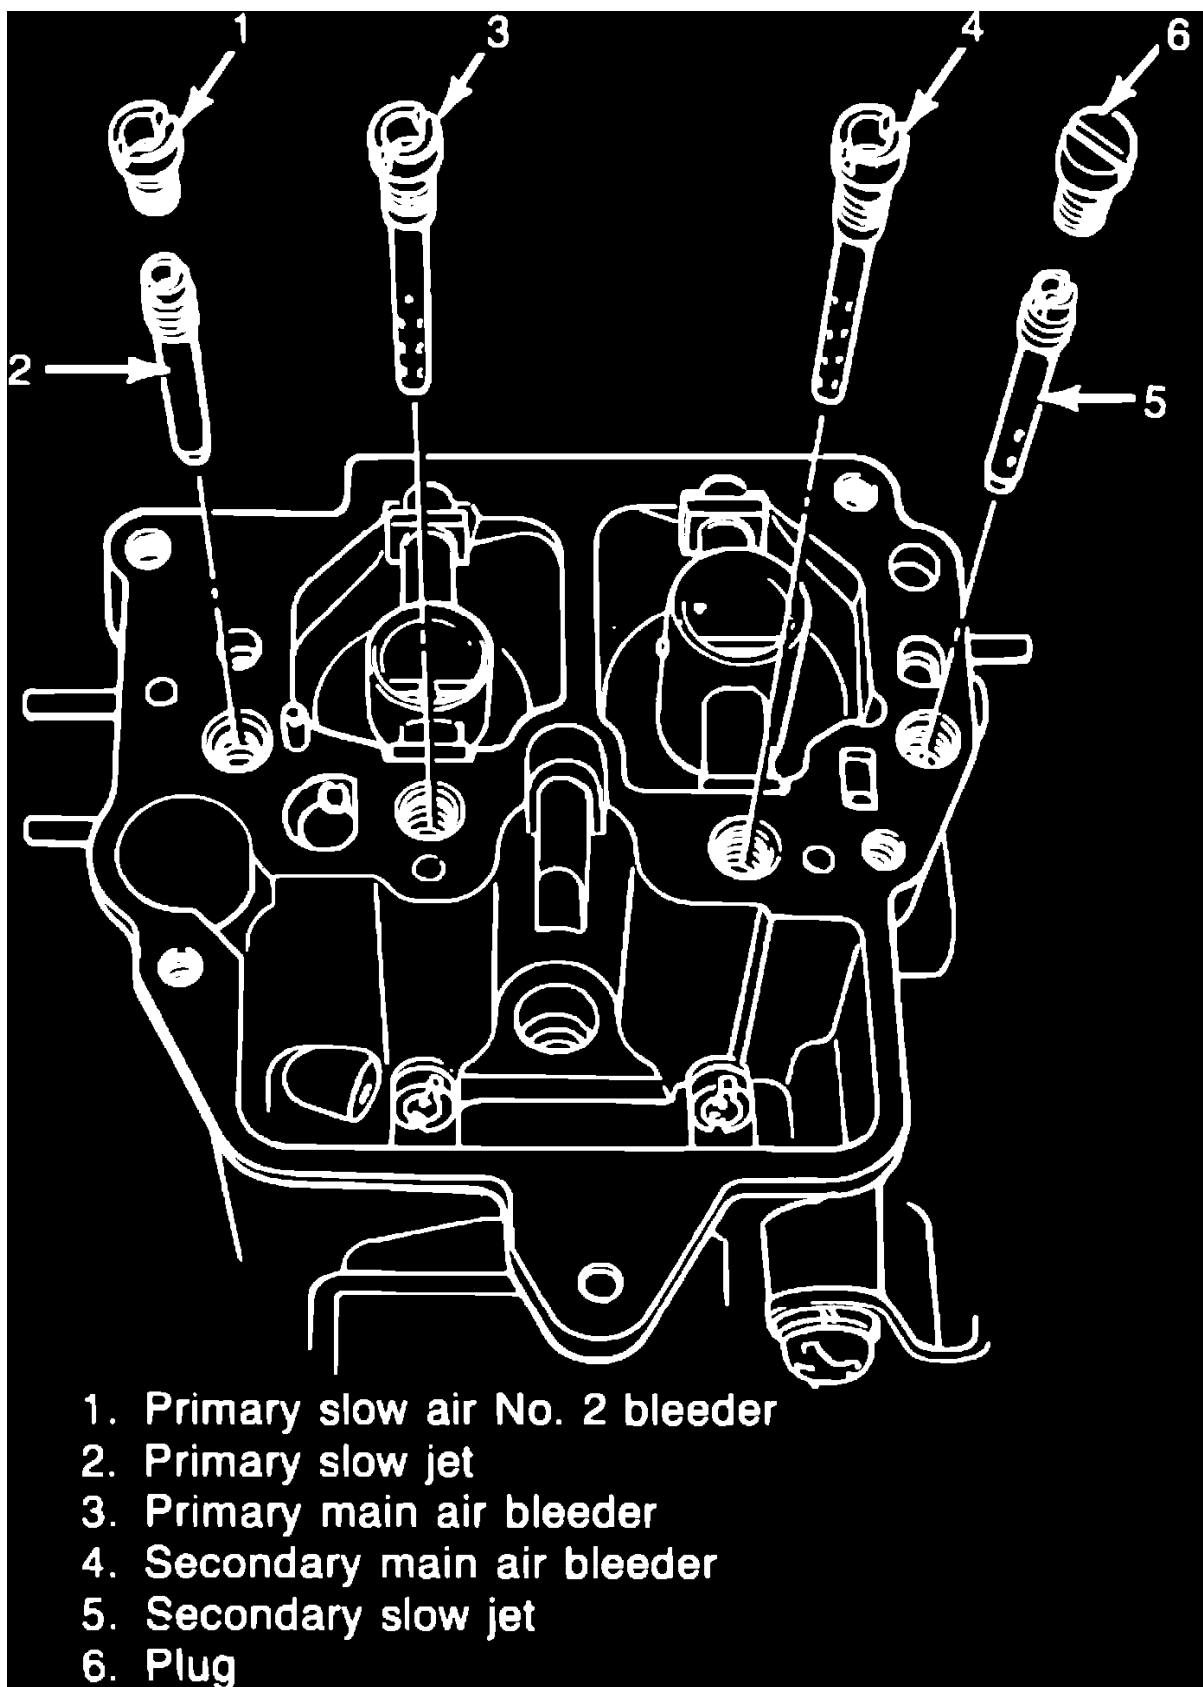
**Fig. 2 Jet & air bleed identification**

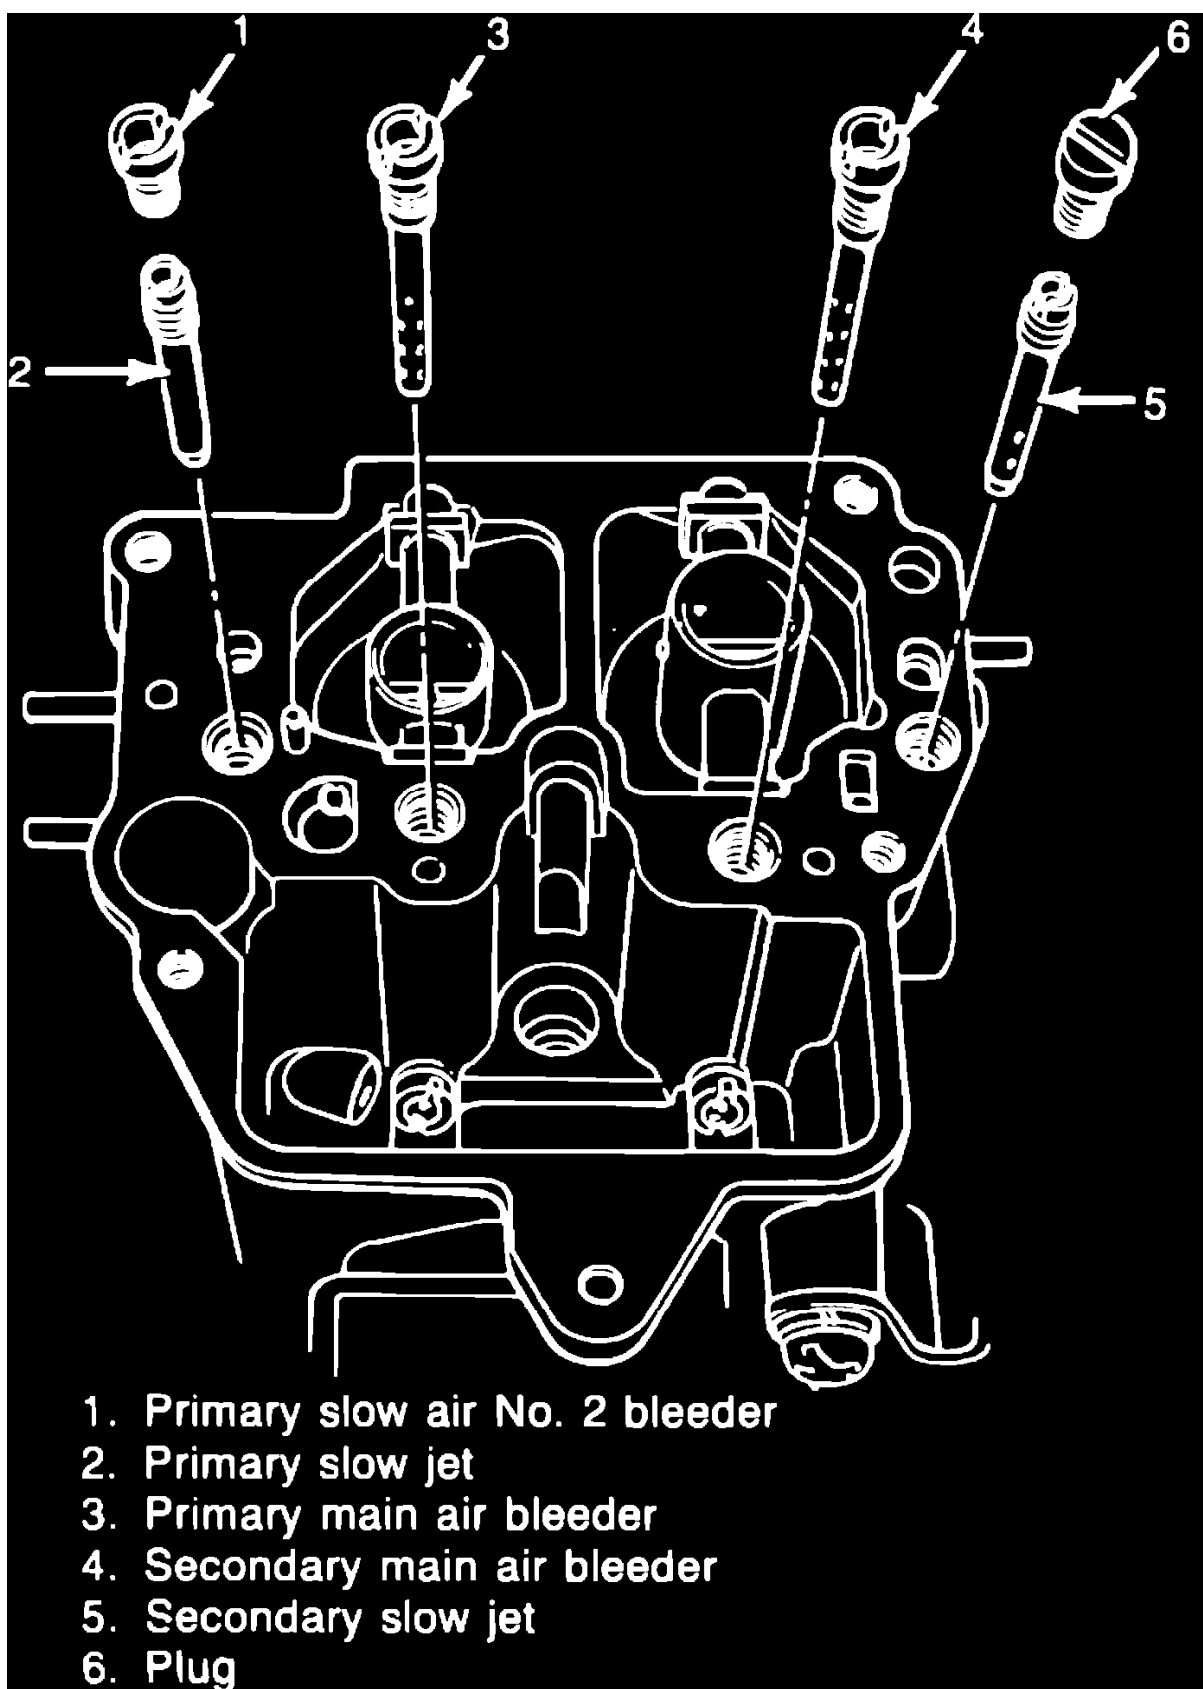
Fig. 2 Jet & air bleed identification

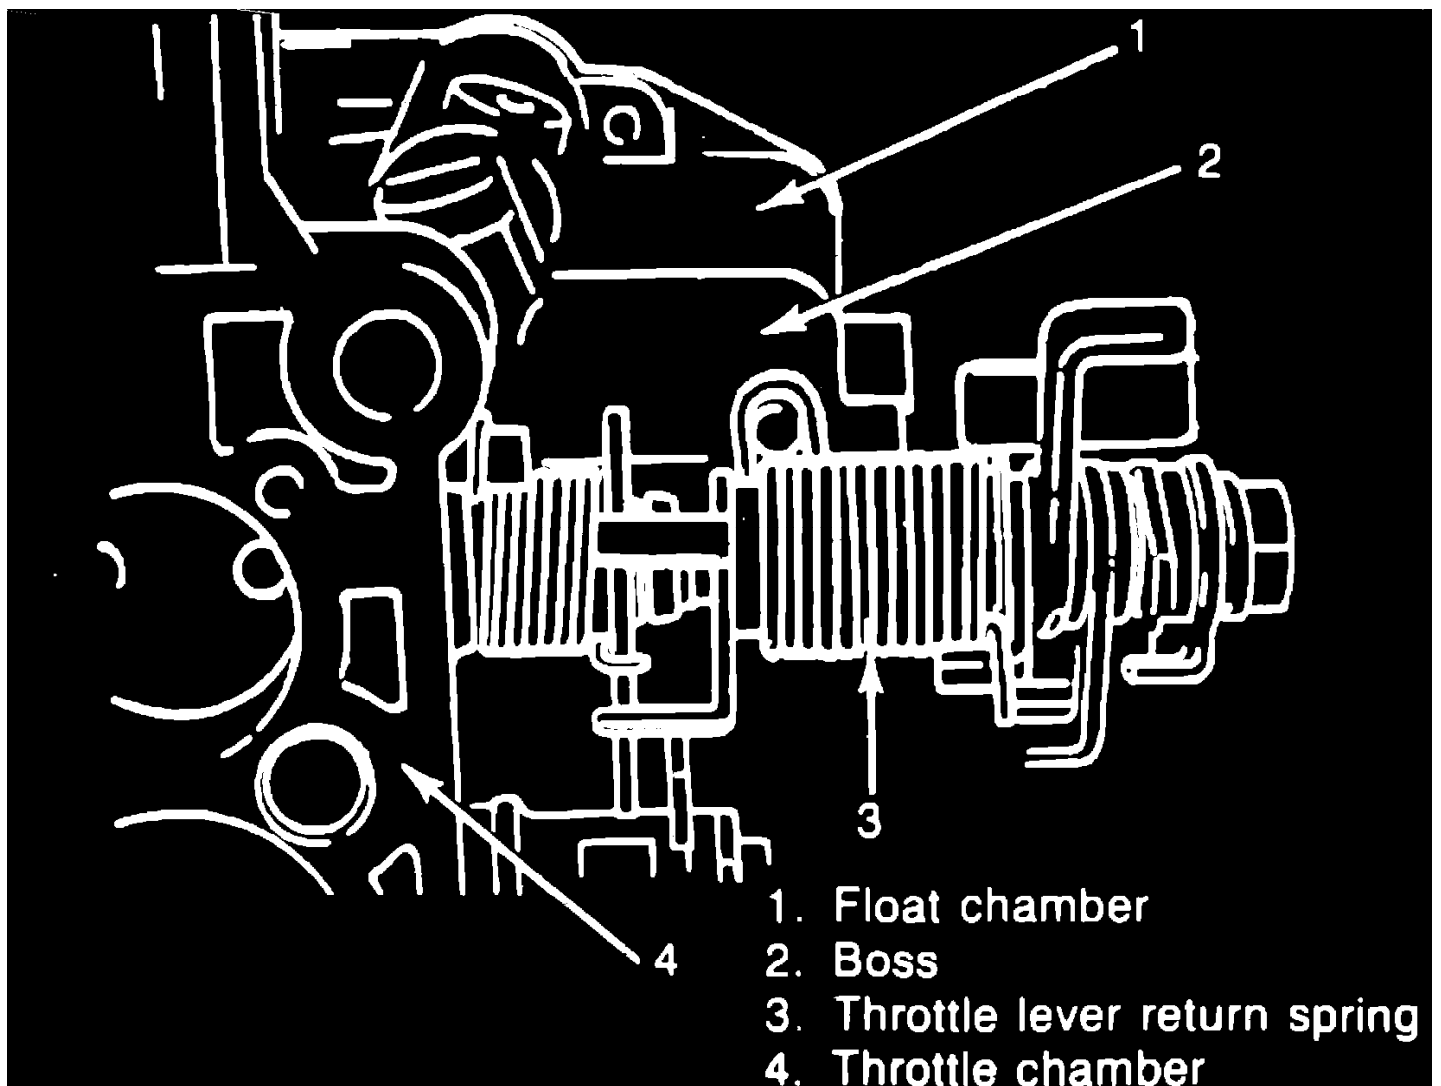
Fig. 3 Throttle return spring installation

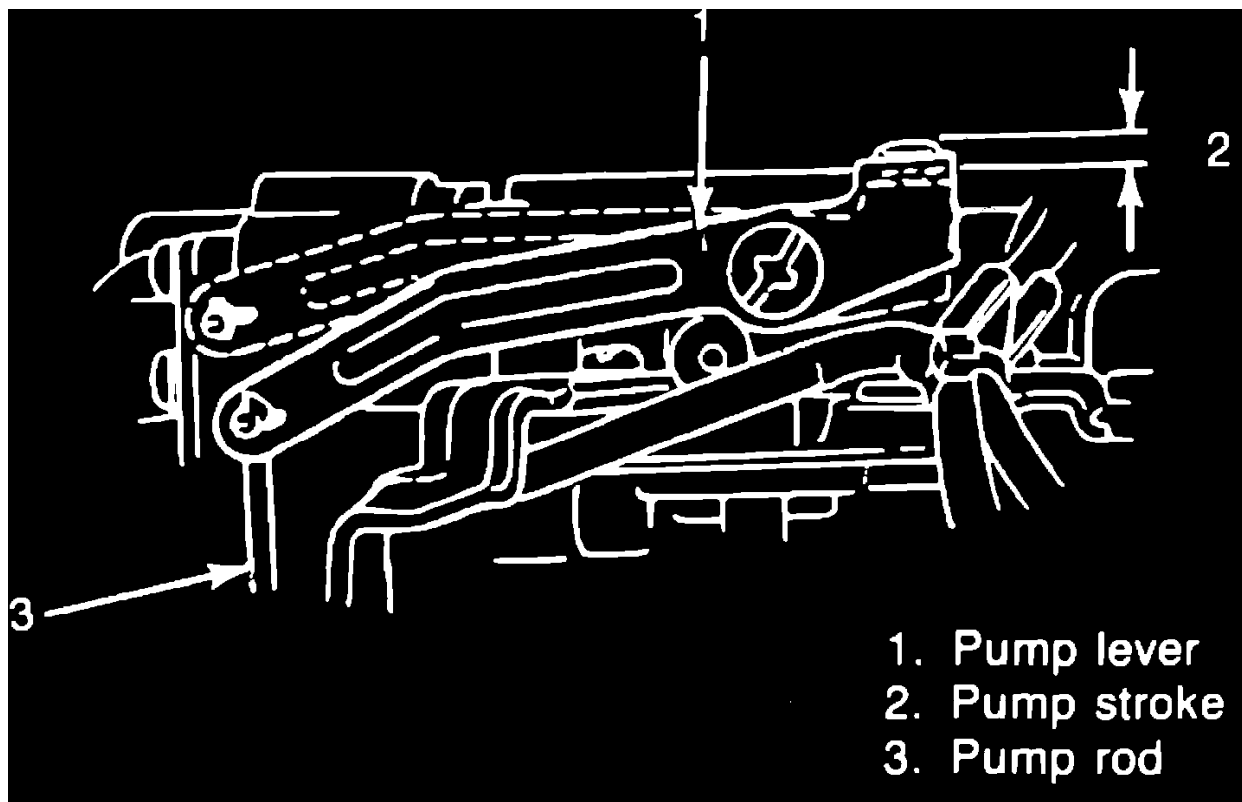
**Fig. 8 Accelerator pump stroke adjustment**

1. Remove air cleaner, open throttle while observing pump operation and ensure that fuel comes out of pump discharge nozzle.
2. Start engine and run until it reaches normal operating temperature, then stop engine.
3. Measure accelerator pump lever stroke at point shown in **Fig. 8**, while moving throttle from fully closed to fully open position.
4. If pump stroke is not as specified in ``Adjustment Specifications," check operation of pump lever and link, and repair linkage or adjust length of link as needed to obtain specified stroke.

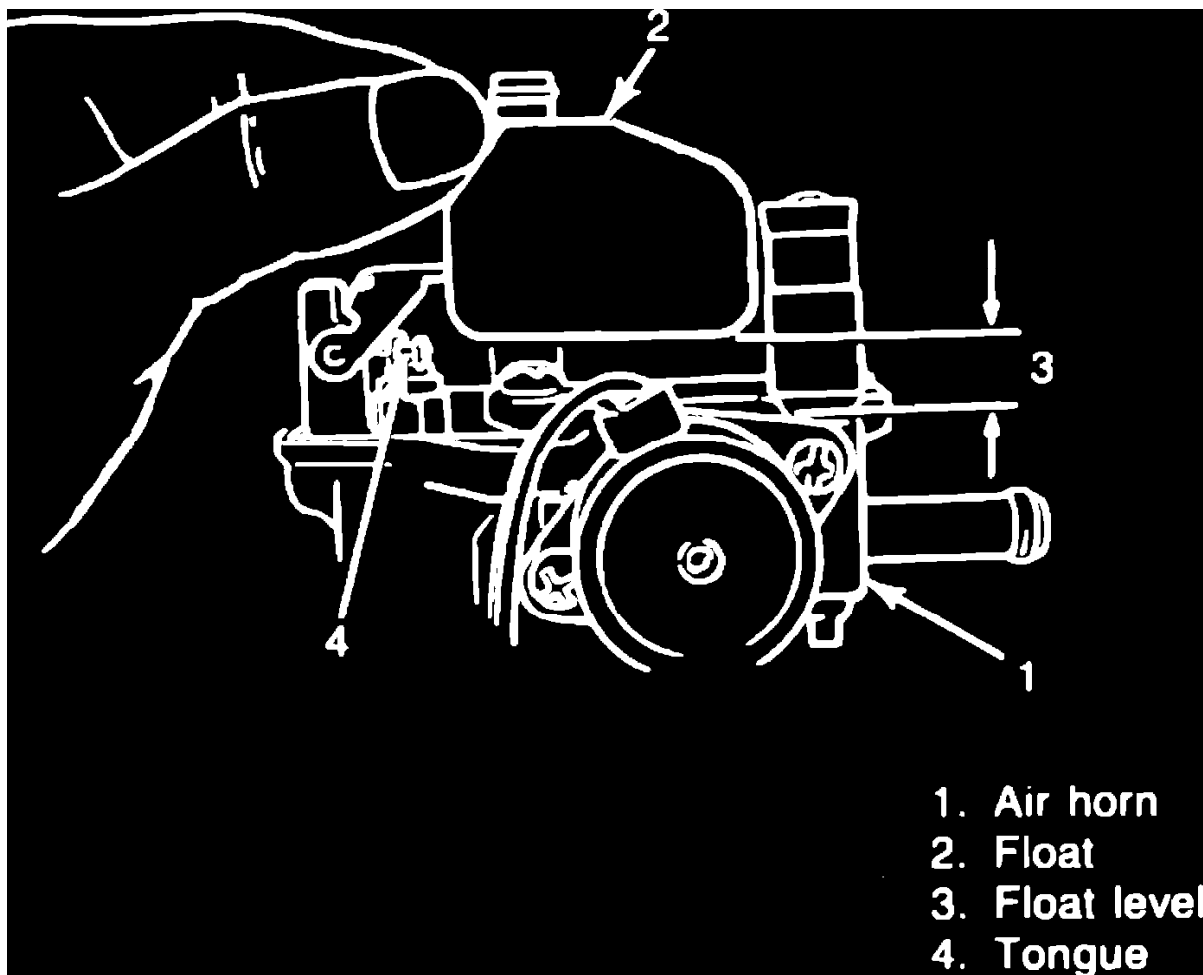
**Fig. 4** Float level adjustment

1. With carburetor installed on engine, inspect fuel level through float bowl sight glass.
2. If fuel level is not within round mark on sight glass, remove air horn to adjust float.
3. Invert air horn, then raise and lower float, allowing it to rest on needle valve.
4. Measure clearance between air horn gasket surface and toe of float, **Fig. 4**, with air horn gasket removed.
5. If clearance is not as specified in ``Adjustment Specifications," adjust float level by bending tongue of float up or down as needed.
6. After adjusting float, reinstall air horn and recheck fuel level in float bowl.

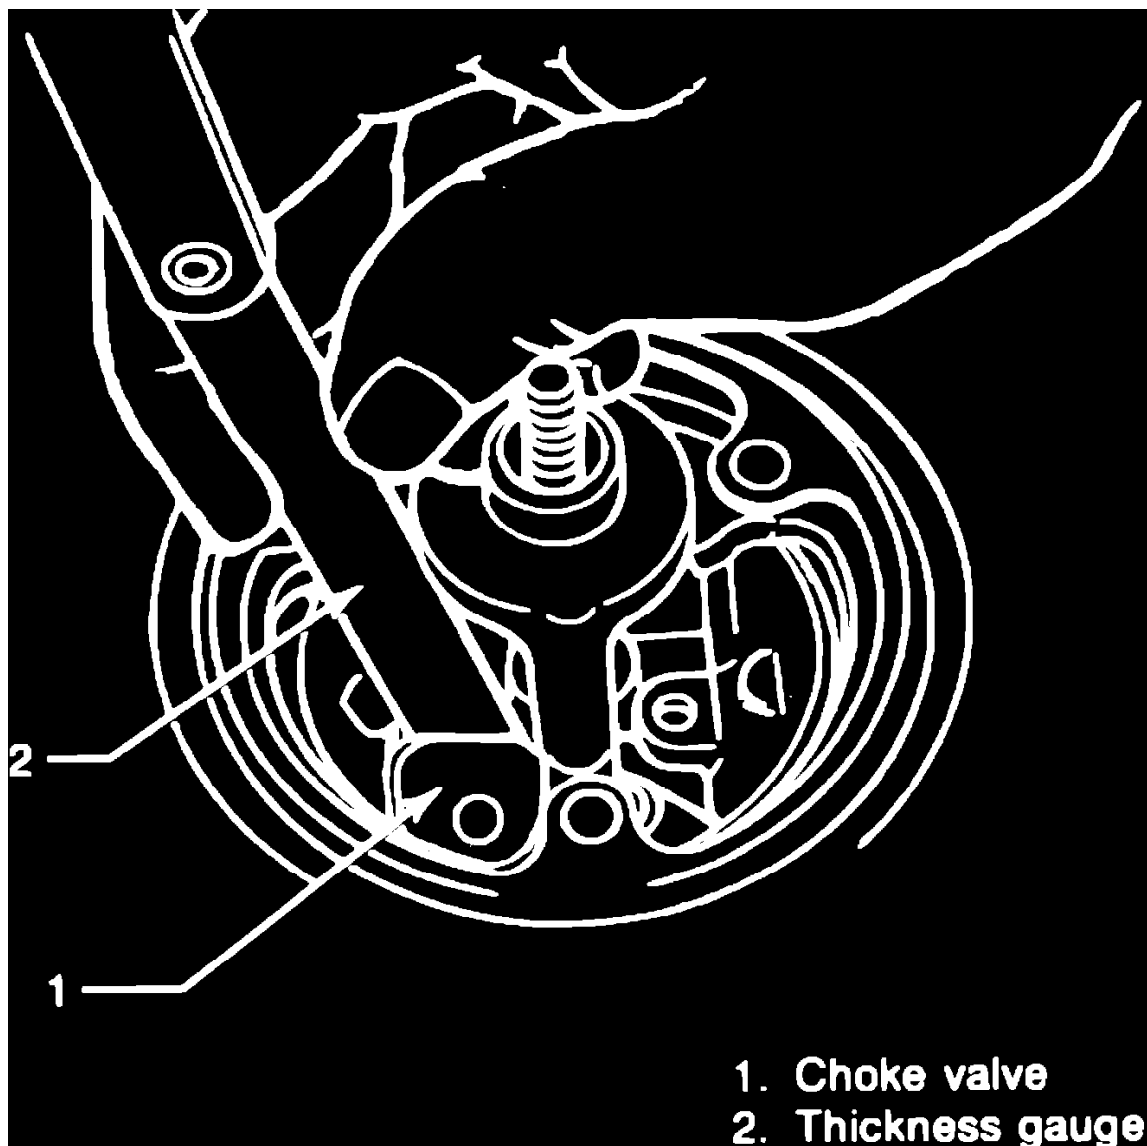
Fig. 5 Measuring choke valve clearance

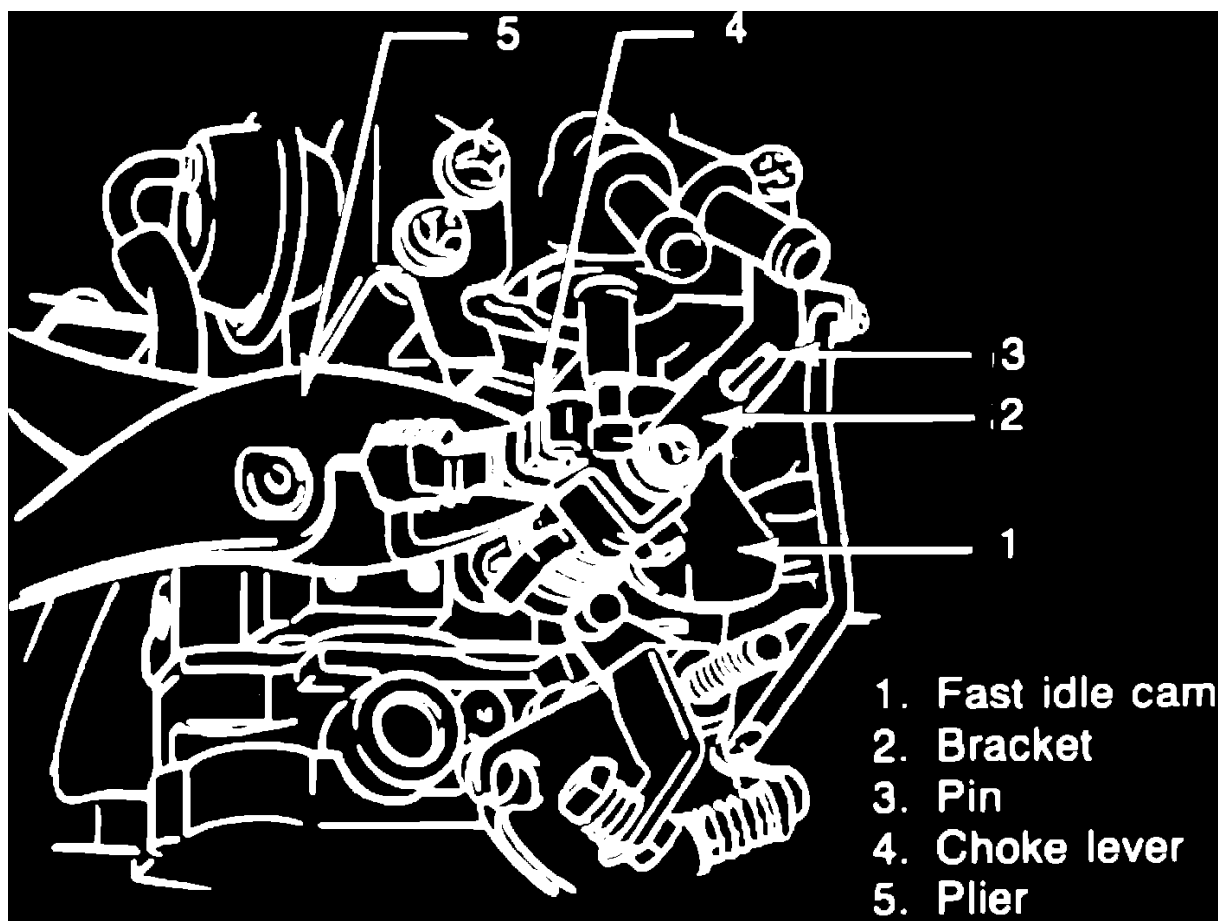
**Fig. 6 Choke lever adjustment**

1. Ensure that choke valve moves freely throughout its range, without binding or sticking.
2. With engine cold and ambient temperature below 77°F, open and close throttle and ensure that choke blade is almost completely closed.

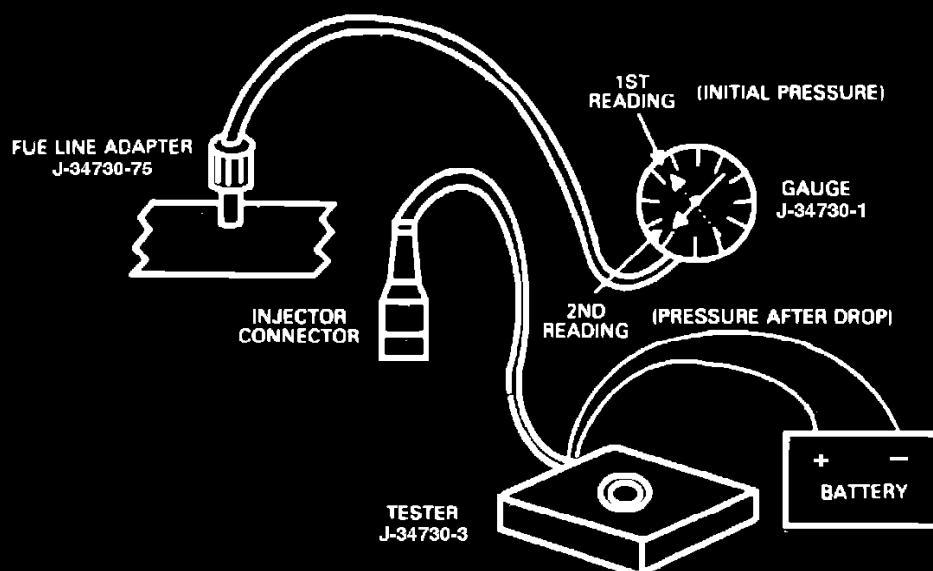
1. Repeat step 2 on all injectors and record pressure drop on each. Retest injectors that appear faulty (Any injectors that have a 10 kPa difference, either more or less, in pressure from the average).

CYLINDER	1	2	3	4	5	6
1ST READING	225	225	225	225	225	225
2ND READING	100	100	100	90	100	115
AMOUNT OF DROP	125	125	125	135	125	110
	OK	OK	OK	FAULTY, RICH (TOO MUCH) (FUEL DROP)	OK	FAULTY, LEAN (TOO LITTLE) (FUEL DROP)

Fig. 19b Injector balance test

Refer to Fig. 19, when performing this test.

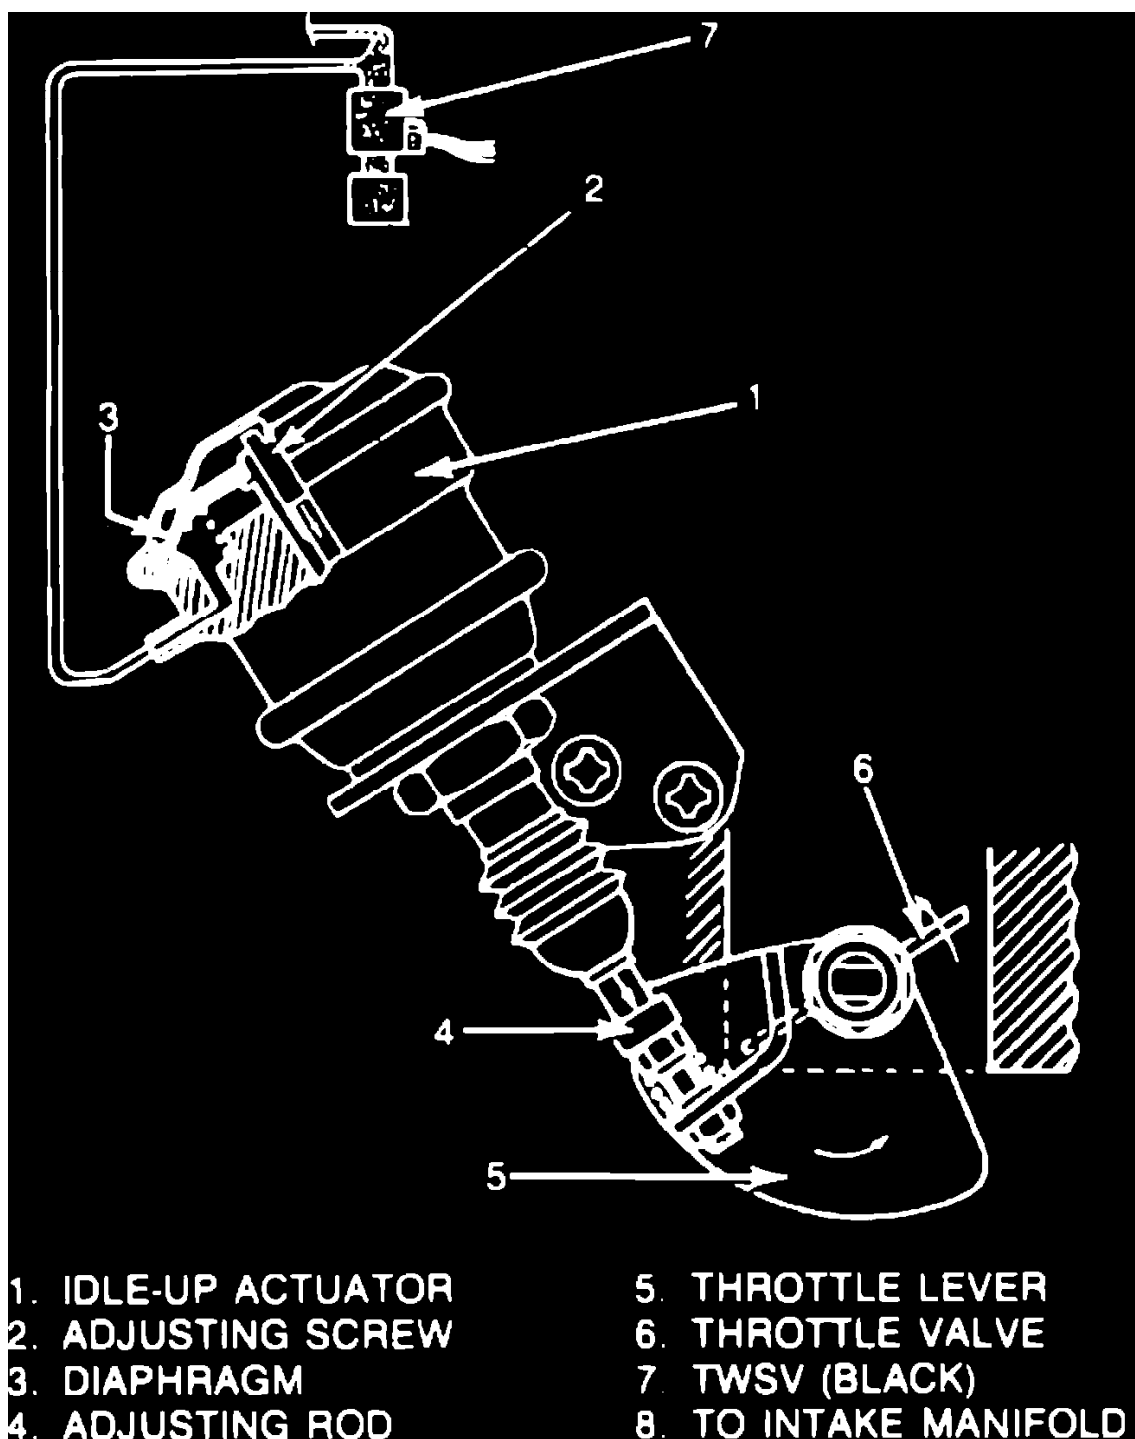
**Fig. 7 Idle-up compensator system**

Idle speed compensation is provided for varying engine loads by a vacuum operated idle-up compensator which is controlled by a Three-Way Switching Valve (TWSV), **Fig. 7**. The ECM sends electrical signals to the TWSV in order to control idle-up compensator operation. When an electrical signal is transmitted to the TWSV, the inner diaphragm of the valve opens and allows manifold vacuum to be applied to the compensator. Manifold vacuum is applied to the compensator diaphragm which in turn operates an adjusting rod and screw assembly. The rod and screw move down in response to vacuum applied to the diaphragm, opening the throttle to compensate for increased engine loads.

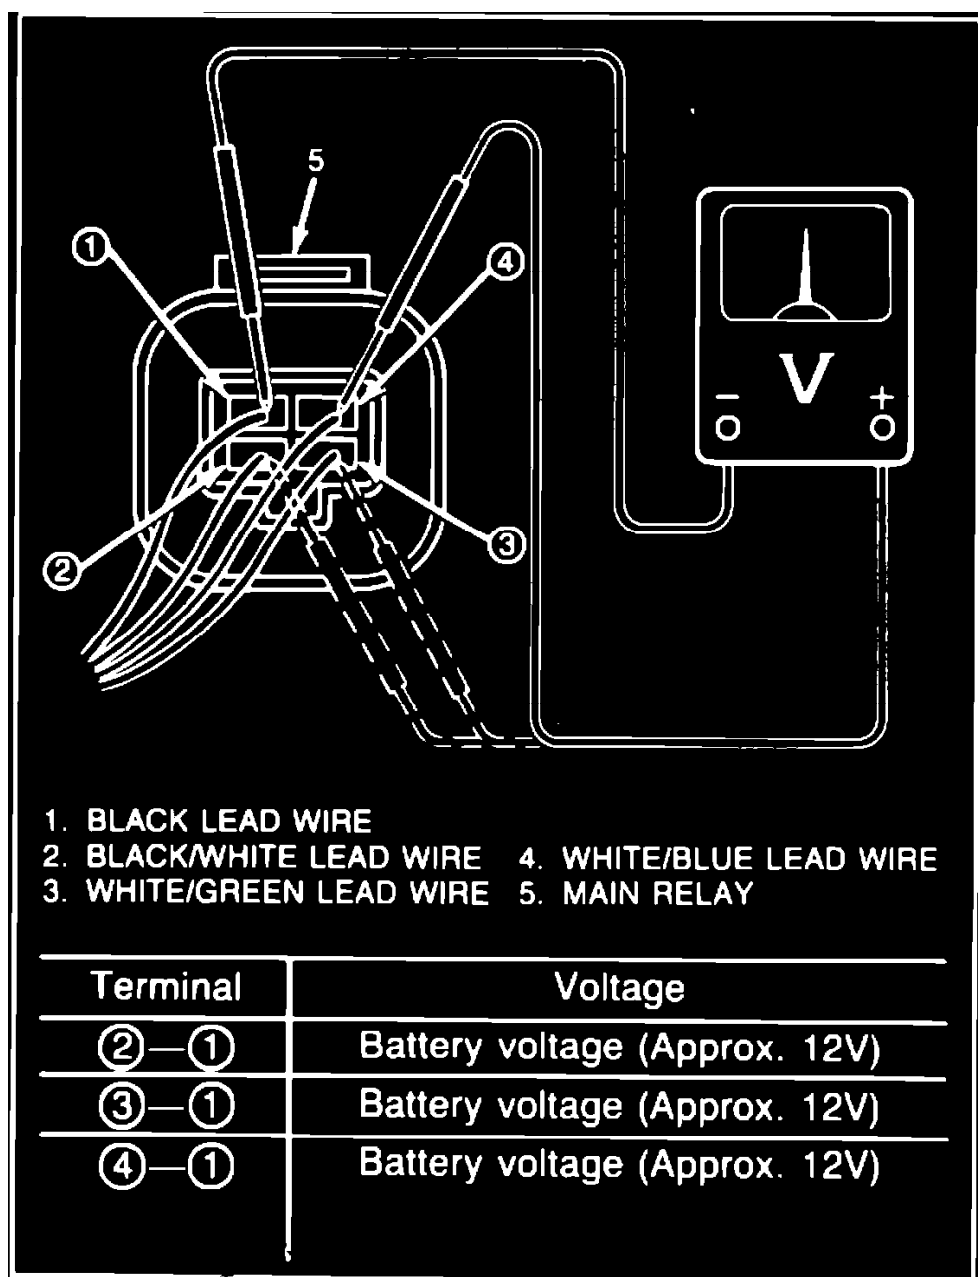
Fig. 16 Checking main relay voltage

1. Check main relay for sound of operation when ignition switch is turned "On." If no sound is heard, proceed to step 2.
2. With ignition switch "On," check voltage between terminals as indicated, Fig. 16. **The same component is used for main and fuel pump relay. To identify main relay, check lead wire for black, black/white, white/blue, and white/green wire.**
3. With ignition switch "Off," remove main relay and disconnect electrical connector. Check resistance between each terminal as shown, Fig. 17.
4. Check for continuity between terminals 3 and 4 when battery voltage is applied to terminals 1 and 2.

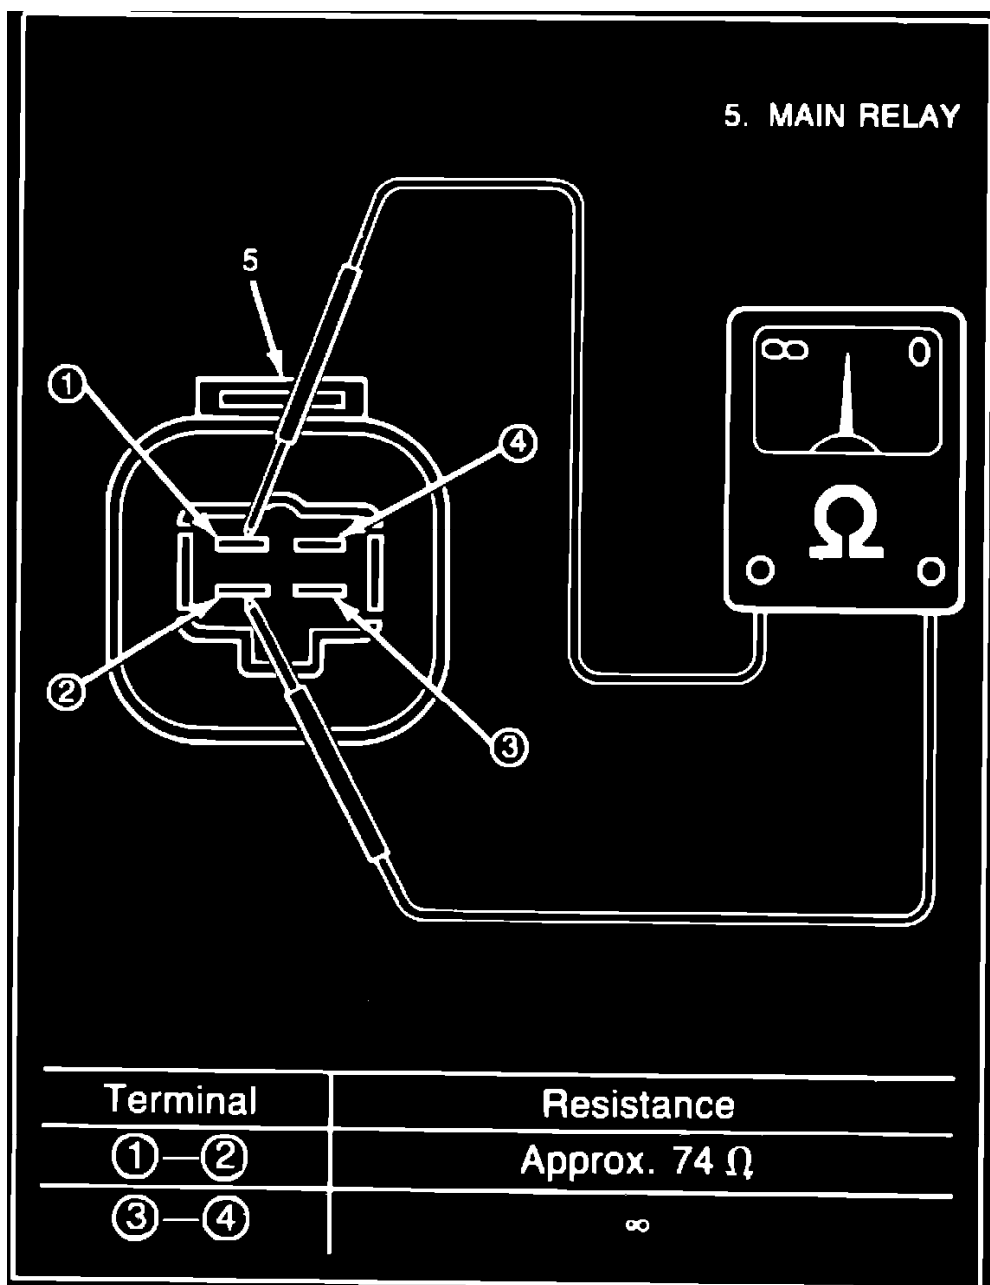
Fig. 17 Checking main relay resistance

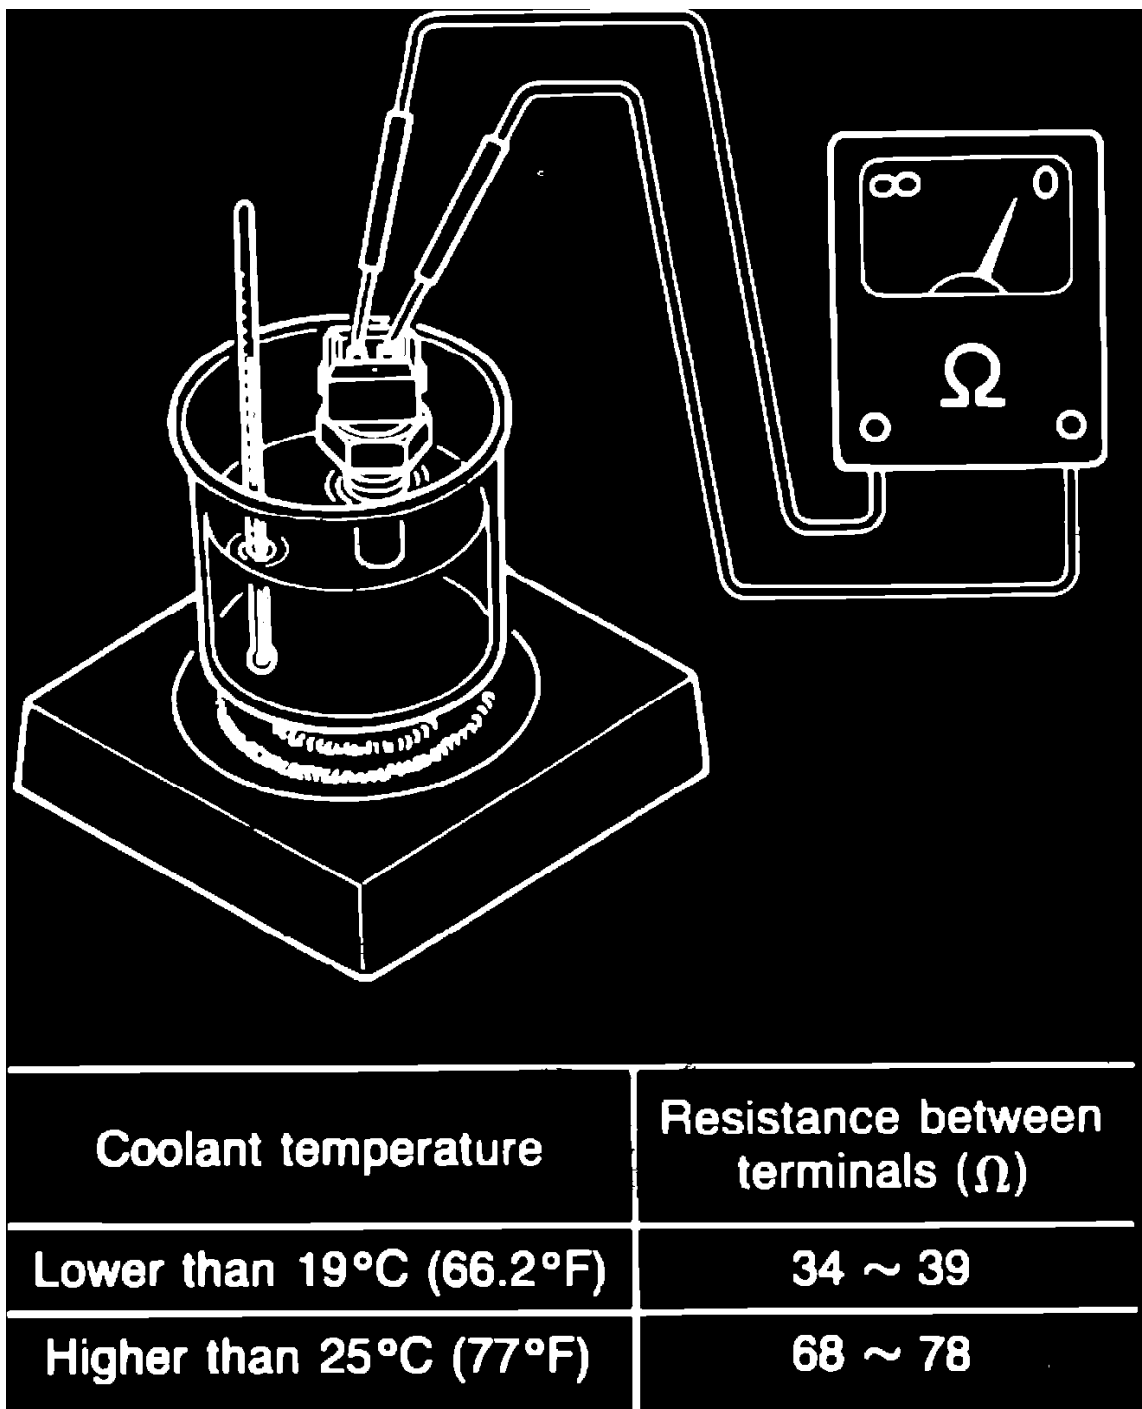
Fig. 14 Checking starter injector time switch

1. Gradually warm switch, then check for specified resistance at temperatures shown, Fig. 14.
2. Check resistance between starter injector time switch body and STA terminal as shown, Fig. 15.

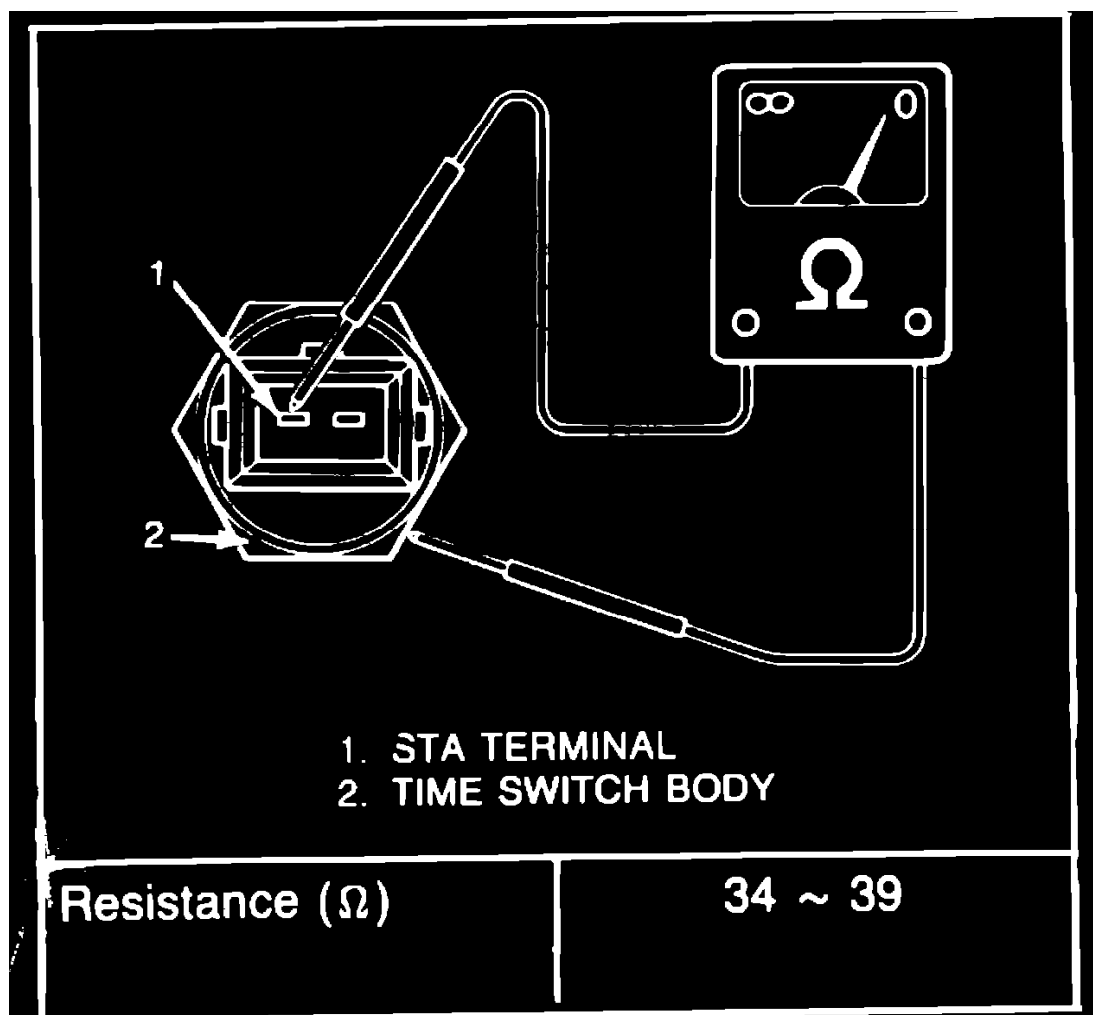
Fig. 15 Checking starter injector time switch terminal

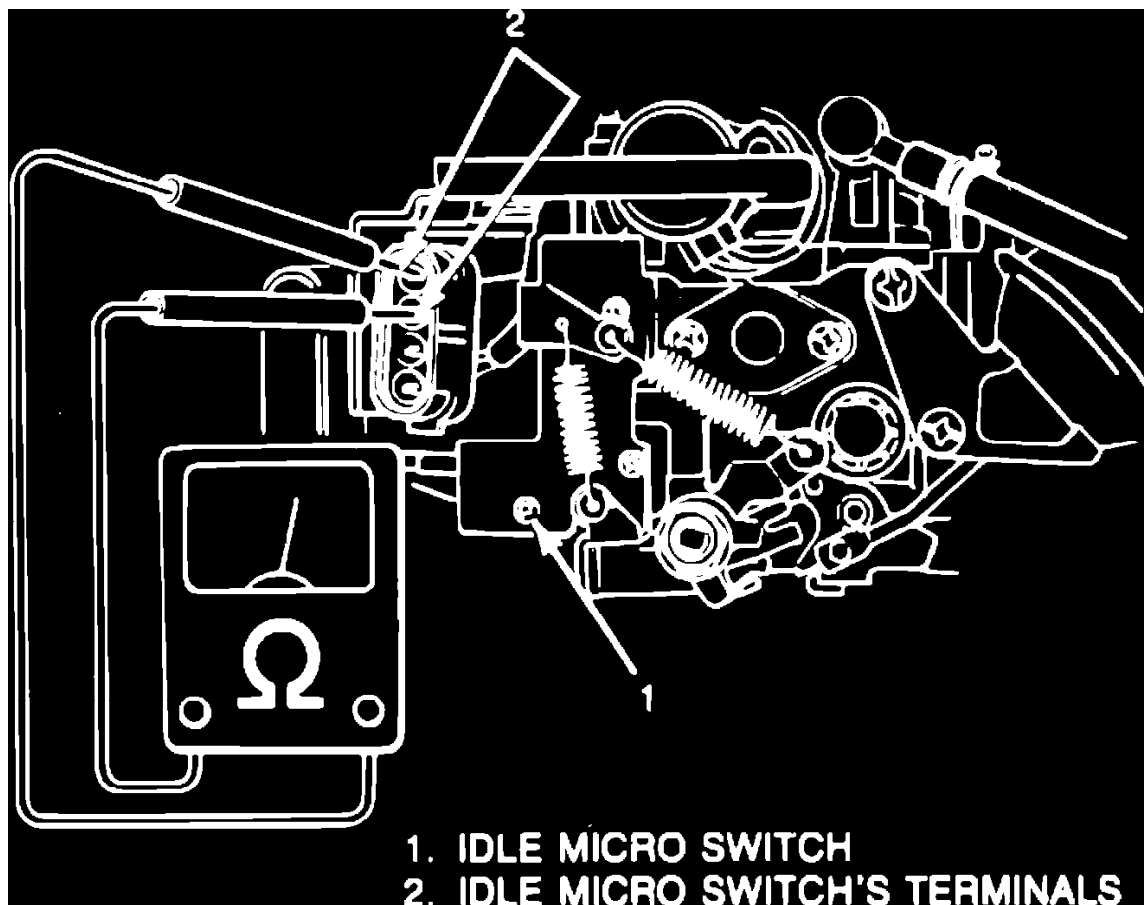
Fig. 10 Idle micro switch test connections

1. Start engine and allow to reach normal operating temperature.
2. Disconnect microswitch electrical connector, **Fig. 10**, and connect an ohmmeter to switch terminals.
3. Check that ohmmeter indicates zero ohms with engine at idle.
4. Connect tachometer to engine.
5. Gradually increase engine speed from idle speed. Check that engine speed is in range of 1500 - 2400 RPM when ohmmeter indicates infinite resistance. If speed is outside of range, adjust by bending lever as shown in **Fig. 47**.
