Vehicle: Application and ID

## Engine: Service and Repair

## Camshaft: Service and Repair

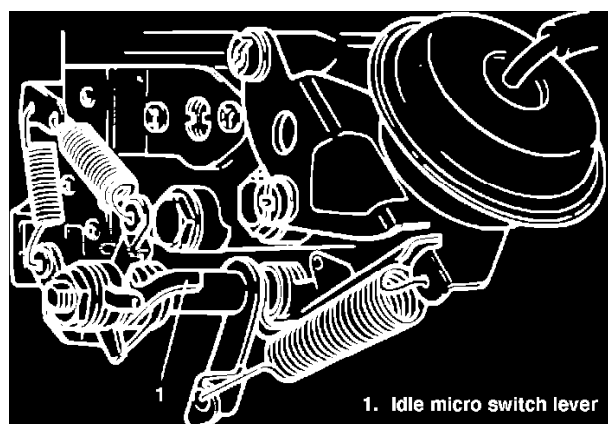
Fig. 47 Idle micro switch lever. 1987 - 88 models

1. Start engine and allow to reach normal operating temperature.
2. Disconnect microswitch electrical connector, **Fig. 10**, and connect an ohmmeter to switch terminals.
3. Check that ohmmeter indicates zero ohms with engine at idle.
4. Connect tachometer to engine.
5. Gradually increase engine speed from idle speed. Check that engine speed is in range of 1500 - 2400 RPM when ohmmeter indicates infinite resistance. If speed is outside of range, adjust by bending lever as shown in **Fig. 47**.

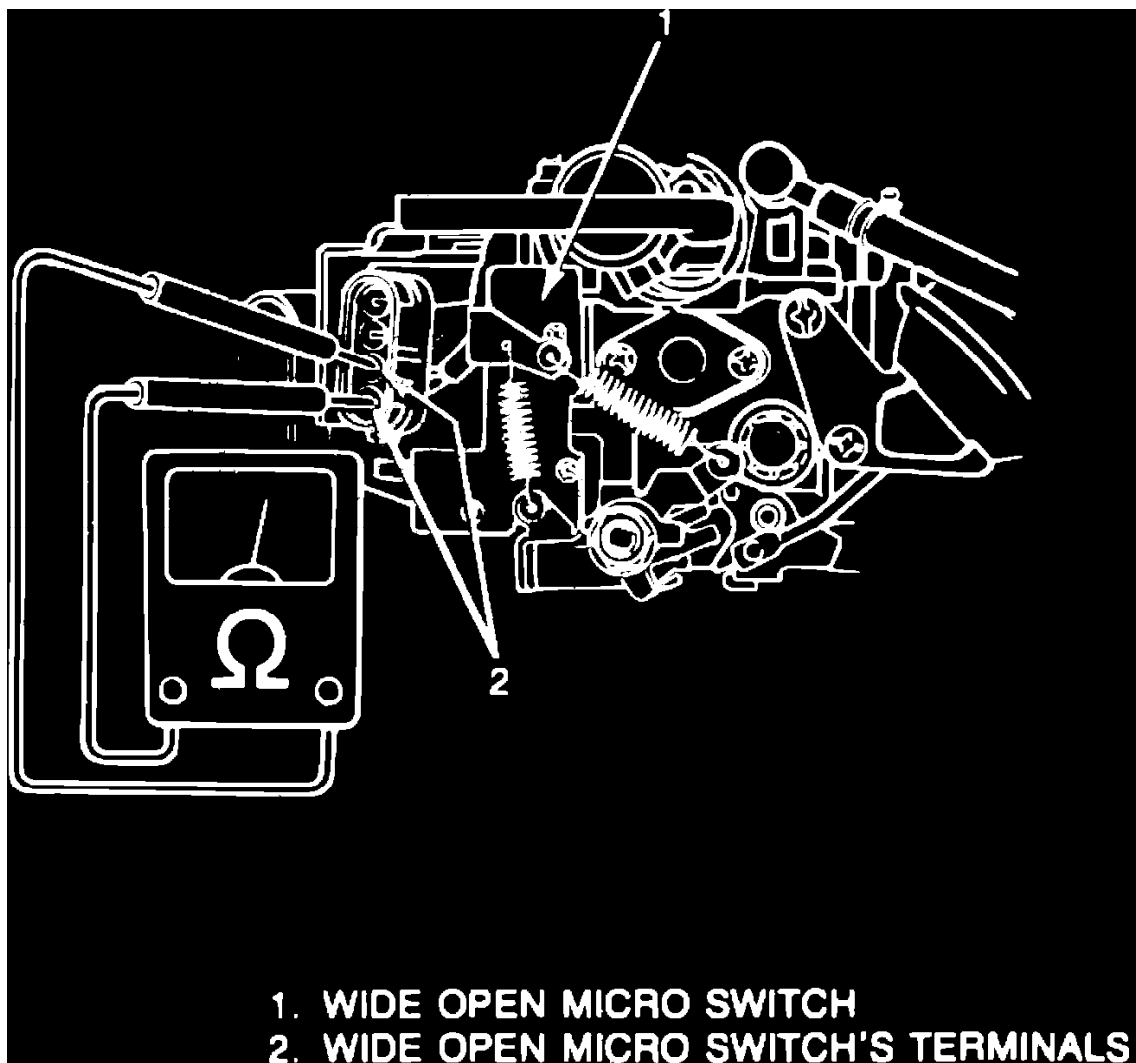
Fig. 12 Wide open throttle micro switch test connections

1. Remove air cleaner and carburetor.
2. Connect ohmmeter to switch as shown in **Fig. 12**. Resistance between terminals should be infinite.
3. Open throttle gradually until ohmmeter indicates zero ohm. Measure clearance between throttle butterfly and carburetor bore, **Fig. 13**. Clearance should be .29 - .33 inch (7.2 - 8.4 mm). If clearance is out of range, adjust by bending lever, **Fig. 14**.

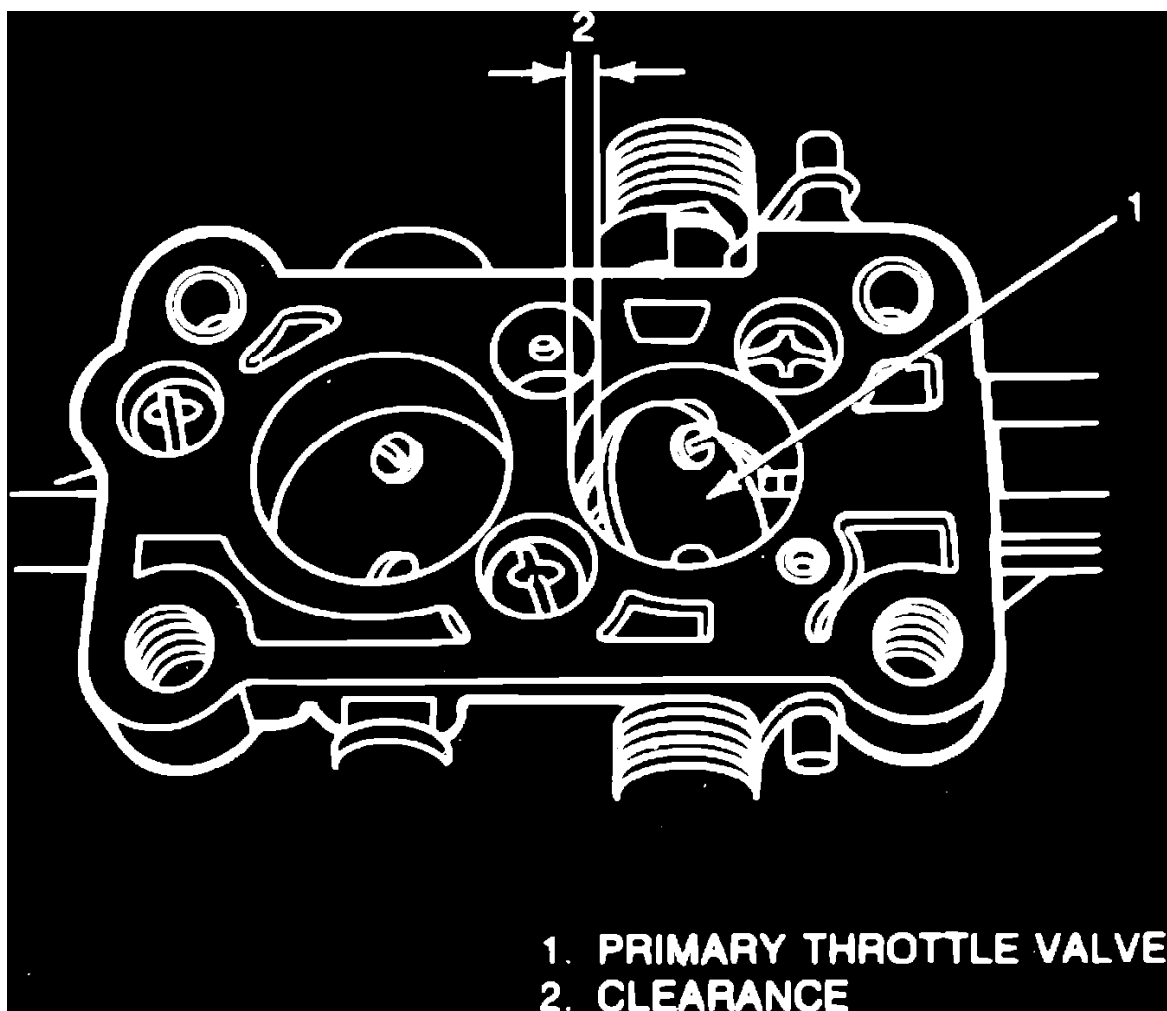
Fig. 13 Throttle plate clearance measurement

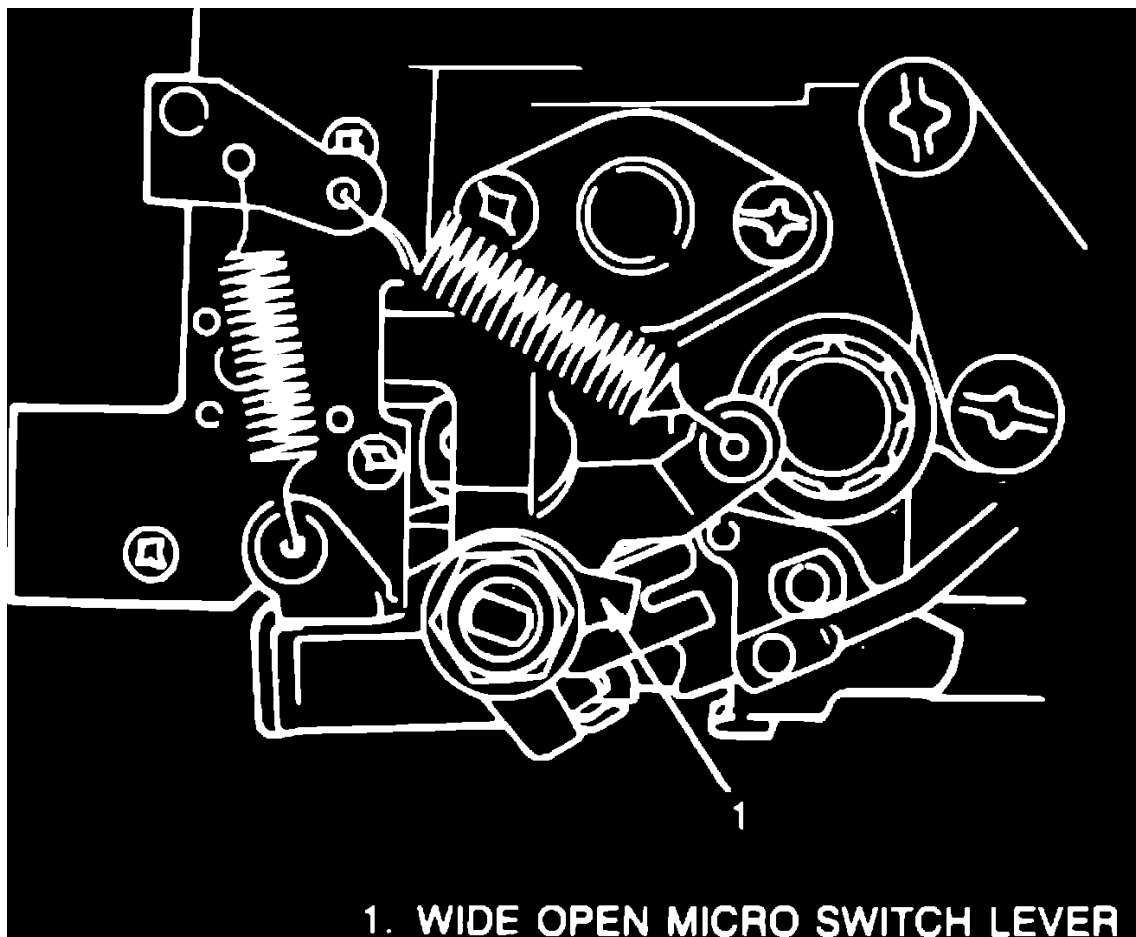
Fig. 14 Wide open throttle micro switch adjustment

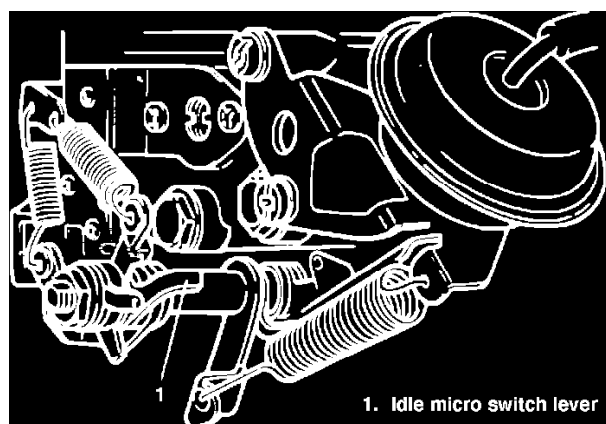
Fig. 47 Idle micro switch lever. 1987 - 88 models

1. Start engine and allow to reach normal operating temperature.
2. Disconnect microswitch electrical connector, **Fig. 10**, and connect an ohmmeter to switch terminals.
3. Check that ohmmeter indicates zero ohms with engine at idle.
4. Connect tachometer to engine.
5. Gradually increase engine speed from idle speed. Check that engine speed is in range of 1500 - 2400 RPM when ohmmeter indicates infinite resistance. If speed is outside of range, adjust by bending lever as shown in **Fig. 47**.

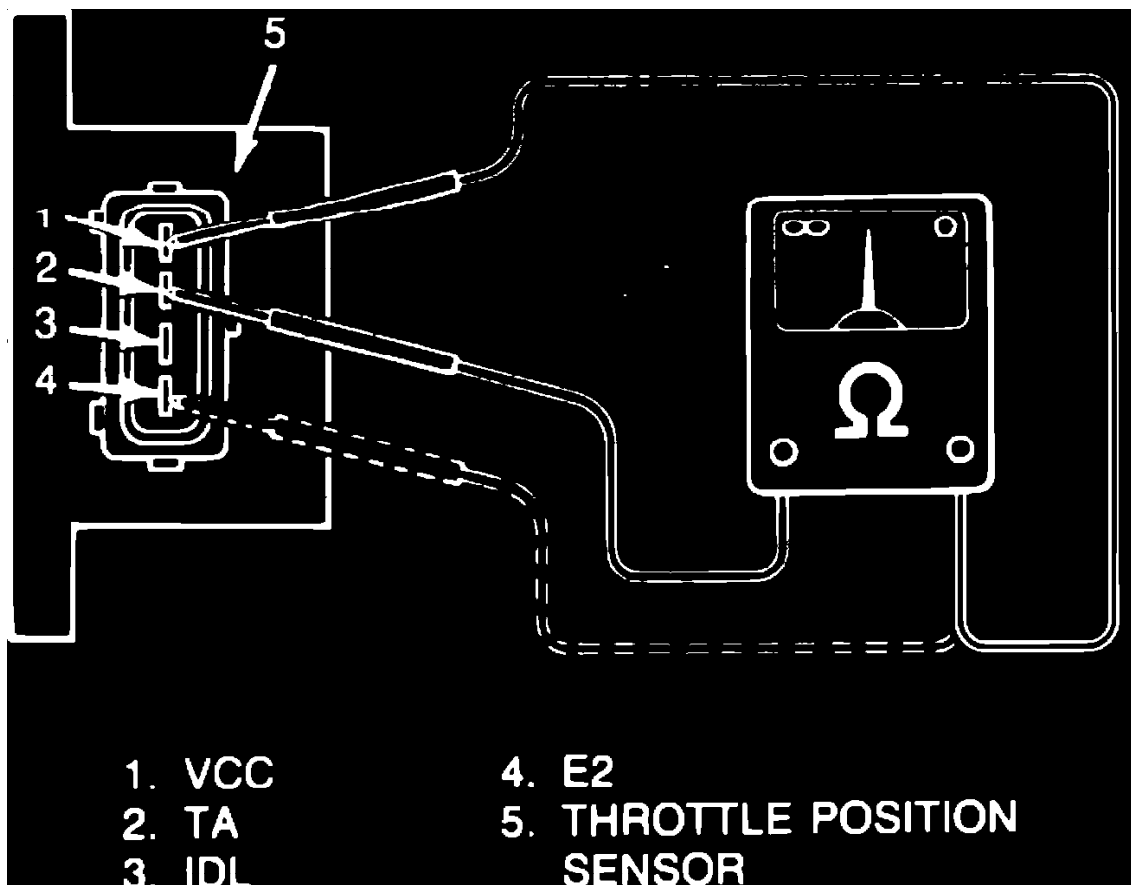
Fig. 11 Checking throttle position sensor (VCC-TA & TA-E2)

1. Check continuity between VCC-TA and TA-E2. Although a value is given, only a continuity check is necessary, Fig. 11.

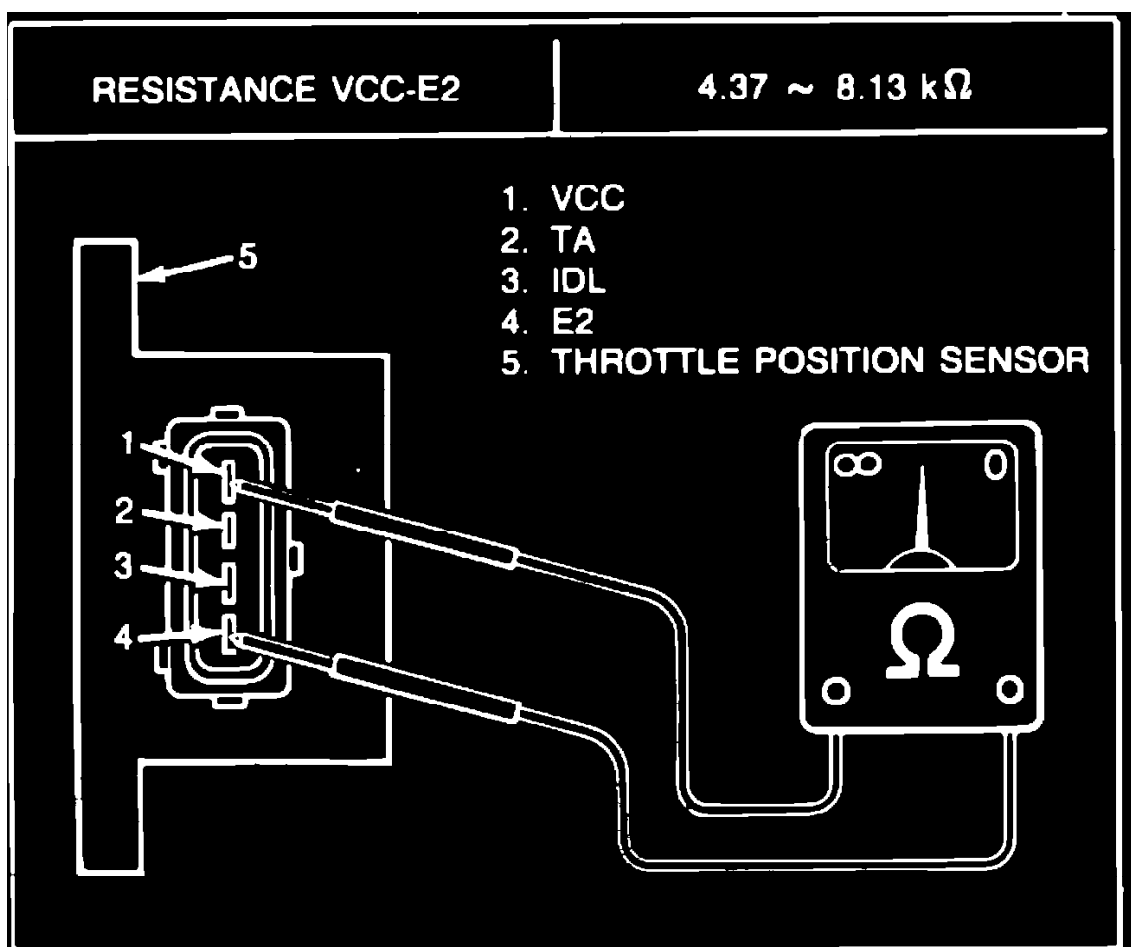
Fig. 12 Checking throttle position sensor (VCC-E2)

2. Check that throttle lever contacts throttle stopper bolt when when throttle valve is fully closed.
3. Check for continuity after inserting a .016 inch thick gauge between throttle lever and throttle stopper bolt. Continuity should exist. Continuity should not exist when a .031 inch thick gauge is inserted. If check is not as specified, adjust installation angle throttle position angle as described under ``Throttle Position Sensor, Replace" procedure.
4. Check resistance of VCC-E2 as described, **Fig. 12.**

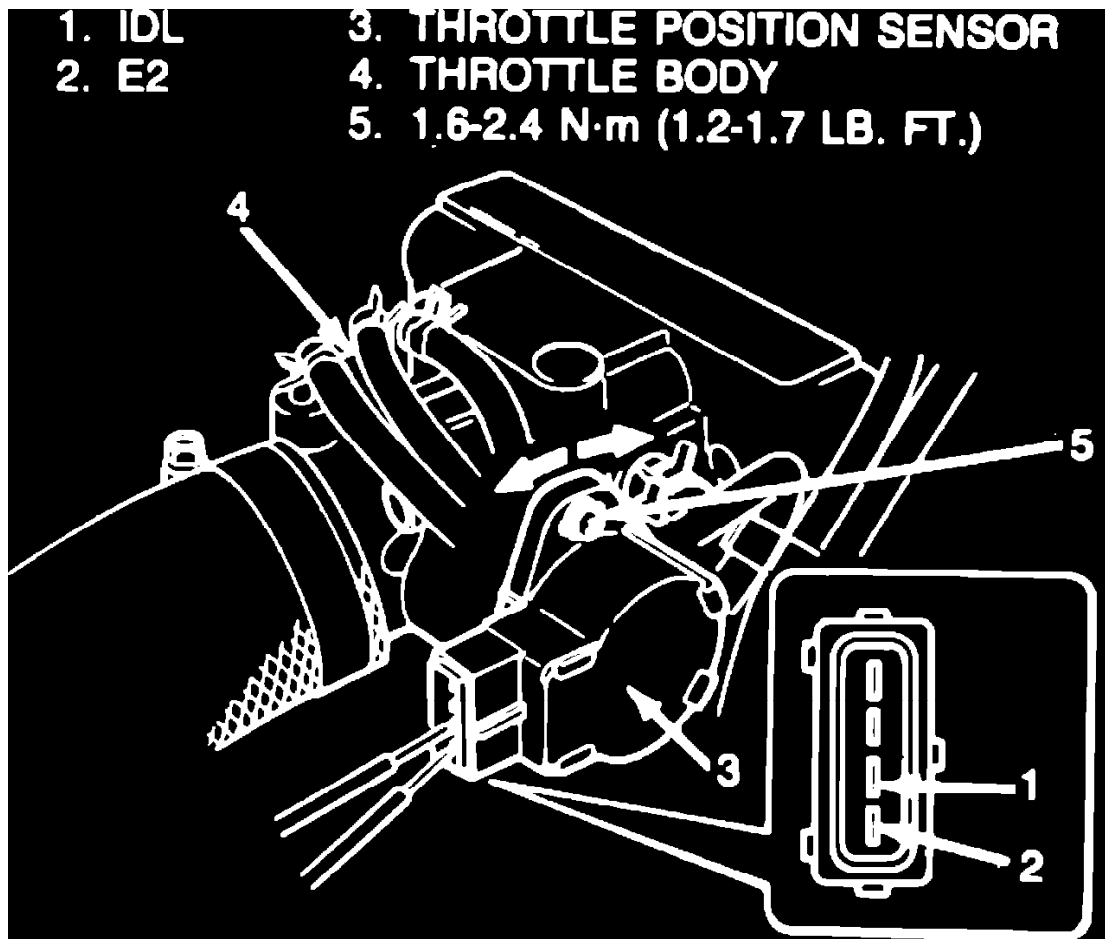
Fig. 20 Installing throttle position sensor

3. Adjust angle of throttle position as follows:
  - a. Insert a .024 inch thickness gauge between throttle stop screw and throttle lever. Move throttle position lever as necessary until continuity between terminals IDL and E2 is present, **Fig. 20**. At that position, torque sensor screw to 1.2 - 1.7 ft. lbs.

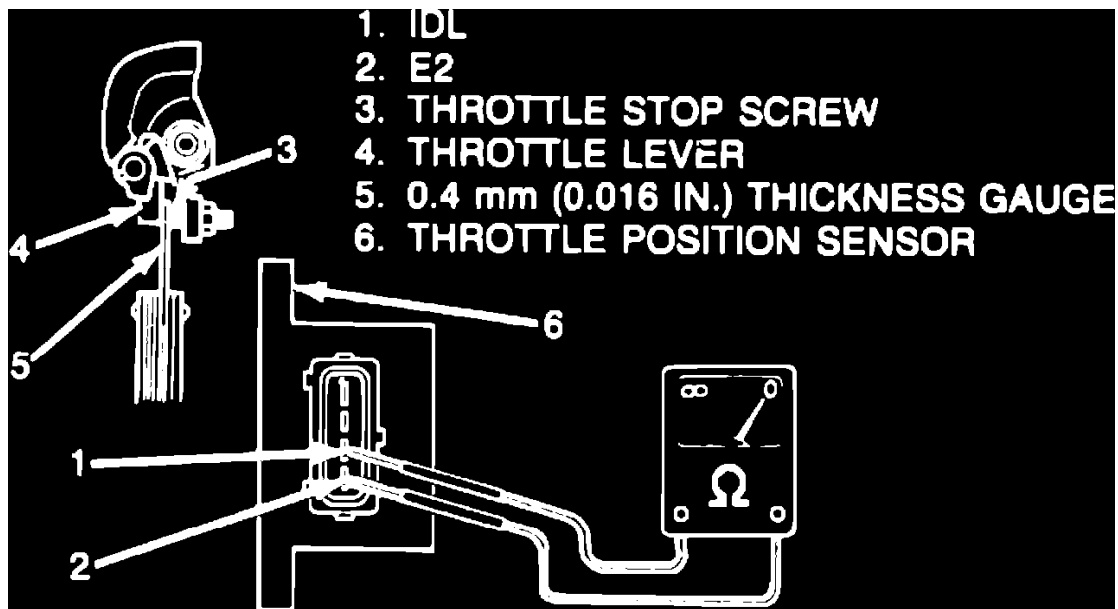
Fig. 21 Adjusting throttle position sensor

- b. Ensure no continuity exists between IDL and E2 of throttle position sensor when a .031 inch thickness gauge is inserted between throttle stop screw and throttle lever, **Fig. 21**.

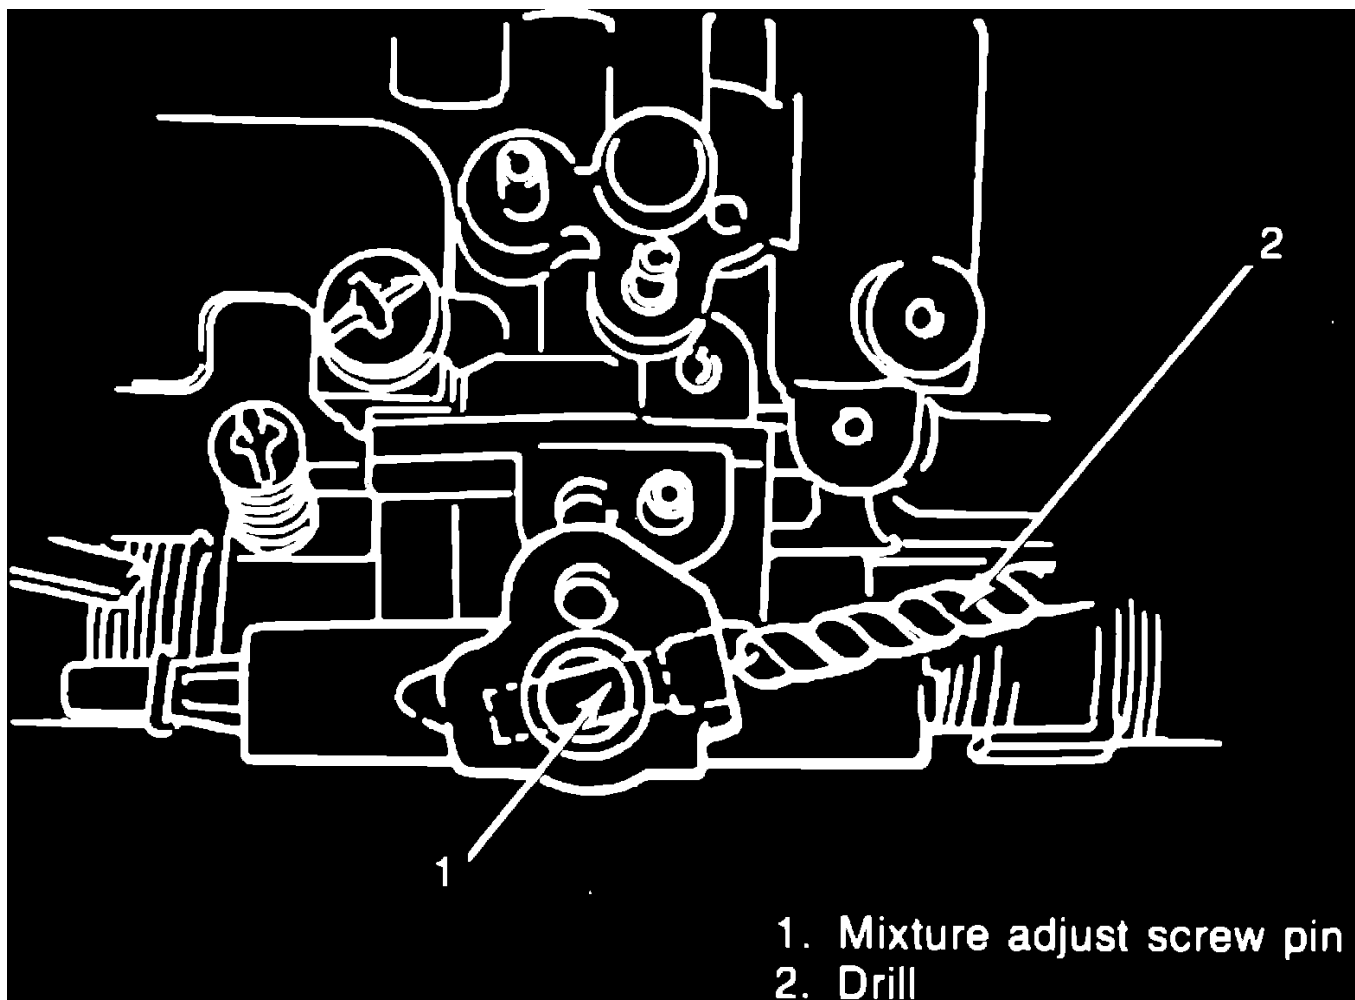
**Fig. 10 Mixture adjusting screw pin removal**

The idle mixture adjusting screw is recessed into the throttle body and blocked by a steel pin to prevent tampering. Idle mixture should not be adjusted unless carburetor is overhauled or diagnosis indicates the carburetor as the cause of driveability or emissions related complaints. If idle mixture adjustment is required, remove pin sealing adjusting screw using the following procedure:

1. Remove carburetor from manifold.
2. Drill hole in pin as shown in **Fig. 10**, using 4 - 4.5 mm drill bit.
3. Drive pin from throttle body using suitable drift, supporting throttle body to prevent breakage.
4. Install carburetor, then adjust idle mixture as required.

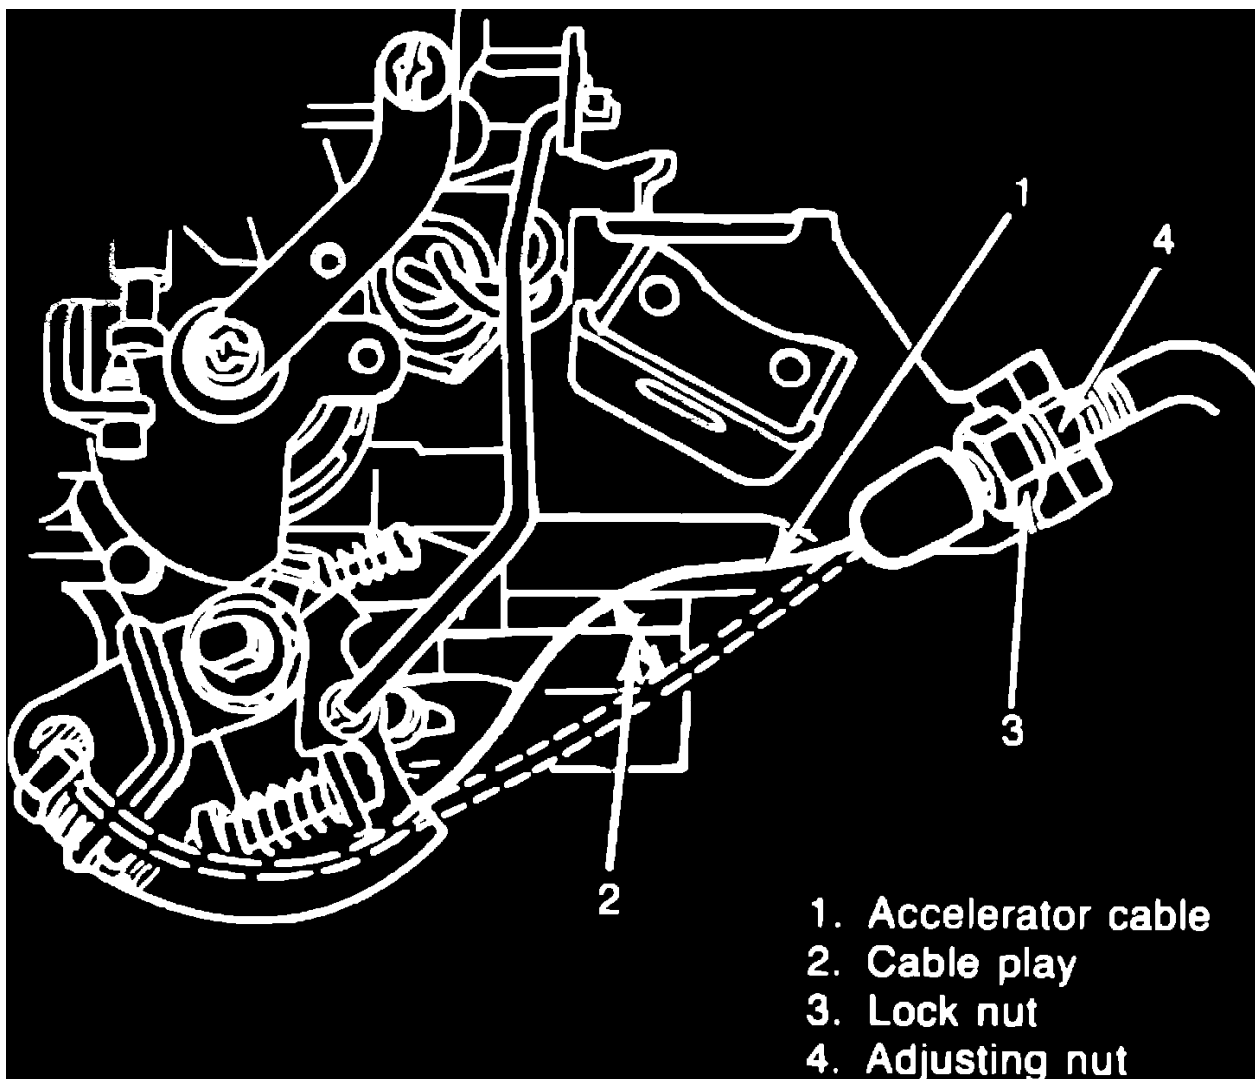
**Fig. 9 Accelerator cable adjustment**

1. Check freeplay of accelerator cable between cable bracket and throttle lever, **Fig. 9**.
2. Freeplay should be .40 - .59 inch with engine cold and .12 - .19 inch with engine at normal operating temperature.
3. If freeplay is not within specifications, loosen cable adjuster locknut and turn adjusting nut as needed to obtain specified play, **Fig. 9**.
4. Securely tighten locknut while holding adjusting nut, then recheck cable freeplay.

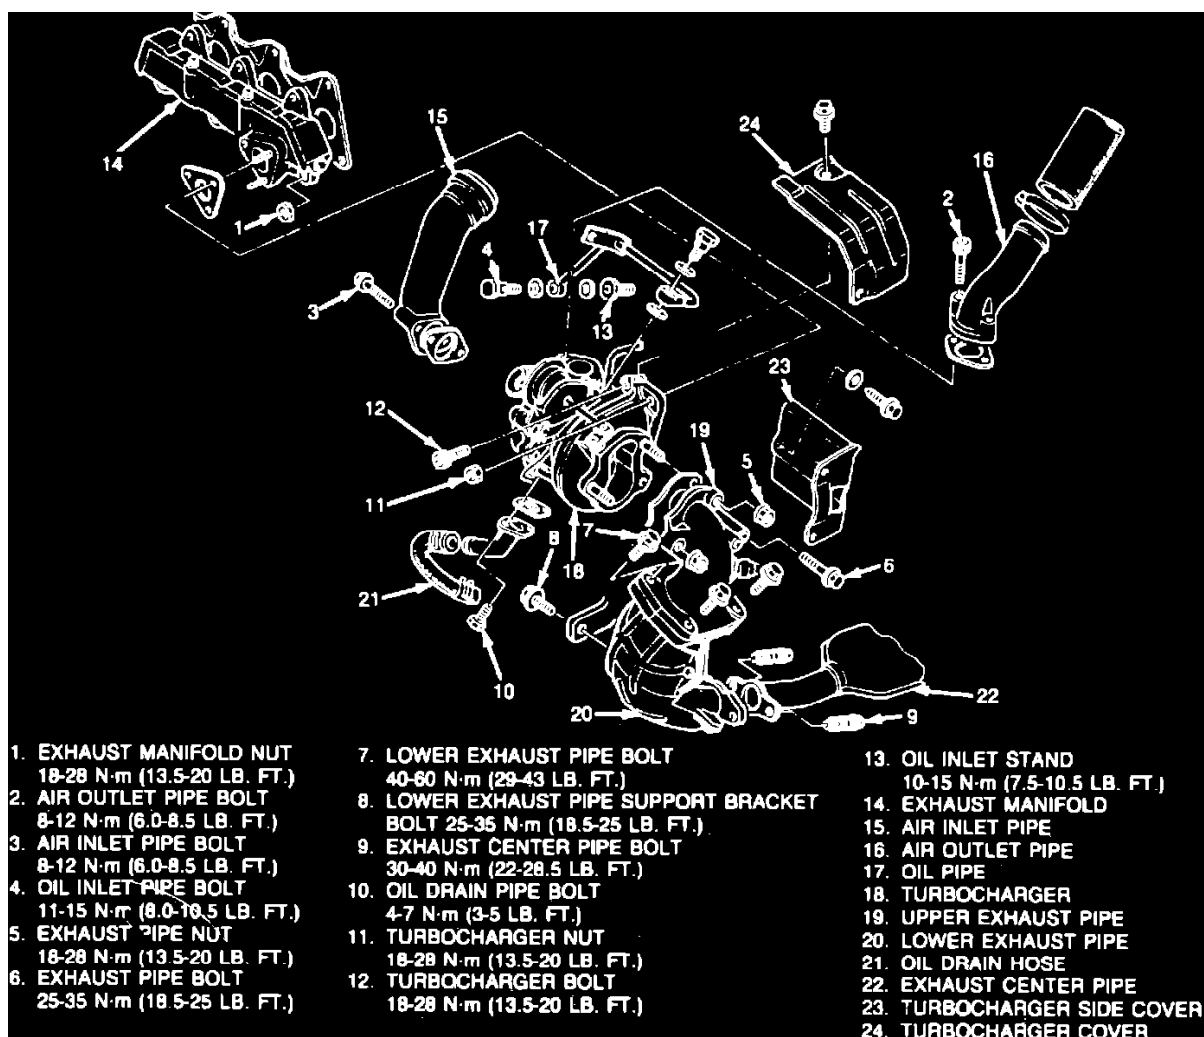
**Fig. 1 Turbocharger assembly**

The turbocharger, **Fig. 1**, is a mechanism used to increase horsepower. The high temperature and high pressure and high energy of the exhaust gas runs the exhaust turbine. The compressor is on the same shaft as the turbine. The compressor is on the same shaft as the turbine, and is driven to compress the air drawn in. This allows more air to enter the combustion chamber and the power strokes become stronger. The turbocharger is installed on the exhaust manifold and consists of a turbine wheel which utilizes energy in the exhaust gasses to drive the compressor; a compressor wheel which compresses the intake air and supercharges it to the intercooler; a center bearing and center housing which retains the shaft linking the compressor wheel and turbine wheel; a compressor housing and turbine housing which guides the intake air and exhaust gasses and a wastegate valve which controls the turbocharged pressure.

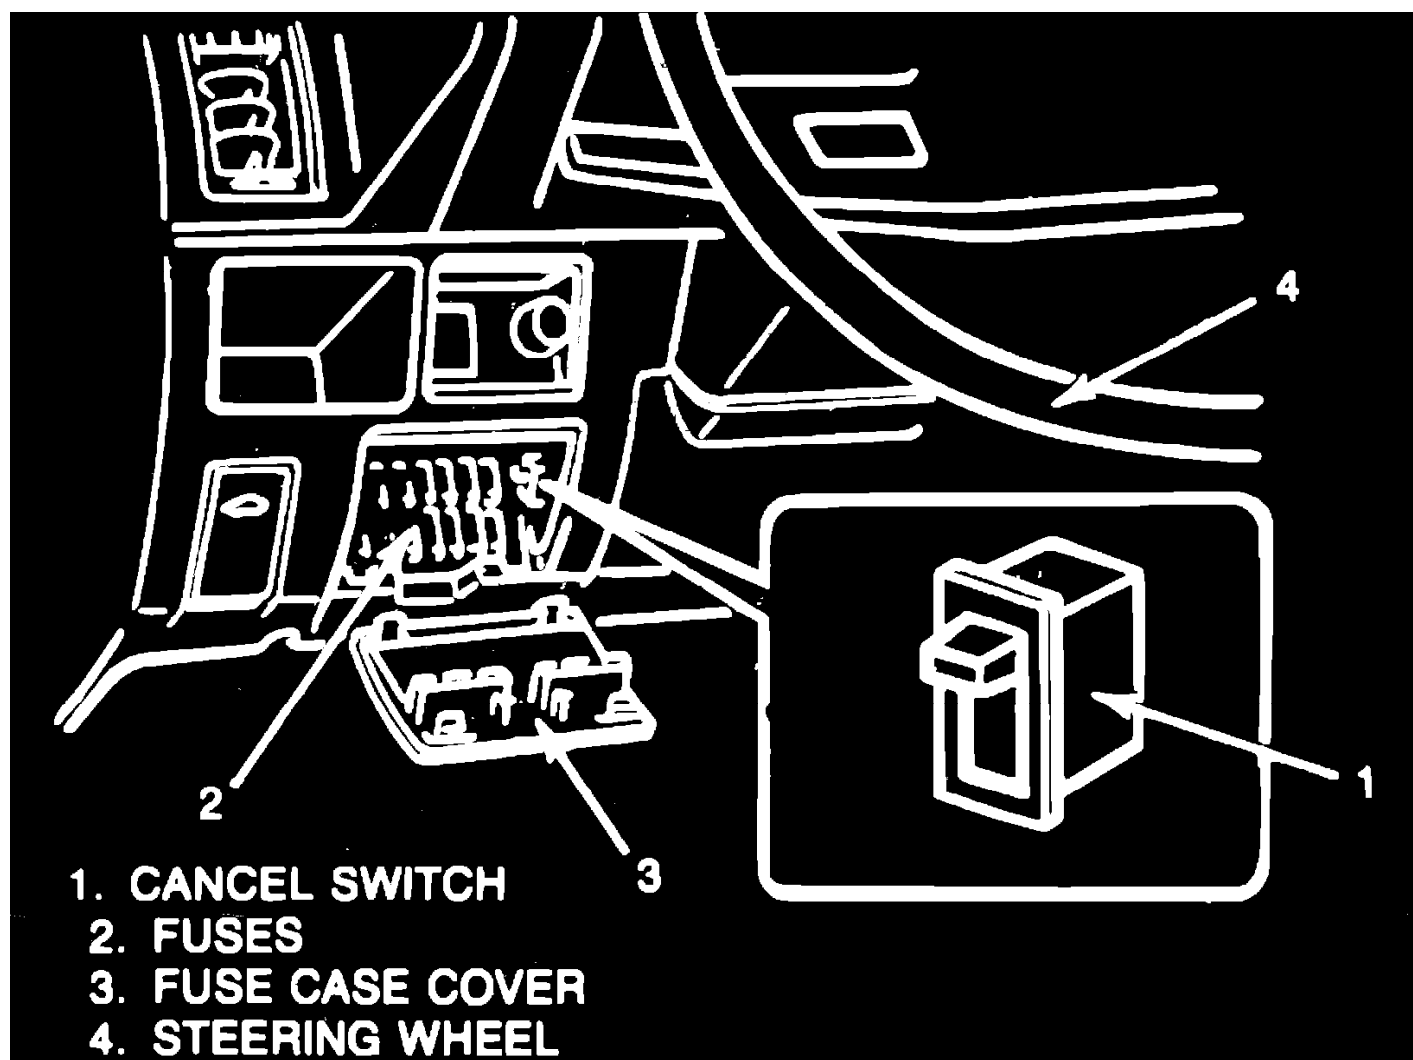
Fig. 6 Oxygen sensor indicator lamp cancel switch

1. Ensure that ignition switch is off, remove fuse panel cover and move cancel switch to on position, **Fig. 6**.
2. Turn ignition switch to on position and observe "Sensor" lamp. If lamp does not light (without flashing), check for defective bulb or open feed circuit and repair as needed.
3. After lighting of lamp is confirmed, start engine and run until it reaches normal operating temperature.
4. Run engine at 1500 - 2000 RPM while observing lamp.
5. If lamp flashed, system is operating properly. If lamp does not flash, refer to "Computer Controlled Emission Control System" section for diagnosis and testing procedures.
6. After proper system operation has been verified, place cancel switch in off position to reset automatic indicator system.

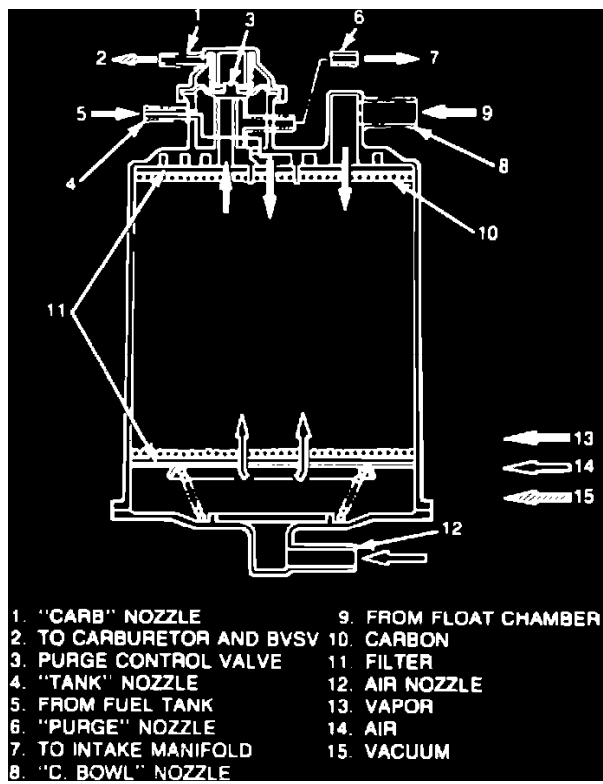
**Fig. 5 Vapor storage canister cross sectional view**

Fuel vapors from the fuel tank and carburetor float chamber are vented to the canister which contains charcoal. When the engine is running, manifold vacuum is applied to a purge control valve on the canister. The purge valve opens and allows the fuel vapors to be drawn into the intake manifold through the purge line. Air is drawn in through a filter in the bottom of the canister, **Fig. 5.**

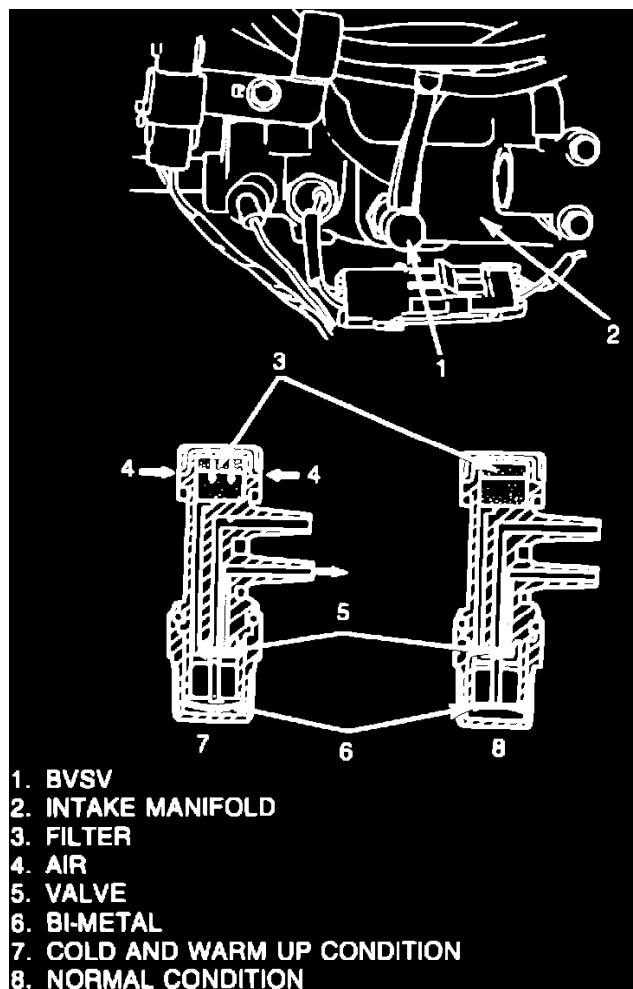
**Fig. 6 Bi-metal vacuum switching valve (BVSF)**

Fuel vapors are not purged while coolant temperature is low. The BVSF bleeds off the vacuum which would otherwise be applied to the purge valve. As coolant temperature rises, the BVSF closes off the vacuum bleed, thus directing full manifold vacuum to the purge valve, **Fig. 6.**

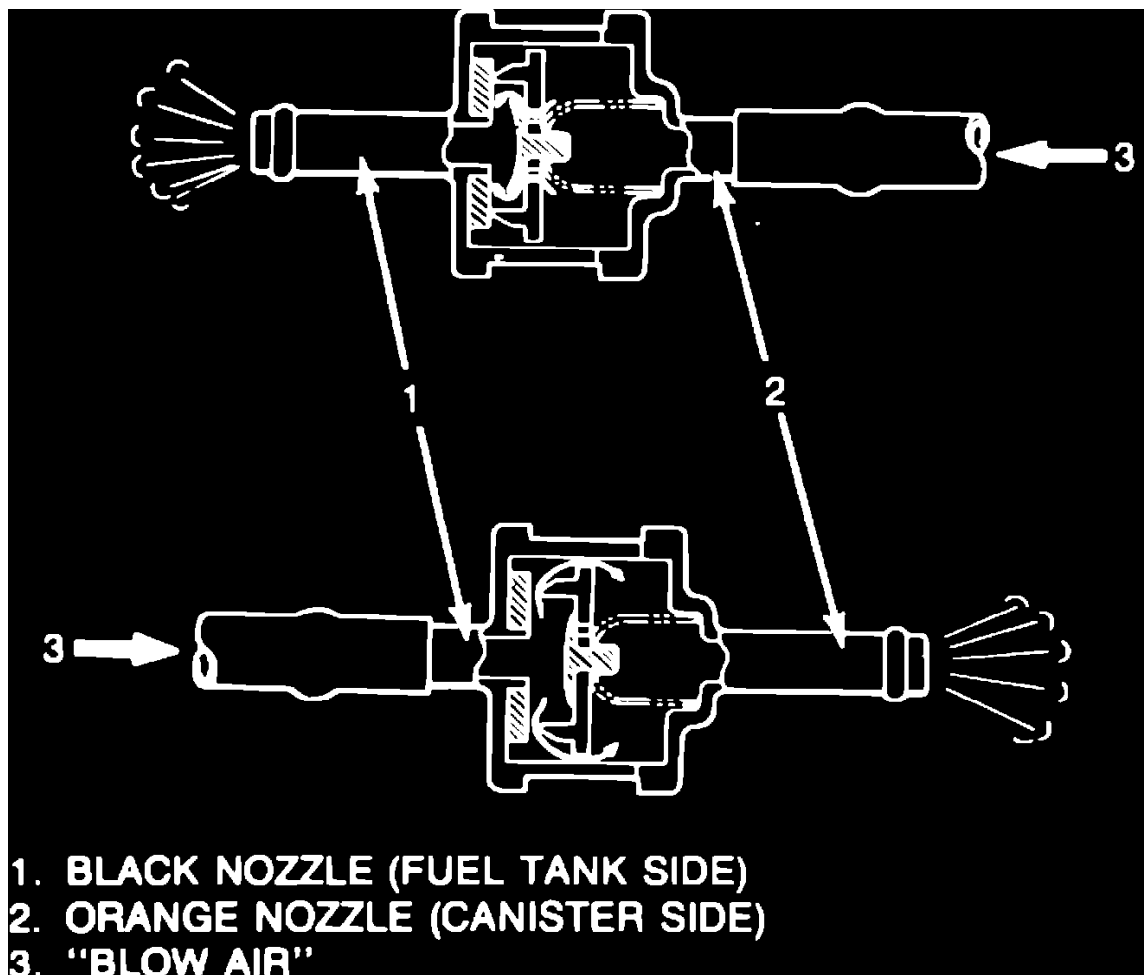
Fig. 7 Checking two-way check valve

1. Connect new hose to orange nozzle (canister side). Blow into new hose and check that air escapes from black nozzle (fuel tank side), **Fig. 7**.
2. Install new hose to black nozzle. Blow air into hose and check that air escapes from orange nozzle.

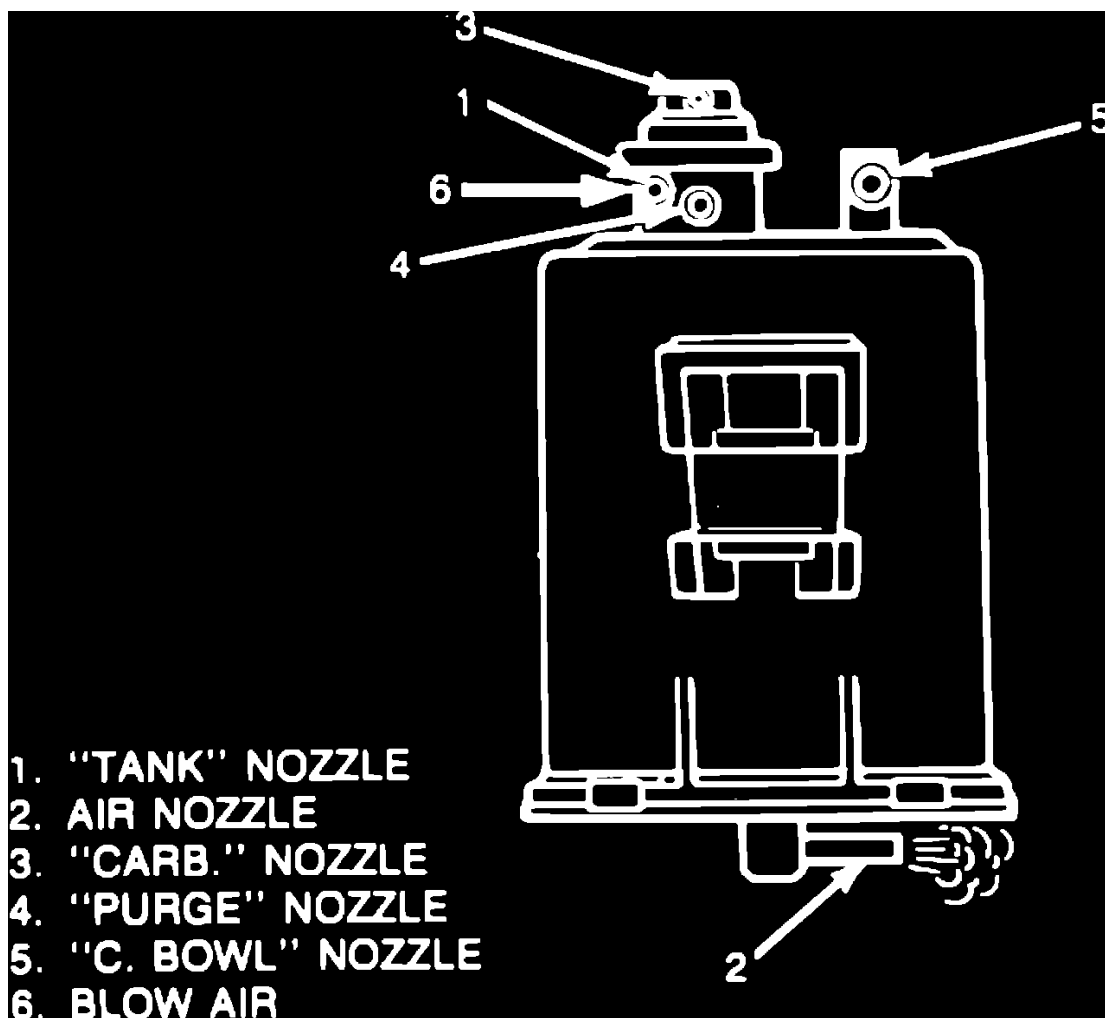
Fig. 8 Checking air flow from TANK nozzle

1. Blow air into TANK nozzle and check that air escapes from air nozzle at bottom of canister, **Fig. 8**.
2. Blow air into PURGE nozzle and check that no air escapes from other 4 nozzles since purge control valve should close, **Fig. 9**.
3. Apply a vacuum of at least 3.15 inches Hg (80 mm Hg) to CARB nozzle and blow air into PURGE nozzle. Air should escape from TANK and C. BOWL nozzles and air nozzle at bottom of canister, **Fig. 10**.

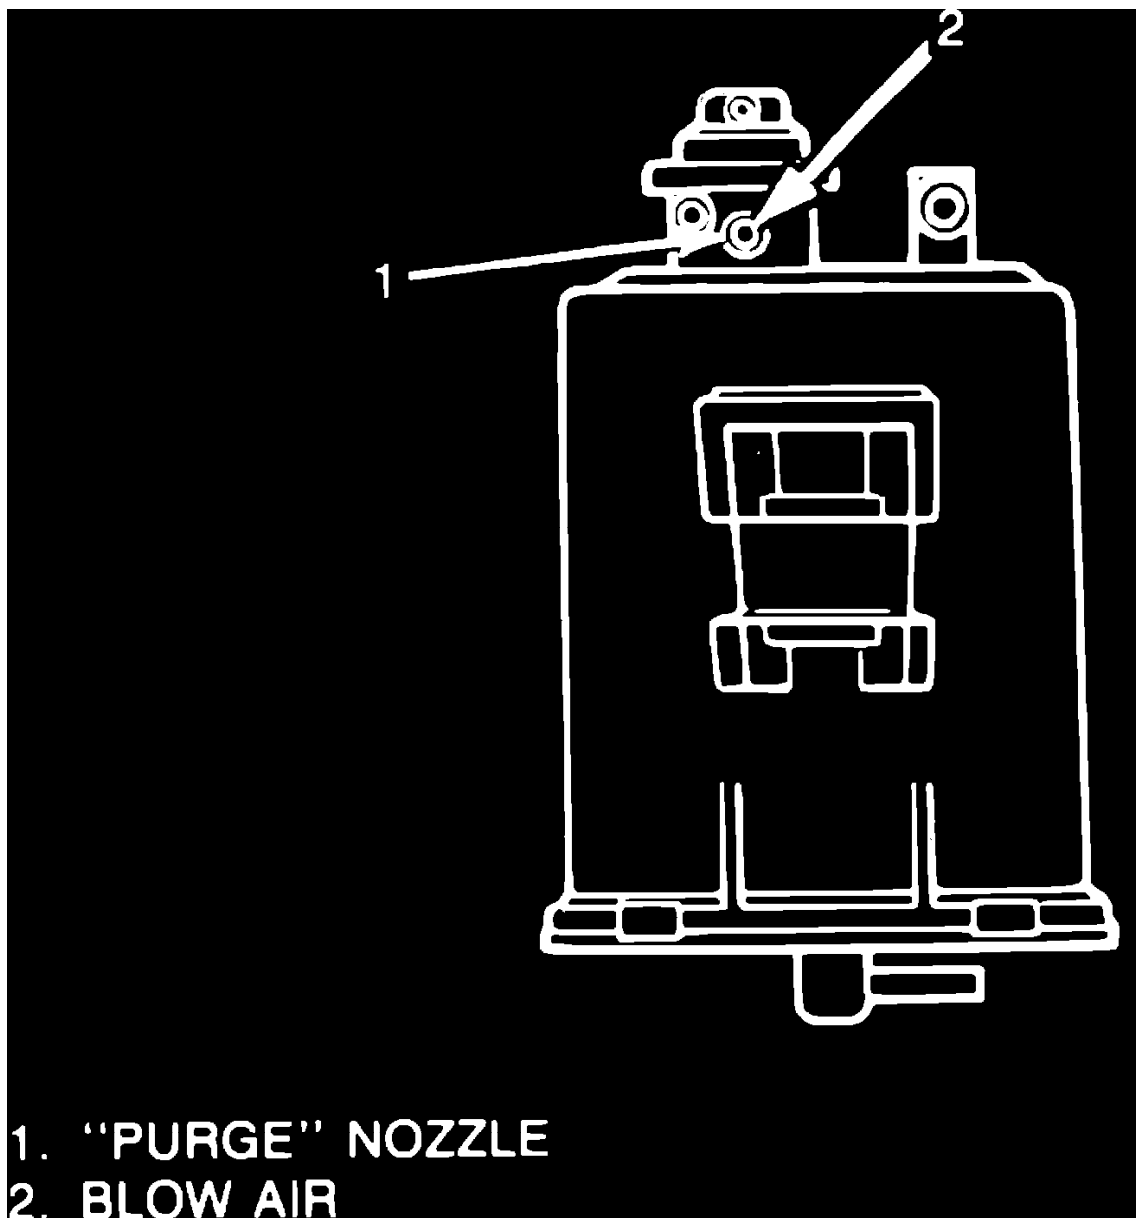
Fig. 9 Checking air flow from PURGE nozzle

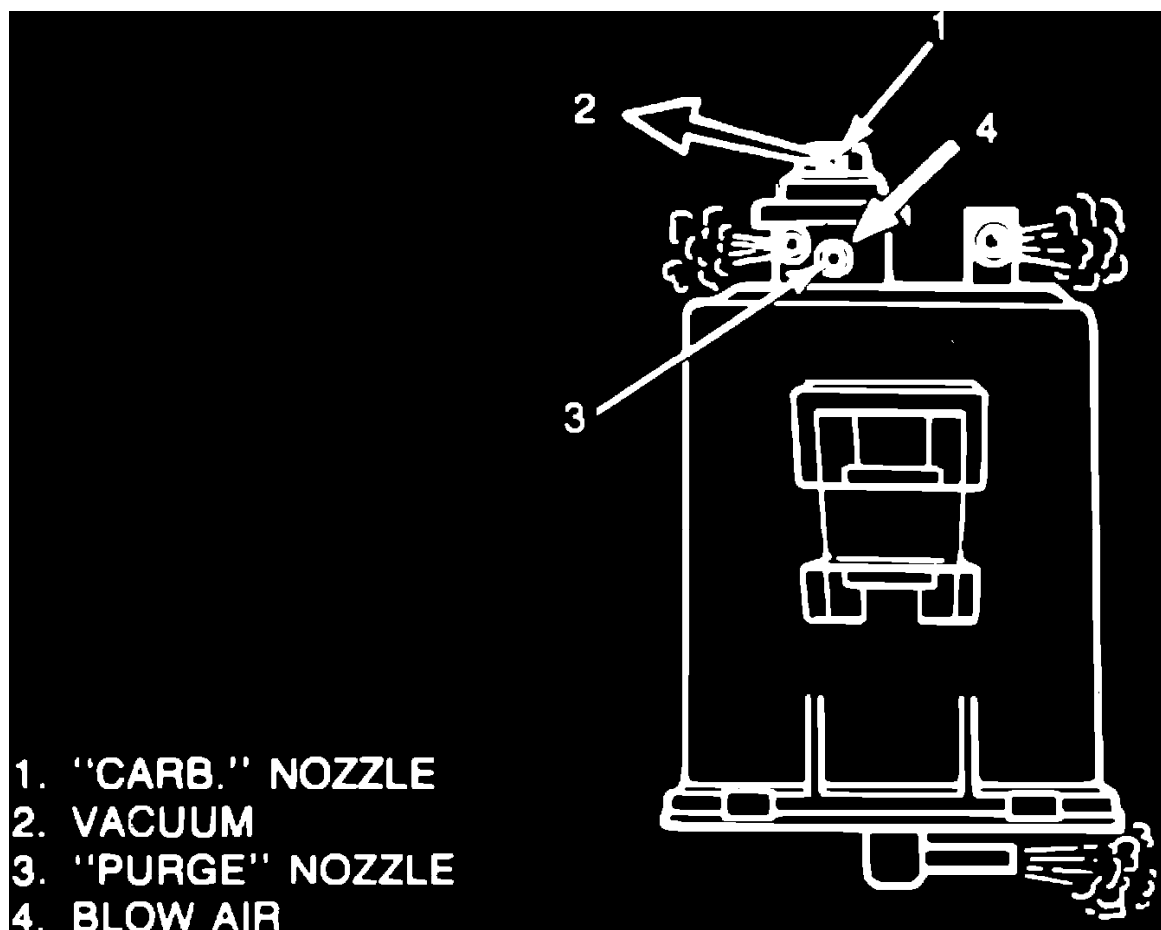
**Fig. 10 Checking operation of purge valve with vacuum applied**

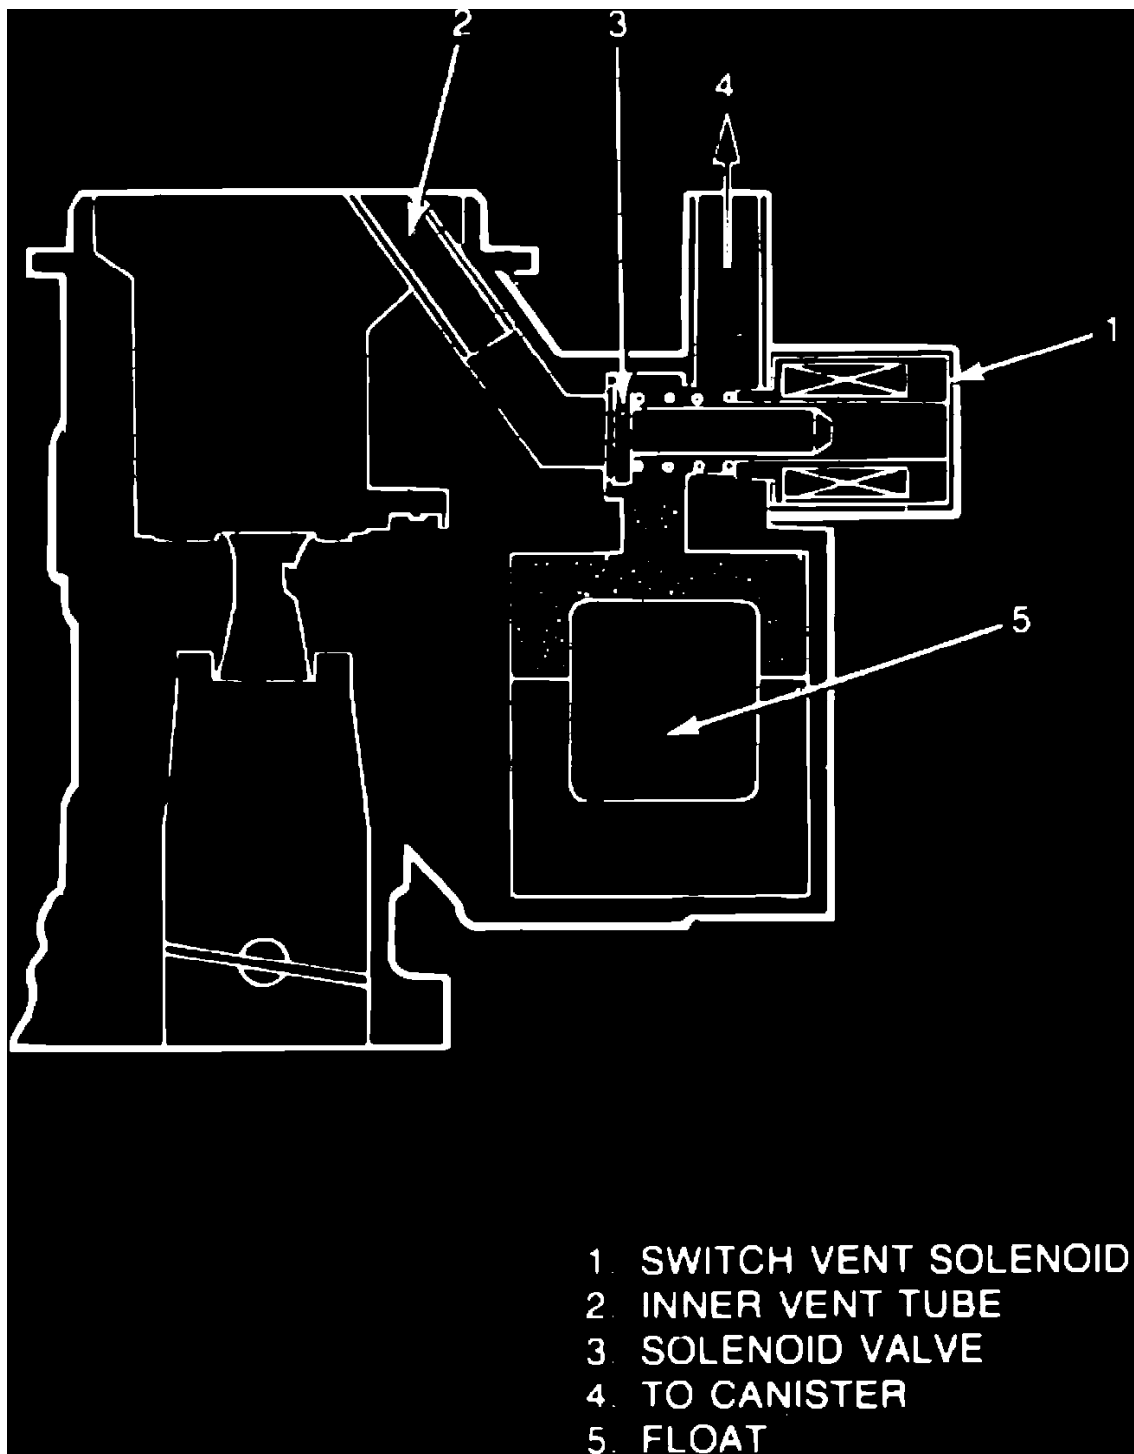
**Fig. 1 Bowl ventilation system cross sectional view**

This system consists of a carburetor mounted switch vent solenoid (SVS), **Fig. 1**, and prevents carburetor fuel bowl vapors from being discharged into the atmosphere. When the engine is stopped, the SVS directs fuel bowl vapors into the EEC system vapor storage canister where they remain until the canister is purged. During normal engine operation, the SVS directs fuel bowl vapors into the inner vent tube, **Fig. 1**, where they are drawn into the intake air stream and burned. The SVS receives operating signals from the ignition switch and the Computer Controlled Emission Control System ECM.
