Vehicle: Application and ID

## Engine: Service and Repair

## Camshaft: Service and Repair

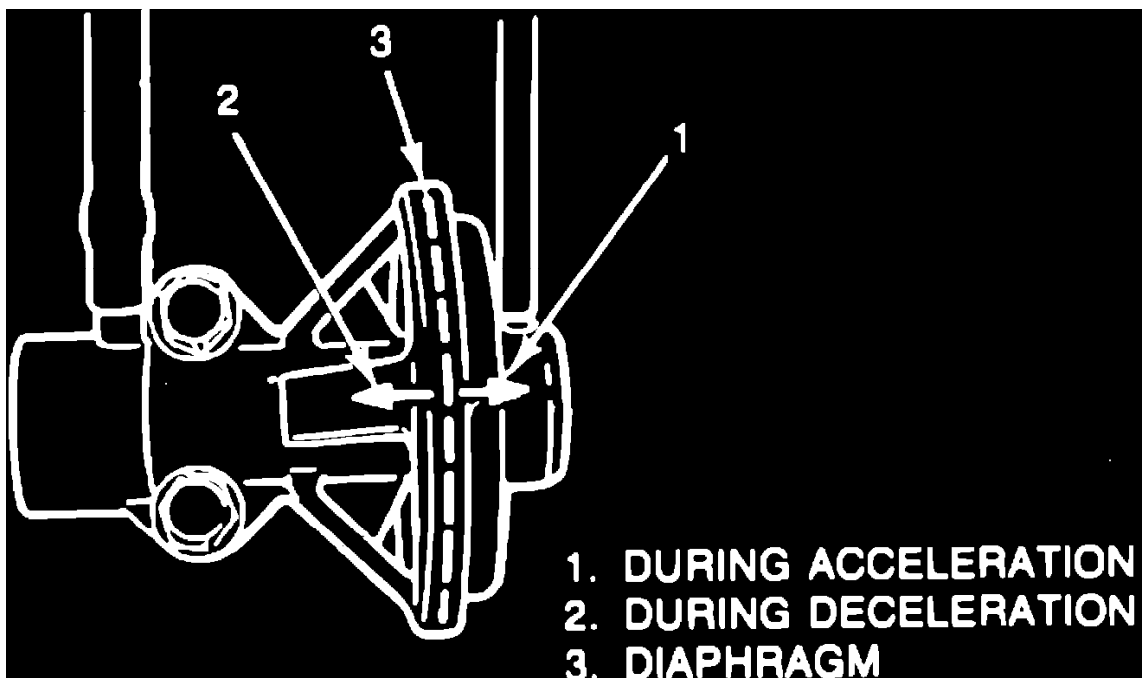
Fig. 13 Checking movement of EGR valve diaphragm

1. With engine running and coolant temperature below 113°F (45°C), check that EGR valve is not open by feeling diaphragm.
2. Allow engine to reach normal operating temperature. Race engine and check that diaphragm moves toward 1, **Fig. 13**, during acceleration and toward 2 during deceleration.

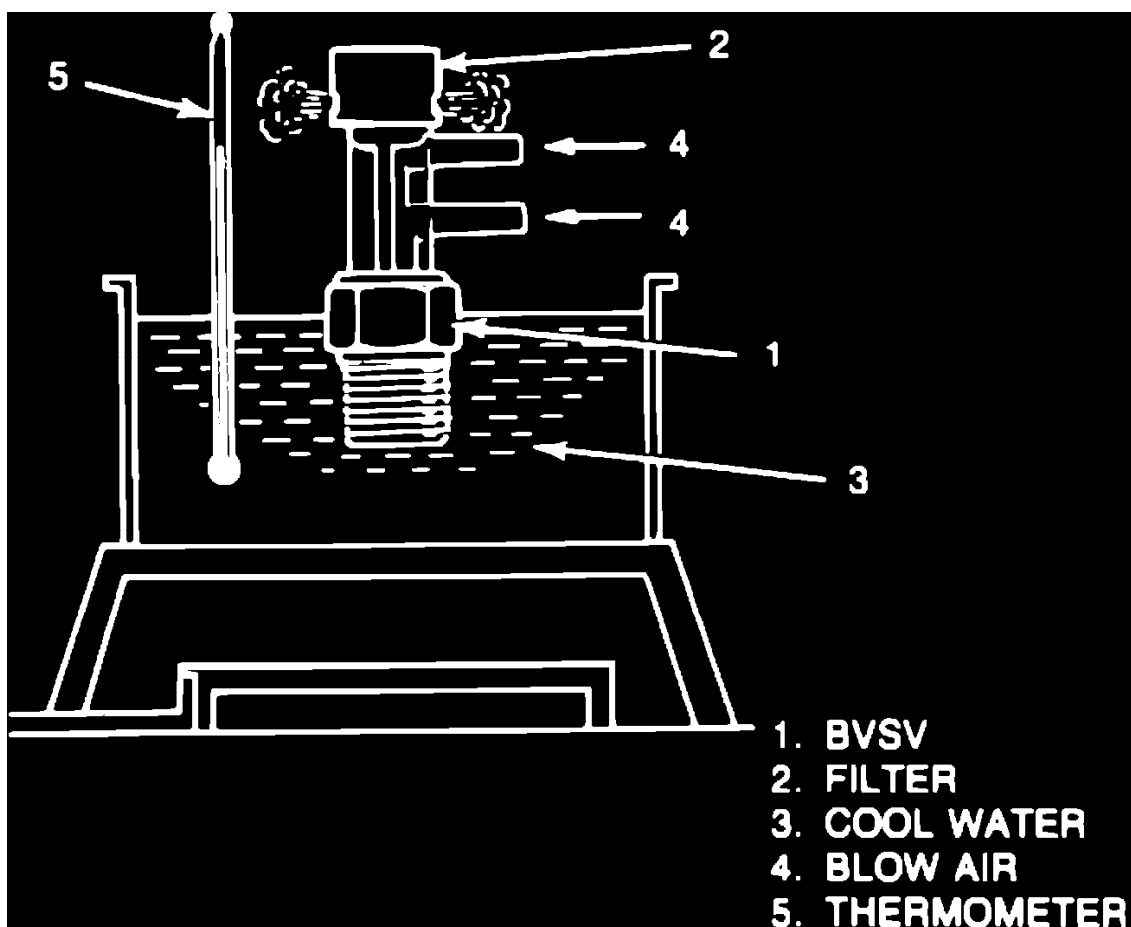
Fig. 14 Checking bi-metal vacuum switching valve low temperature operation

1. With engine cold, drain cooling system.
2. Remove BVSV from intake manifold.
3. With BVSV below 113°F (45°C), blow air into each nozzle individually, **Fig 14**. Air should escape from filter.
4. With BVSV heated above 140°F (60°C) in hot water, blow air into each nozzle individually, **Fig. 15**. Air should not escape from filter.
5. Wrap sealing tape around threads and reinstall BVSV in intake manifold.
6. Reconnect vacuum hoses.

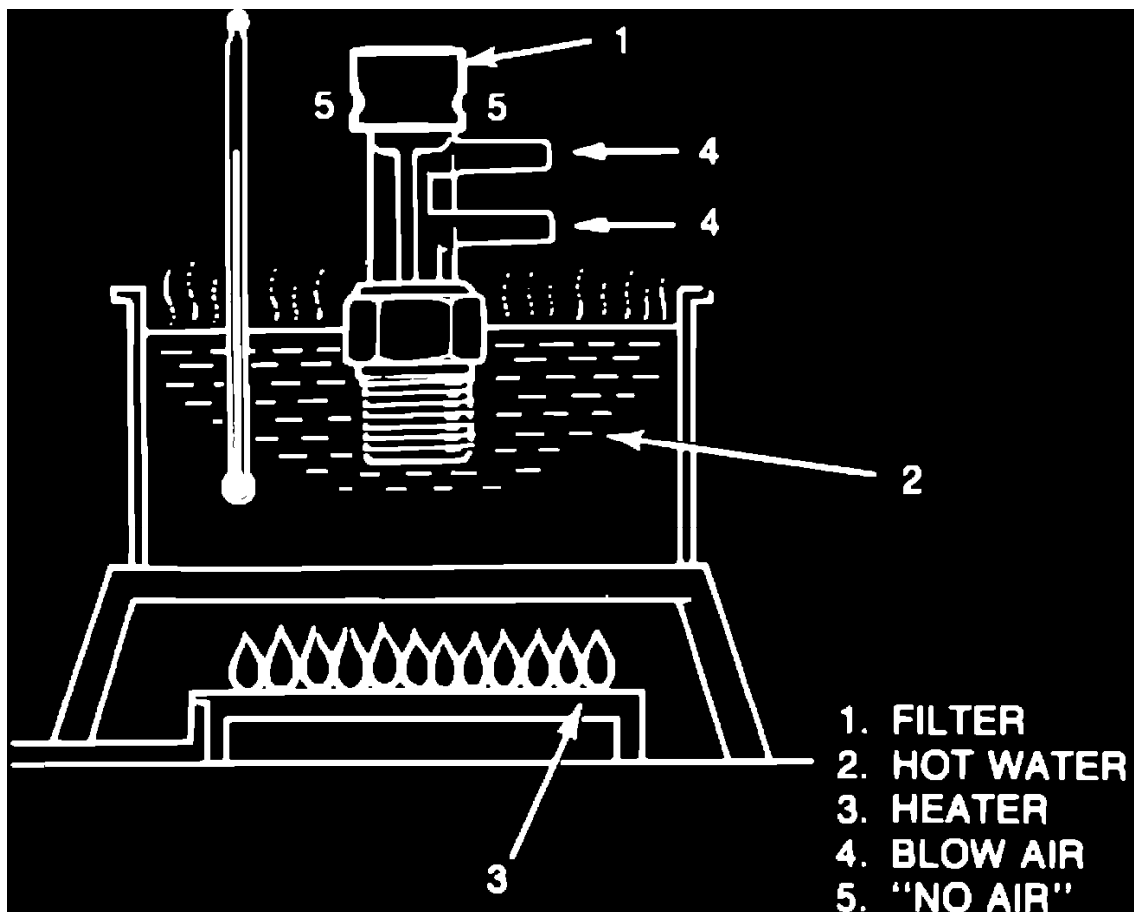
Fig. 15 Checking bi-metal vacuum switching valve high temperature operation

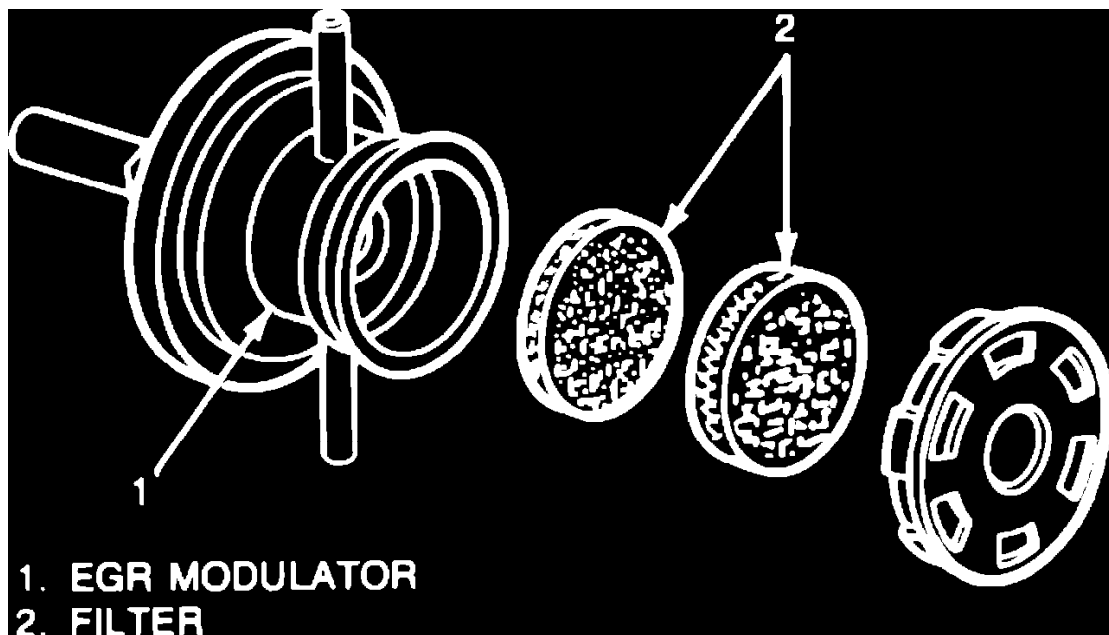
Fig. 16 EGR modulator. Exploded view

1. Inspect filter for dirt or damage, **Fig. 16**. Clean filter using compressed air.
2. With engine off, disconnect 2 vacuum hoses from EGR modulator and plug nozzle. Blow air into other nozzle and check that air escapes freely through filter, **Fig. 17**.
3. Start engine and allow to reach normal operating temperature.
4. Increase engine speed to 5000 RPM and plug one nozzle of modulator. Blow air into other nozzle. Strong resistance to air flow should be felt, **Fig. 18**.
5. Reconnect vacuum hoses.

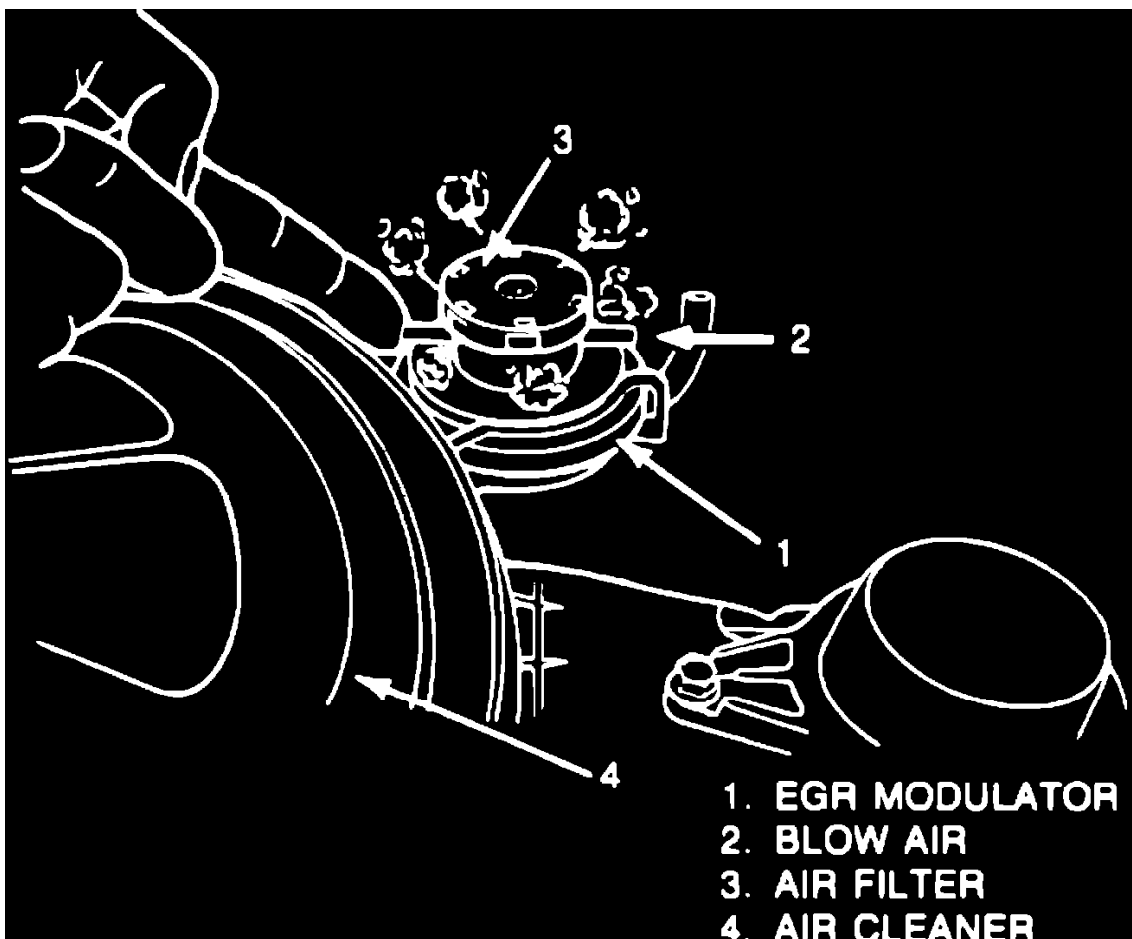
Fig. 17 Testing EGR modulator

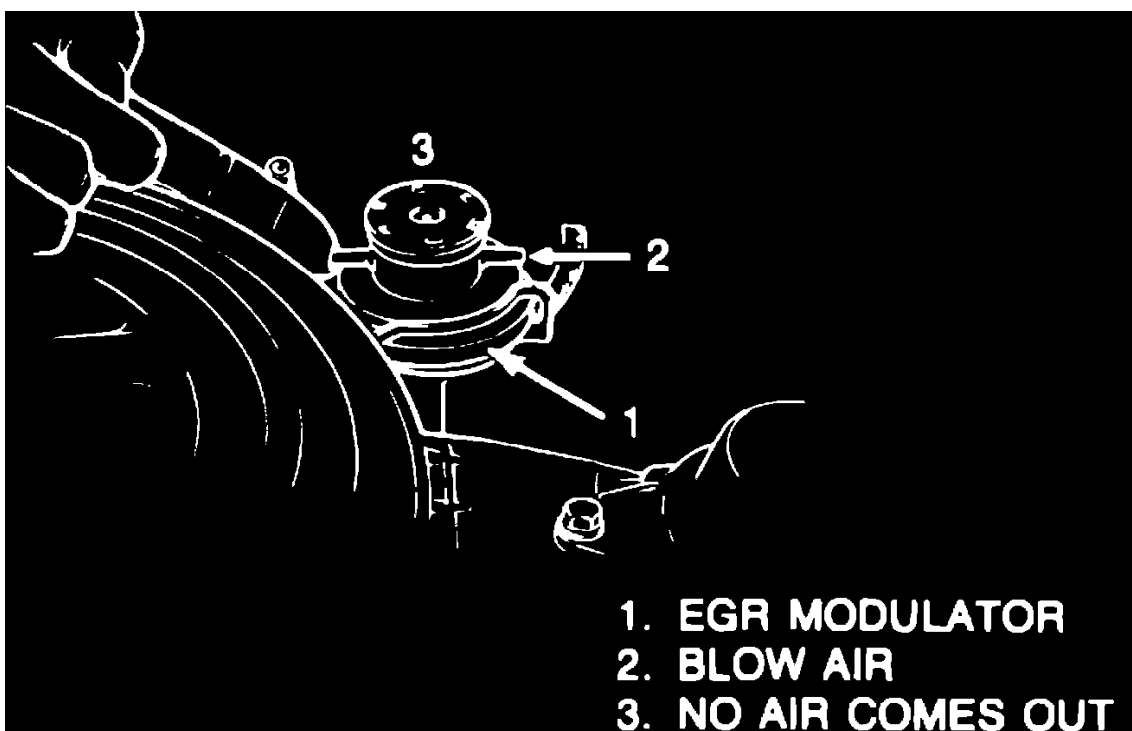
Fig. 18 High speed EGR modulator test

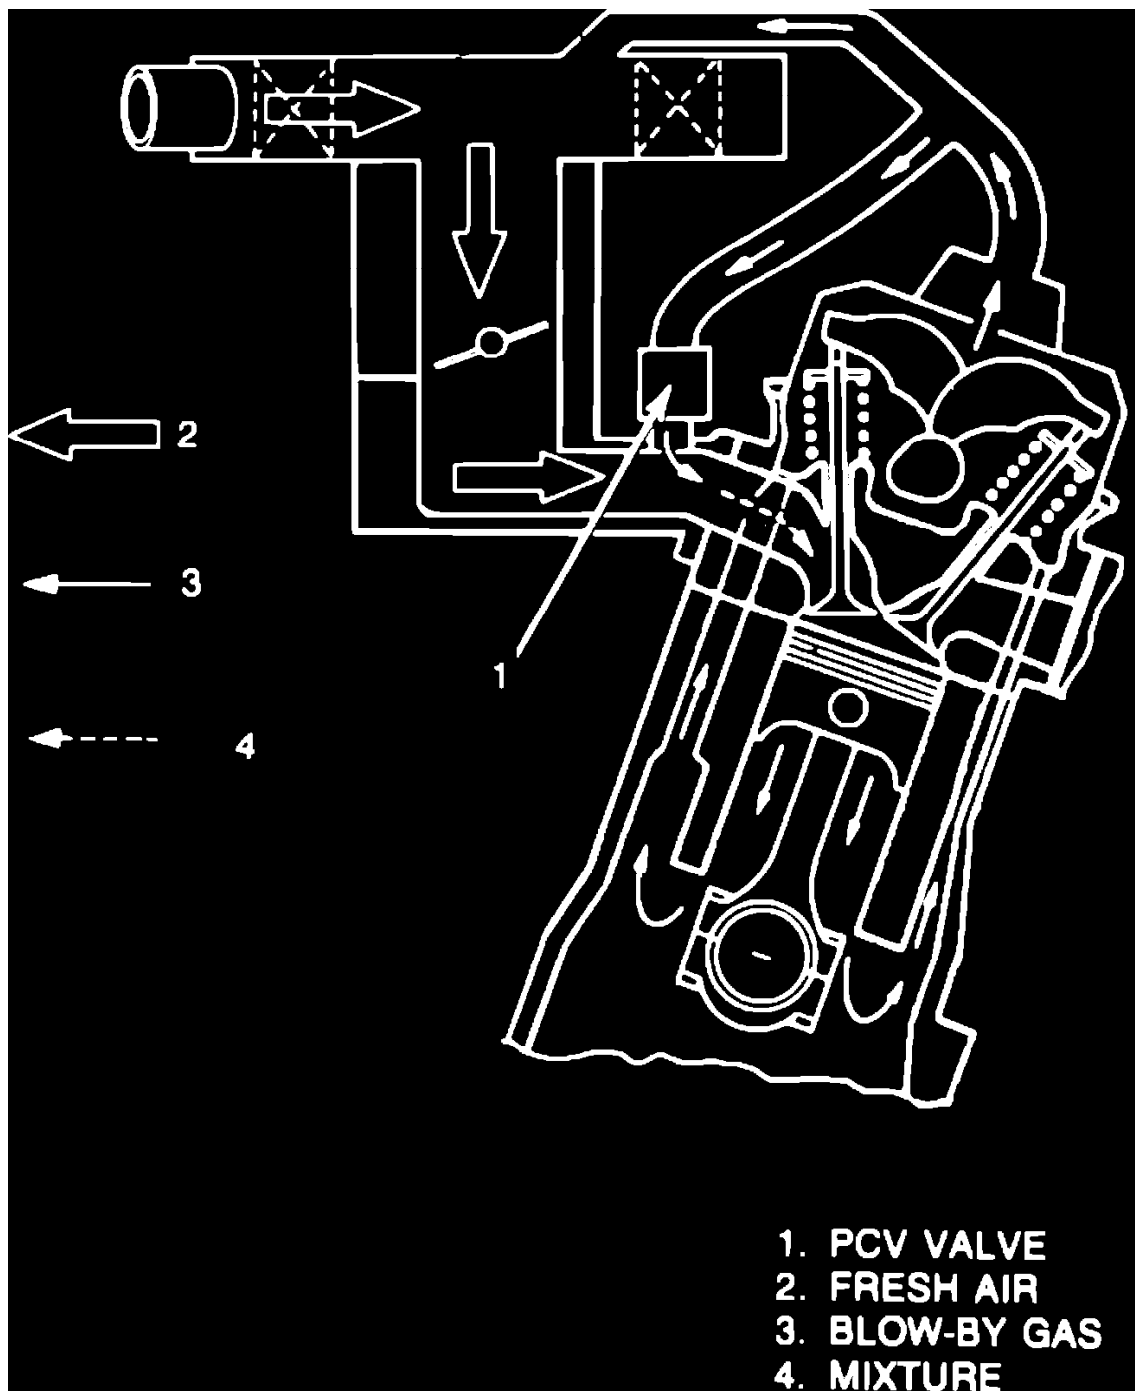
Fig. 24 PCV system. 1985 - 88 exc. 1987 - 88 models w/EFI & turbocharger

The PCV system, **Figs. 24 and 25**, consists of a PCV valve mounted on the intake manifold connected to a hose that is teed into a hose connecting the air cleaner to the valve cover. During small throttle opening/high vacuum conditions, crankcase gasses flow from the valve cover thru the PCV valve. During large throttle openings/low vacuum conditions, crankcase gasses flow from the valve cover to the air cleaner.

The PCV system, **Figs. 24 and 25**, consists of a PCV valve mounted on the intake manifold connected to a hose that is teed into a hose connecting the air cleaner to the valve cover. During small throttle opening/high vacuum conditions, crankcase gasses flow from the valve cover thru the PCV valve. During large throttle openings/low vacuum conditions, crankcase gasses flow from the valve cover to the air cleaner.

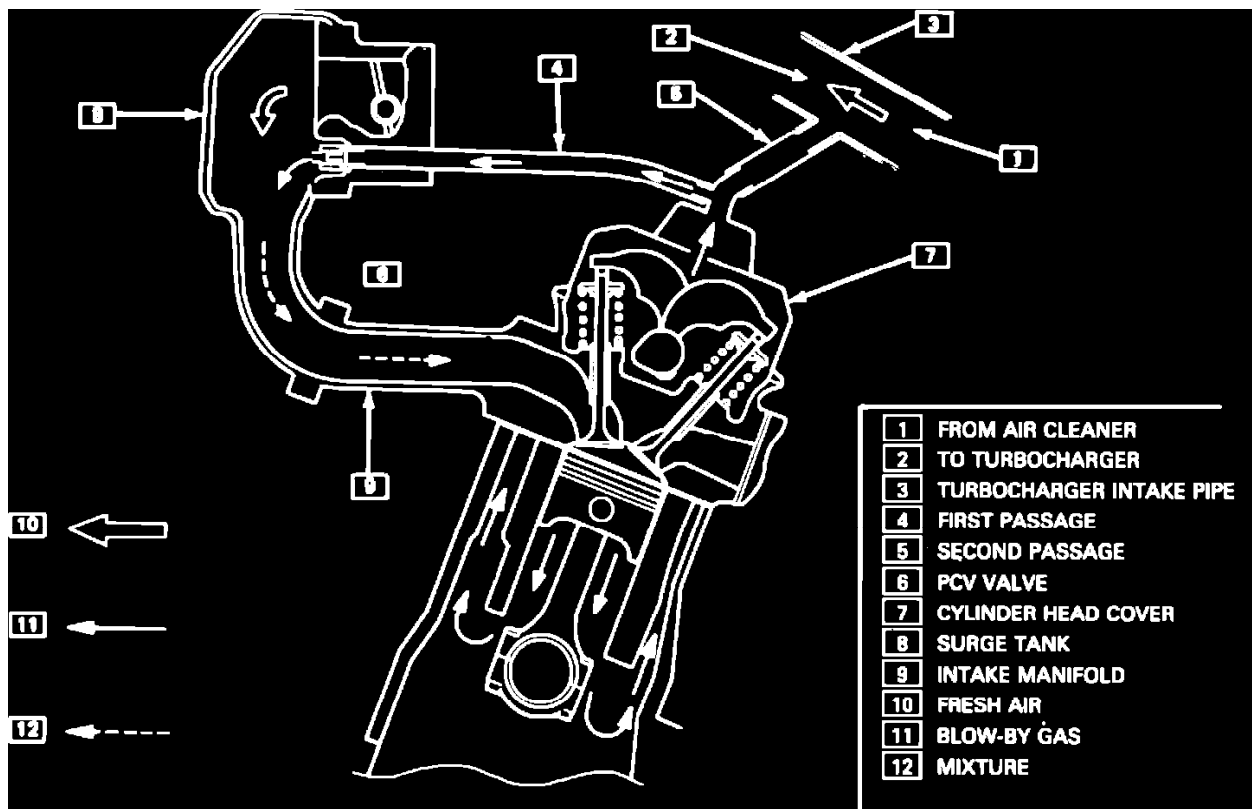
**Fig. 25 PCV system. 1987 - 88 models w/EFI & turbocharger**

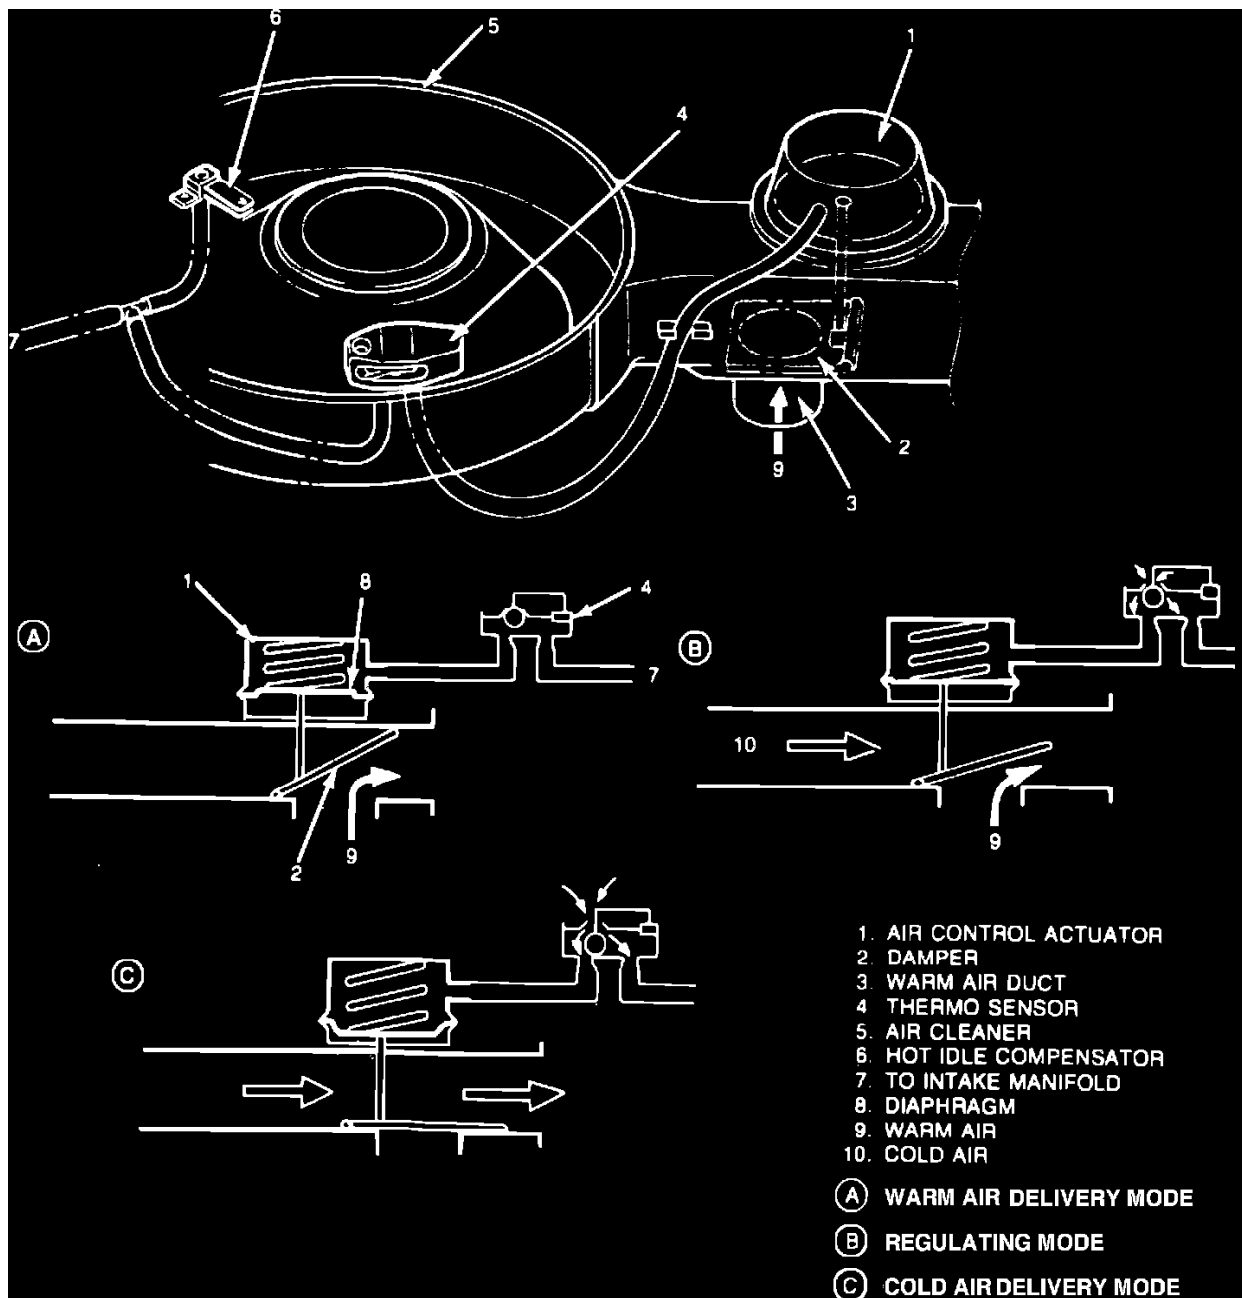
**Fig. 32 Thermostatically controlled air cleaner & air control actuator operation**

This system, consisting of an air control actuator and a thermo-sensor, **Fig. 32**, controls the temperature of the intake air by mixing preheated air and cool air to improve fuel vaporization and engine warm-up operation. The thermo-sensor senses the inside temperature of the air cleaner and regulates the vacuum applied to the air control actuator, thus controlling the damper position, **Fig. 32**.

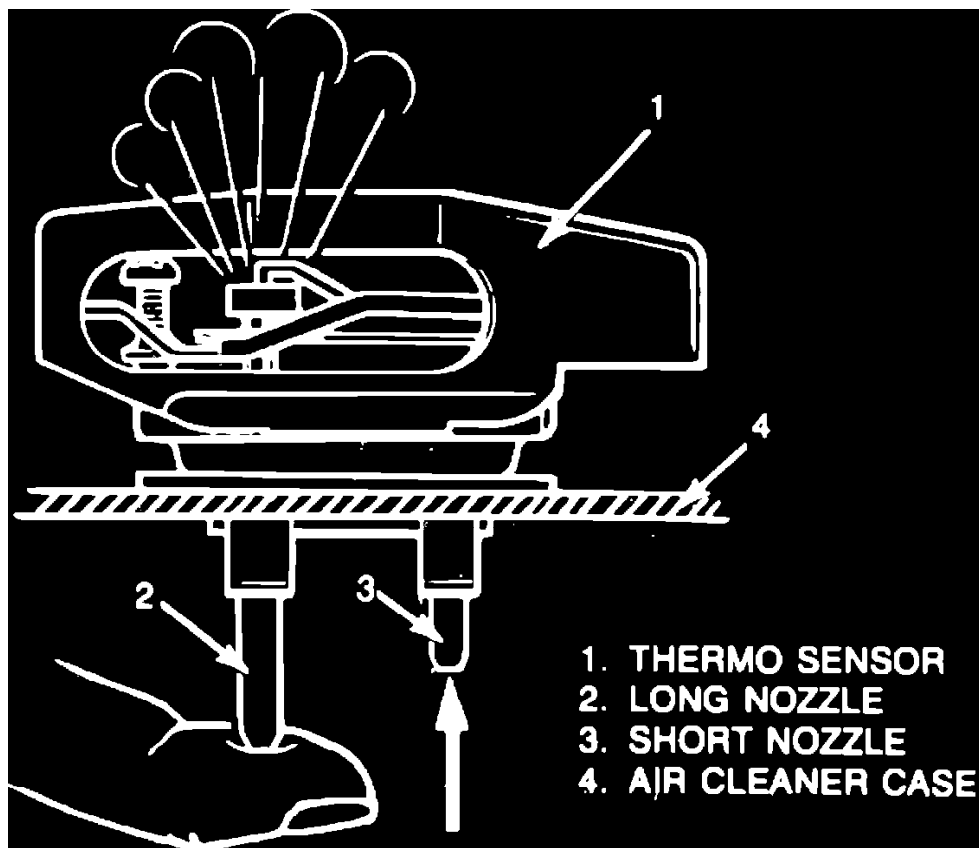
Fig. 33 Testing thermo-sensor

1. Remove air cleaner.
2. Disconnect 2 vacuum hoses from thermo-sensor.
3. Measure temperature around thermo-sensor.
4. Cover long nozzle with finger and blow air into short nozzle, **Fig. 33**. Valve should be open at temperatures above 104°F and closed at temperatures below 77°F.
5. After testing, reconnect vacuum hoses and reinstall air cleaner.

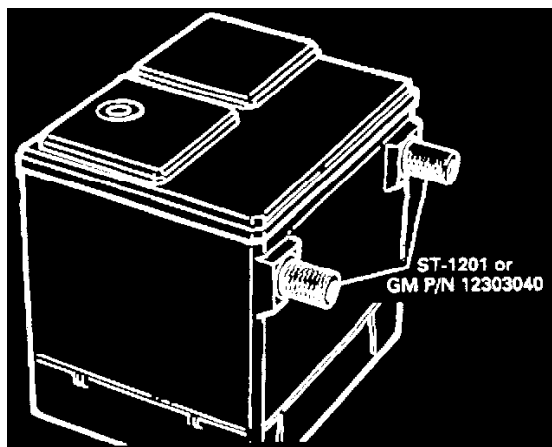
#### Battery Side Terminal Adapters

2. Install the battery side terminal adapter from, AC Delco P/N ST-1201 or GM P/N 12303040 or equivalent, in the negative terminal of the battery.
3. Install the other battery side terminal adapter or a 3/8-inch nut with standard threads (16 UNC) on the negative battery cable to assure a good electrical contact with metal face on cable for testing (add a washer behind nut if nut does not contact firmly). Yellow or black finish nuts are generally non-conductive and should not be used.

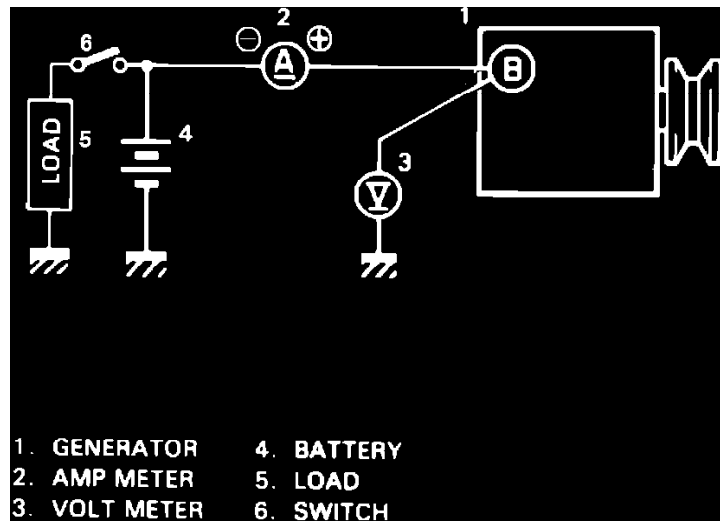
**Fig. 1 Alternator test connections**

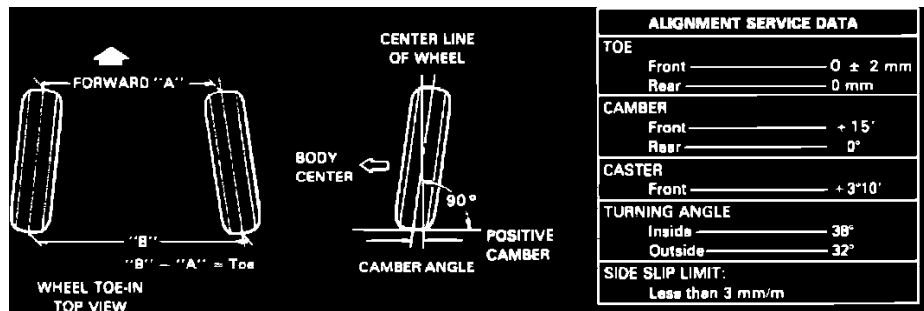
Fig. 1 Wheel alignment specifications

1. Position vehicle on suitable alignment fixture following manufacturer's instructions and check caster and camber angles. Refer to **Fig. 1** for specifications. Bumper should be bounced three times before inspection, to prevent incorrect reading.
2. Camber and caster cannot be adjusted. Should either be found out of specification, locate the cause first.
3. If improper alignment is caused by damaged, worn or loose suspension parts, they should be replaced. If vehicle body or chassis is damaged, it should be repaired.

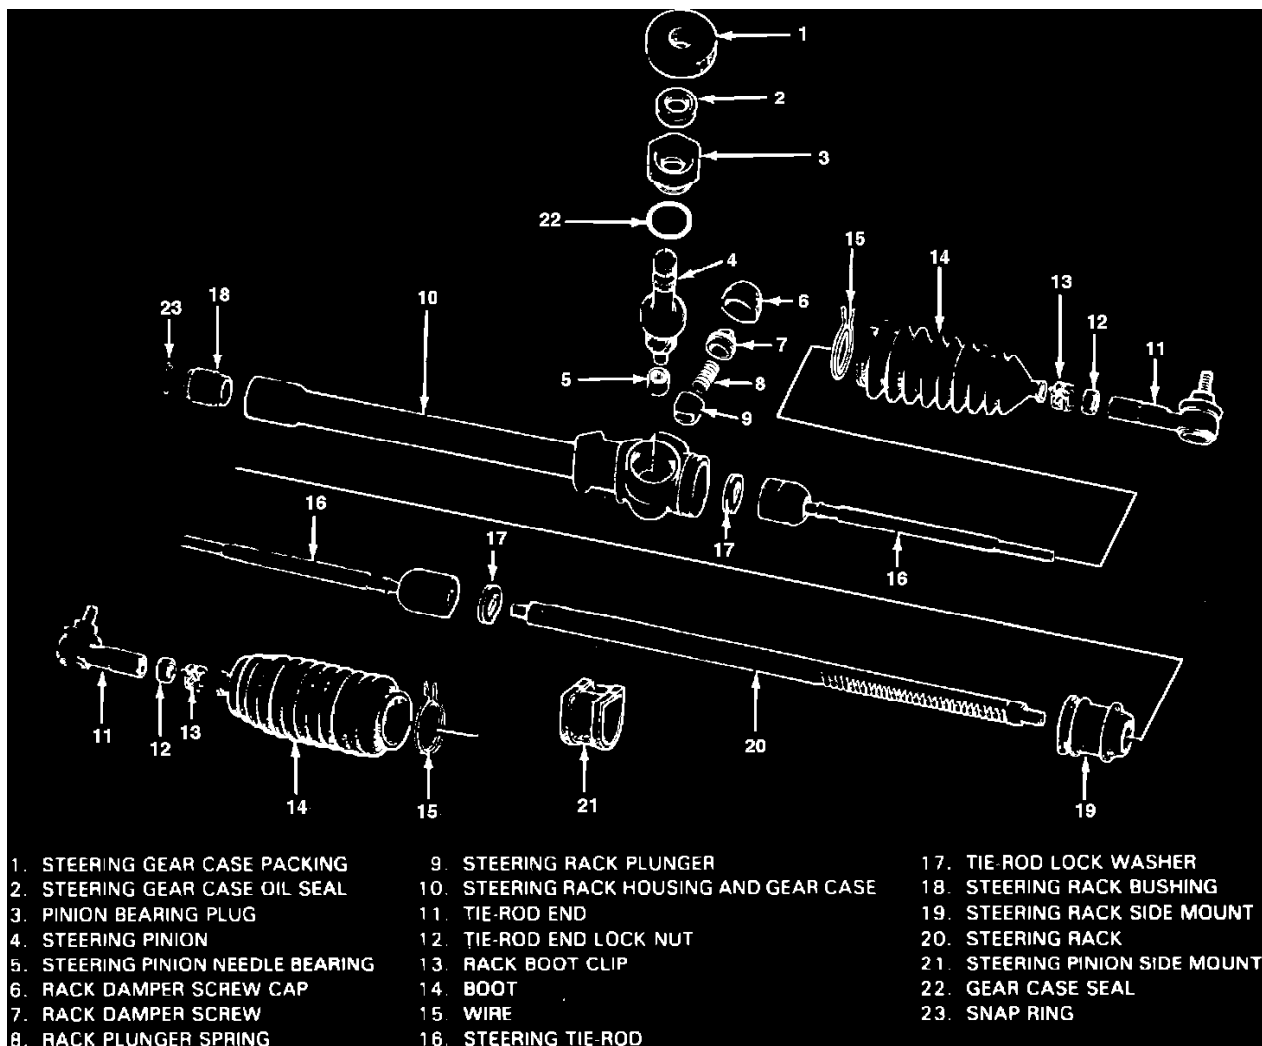
**Fig. 1 Manual rack & pinion steering assembly**

Refer to Fig. 1 when servicing steering gear assembly.

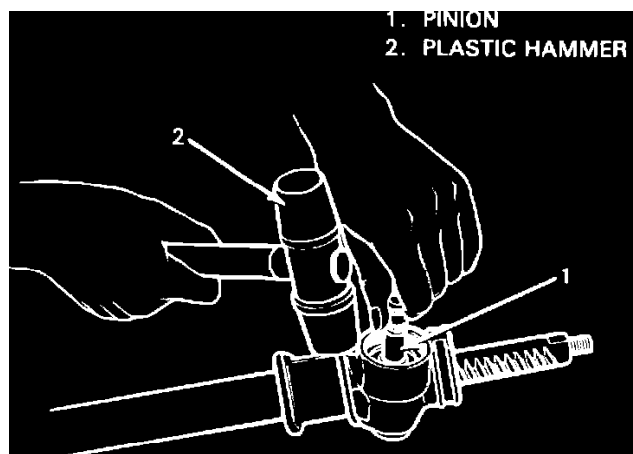
**Fig. 2 Separating pinion from housing**

5. Tap on position shown in Fig. 2 with a plastic hammer to separate pinion assembly from housing.

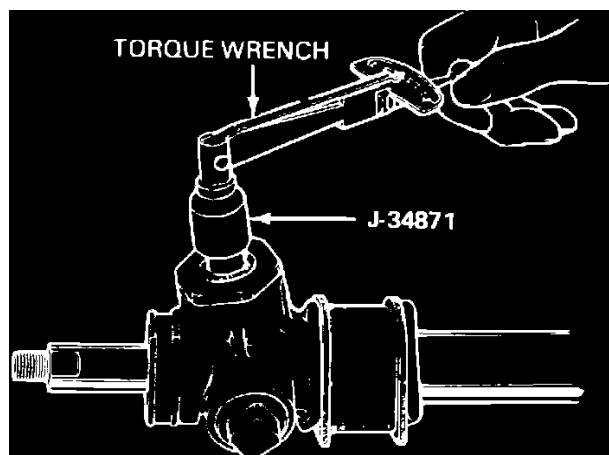
**Fig. 3 Checking pinion torque**

6. After tightening damper screw, back it off 90 degrees and check rotational torque of pinion. Pinion torque should be 58-94 ft. lbs., Fig. 3.

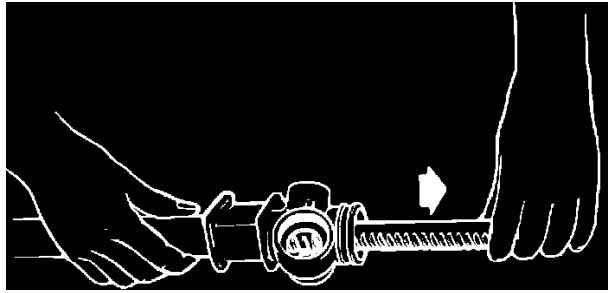
**Fig. 4** Removing rack from gear case

1. Remove boot wires and clips. Slide boots toward tie rod end.
2. Unbend tie rod lock washers and remove tie rods. Mark left and right tie rods.
3. Remove rack plunger and pinion assembly as described under Steering Pinion.
4. Remove rack from gear case as shown in **Fig. 4**.

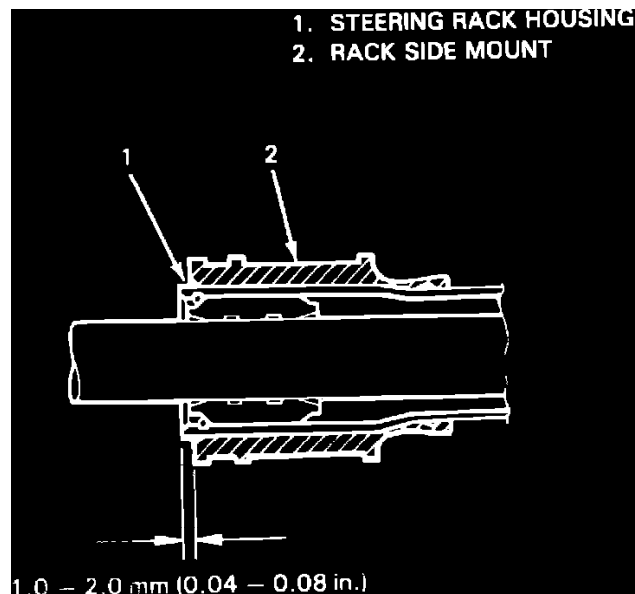
**Fig. 5** Ensuring that rack side mount is positioned

4. Install boot to steering rack housing, ensuring that rack side mount is positioned as shown in **Fig. 5**.
5. Install tie rods as described under "Steering Rack."

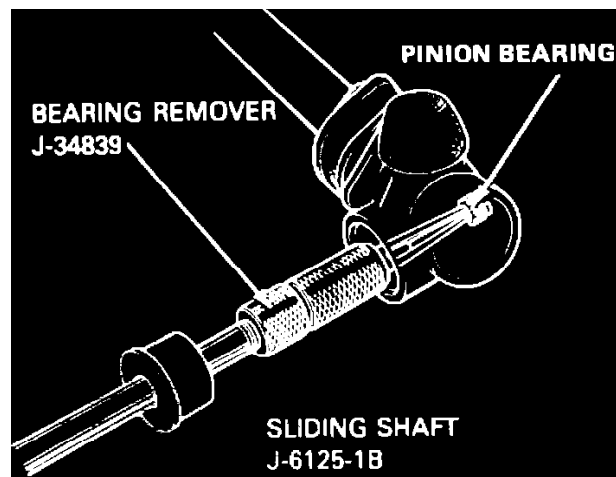
Fig. 6 Removing pinion bearing

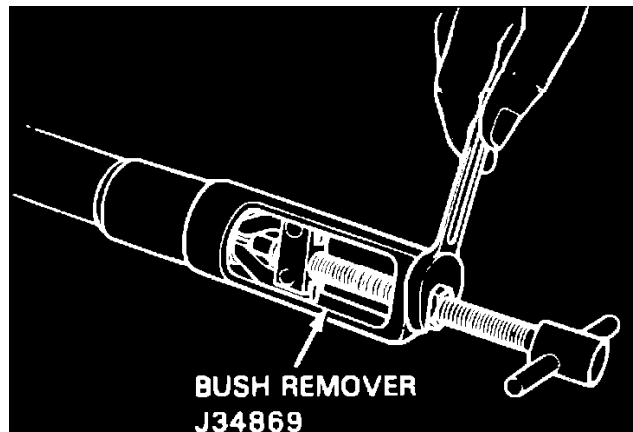
Fig. 7 Removing rack bushing

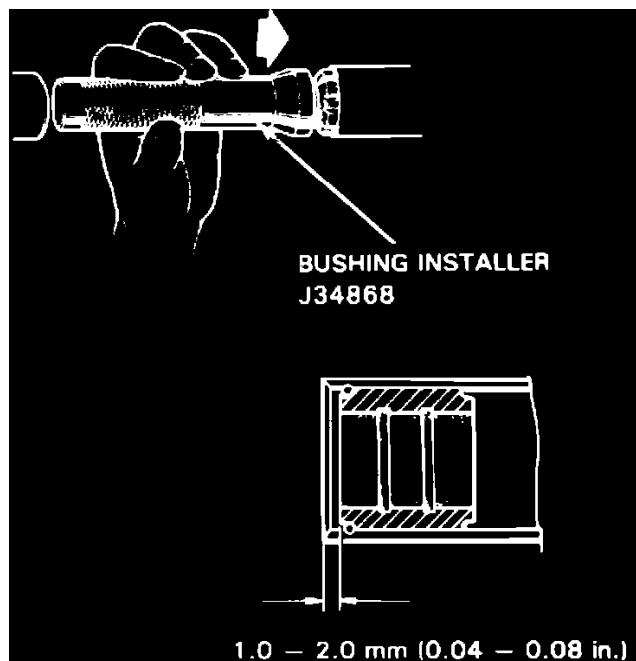
**Fig. 8 Installing rack bushing**

1. Apply a suitable lithium based grease to inner surface of bushing.
2. Using tool J-34868 or equivalent, install bushing into rack housing, ensuring bushing to housing clearance is as shown, **Fig. 8**.
3. Install snap ring.
4. Install steering rack assembly as described under Steering Rack Assembly.

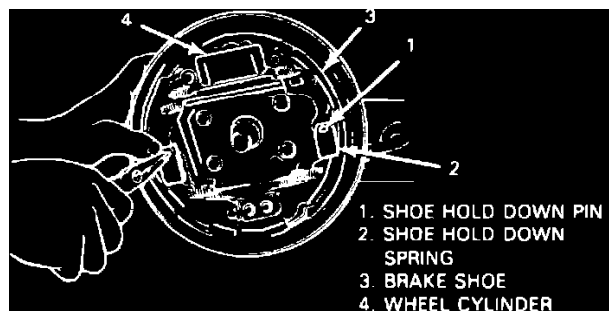
**Fig. 3 Brake shoe hold down spring removal**

1. Raise and support vehicle.
2. Remove rear brake drums.
3. Disconnect brake hoses from lines.
4. Disconnect brake hoses and retainers from trailing arm.
5. Plug brake hoses to prevent loss of brake fluid.
6. Remove brake shoe hold down spring by turning shoe hold down pin as shown in **Fig. 3**.
7. Disconnect parking brake cable from parking brake shoe lever and remove brake shoes. Remove cable from back plate.
8. Remove brake back plate from rear axle.
9. Support center of axle with suitable jack.

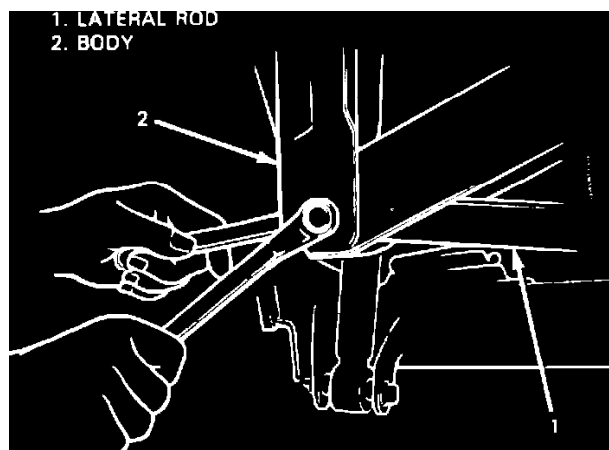
**Fig. 4 Lateral rod body side bolt location**

10. Remove lateral rod body side bolt, **Fig. 4**.
11. Remove shock absorber lower mounting bolt.
12. Lower rear axle slowly, until tension of suspension spring is relieved. Remove spring.
13. Remove trailing arm front side bolt and lower rear axle.
14. Remove trailing arm bushing with suitable tool.
15. Reverse procedure to install. **When press fitting bushing into trailing arm, direct its slit side toward front and rear.**

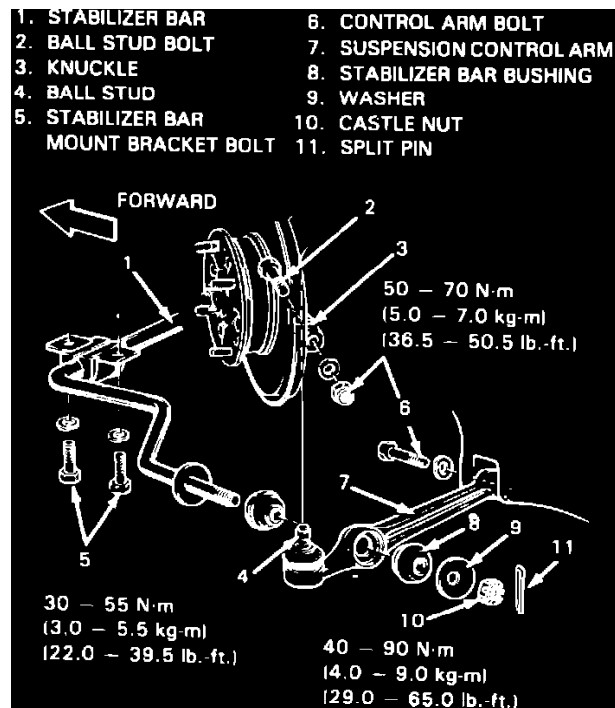
**Fig. 9 Removing lower control arm**

1. Raise and support vehicle.
2. Remove stabilizer bar cotter pin, castle nut, washer and bushing, **Fig. 9**.
3. Remove stabilizer bar bracket bolts on same side as control arm to be removed.
4. Remove ball joint stud bolt 2, **Fig. 9**.
5. Remove control arm bolt 5, **Fig. 9**, and control arm.
6. Reverse procedure to install.

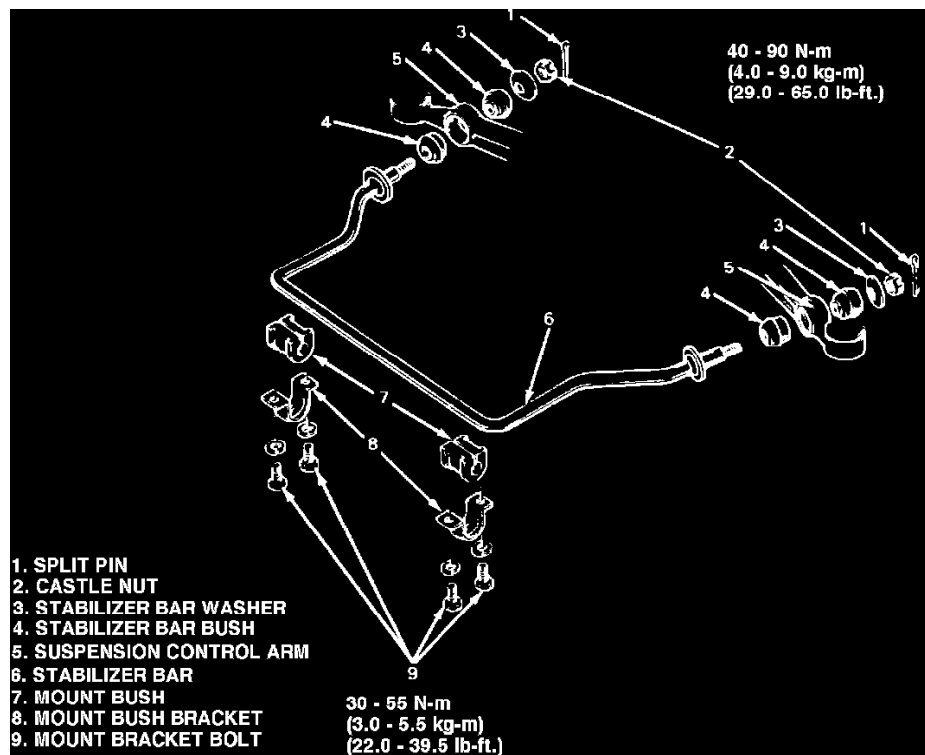
**Fig. 3 Stabilizer bar and bushings**

1. Raise and support vehicle.
2. Remove both front wheels.
3. Remove stabilizer bar bracket bolts, **Fig. 3**.
4. Remove nuts from stabilizer bar ends and disconnect stabilizer bar ends from suspension control arms.

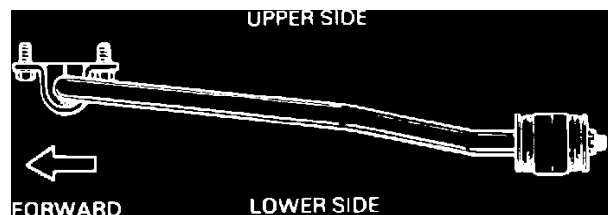
**Fig. 4 Correct installation of stabilizer bar**

5. Reverse procedure to install. Refer to **Fig. 4** for proper orientation of stabilizer bar.

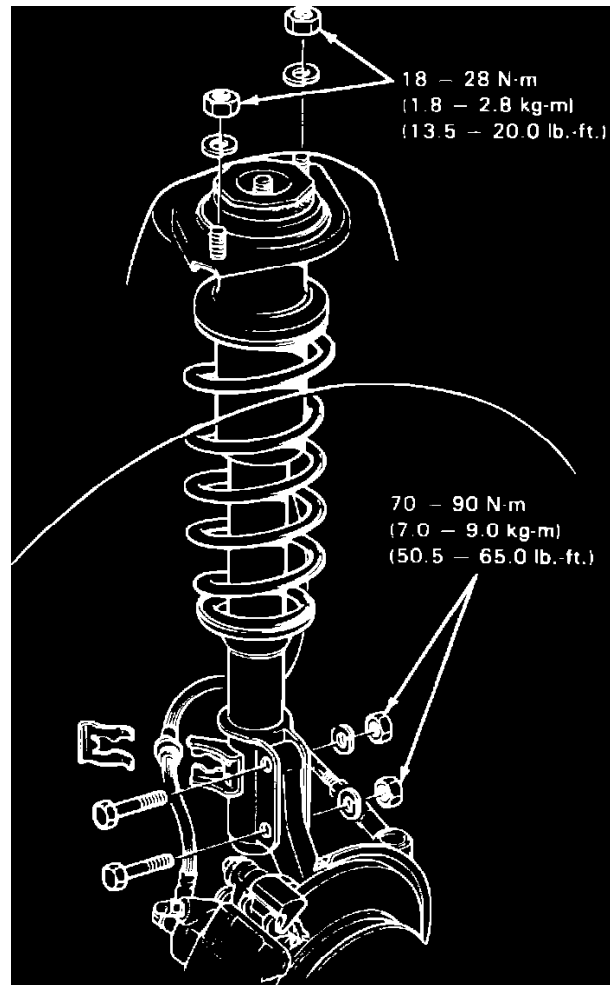
**Fig. 1 Removing MacPherson strut**

1. Raise and support vehicle allowing front suspension to hang free.
2. Remove front wheel.
3. Remove E-clip from brake hose and disengage hose from strut bracket, **Fig. 1**.
4. Support lower control arm and knuckle assembly and remove strut to knuckle bolts.
5. Remove upper strut mount nuts and remove strut from vehicle.
6. Reverse procedure to install.

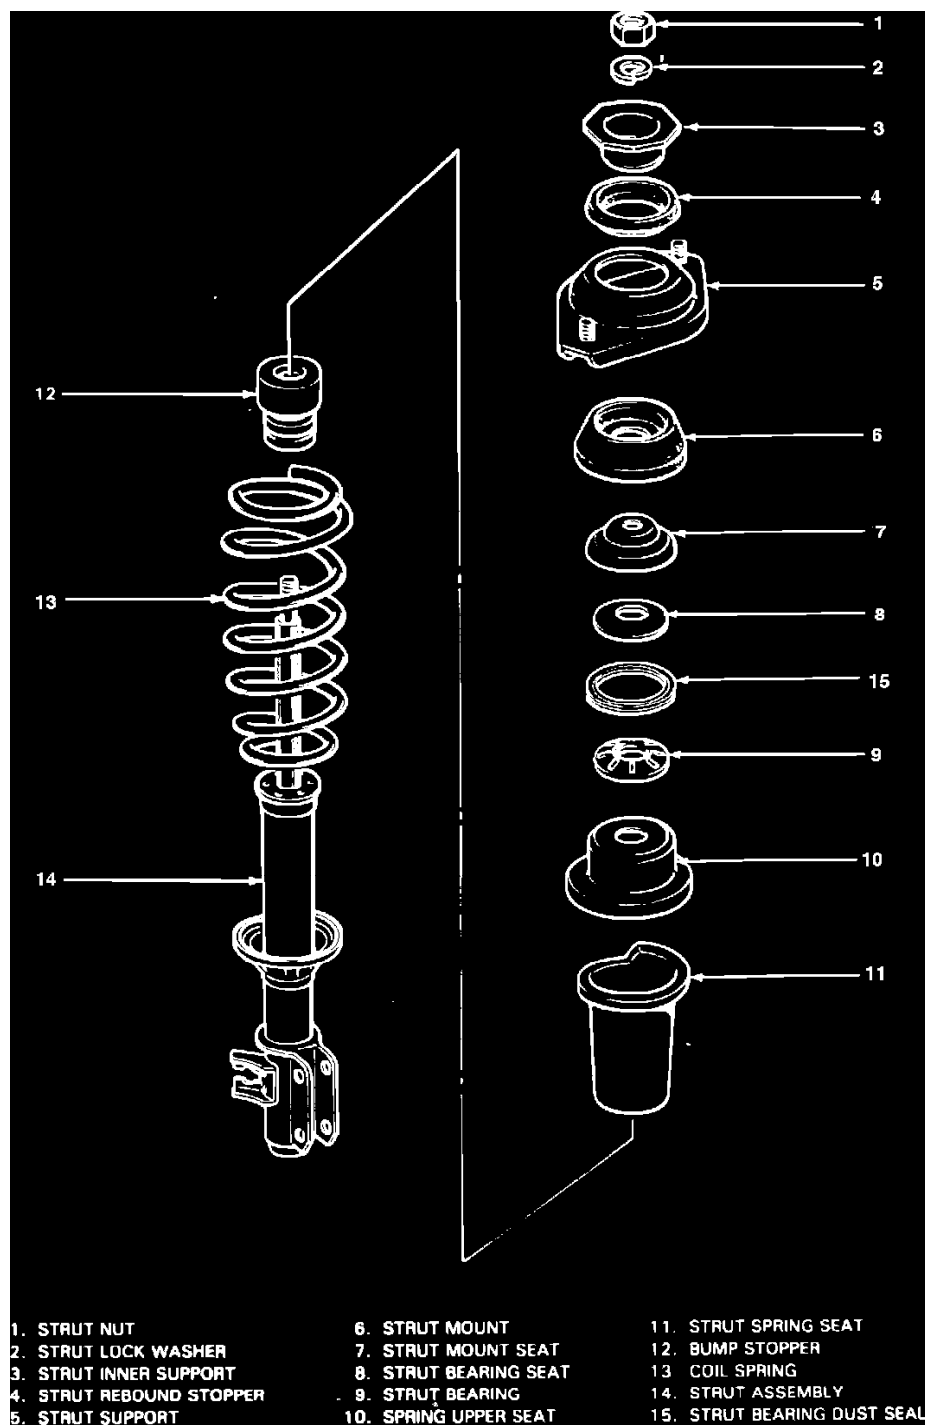
**Fig. 2 MacPherson strut assembly exploded view**

1. Mount strut in suitable spring compressor.
2. Compress spring to about 1/2 its height. Do not bottom spring.
3. Remove nut from strut shaft and remove components, **Fig. 2**.
4. Reverse procedure to assemble. Compress spring so strut shaft protrudes through cap by about 1 inch. Torque nut to 29 ft. lbs.

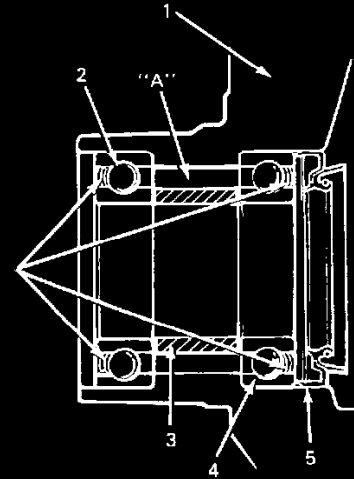
Before installing wheel bearings, apply wheel bearing lithic grease to balls and oil seal lips of wheel bearings. Also fill it in the clearance outside spacer (shown as "A" in figure) with 40% amount of the clearance capacity.

1. KNUCKLE
2. OUTER BEARING
3. SPACER
4. INNER BEARING
5. SEAL

The bearings own internal seal should be installed facing outward as shown.

**NOTE:** Spacer must be snug and centered between inner and outer bearings.

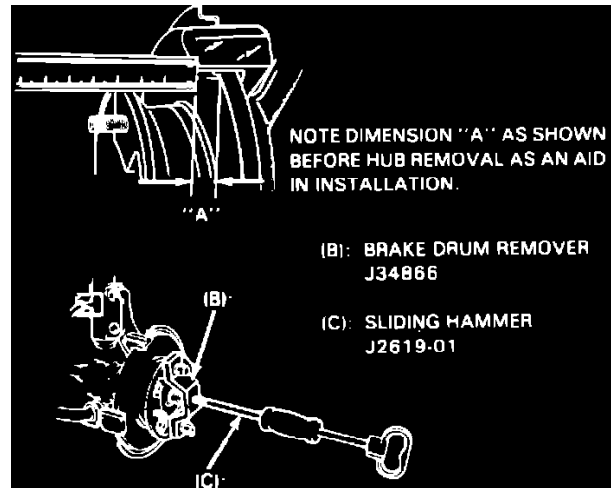
Fig. 5 Checking dimension "A" to assure proper installation of hub

1. Raise and support vehicle and remove front wheel.
2. Remove cotter pin and driveshaft castle nut.
3. Remove caliper bolts and caliper. Hang caliper aside.
4. Refer to **Fig. 5**, and measure dimension A for assembly reference. Pull hub out of knuckle.

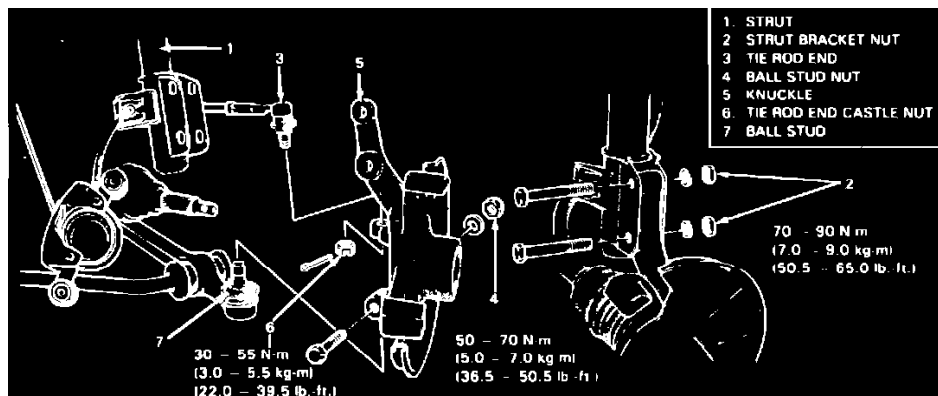
Fig. 6 Removing steering knuckle

5. Disconnect tie rod end from knuckle with tool J-21687-02 or equivalent.
6. Remove strut to knuckle bolts and then ball joint stud pinch bolt, **Fig. 6**.
7. Remove knuckle.
8. Using suitable drift, remove outer, then inner bearing from knuckle.

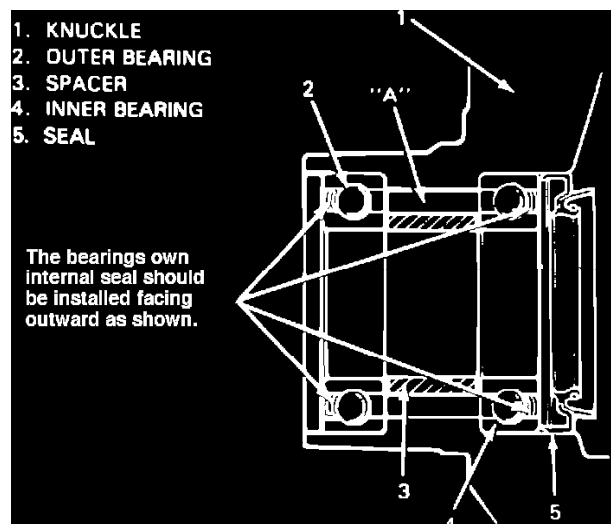
Fig. 7 Steering knuckle hub bearings and seal

9. Apply suitable grease to balls and oil seal lips of wheel bearings. Fill area A, **Fig. 7**, with grease.
10. Install wheel bearings using bearing installer J-34856 or equivalent.
11. Install wheel bearing seal 5, **Fig. 7**, using tool J-34881 or equivalent.

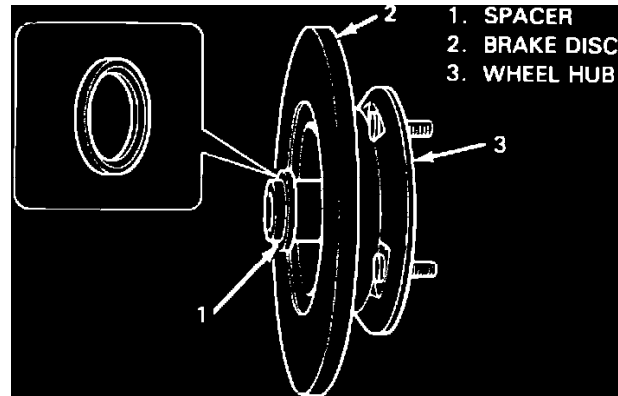
**Fig. 8 Installing spacer on wheel hub**

12. Install spacer on hub with bevel side first, **Fig. 8**.
13. Check that wheel bearing spacer bore is aligned with bearing bores. If not, move spacer until aligned.
14. Using plastic hammer, tap hub lightly into knuckle, taking care that hub does not cock.
15. Using installing tool J-34856 or J-7079-2 or equivalent, drive hub until dimension A, noted in step 4, is obtained.
16. Install brake pad and caliper.
17. Torque caliper bolts to 17.5-26 ft. lbs.
18. Torque drive shaft castle nut to 108.5-195 ft. lbs.
19. Install cotter pin.
20. Install wheel and lower vehicle.
