Vehicle: Application and ID

## Engine: Service and Repair

## Camshaft: Service and Repair

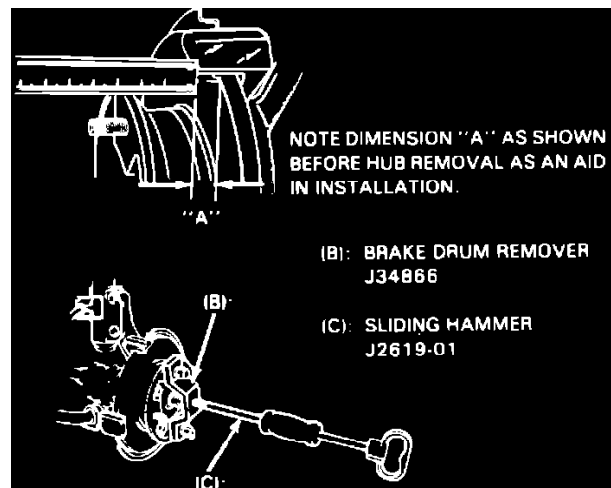
**Fig. 5** Checking dimension "A" to assure proper installation of hub

1. Raise and support vehicle and remove front wheel.
2. Remove cotter pin and driveshaft castle nut.
3. Remove caliper bolts and caliper. Hang caliper aside.
4. Refer to **Fig. 5**, and measure dimension A for assembly reference. Pull hub out of knuckle.

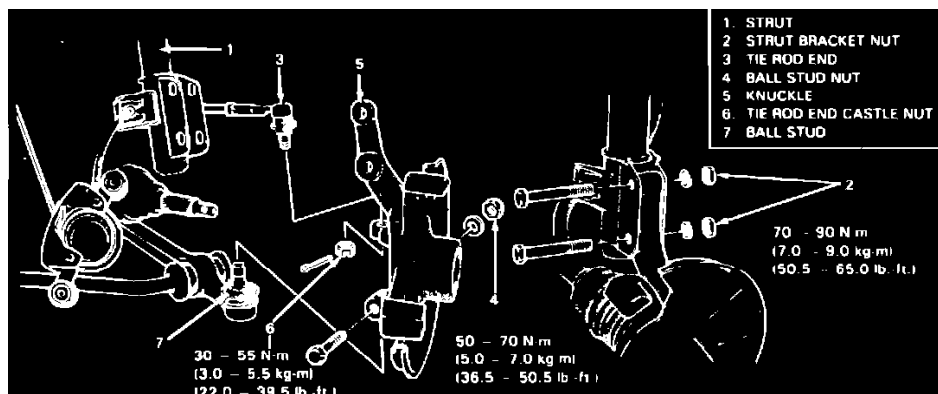
**Fig. 6** Removing steering knuckle

5. Disconnect tie rod end from knuckle with tool J-21687-02 or equivalent.
6. Remove strut to knuckle bolts and then ball joint stud pinch bolt, **Fig. 6**.
7. Remove knuckle.
8. Using suitable drift, remove outer, then inner bearing from knuckle.

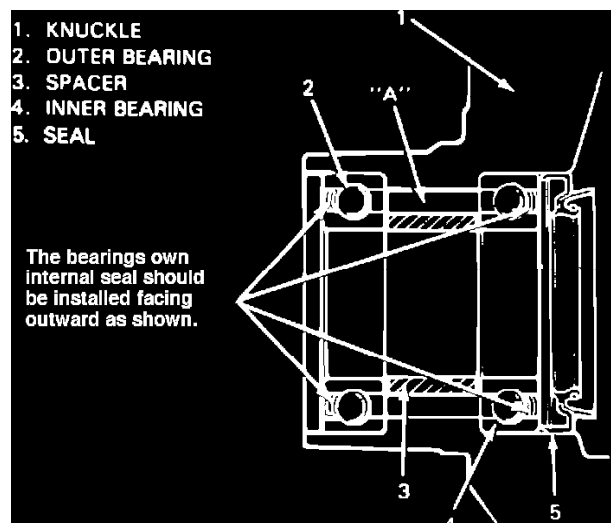
**Fig. 7** Steering knuckle hub bearings and seal

9. Apply suitable grease to balls and oil seal lips of wheel bearings. Fill area A, **Fig. 7**, with grease.

10. Install wheel bearings using bearing installer J-34856 or equivalent.
11. Install wheel bearing seal 5, **Fig. 7**, using tool J-34881 or equivalent.

9. Apply suitable grease to balls and oil seal lips of wheel bearings. Fill area A, **Fig. 7**, with grease.
10. Install wheel bearings using bearing installer J-34856 or equivalent.
11. Install wheel bearing seal 5, **Fig. 7**, using tool J-34881 or equivalent.

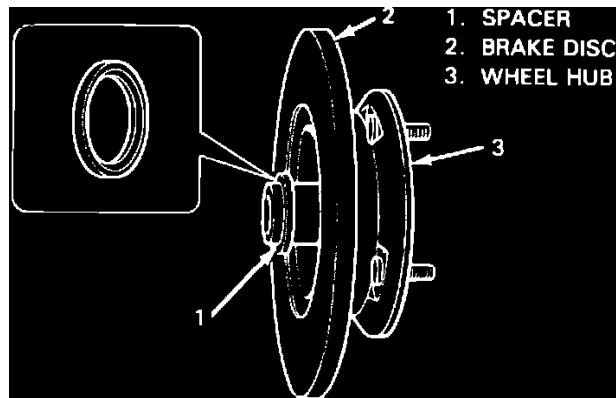
**Fig. 8 Installing spacer on wheel hub**

12. Install spacer on hub with bevel side first, **Fig. 8**.
13. Check that wheel bearing spacer bore is aligned with bearing bores. If not, move spacer until aligned.
14. Using plastic hammer, tap hub lightly into knuckle, taking care that hub does not cock.
15. Using installing tool J-34856 or J-7079-2 or equivalent, drive hub until dimension A, noted in step 4, is obtained.
16. Install brake pad and caliper.
17. Torque caliper bolts to 17.5-26 ft. lbs.
18. Torque drive shaft castle nut to 108.5-195 ft. lbs.
19. Install cotter pin.
20. Install wheel and lower vehicle.

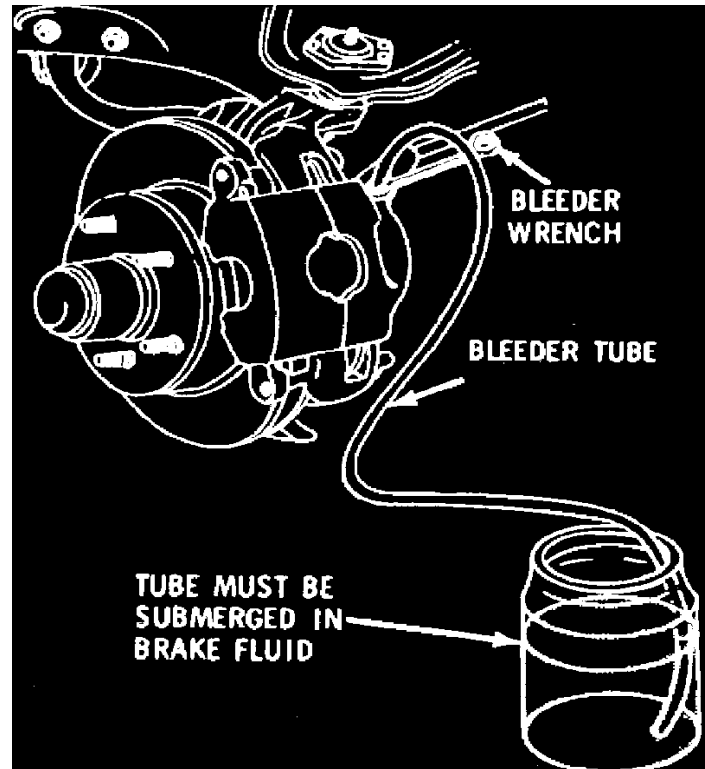
**Fig. 27 Flushing Hydraulic System**

Flushing is performed at each wheel in the same manner as the bleeding operation except that the bleeder valve is opened 1-1/2 turns and the fluid is forced through the lines and bleeder valve until it emerges clear in color. Approximately one quart of clean brake fluid is required to flush the hydraulic system. After completing the flushing operation at all bleeder valves, check to ensure the master cylinder is filled to the proper level.

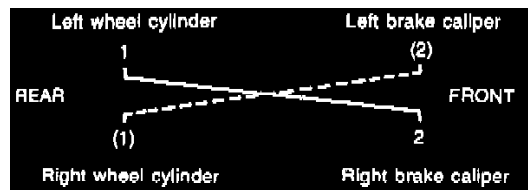
#### Bleeding Sequence

**NOTE:** Perform bleeding operation starting with wheel cylinder farthest from master cylinder and then at front caliper of the same brake line. Do the same on the other brake line.

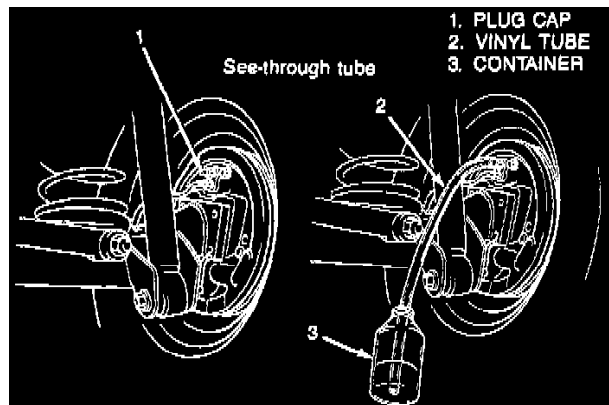
#### Attaching Bleeder Tube

- Remove bleeder plug cap.
- Attach a vinyl tube to the bleeder plug of wheel cylinder, and insert the other end into a container.

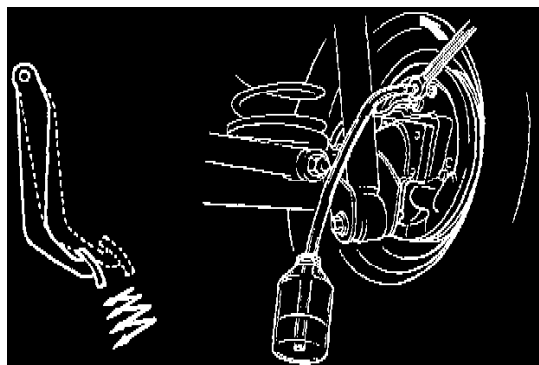
#### Depressing Brake Pedal/Bleeding Fluid

- Depress brake pedal several times, and then while holding it depressed, loosen bleeder plug about one third to one-half turn.

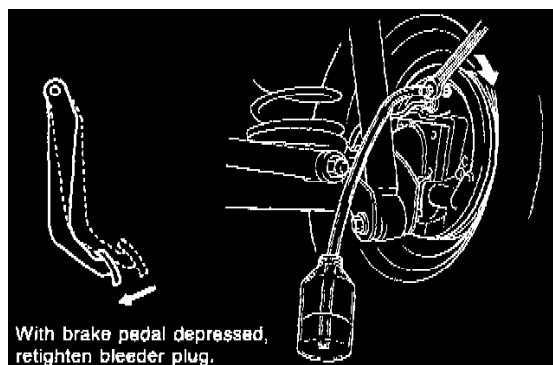
#### Tightening Bleeder Plug

- When the fluid pressure in the cylinder is almost depleted, retighten the bleeder plug.
- Repeat this operation until there are no more air bubbles in hydraulic line.

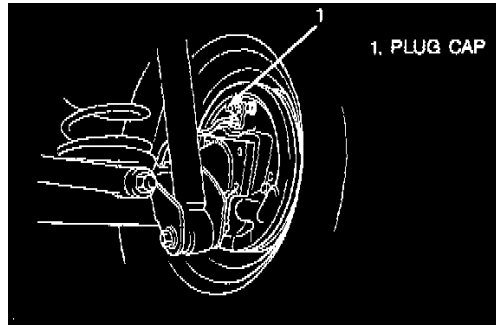
#### **Attaching Bleeder Plug Cap**

7. When bubbles stop, depress and hold brake pedal and tighten bleeder plug then attach bleeder plug cap.
8. After completing bleeding operation, apply fluid pressure to pipe line and check for leakage.

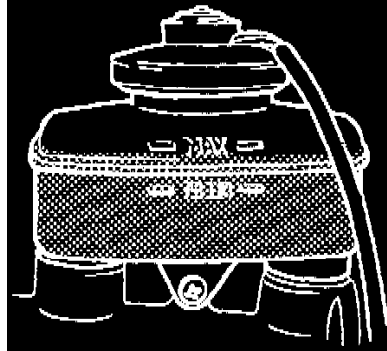
#### **Replenishing Fluid To Specified Level**

9. Replenish the fluid in the reservoir to specified level and check brake pedal for "sponginess". If found spongy, repeat entire procedure of bleeding.

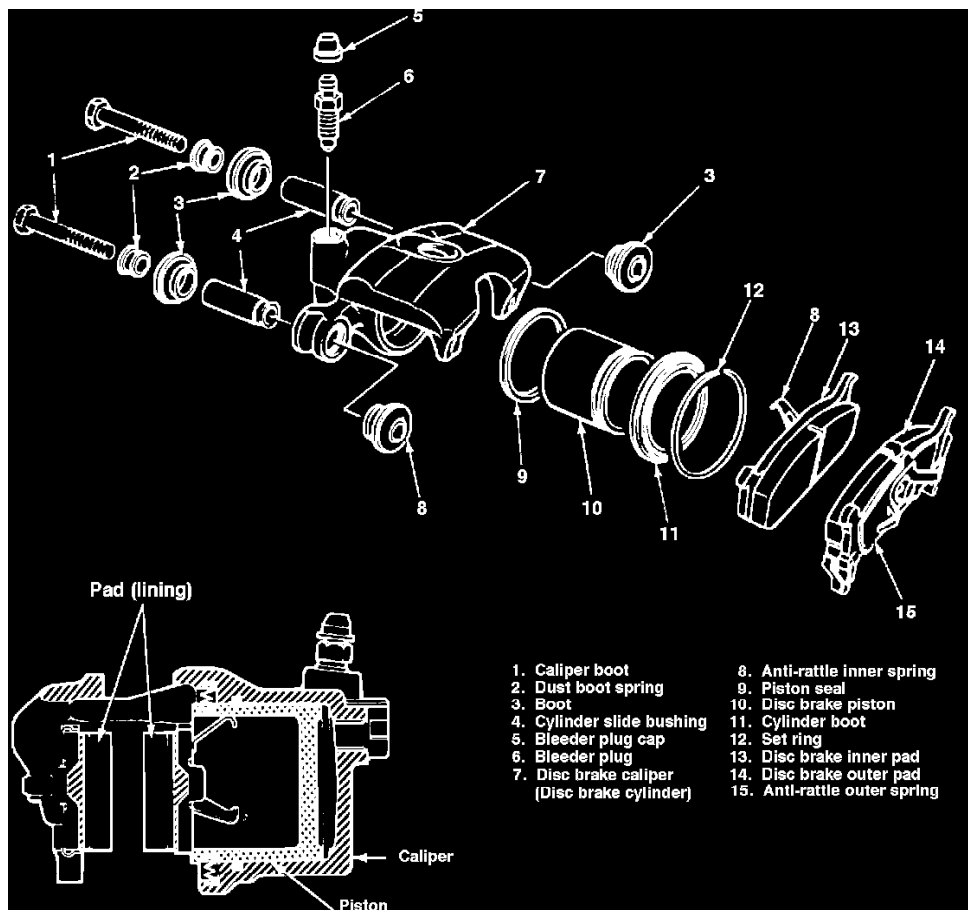
Fig. 7 Disassembled view of brake caliper

1. Raise and support vehicle.
2. Disconnect brake hose from caliper.
3. Remove caliper mounting bolts.
4. Remove caliper from knuckle.
5. Clean caliper with brake fluid.
6. Remove cylinder boot set ring and boot from cylinder groove, **Fig. 7**.
7. Using compressed air, remove brake cylinder. Keep fingers away from piston.
8. Remove piston seal, taking care not to damage cylinder bore.
9. Install new piston seal in cylinder.

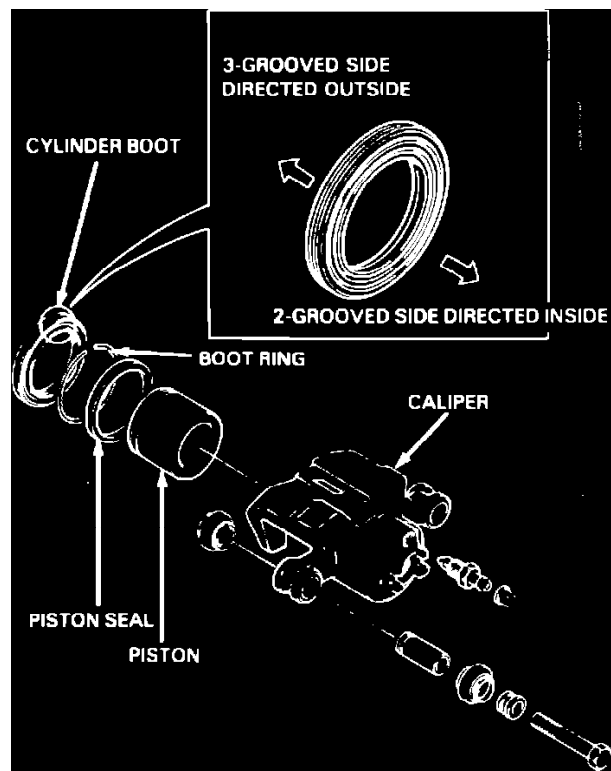
**Fig. 8 Installing caliper boot**

10. Install new boot on piston so side with 2 grooves faces in toward cylinder and side with 3 grooves faces out, **Fig. 8**.
11. Install piston in caliper so it projects about .4 inch to ease installation. Install boot set ring.
12. Check that caliper slide bushings are lubricated with rubber grease. Check that slide bushing in each carrier hole can be moved smoothly in each direction.
13. Install caliper and inside pad on knuckle.
14. Tighten caliper bolts.
15. Connect brake hose.
16. Install wheel.
17. Lower vehicle and test brakes.

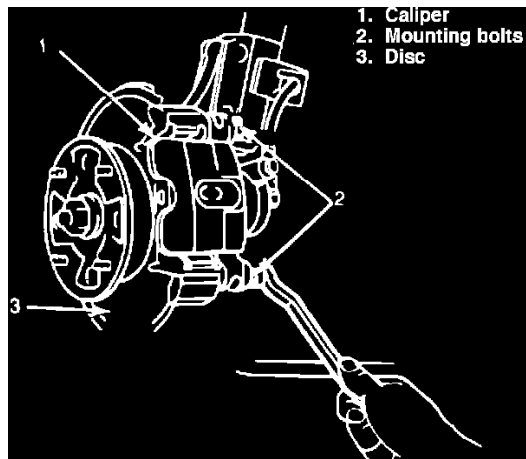
**Fig. 4 Removing caliper mounting bolts**

1. Raise and support vehicle and remove wheel.
2. Remove caliper mounting bolts, **Fig. 4**.
3. Remove caliper from knuckle, taking care not to drop inside pad. Hang caliper aside.
4. Remove outside pad.

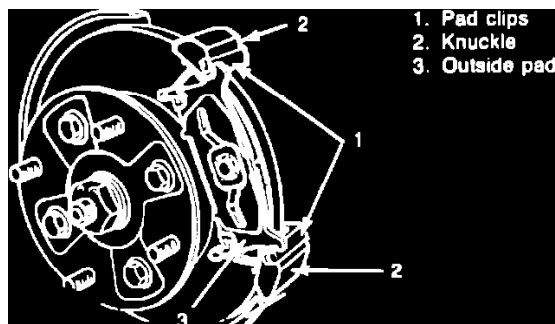
**Fig. 5 Installing outside pad**

5. Install caliper and inside pad to knuckle, **Fig. 5**.

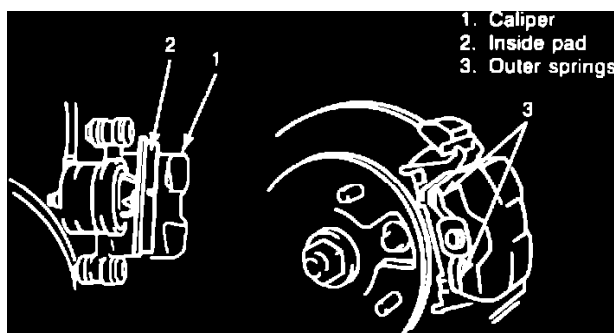
**Fig. 6 Installing inside pad & caliper**

6. Install caliper and inside pad to knuckle, **Fig. 6**. Position outer springs over caliper as shown.
7. Torque caliper bolts to 17.5-26 ft. lbs.
8. Install front wheel.
9. Lower vehicle and perform brake test.

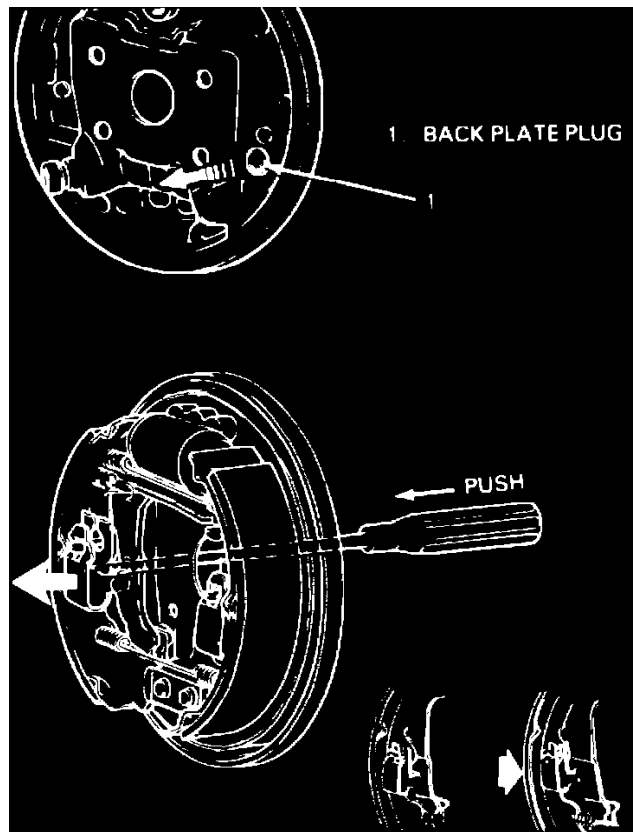
**Fig. 2 Removing backing plate plug**

1. Raise and support vehicle.
2. Remove spindle cap by hammering lightly at 3 points around cap.
3. Remove cotter pin, castle nut and washer.
4. Loosen parking brake cable adjusting nuts.
5. Remove backing plate plug, **Fig. 2**.
6. Insert screwdriver into plug hole and push in direction shown. This pushes hold down spring up and releases parking brake shoe lever from hold down spring, resulting in added clearance between shoe and drum.
7. Using slide hammer J-2619-01 and brake drum remover J-34866, pull off brake drum.

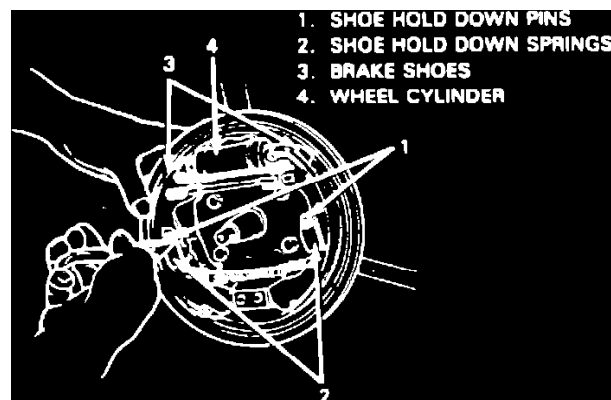
**Fig. 3 Removing brake lining hold down springs**

8. Remove brake shoe hold down springs by turning shoe hold down springs, **Fig. 3**.
9. Disconnect parking brake cable from parking brake shoe lever and remove brake shoes.

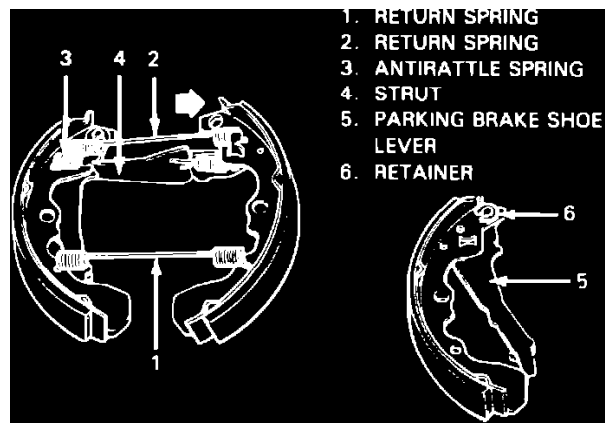
**Fig. 4 Brake shoe return spring identification**

10. Remove spring 1 in **Fig. 4**, pull primary shoe in direction of arrow and disengage strut 4 and return spring 2.
11. Disconnect return spring 3 from shoe.
12. Disconnect parking brake shoe lever from shoe.
13. Remove bleeder screw from wheel cylinder.
14. Slightly loosen brake line flare nut.
15. Remove wheel cylinder mounting bolts. Disconnect brake line from wheel cylinder and put bleeder cap plug onto brake line to prevent brake fluid spillage.
16. Install new gasket on wheel cylinder. Remove bleed cap plug from brake line and connect line to wheel cylinder. Do not final tighten.
17. Torque wheel cylinder mounting bolts to 7.5-9 ft. lbs.
18. Torque brake line flare nut to 10.5-13 ft. lbs.
19. Install bleeder cap plug on bleeder.

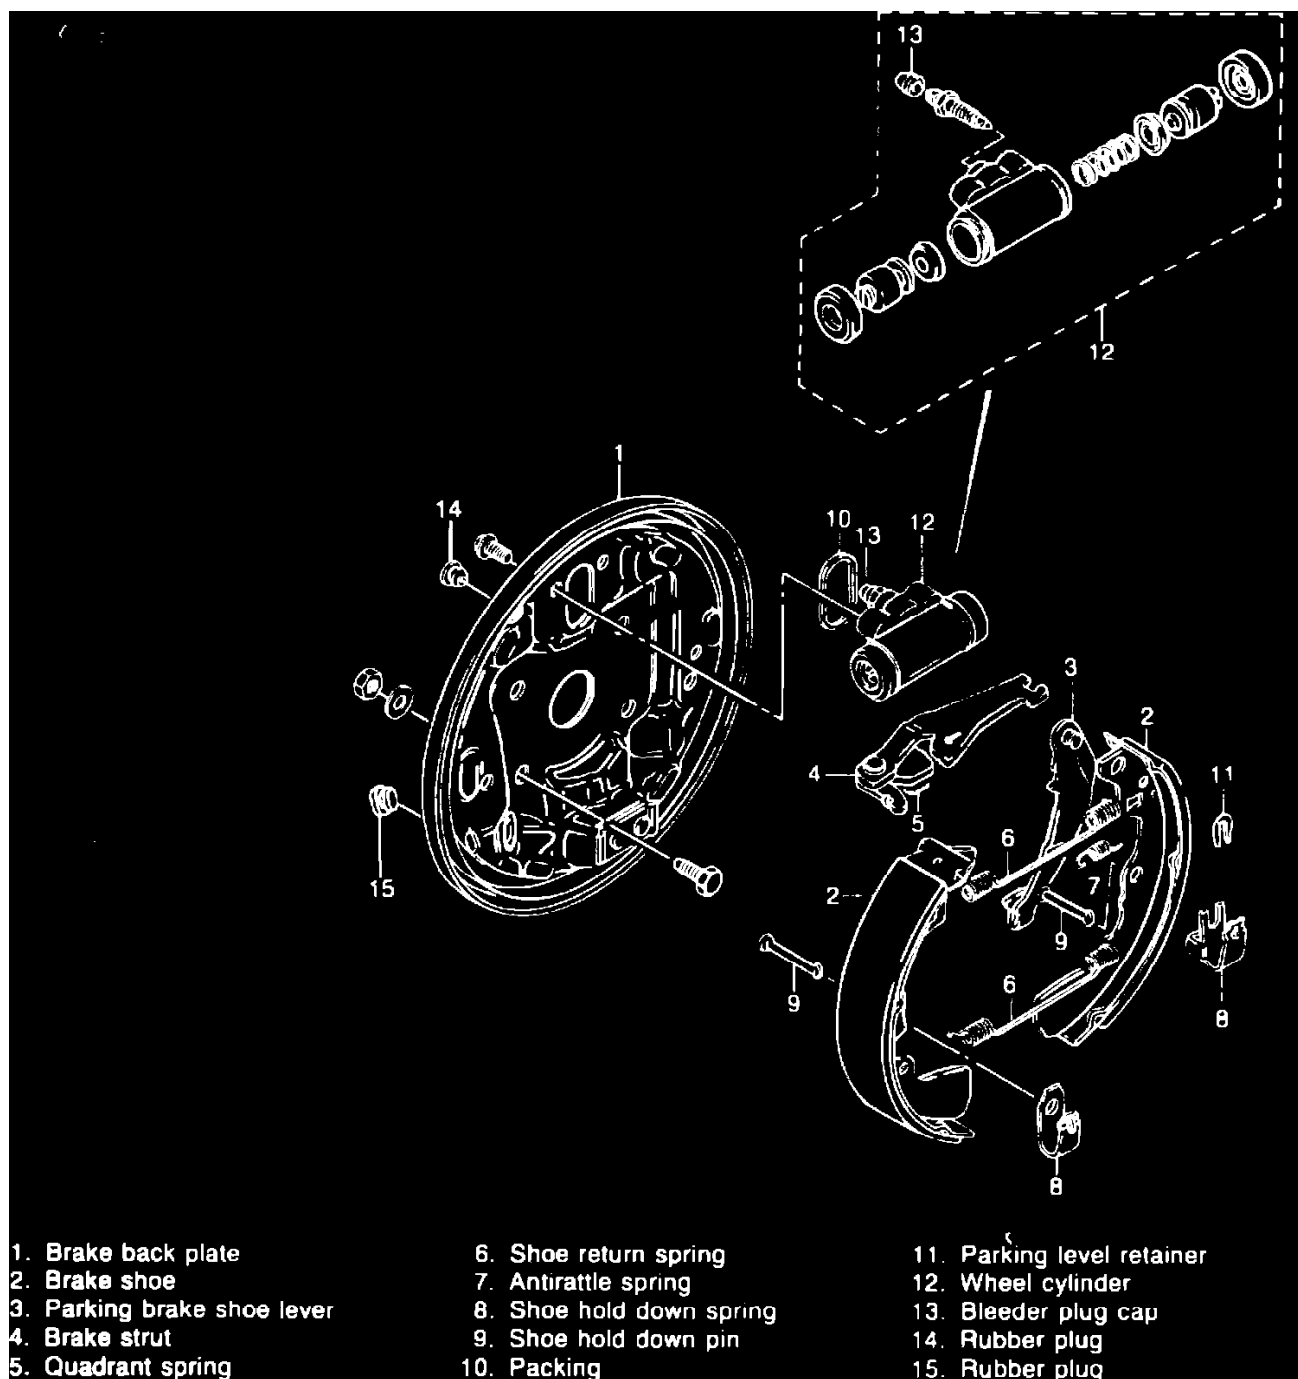
Fig. 5 Assembling rear brake unit

20. Assemble brake shoes, levers and springs as shown in Fig. 5.  
21. Push shoe hold down springs down into place. Turn hold down pins to engage springs.

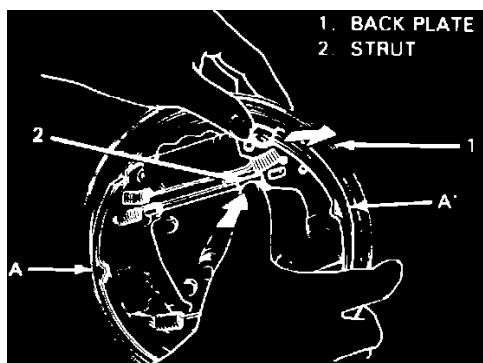
Fig. 6 Brake lining installation

22. To minimize dimension 'A-A,' Fig. 6, push strut towards backplate while pushing out on shoe as shown.  
23. Position tab of spring clip behind parking lever.  
24. Install brake drum and torque castle nut to 58-86.5 ft. lbs. Install cotter pin.

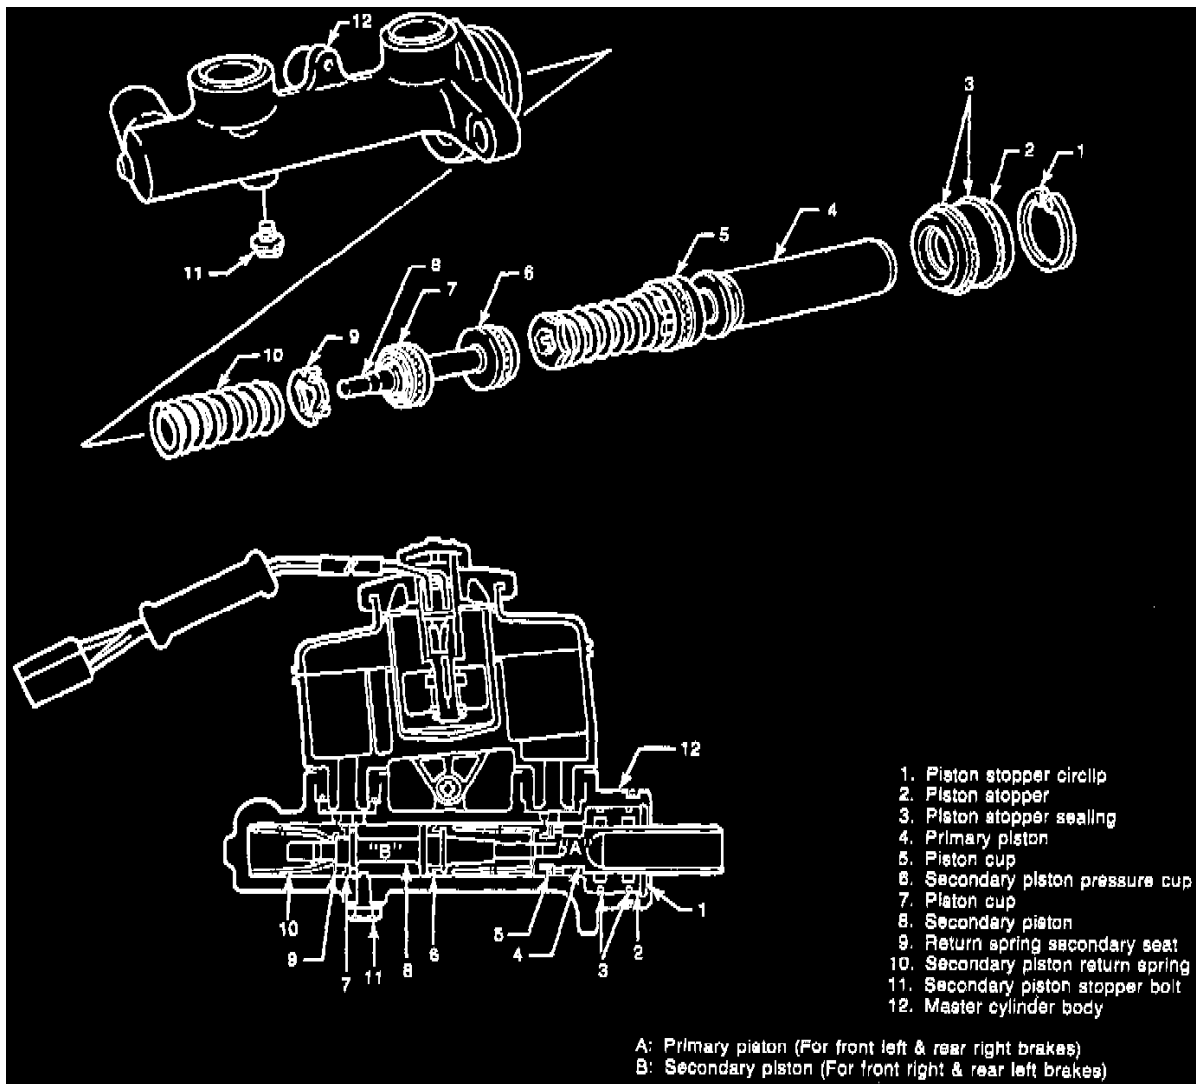
**Exploded View Of Master Cylinder Assembly**

This master cylinder is designed for use in a diagonal split system (one front and one rear brake served by the primary piston, and the opposite front and rear brakes served by the secondary piston).

The tandem master cylinder is similar in construction to an ordinary master cylinder, the principal differences being that it has two pistons and three cups and that hydraulic pressure is developed in two chambers, one for front left & rear right brakes and the other for front right & rear left brakes.

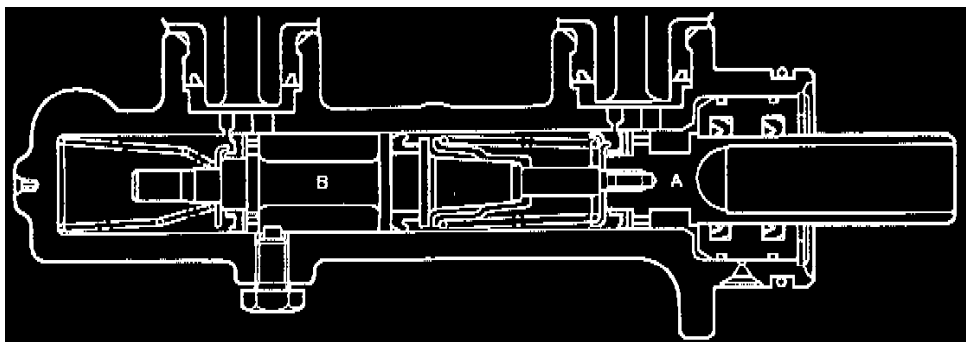
**Master Cylinder - Normal Operation**

Depressing the brake pedal forces primary piston "A" toward the left (in Figure) to pressurize the fluid immediately ahead for front left & rear right brakes. By this pressure and by the force of return spring, secondary piston "B" moves similarly to pressurize the fluid for front right & rear left brakes.

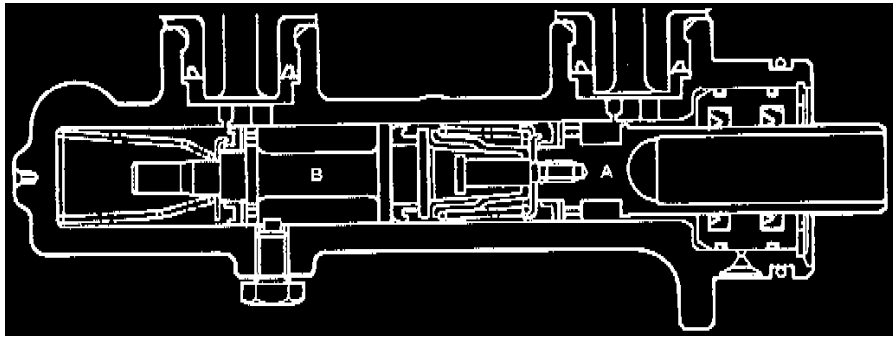
#### Master Cylinder-One Circuit Operation-Front Left & Rear Right Brakes Circuit Failure

Depressing the brake pedal causes primary piston "A" to move as above but, because the front left & rear right brakes circuit cannot hold pressure, the fluid immediately ahead of this piston does not get pressurized. Piston "A" keeps moving, compressing the spring and when it reaches the piston "B" retainer, it begins to push piston "B". From this point on, piston "B" moves to pressurize the fluid ahead and thus actuate the front right & rear left brakes.

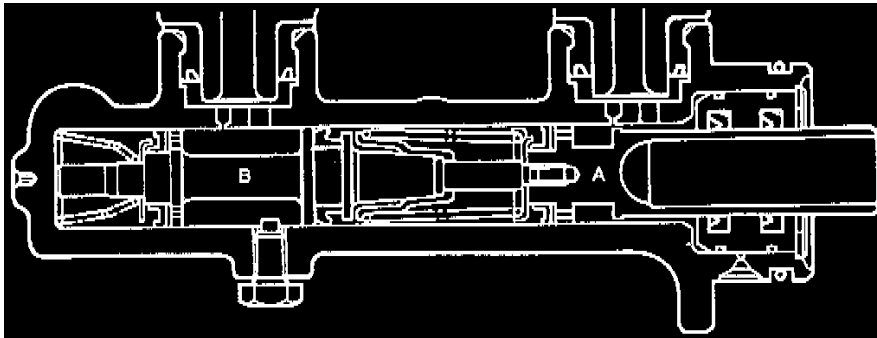
#### Master Cylinder-One Circuit Operation-Front Right & Rear Left Brakes Circuit Failure

In this case, the leftward movement of piston "A" has but little effect in pressurizing its fluid (for front left & rear right brakes) at first, because the initial rise in fluid pressure causes piston "B" to promptly yield and move toward the left. Very soon the forward end of piston "B" comes to and bears against the head of the cylinder. From this point on, the leftward movement of piston "A" becomes effective to pressurize the fluid ahead of it for the front left & rear right brakes. The below Figure shows secondary piston "B" at halt.

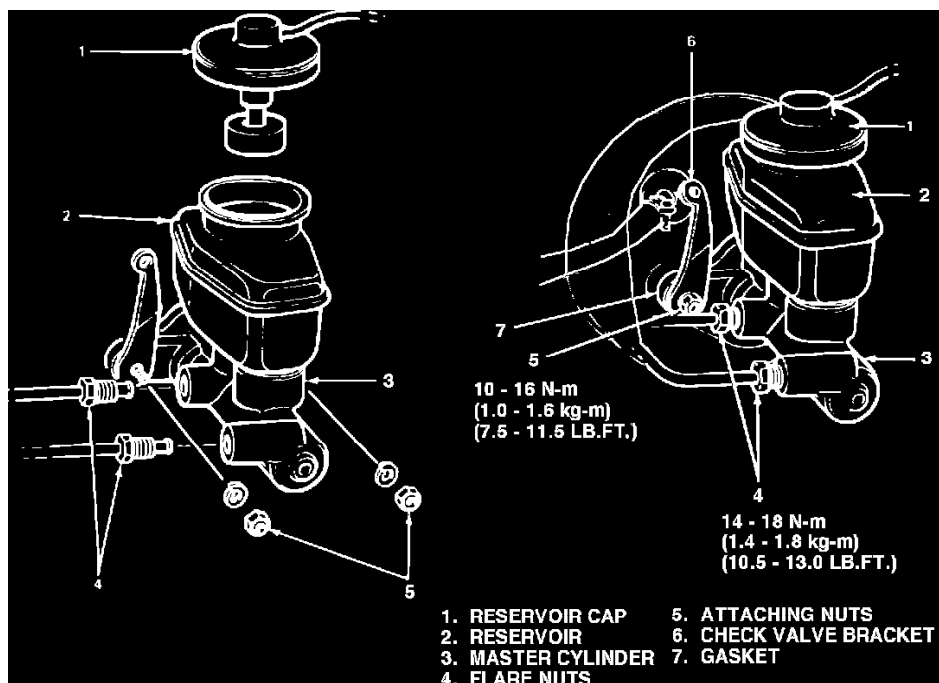
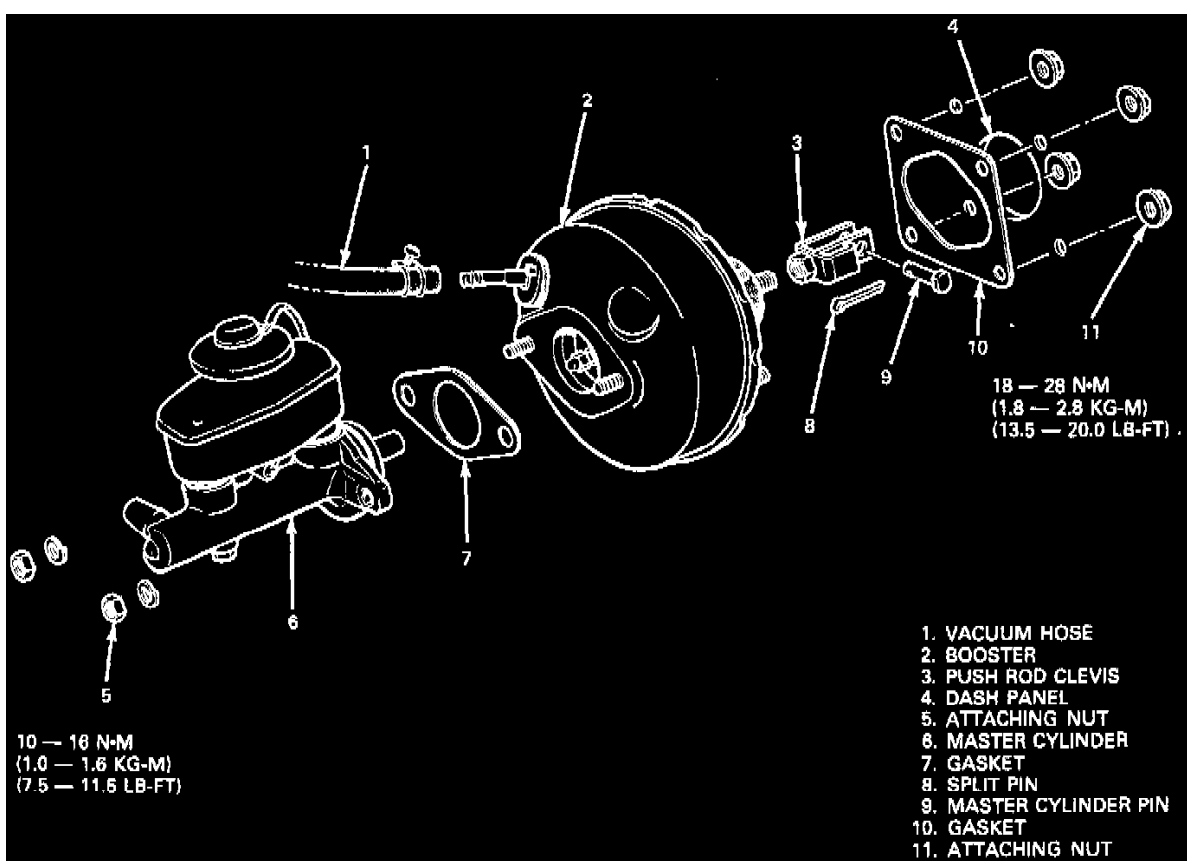
Removing/Installing Master Cylinder Assembly

1. Clean around reservoir cap and take out fluid with a syringe.
2. Disconnect two brake pipes from master cylinder.
3. Remove two attaching nuts and washers.
4. Remove master cylinder.

1. Install master cylinder as shown and torque attaching nuts to **10-16 Nm ( 7.5 - 11.5 ft. lb.)**.
2. Attach two hydraulic lines and torque flare nuts to **14-18 Nm ( 10.5 - 13.0 ft.lb.)**.
3. Fill reservoir with brake fluid.
4. Check brake pedal height.
5. Bleed brakes. **Refer to Brakes/Service and Repair/Bleeding Procedure.** See: Service and Repair

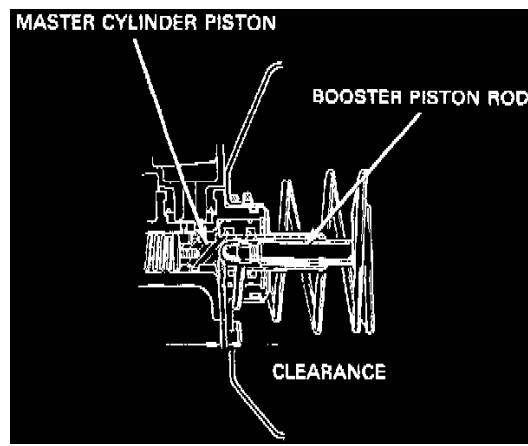
**Master Cylinder Piston To Booster Piston Rod Clearance**

5. Adjust clearance of booster piston rod to master cylinder piston as follows:

- Before measuring clearance, push piston rod several times so as to make sure reaction disc is in place.
- Take measurement with gasket installed to master cylinder.
- Keep inside of booster at atmospheric pressure for measurement.

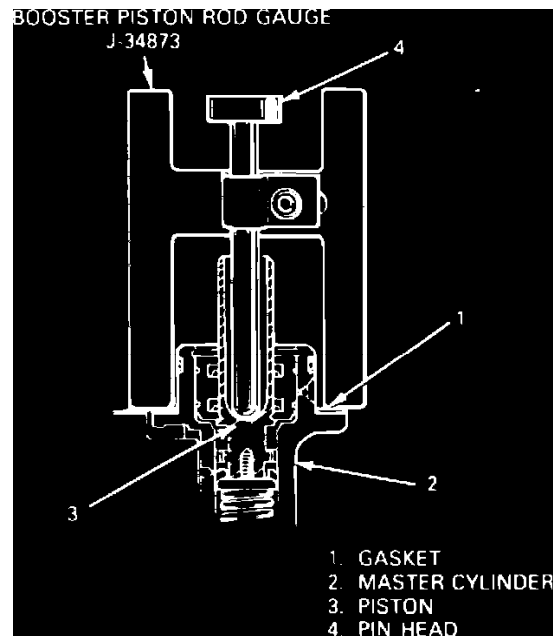
**Fig. 4 Tool J-34873 installation**

a. Set measuring tool J-34873 on master cylinder and push pin until it contacts piston.

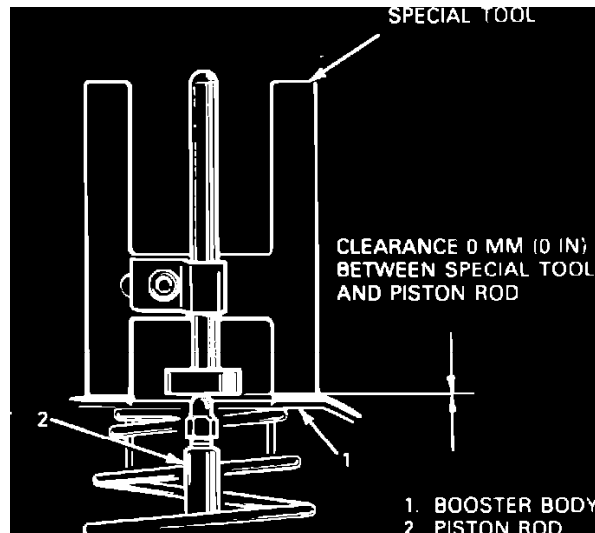
**Fig. 5 Adjusting clearance between tool and piston rod**

- b. Turn tool upside down and place on booster. Adjust booster piston rod length until rod end contacts pin head.
- c. Adjust clearance by turning adjusting bolt of piston rod.

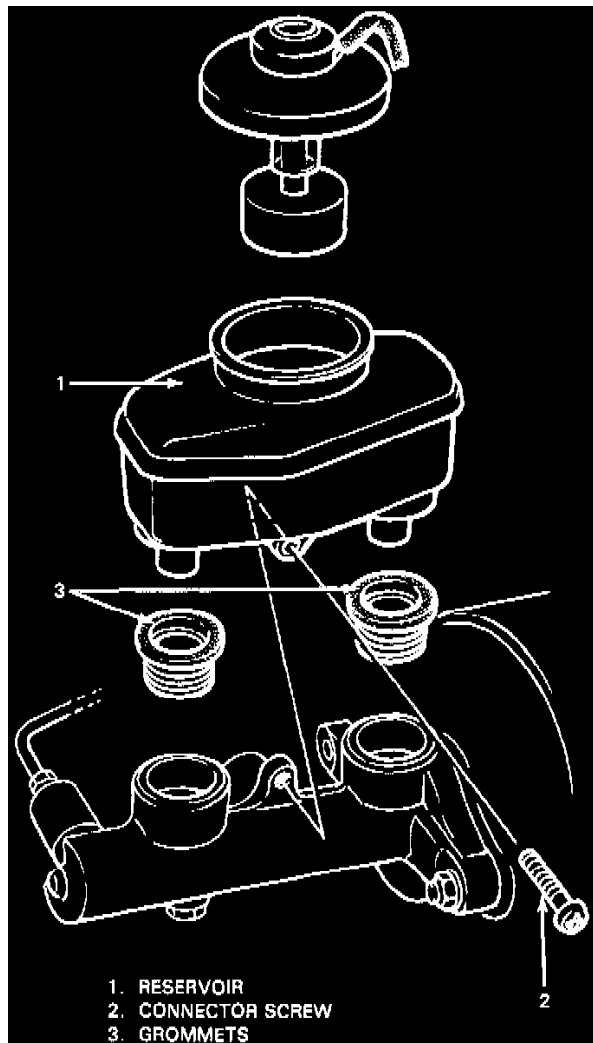
Removing Master Cylinder Reservoir

1. Clean outside of reservoir.
2. Take out fluid with a syringe.
3. Remove reservoir connector screw.
4. Remove reservoir.

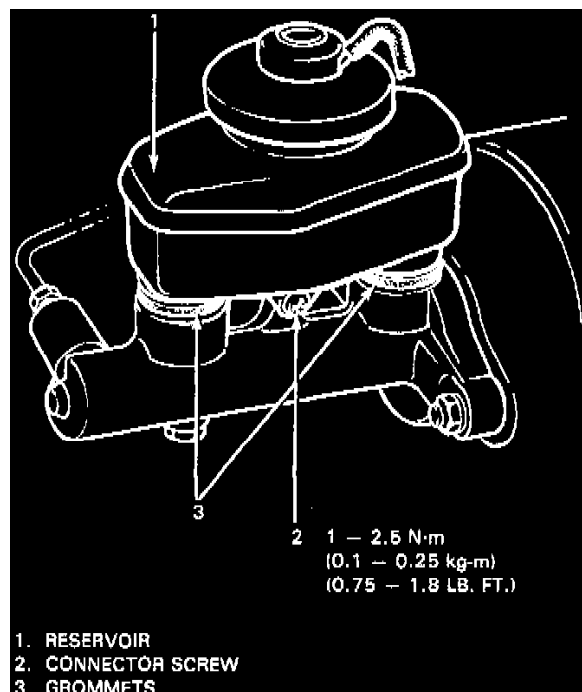
### Installing Master Cylinder Reservoir

1. When using new grommets, lubricate them with brake fluid. Then press-fit grommets to master cylinder. Grommets must be seated in place.
2. Install reservoir and tighten screw to **1-2.5 Nm (0.75-1.8 ft. lb.)**.
3. Fill reservoir with specified fluid.
4. Upon completion of installation, check for fluid leakage.

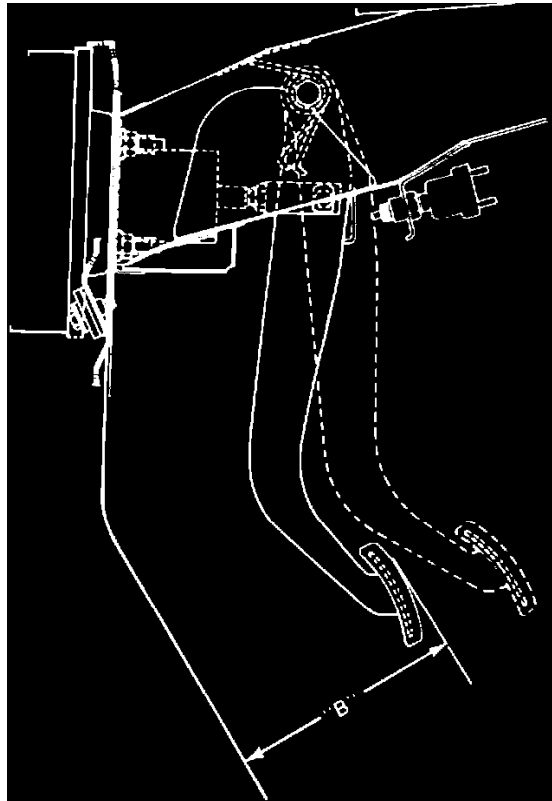
**Fig. 10** Checking brake pedal travel

1. With engine off, pump brake pedal several times to exhaust all vacuum from booster.
2. Apply about 66 lb. load to brake pedal and measure pedal arm to firewall clearance B, **Fig. 10**. Clearance must not be less than 3.35 inches.
3. Possible causes for a low pedal are:
  - a. Worn rear brake shoes.
  - b. Brake lines need bleeding.
  - c. Booster pushrod out of alignment.
  - d. Rear brake shoe adjusters malfunctioning.

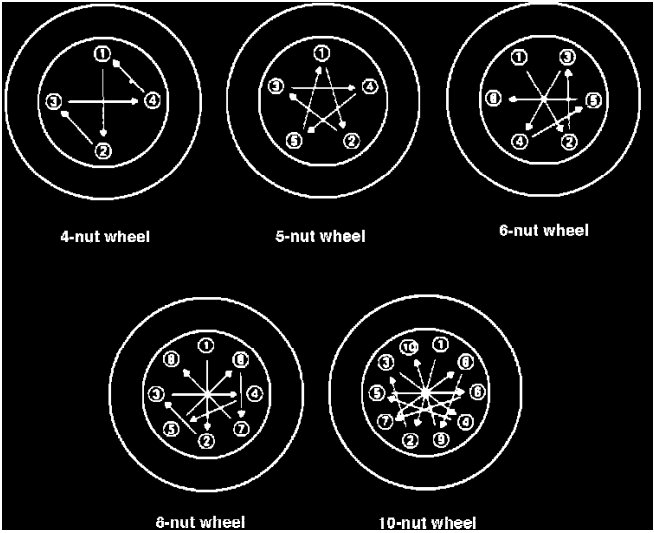
Lug Nut Torque Patterns

Check all parts, including rims, lug studs, lug nuts, and mating surfaces of hubs and tire rims for rust, damage, or dirt. Clean mating surfaces with wire brush. Tighten the fasteners a quarter turn at a time using the tightening sequence diagram as a guide. This is very important to prevent misalignment of wheels.

**CAUTION:** Improper torque or tightening sequence can cause distortion, fatigue cracks, or alignment problems. After driving the vehicle for a short distance, recheck the torque.

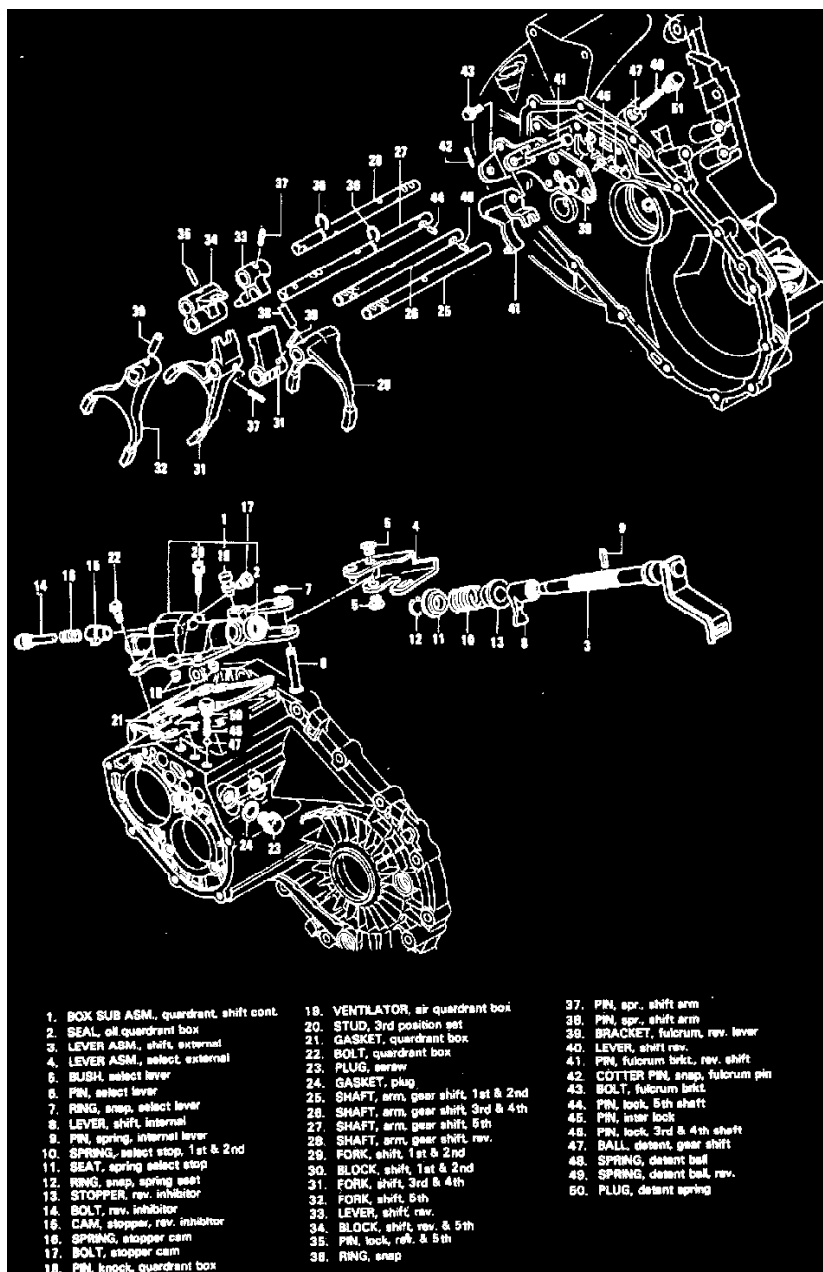
| 1. BOX SUB ASM., quadrant, shift cont. | 19. VENTILATOR, air quadrant box | 37. PIN, spr. shift arm |

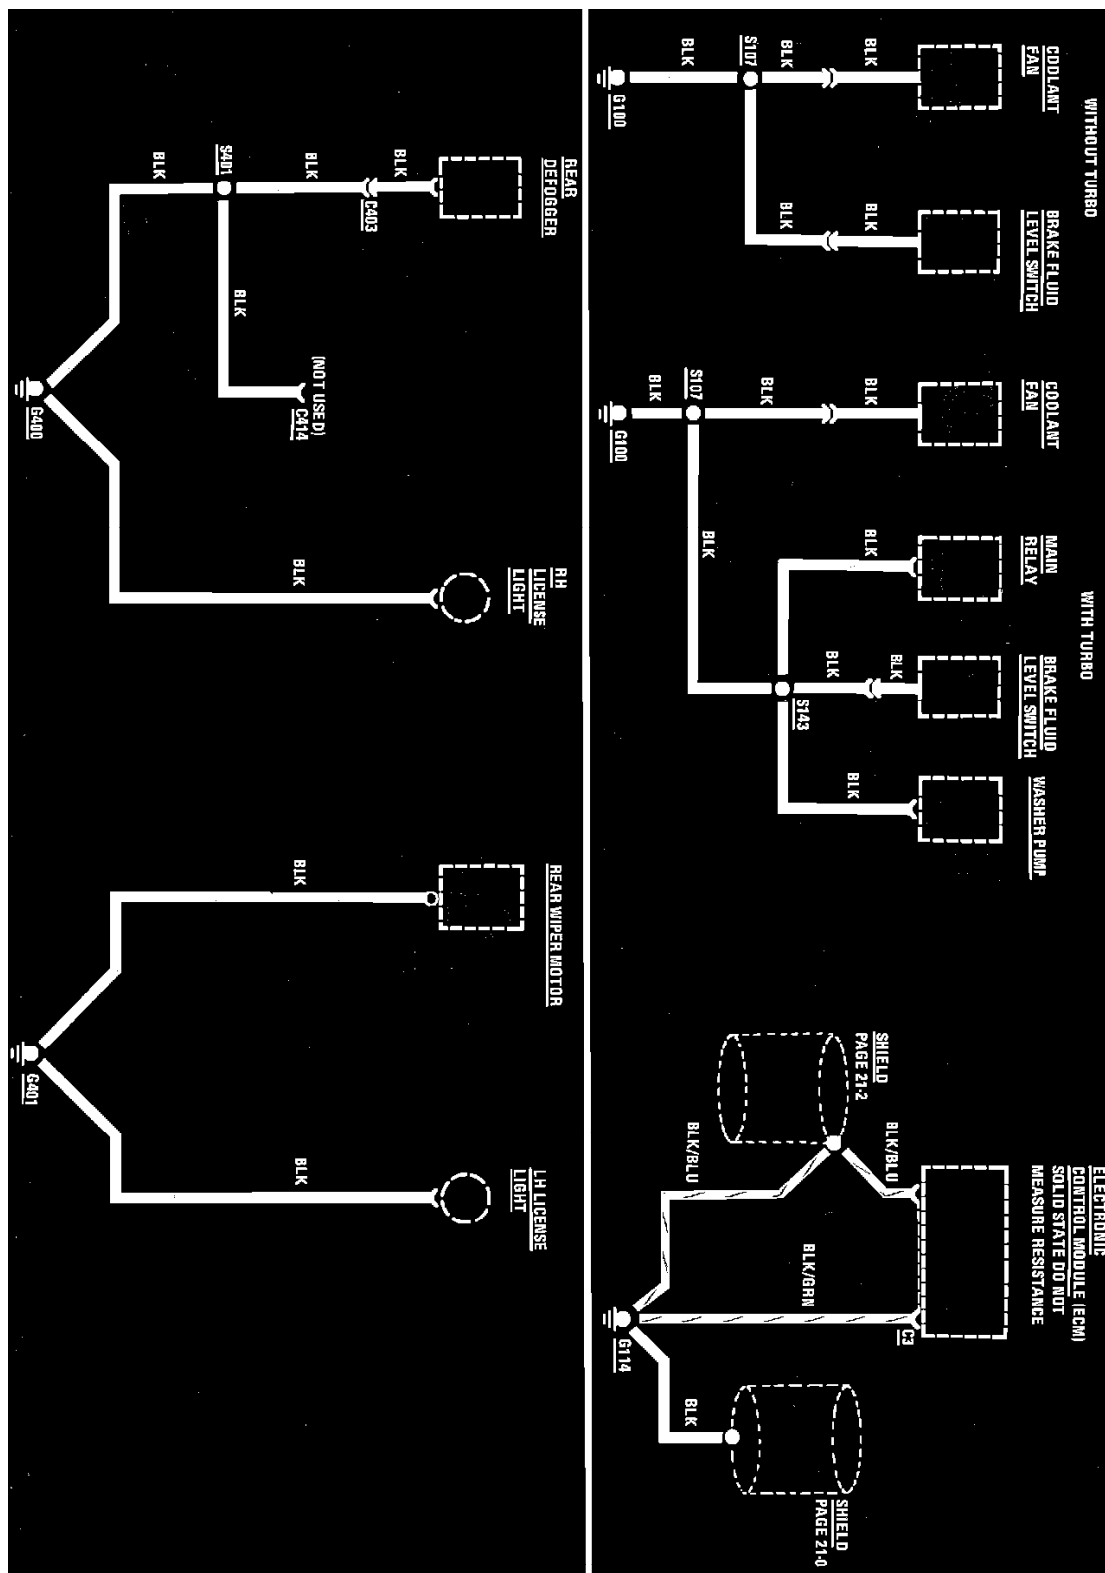
Fig. 23 Ground Distribution. G100, G114, G400 &amp; G401

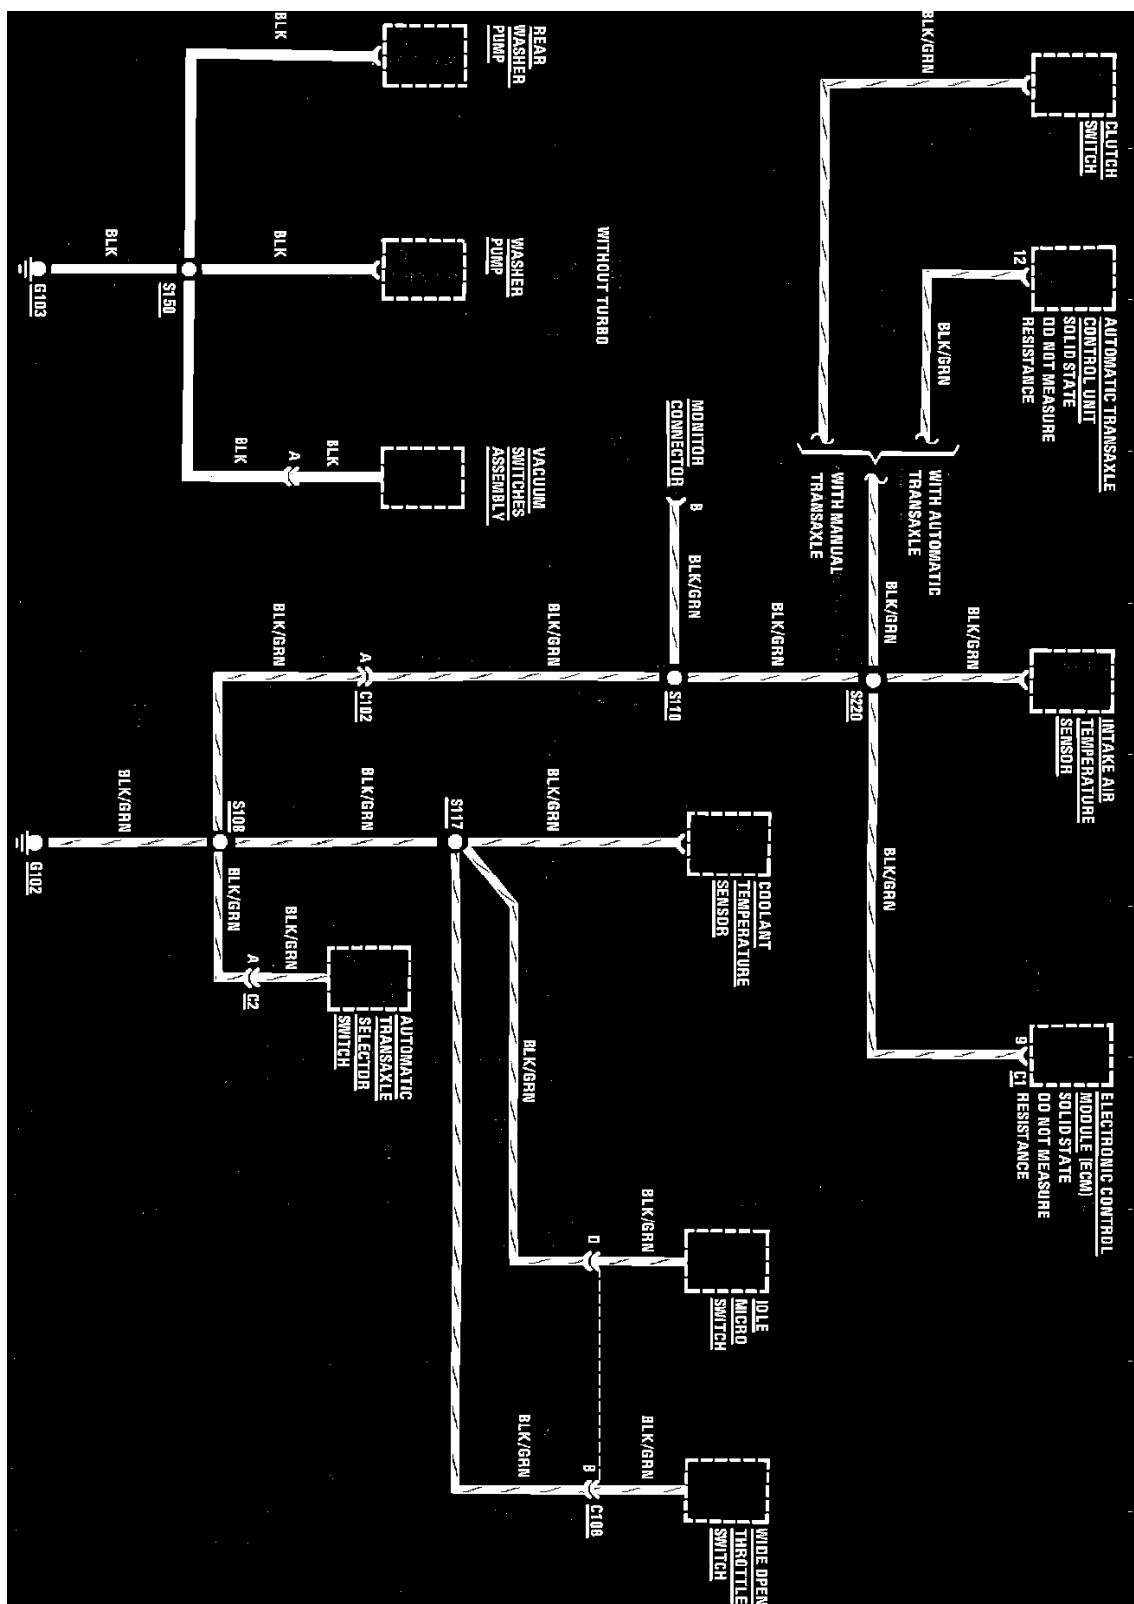
Fig. 24 Ground Distribution. G102 &amp; G103
