Vehicle: Application and ID

## Engine: Service and Repair

## Camshaft: Service and Repair

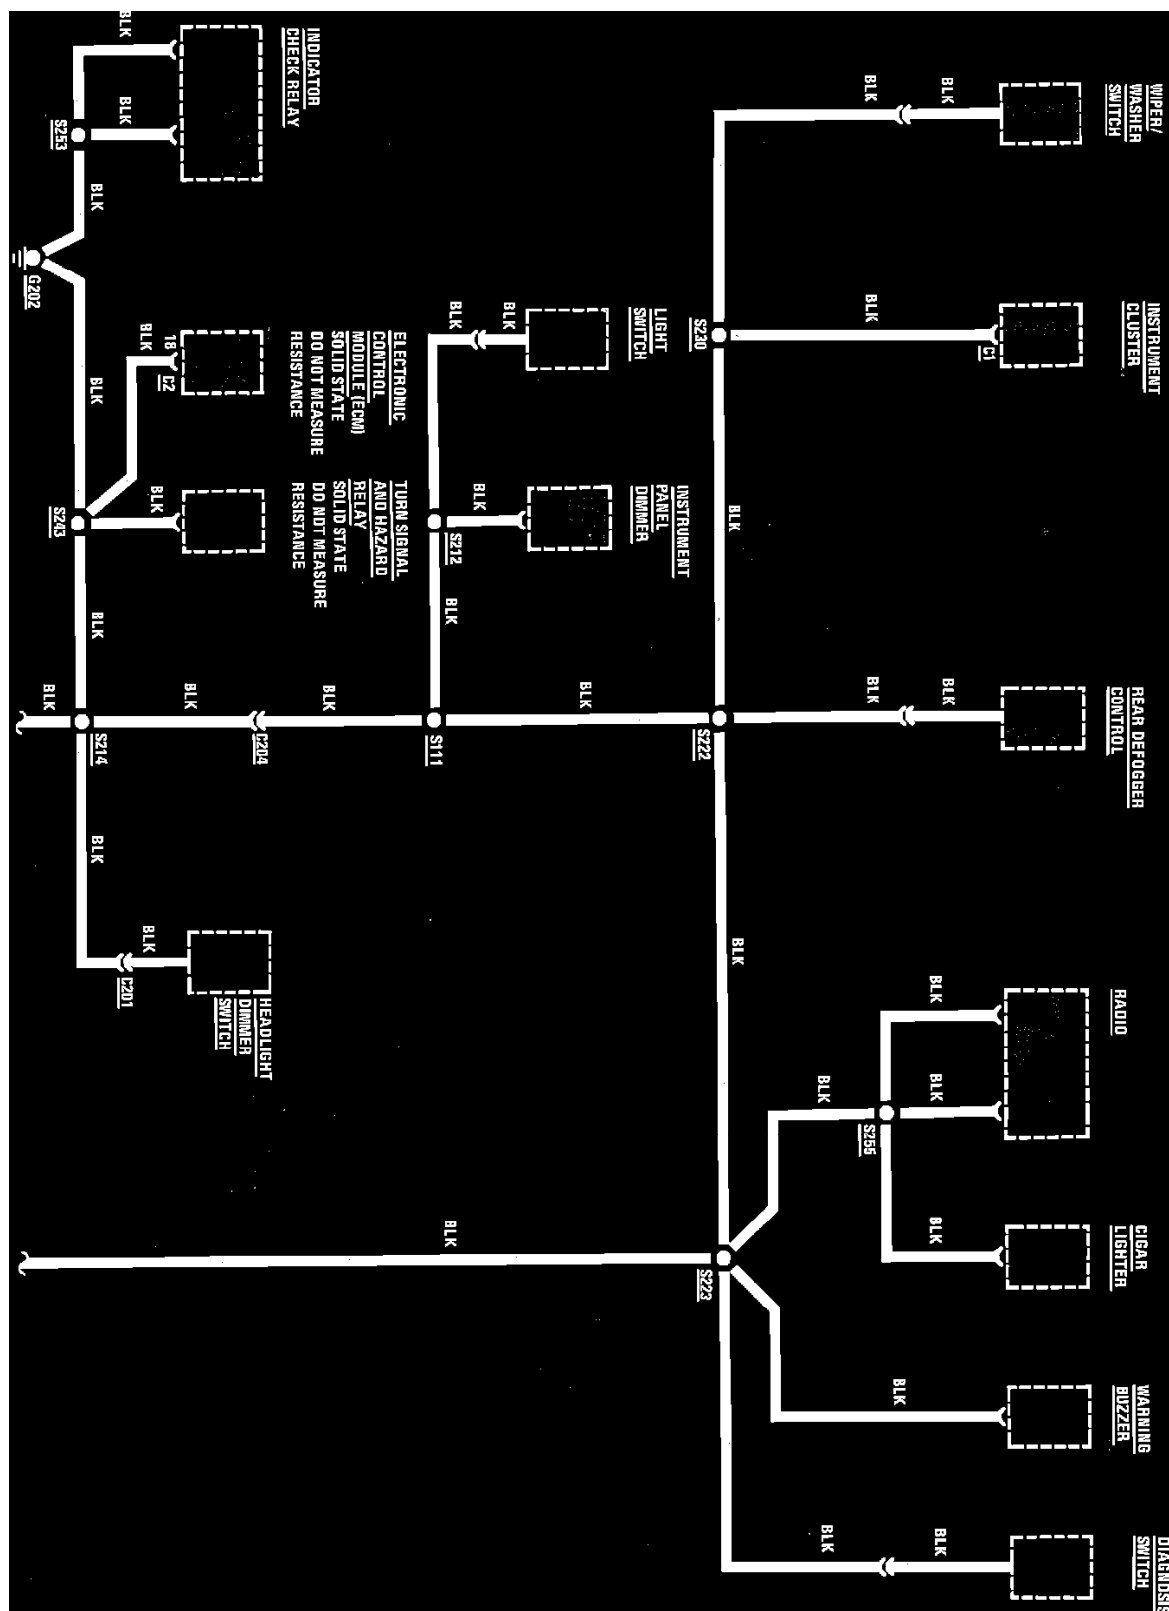
Fig. 26a Ground Distribution. (Part 1 of 2). G200, G201 &amp; G202

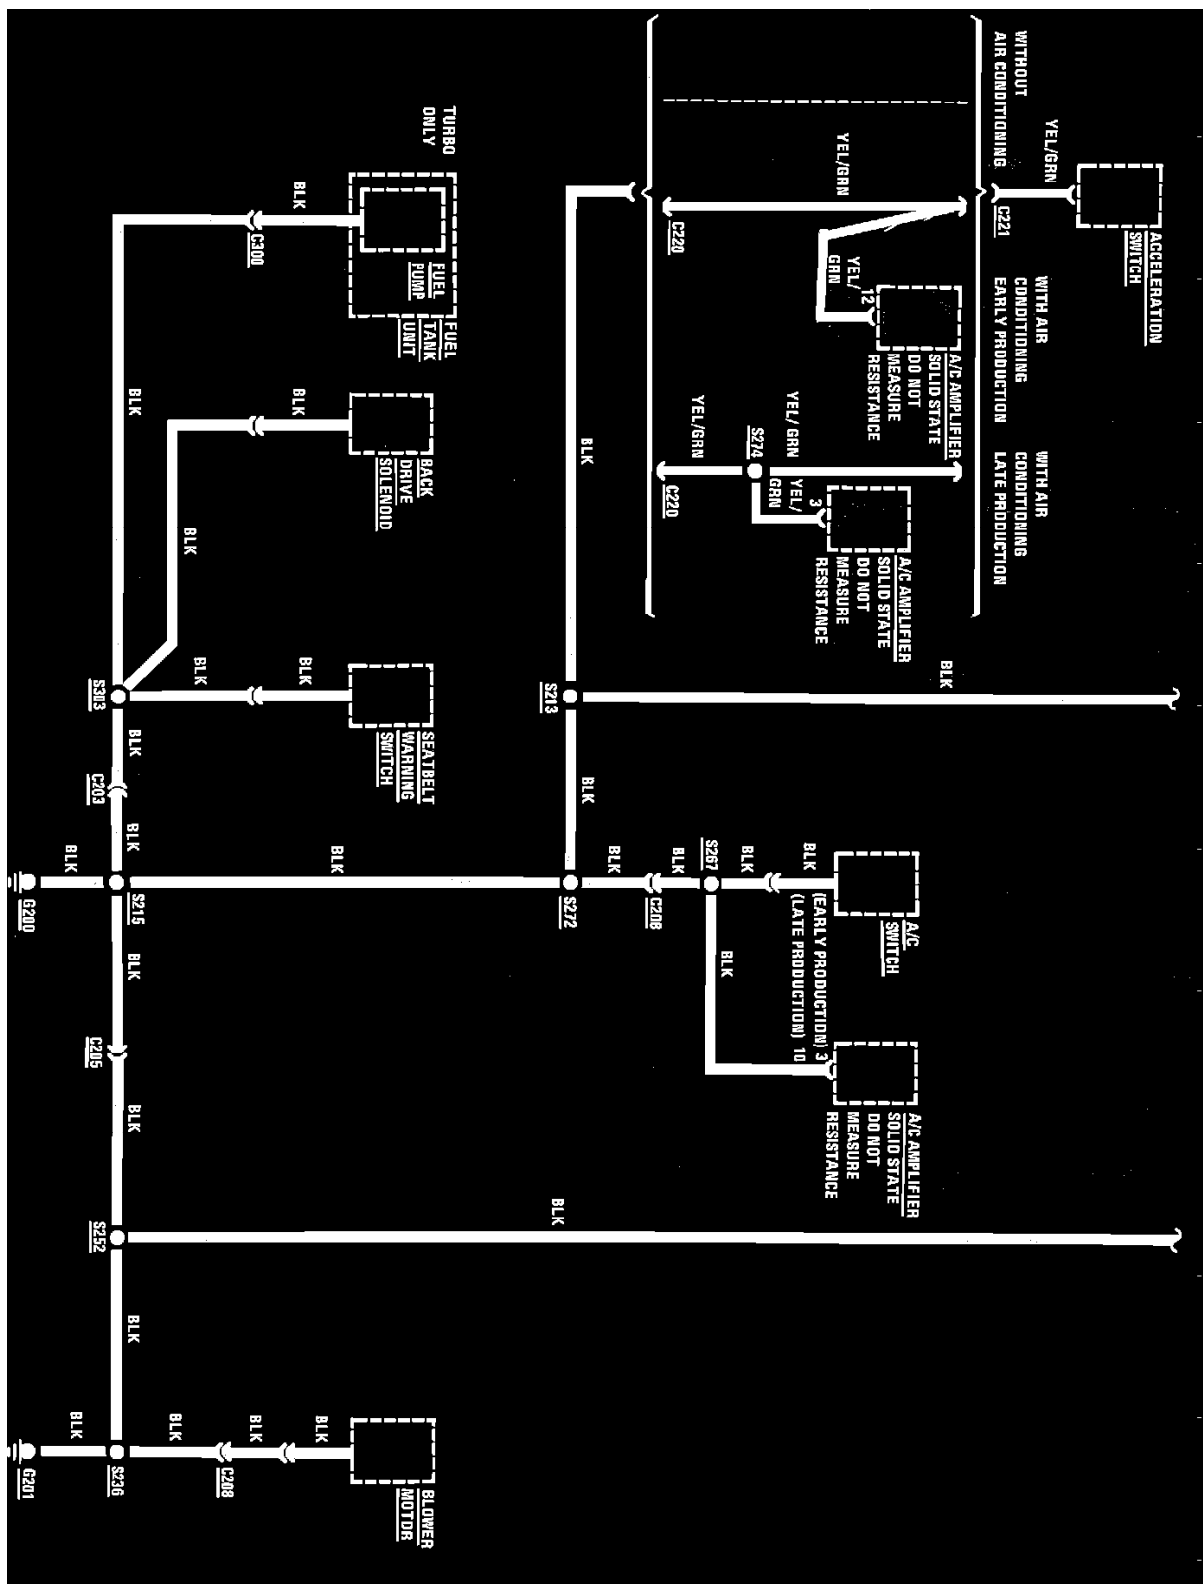
Fig. 26b Ground Distribution. (Part 2 of 2). G200, G201 &amp; G202

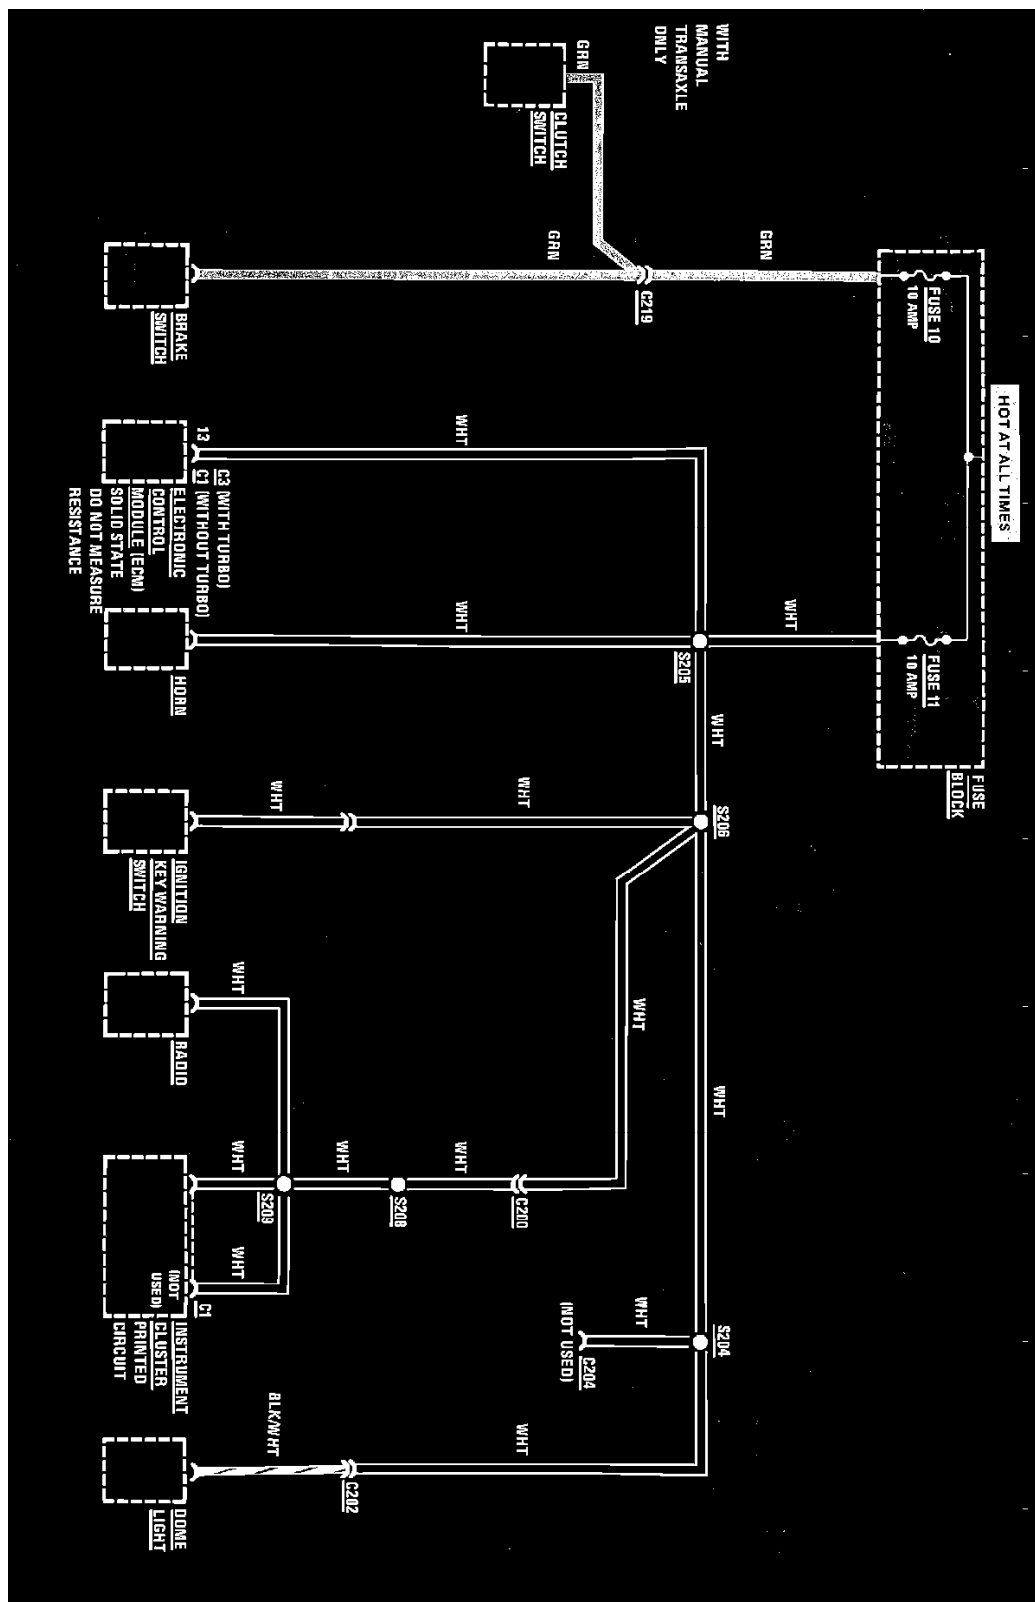
Fig. 22 Fuse Block Details. Fuses 10 &amp; 11

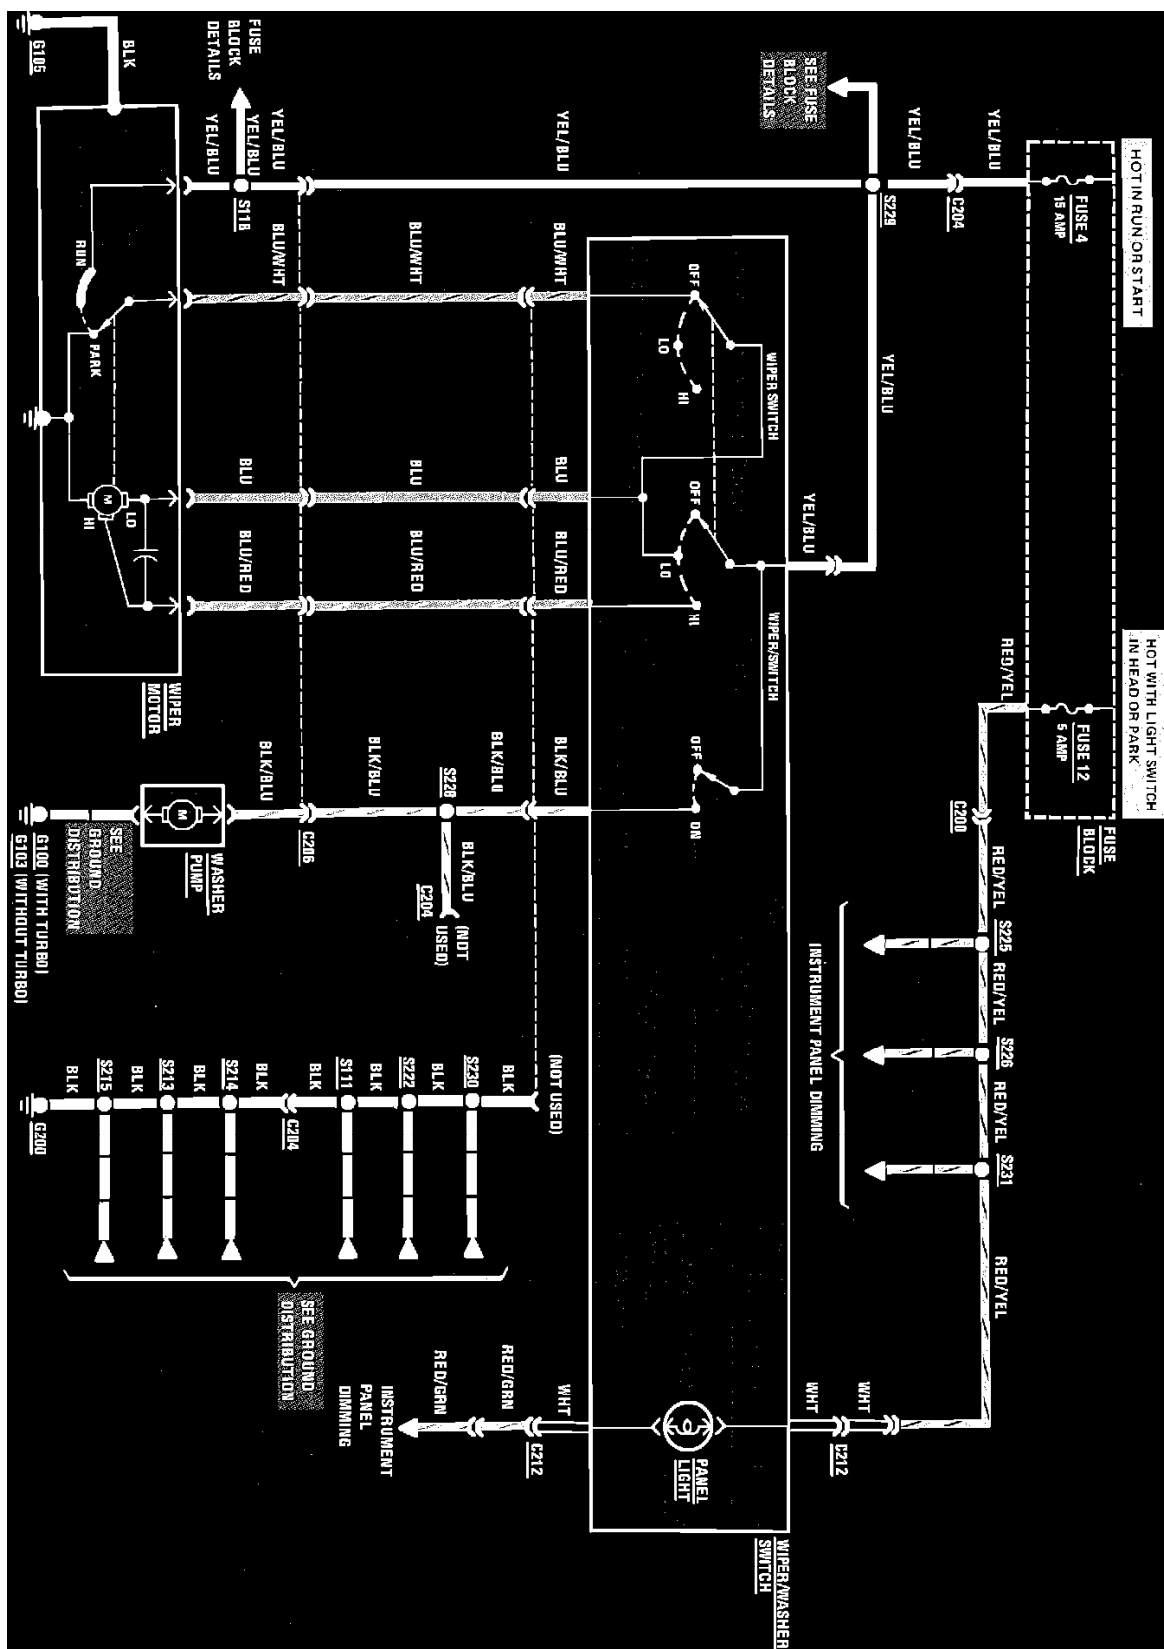
Fig. 45 Wiper/Washer Wiring Circuit. Less Pulse

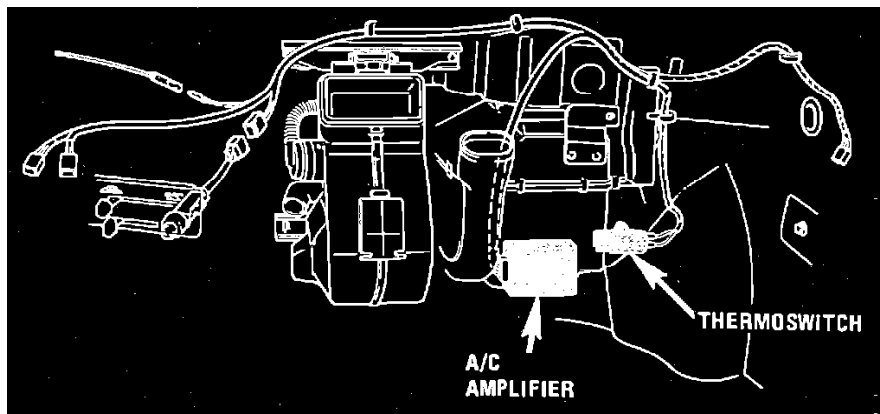
A/C Components Under I/P

Behind Right Side Of I/P  
A/C Compressor

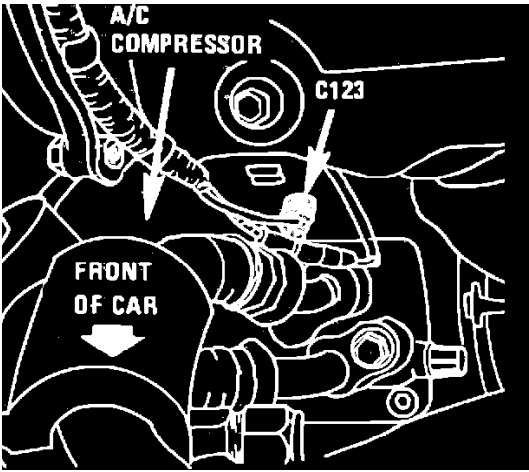
**A/C Compressor Clutch**

Engine Compartment

Lower Right Front Of Engine Compartment

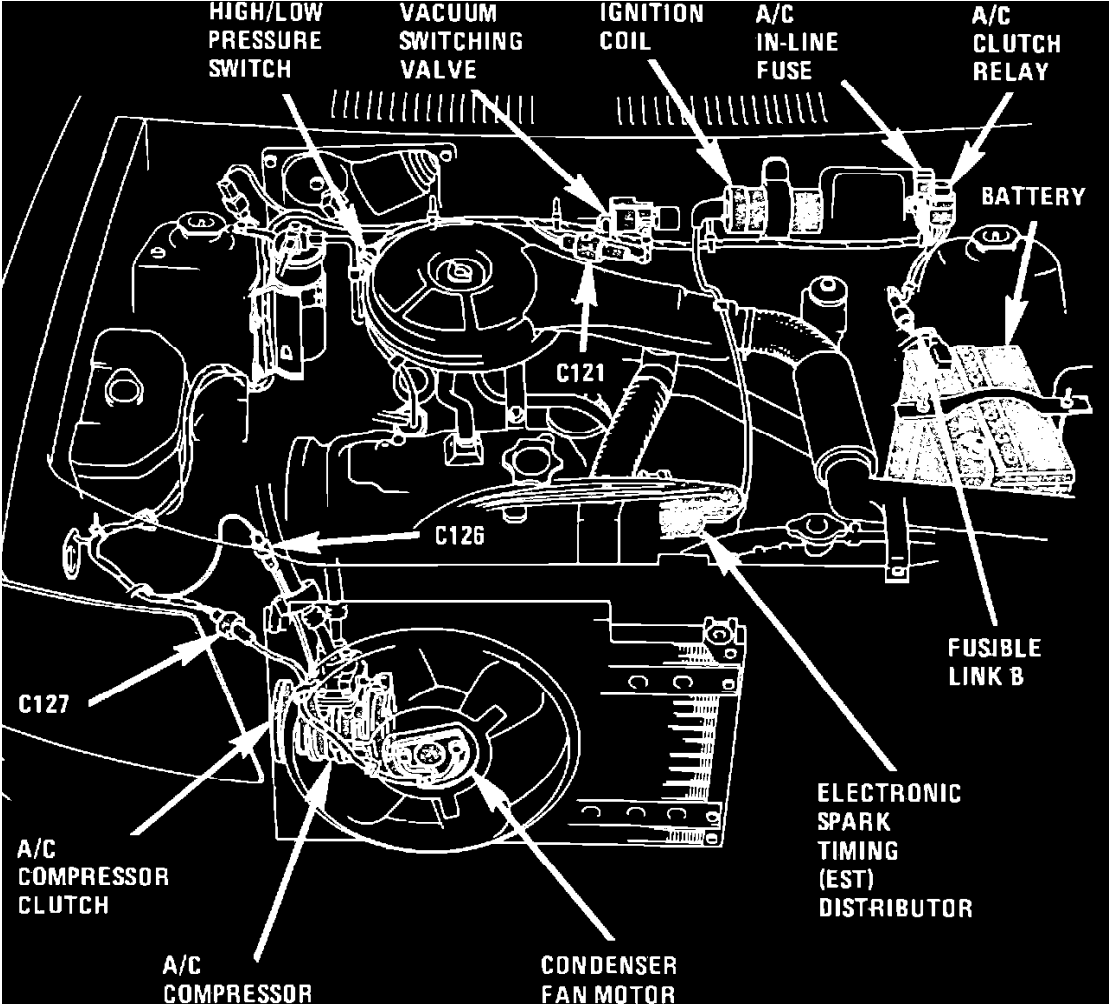
**A/C In-Line Fuse**

Engine Compartment

LH Side Of Engine Compartment Mounted To Cowl

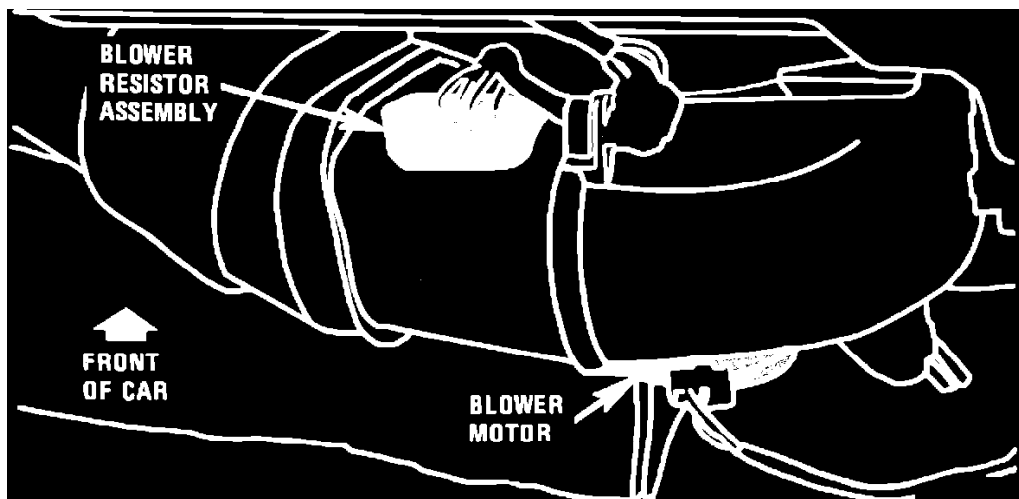
Under Right Side I/P Components

Behind Right Side Of I/P

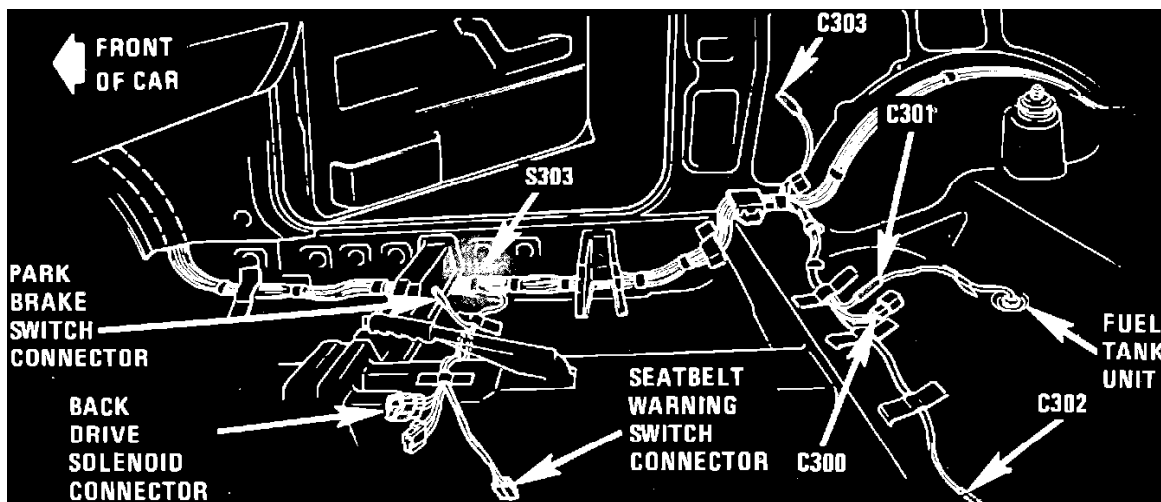
## Fuel Tank Unit

Passenger Compartment Splices & Connectors

Under Rear Of Car, Under Right Rear Seat

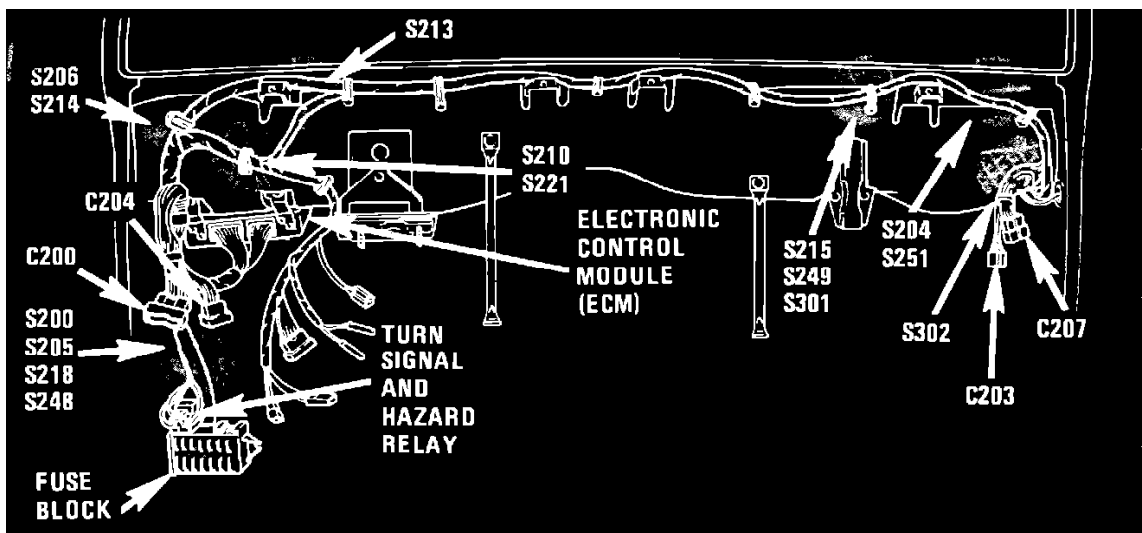
## Fuse Block

Lower I/P Splices & Connectors

Behind LH Side Of I/P  
**Fusible Link B**

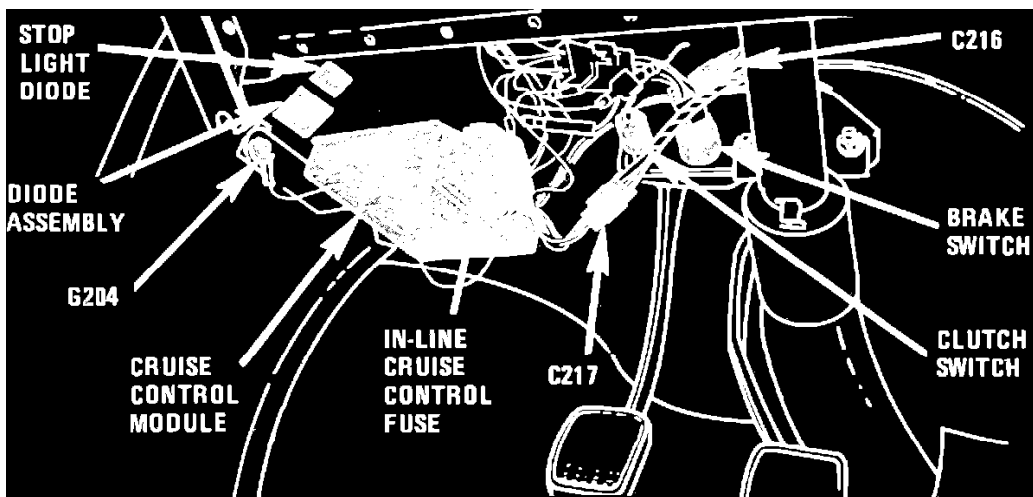
## In-Line Cruise Control Fuse

Under I/P Components

Behind LH Side Of I/P

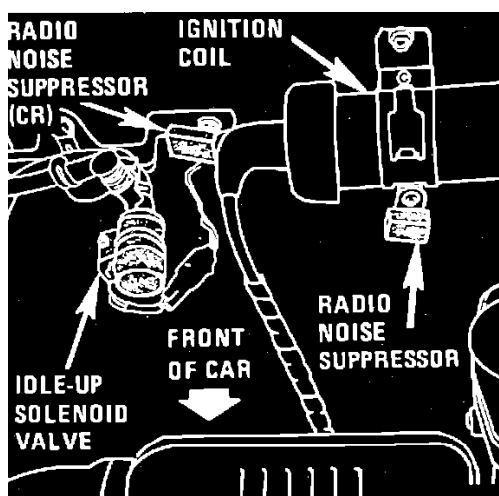
## Radio Noise Suppressor

Left Side Of Cowl

Mounted On Cowl Next Ignition Coil

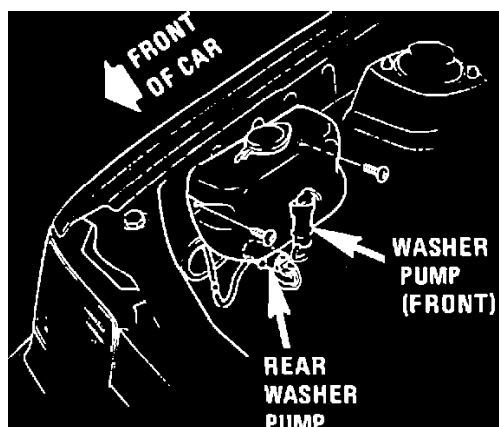
## Rear Washer Pump

Right Front Corner Of Engine Compartment

RH Side Of Engine Compartment

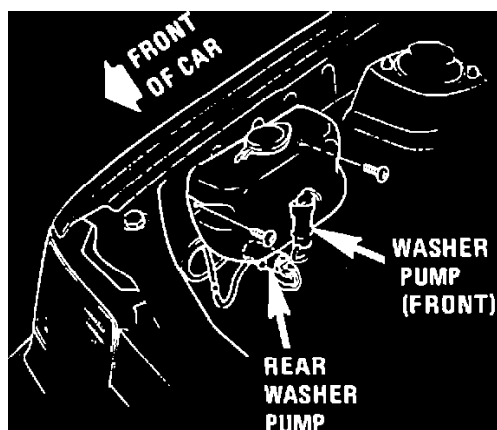
## Washer Pump

Right Front Corner Of Engine Compartment

RH Side Of Engine Compartment

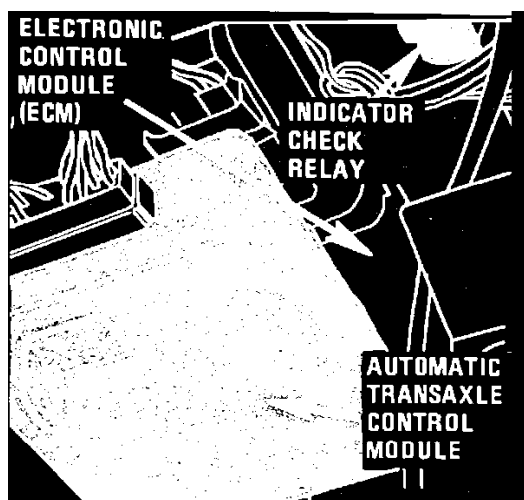
## Automatic Transaxle Control Module

Behind Left Side I/P Components

Behind Left Side Of I/P

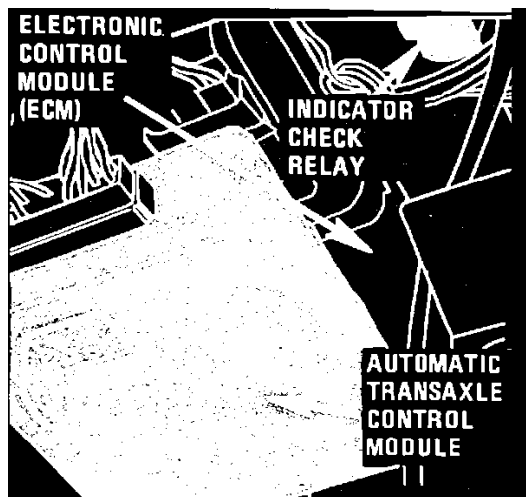
## Electronic Control Module (ECM)

Behind Left Side I/P Components

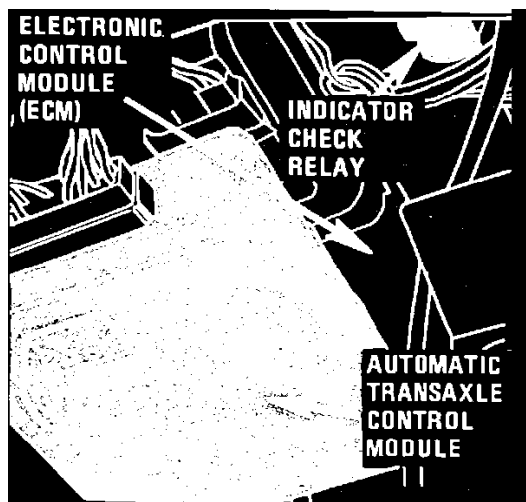
## Indicator Check Relay

Behind Left Side I/P Components

Behind LH Side Of I/P

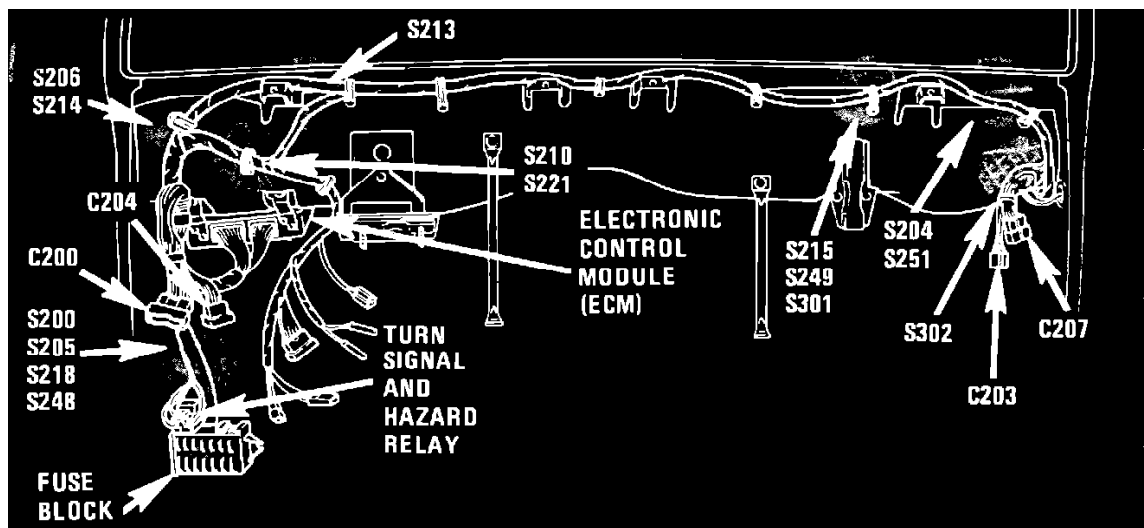
## Turn Signal & Hazard Relay

Lower I/P Splices & Connectors

Under LH Side Of I/P, Mounted To Fuse Block

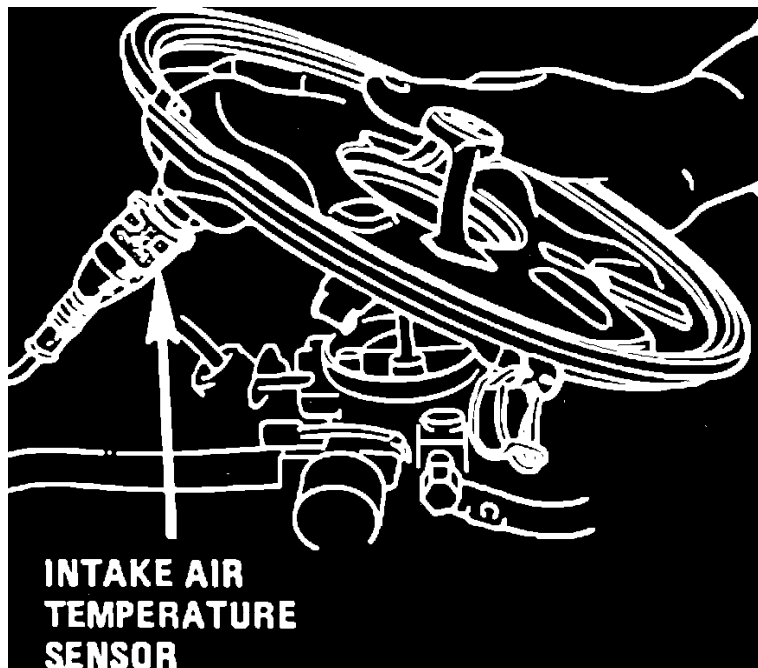
## Intake Air Temperature (IAT) Sensor

Top Of Engine

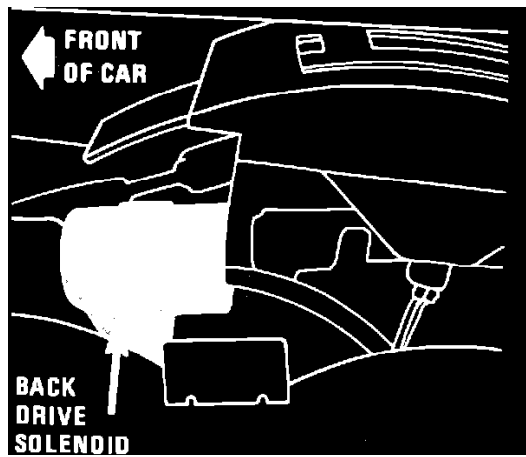
### Back Drive Solenoid

Under Console Components

Under Center Console  
**Idle-Up Solenoid Valve**

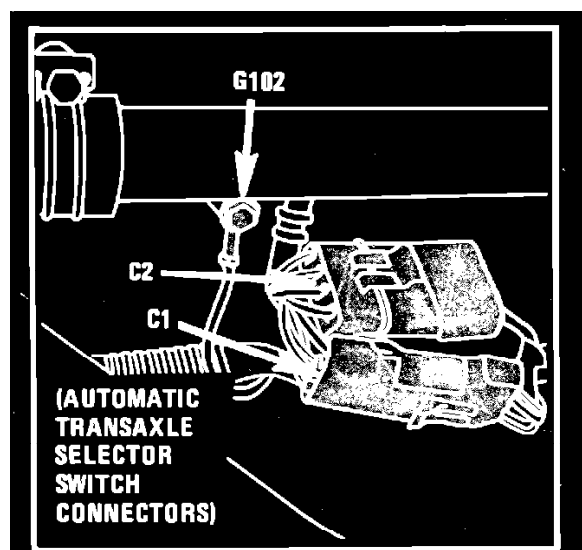
**Automatic Transaxle Selector Switch**

Top Of Transaxle

Mounted To Top Of Transaxle

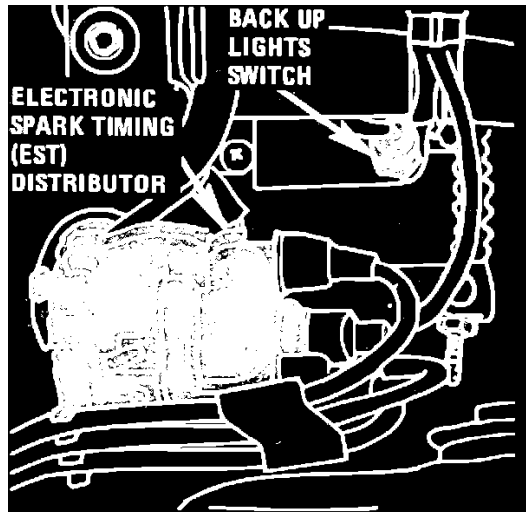
**Back-Up Lamp Switch**

Left Front Of Engine

Mounted To Top Of Transaxle

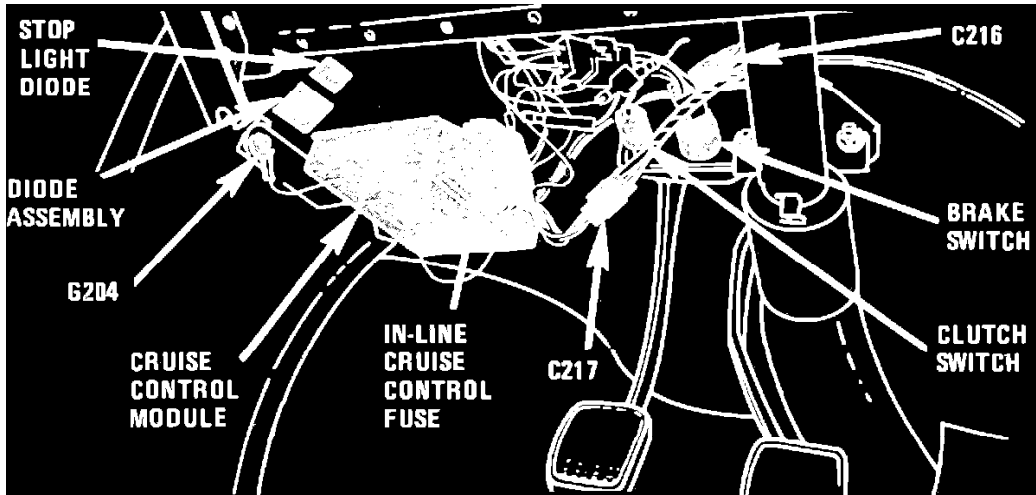
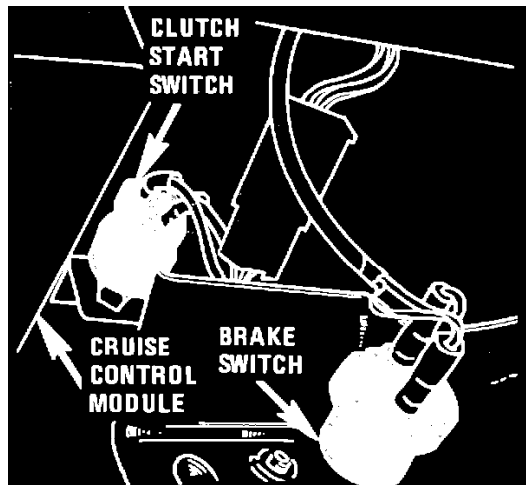
## Brake Switch

Under I/P Components

Under Left Side I/P Components

Mounted To Brake Pedal Support

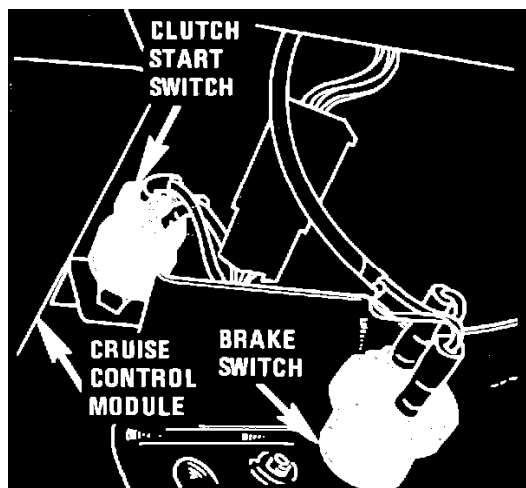
## Clutch Start Switch

Under Left Side I/P Components

Mounted To Clutch Pedal Support

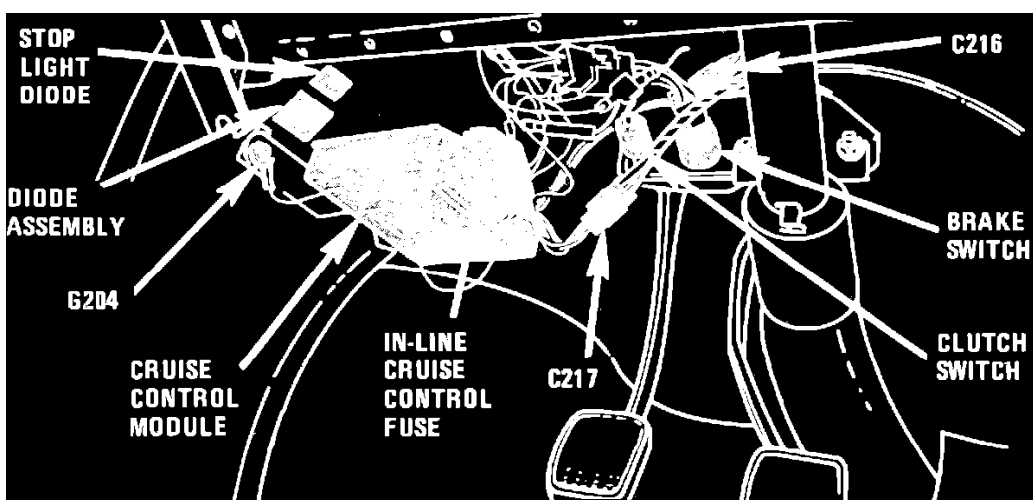
## Clutch Switch

Under I/P Components

Mounted To Clutch Pedal Support

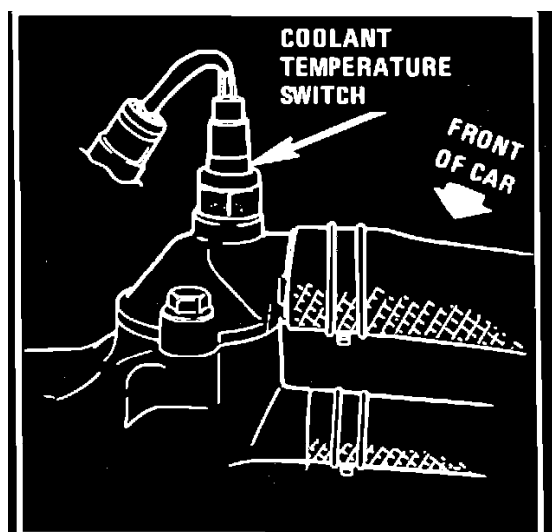
## Coolant Temperature Switch

Top Center Of Engine

Mounted To Top Of Thermostat Housing

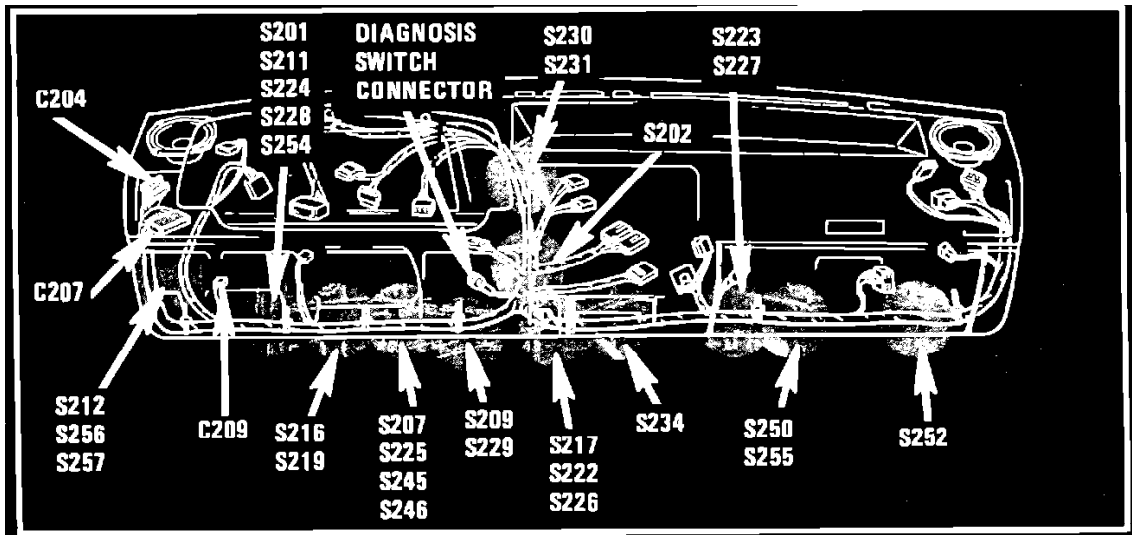
## Diagnosis Switch

Behind I/P Splices & Connectors

Behind LH Side Of I/P

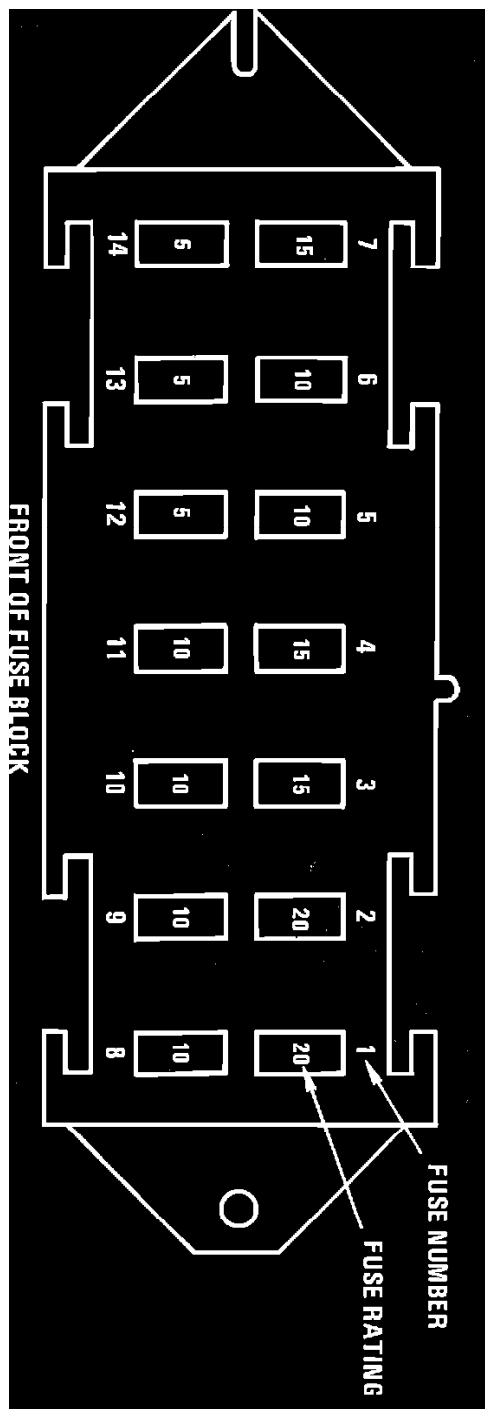
Fig. 1 Fuse Block

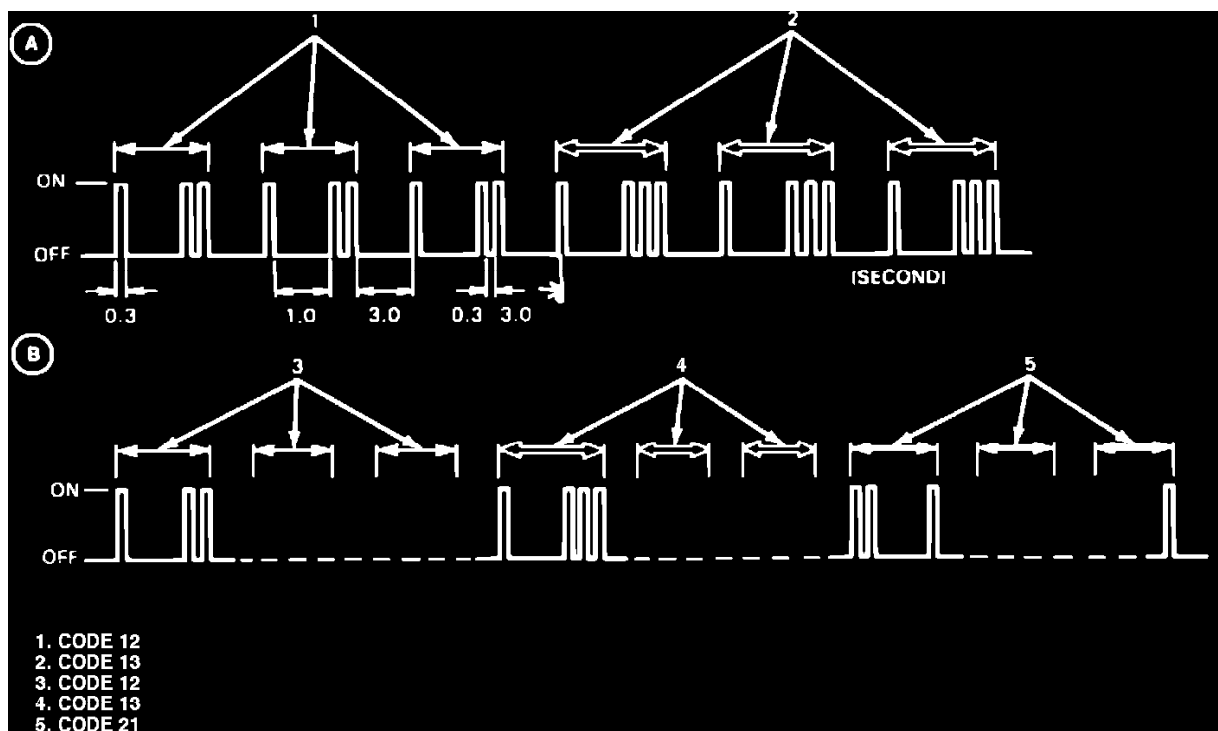
Fig. 39 Reading "Check Engine" lamp codes.

When the ignition switch and the diagnosis switch, **Fig. 38**, are turned "On," the "Check Engine" lamp indicates code 12 three times, then the trouble codes three times each, and continues to cycle between code 12 and the trouble code (13) as shown (A), **Fig. 39**. Code 12 consists of one flash, a short pause, then two flashes, which indicates the system is functioning properly. The code following code 12 is a trouble code, which means that trouble has occurred in the system to which the particular code corresponds.

If two or more trouble codes are stored in trouble code memory (trouble has occurred in more than two systems), the "Check Engine" lamp indicates code 12 three times, then each of the trouble codes in ascending order. **Fig. 39**, (B) illustrates codes 12, 13 and 21.

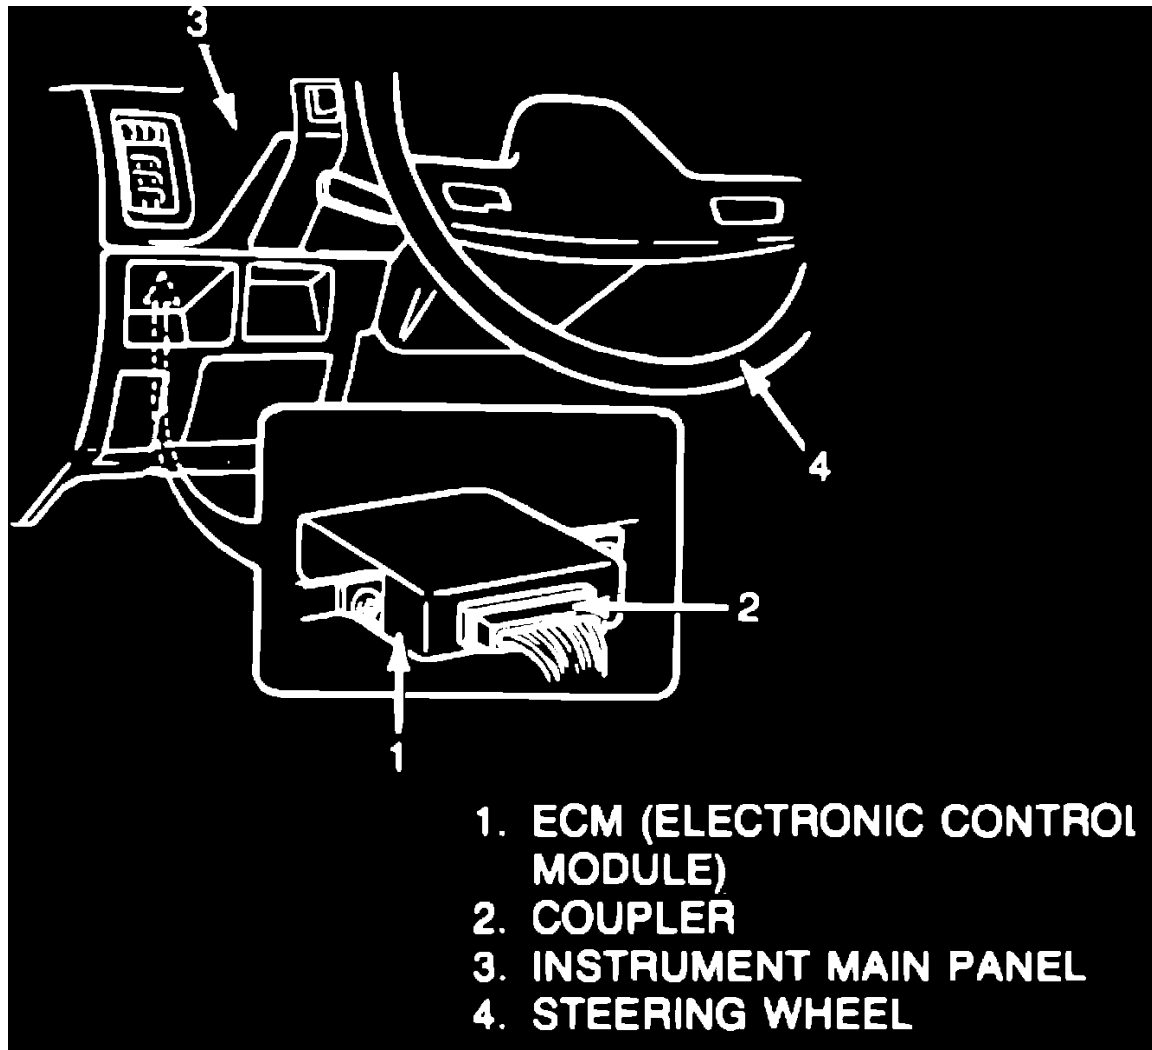
Fig. 26 ECM installation

1. Remove ECM from instrument panel, **Fig. 26**, leaving connector connected.
2. Start engine and allow to idle at normal operating temperature.
3. Connect voltmeter between terminals 4 (oxygen sensor signal) and 9 (ground), **Fig. 45**.

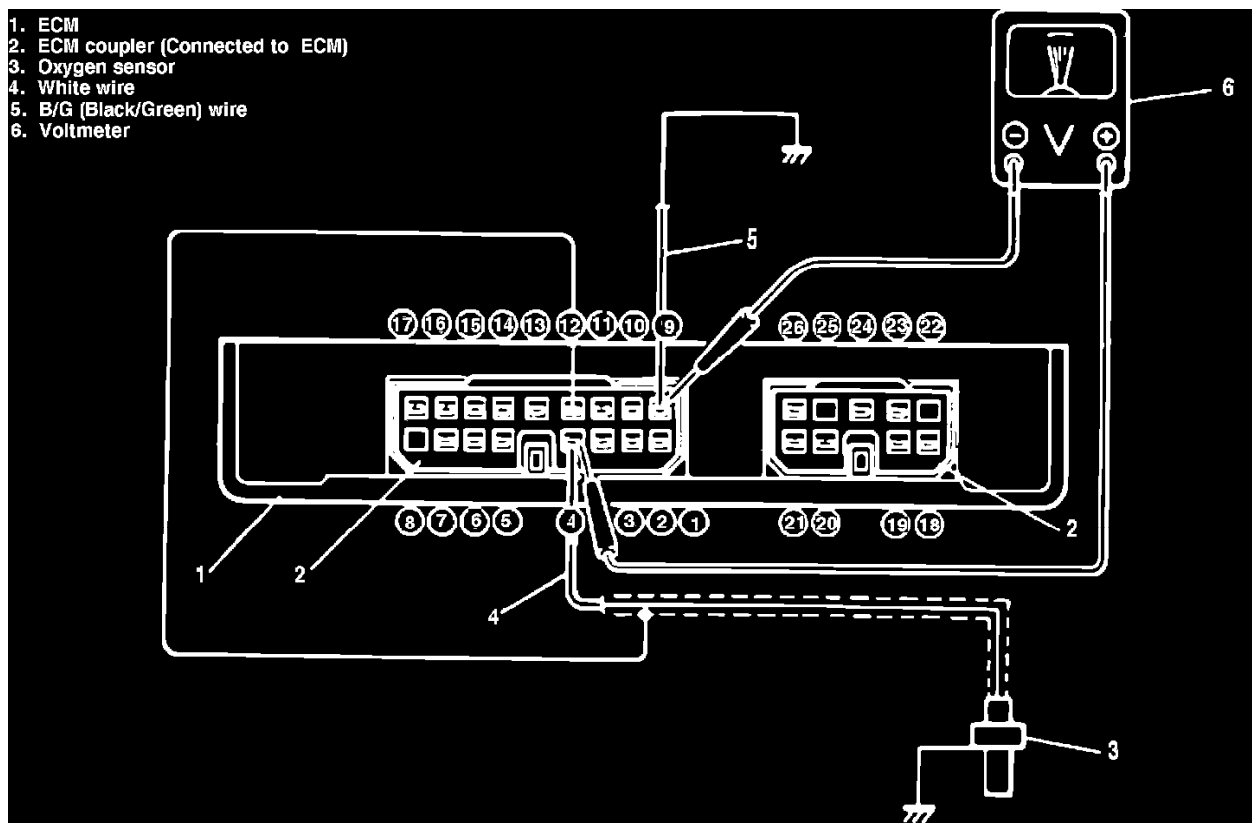
Fig. 45 Checking oxygen sensor signal. 1987 - 88 models

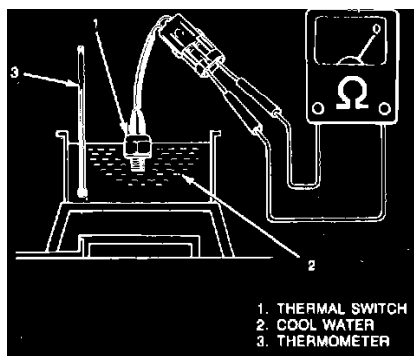
Fig. 17 Coolant temperature thermal switch test. Low temperature

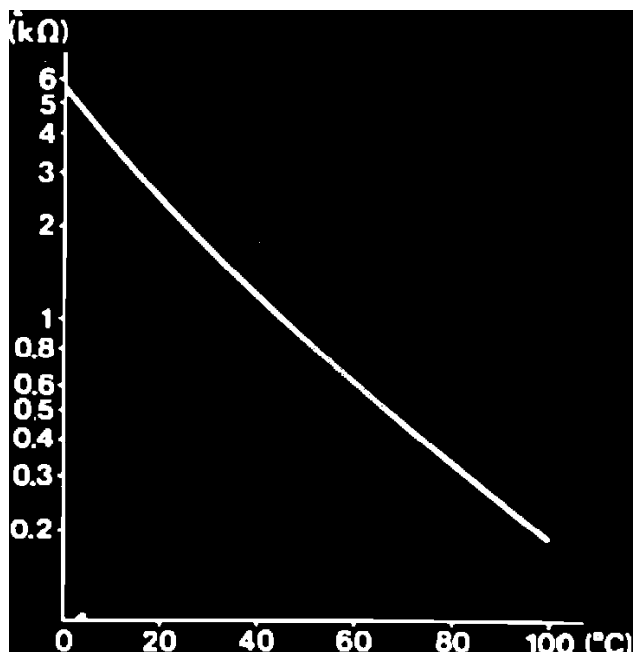
Fig. 46 Coolant temperature sensor, temperature-to-resistance curve. 1987 - 88 models

1. Disconnect battery ground cable, then drain cooling system.
2. Disconnect coolant temperature sensor connector, remove coolant temperature sensor from intake manifold.
3. Connect temperature sensor to a suitable ohmmeter, then immerse temperature sensing part into water and read resistance on ohmmeter while slowly raising water temperature, **Fig. 17**. Temperature to resistance relationship should be as shown, **Fig. 46**.
4. If measured resistance at each temperature is not equal to that indicated in graph, replace sensor.
5. Install sensor in intake manifold with new gasket, then torque sensor to 9.5 - 12.0 ft. lbs.
6. Connect electrical connector to temperature sensor, then refill cooling system.
7. Connect battery ground cable.
