Vehicle: Application and ID

## Engine: Service and Repair

## Camshaft: Service and Repair

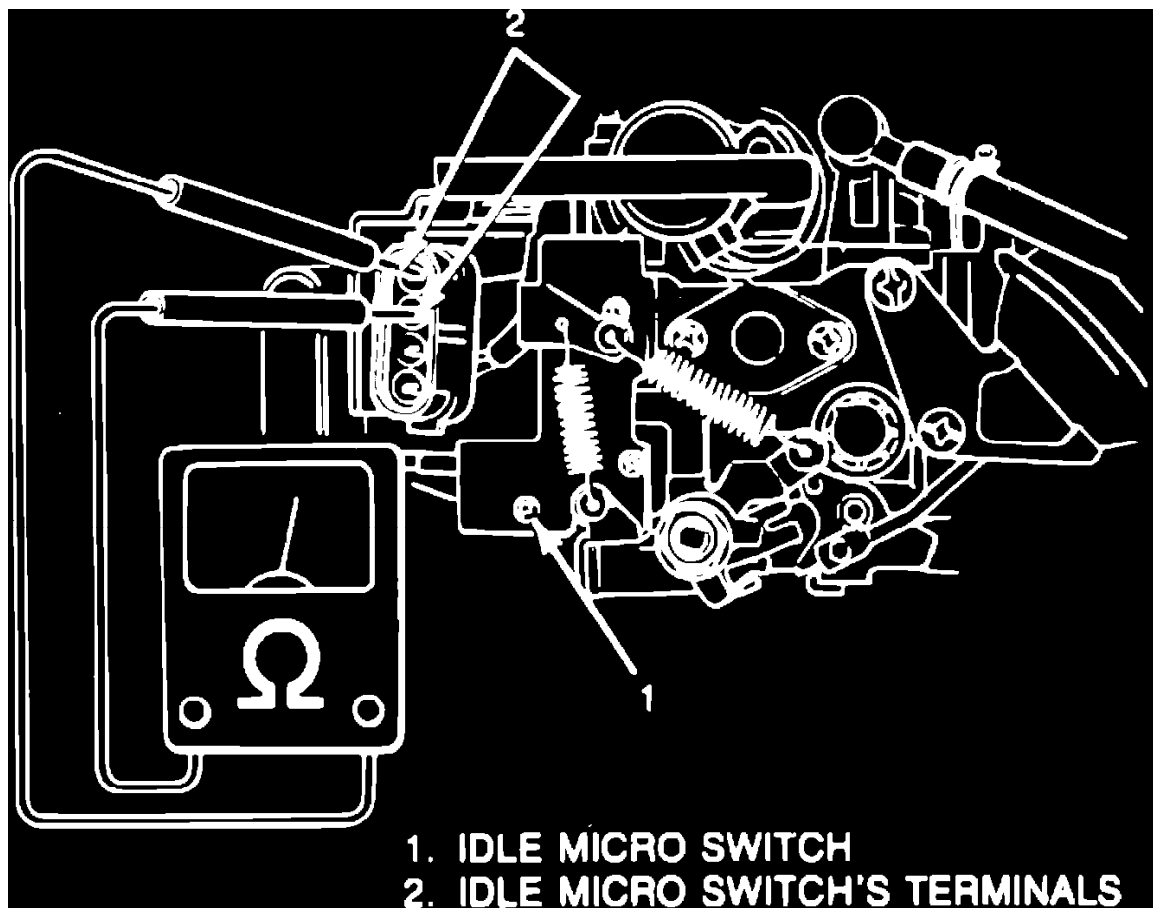
Fig. 10 Idle micro switch test connections

1. Start engine and allow to reach normal operating temperature.
2. Disconnect microswitch electrical connector, **Fig. 10**, and connect an ohmmeter to switch terminals.
3. Check that ohmmeter indicates zero ohms with engine at idle.
4. Connect tachometer to engine.
5. Gradually increase engine speed from idle speed. Check that engine speed is in range of 1500 - 2400 RPM when ohmmeter indicates infinite resistance. If speed is outside of range, adjust by bending lever as shown in **Fig. 47**.

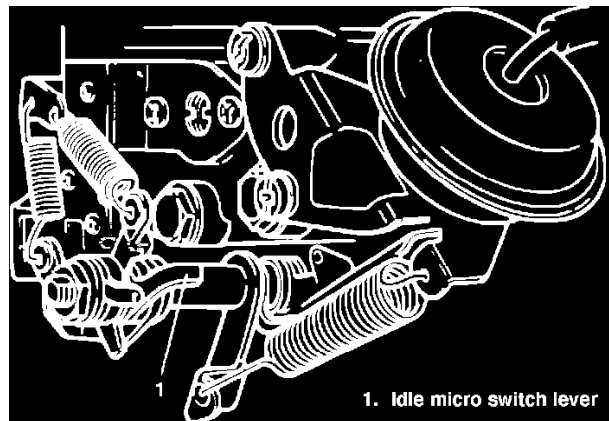
Fig. 47 Idle micro switch lever. 1987 - 88 models

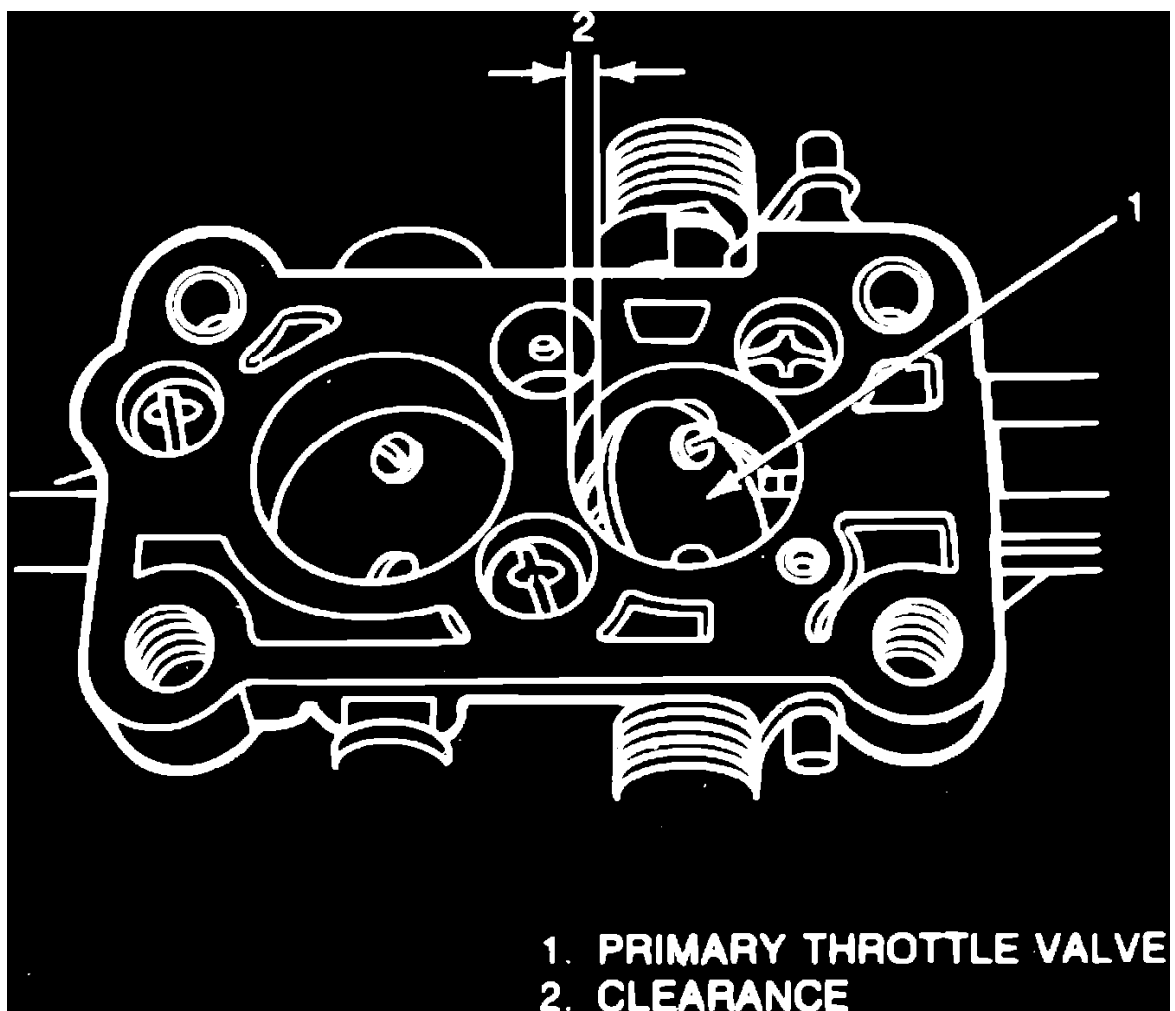
Fig. 13 Throttle plate clearance measurement

1. Remove air cleaner and carburetor.
2. Connect ohmmeter to switch as shown in **Fig. 12**. Resistance between terminals should be infinite.
3. Open throttle gradually until ohmmeter indicates zero ohm. Measure clearance between throttle butterfly and carburetor bore, **Fig. 13**. Clearance should be .29 - .33 inch (7.2 - 8.4 mm). If clearance is out of range, adjust by bending lever, **Fig. 14**.

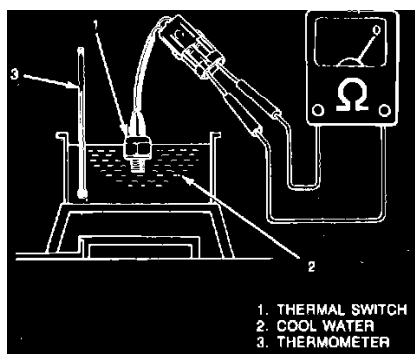
Fig. 17 Coolant temperature thermal switch test. Low temperature

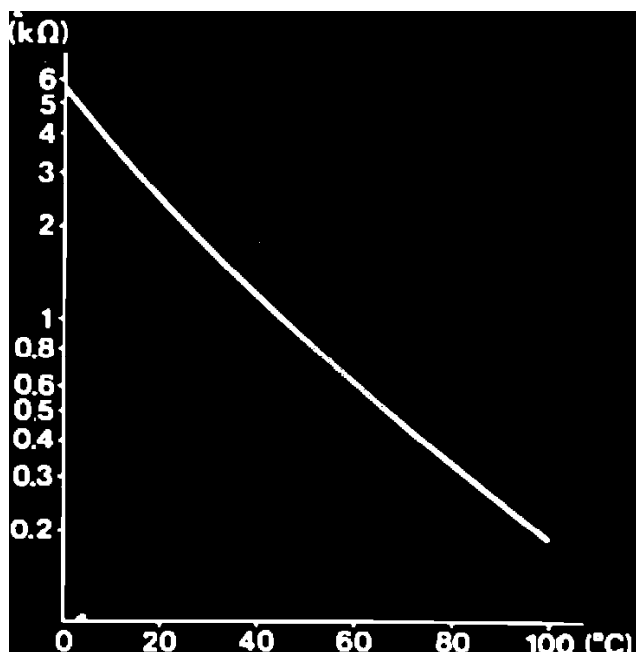
Fig. 46 Coolant temperature sensor, temperature-to-resistance curve. 1987 - 88 models

1. Disconnect battery ground cable, then remove air cleaner upper case and air cleaner element
2. Remove air cleaner lower case, then disconnect intake air temperature sensor electrical connector.
3. Remove intake air temperature sensor from air cleaner lower case.
4. Connect temperature sensor to a suitable ohmmeter, then immerse temperature sensing part into water and read resistance on ohmmeter while slowly raising water temperature, **Fig. 17**. Temperature to resistance relationship should be as shown, **Fig. 46**.
5. Install intake air temperature sensor into air cleaner lower case, then torque to 5 - 12 ft. lbs.
6. Connect electrical connector to temperature sensor, then install air cleaner lower case. Install air cleaner element, then the air cleaner upper case.
7. Connect battery ground cable.

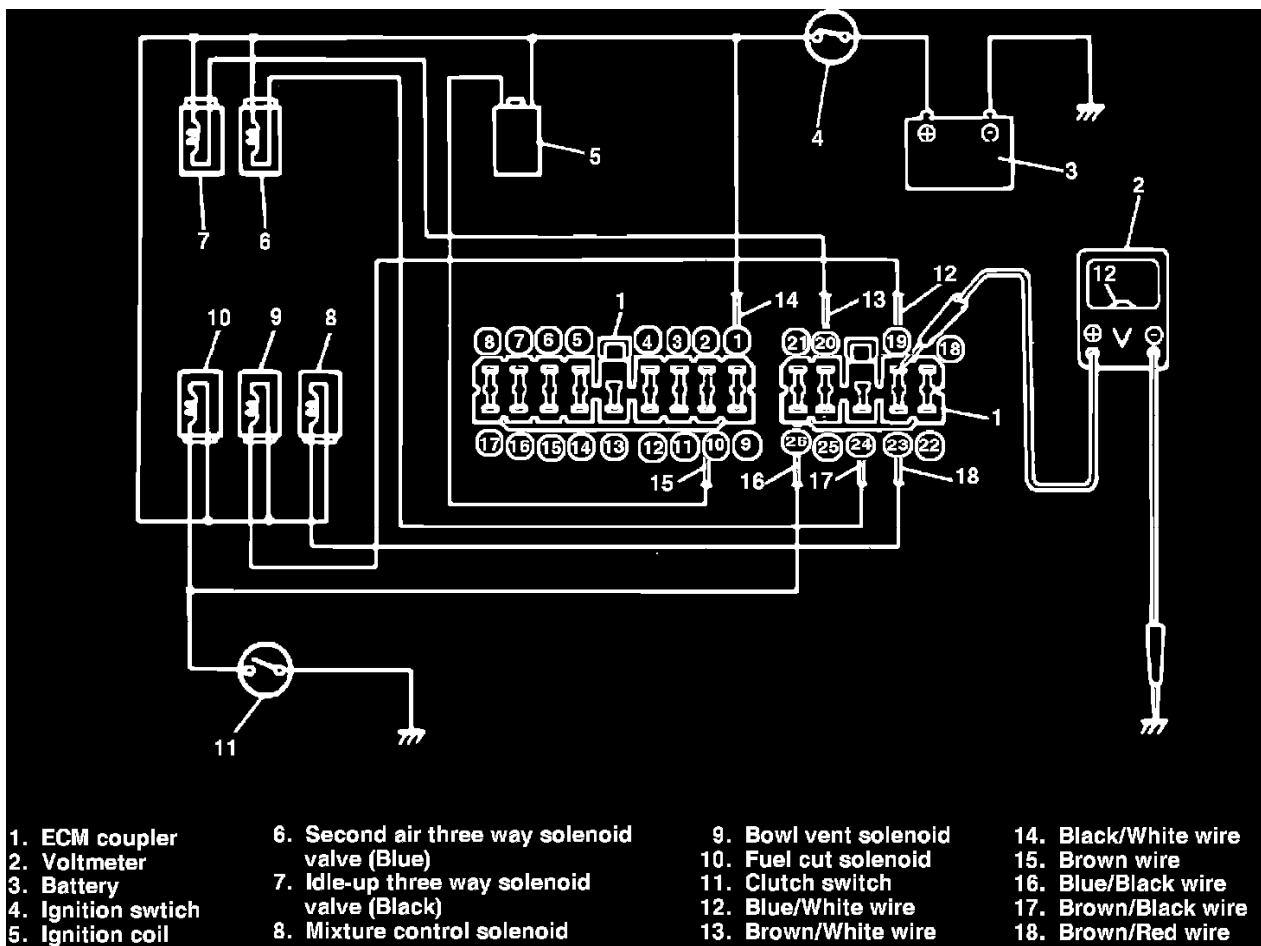
**Fig. 42 Checking ECM power circuits. 1987 - 88 models**

The ignition coil, solenoids and solenoid valves are all connected to the ECM. A loose or open connection in any of these circuits will cause a loss of signal to the ECM, thus causing the system to malfunction. Check all power circuits as follows:

1. Disconnect ECM connector.
2. Turn ignition on without starting engine.
3. Connect voltmeter between terminal 19 of ECM connector and body ground, **Fig. 42**, and measure voltage. Voltage should be 12 volts. Repeat with terminals 20, 23, 24, 26, 1 and 10.
4. Connect voltmeter between terminal 26 of ECM connector and body. Voltage should be 12 volts. Depress clutch pedal. Voltage should drop to zero. If not check wiring.
5. Turn ignition "Off," then reconnect ECM connector securely.

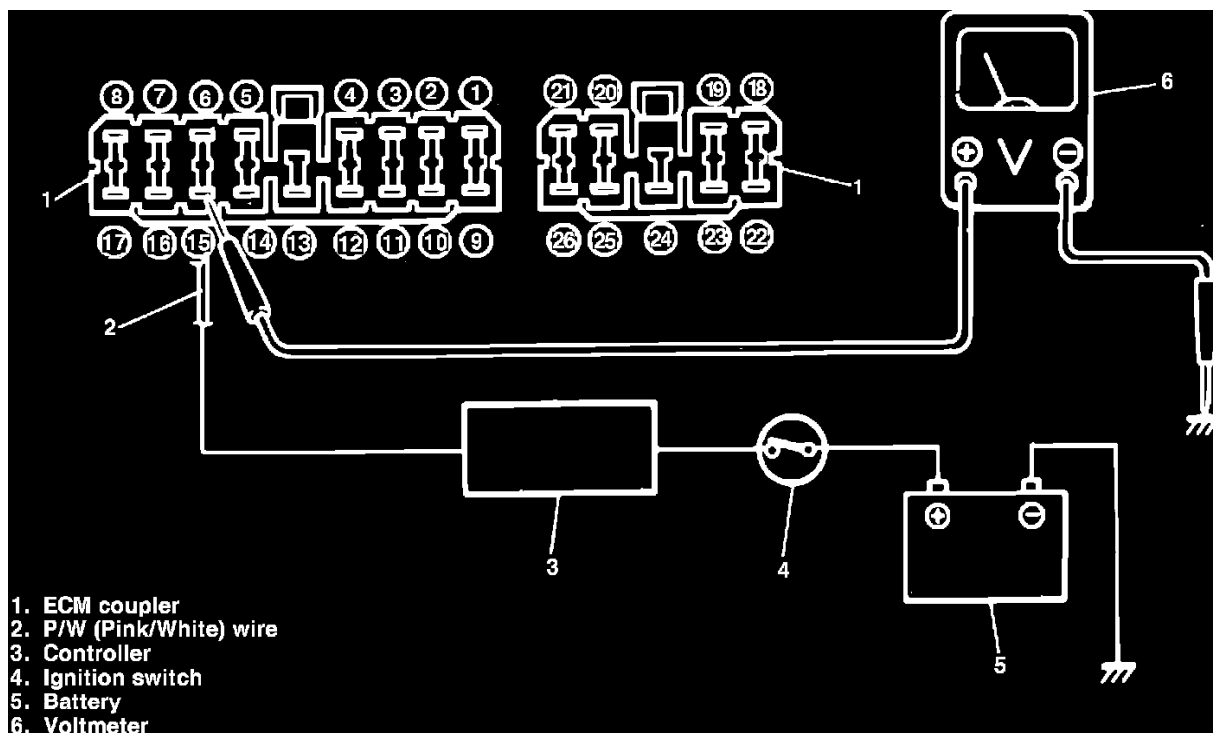
**Fig. 52 Checking idle-up signal. 1987 - 88 models w/automatic transmission**

1. Disconnect ECM connector.
2. Switch on ignition without starting engine, then connect voltmeter between terminal 15 and body ground as shown in **Fig. 52**.
3. Position shift lever in each range indicated above and observe voltmeter. Voltmeter should read 11 - 14 volts. If reading of 11 - 14 volts is not obtained, the circuit is making poor contact or is open, or the controller is defective. Correct as necessary.
4. Reconnect ECM connector securely.

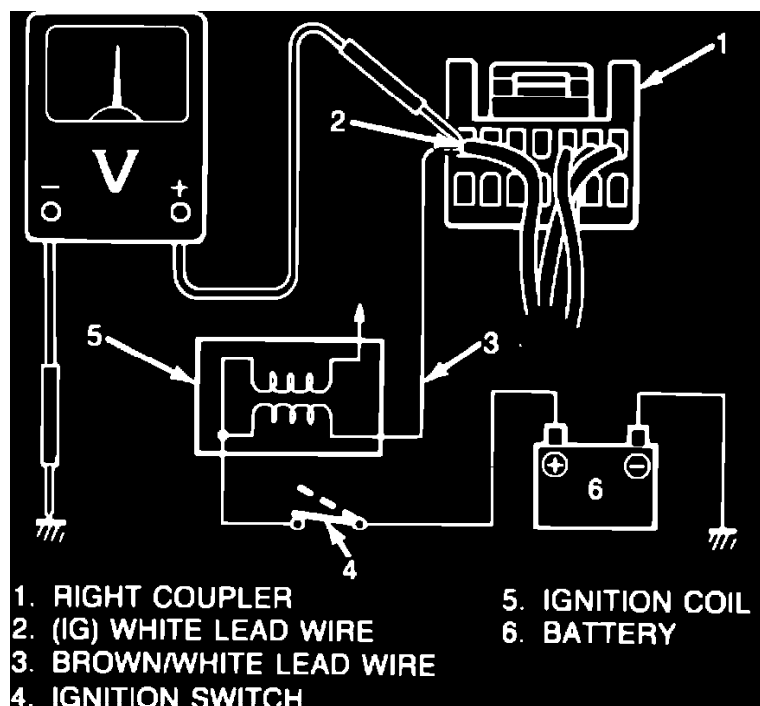
**Fig. 18 Checking ignition signal**

1. With ignition switch "Off," remove right connector from ECM.
2. Insert positive tester probe into white lead wire terminal from cord side of disconnected right connector and negative tester probe connected to body ground, check that 0 volts is detected with ignition switch "Off," and battery voltage applied as shown, **Fig. 18**.
3. If battery voltage is not present, check ignition coil and related circuit.
4. Turn ignition switch "Off," then reconnect ECM connector.

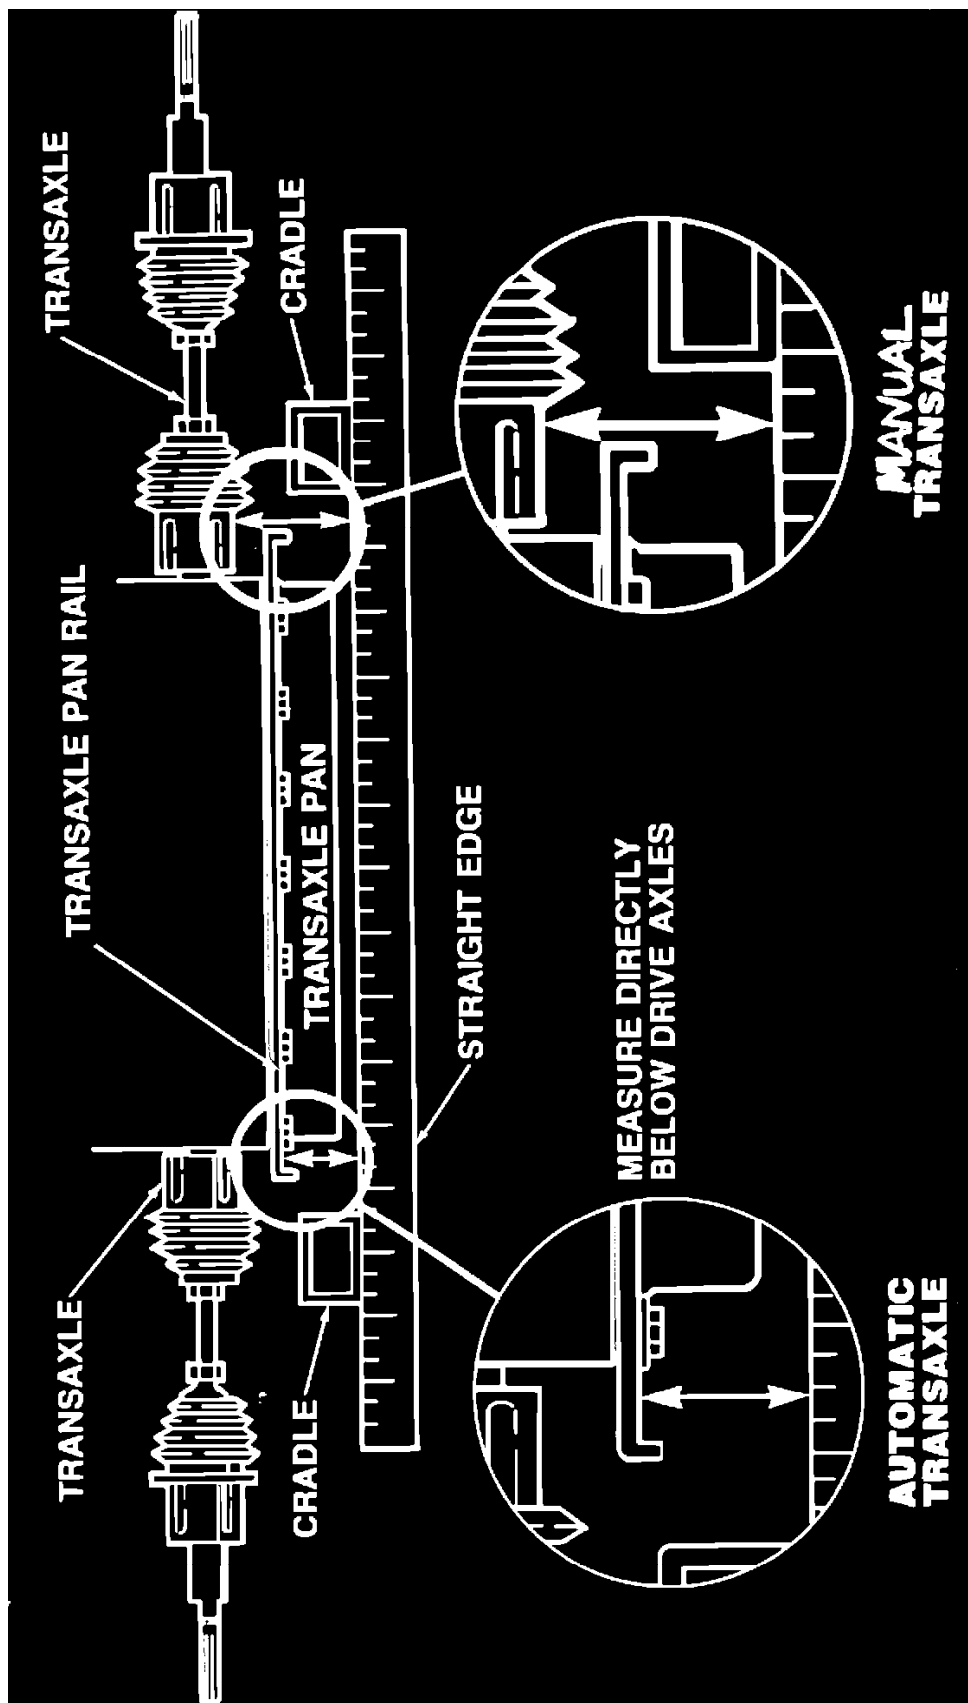
3. Difference in left and right drive axle angles.

Automatic Transmission - Differences in drive axle angles will be indicated by measuring a difference in the transmission left and right pan rail height. (See Illustration).

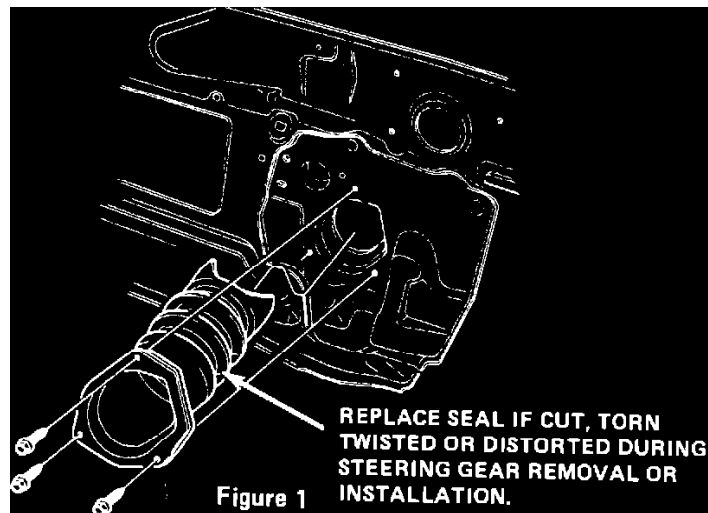
FIGURE 1

When removing or installing any rack and pinion steering gear for service, be sure to inspect the intermediate steering shaft or steering coupling seal for cuts or tears which would allow noises to be transmitted into the passenger area. Also inspect the seal for being twisted, crushed or distorted as this can cause a clunk or rubbing sound. See Figure 1 for typical cavalier car seal. Replace the seal as necessary.

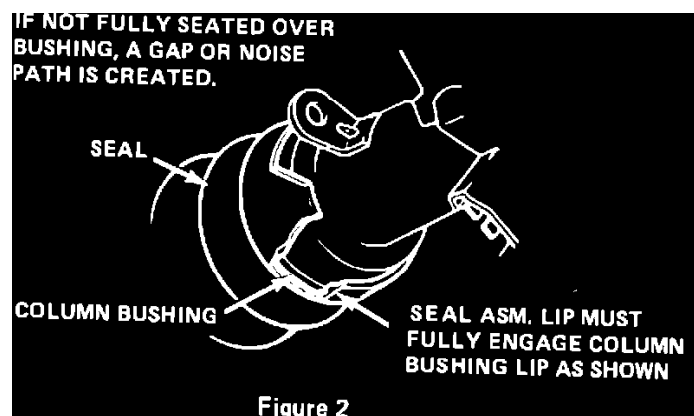
FIGURE 2

On Cavalier models, check the upper portion of the steering coupling seal to be sure it is fully seated over the bushing or a noise path could be created. The seal is retained by the lip on the bushing. Refer to Figure 2. On Celebrity models, check the seal to be sure it is securely fastened to the cowl and lower column.

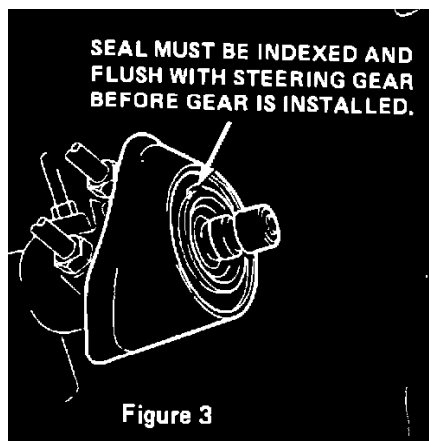
FIGURE 3

The center-take-off gears used on the Cavalier models, also use a dash seal which must be properly indexed on the housing before the gear is installed in the car. See Figure

3. If the dash seal is mispositioned another noise path can be created. A mispositioned dash seal could also cause a condition of stiff steering if the seal is rubbing on the steering coupling.

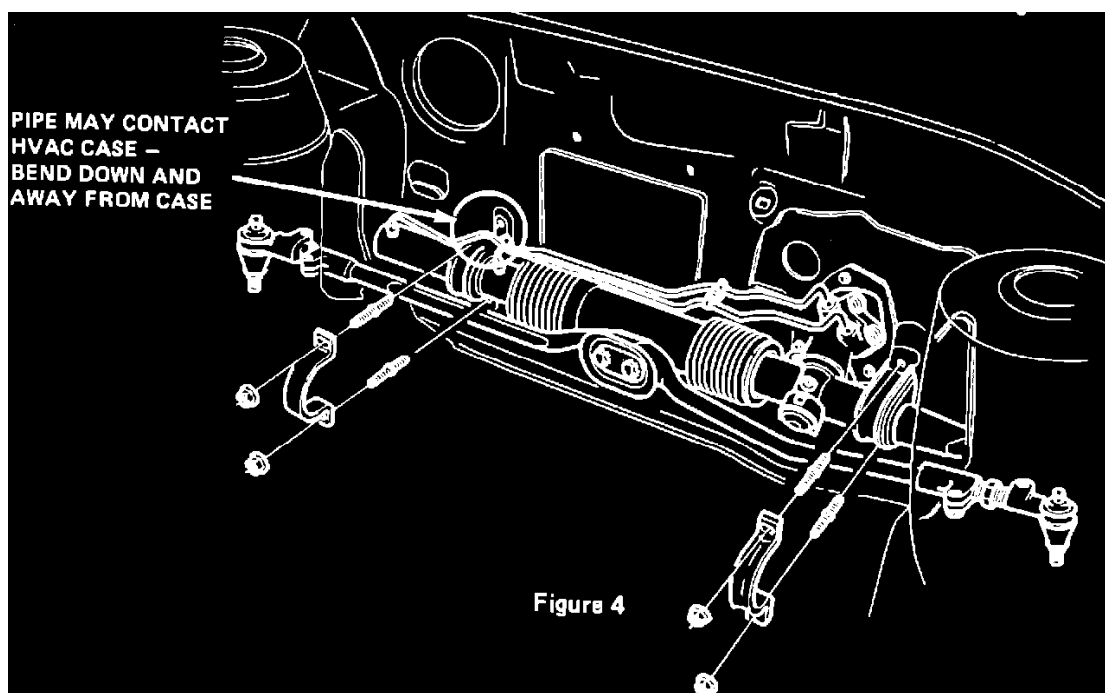
FIGURE 4

When diagnosing a growl, ground out, or rattle noise on Cavalier models, there is a possibility that one of the cylinder lines of the gear could be grounding out on the heater case on the right side of the cowl. See Figure 4. If this condition exists, bend the pipe away from the contact area to gain clearance.

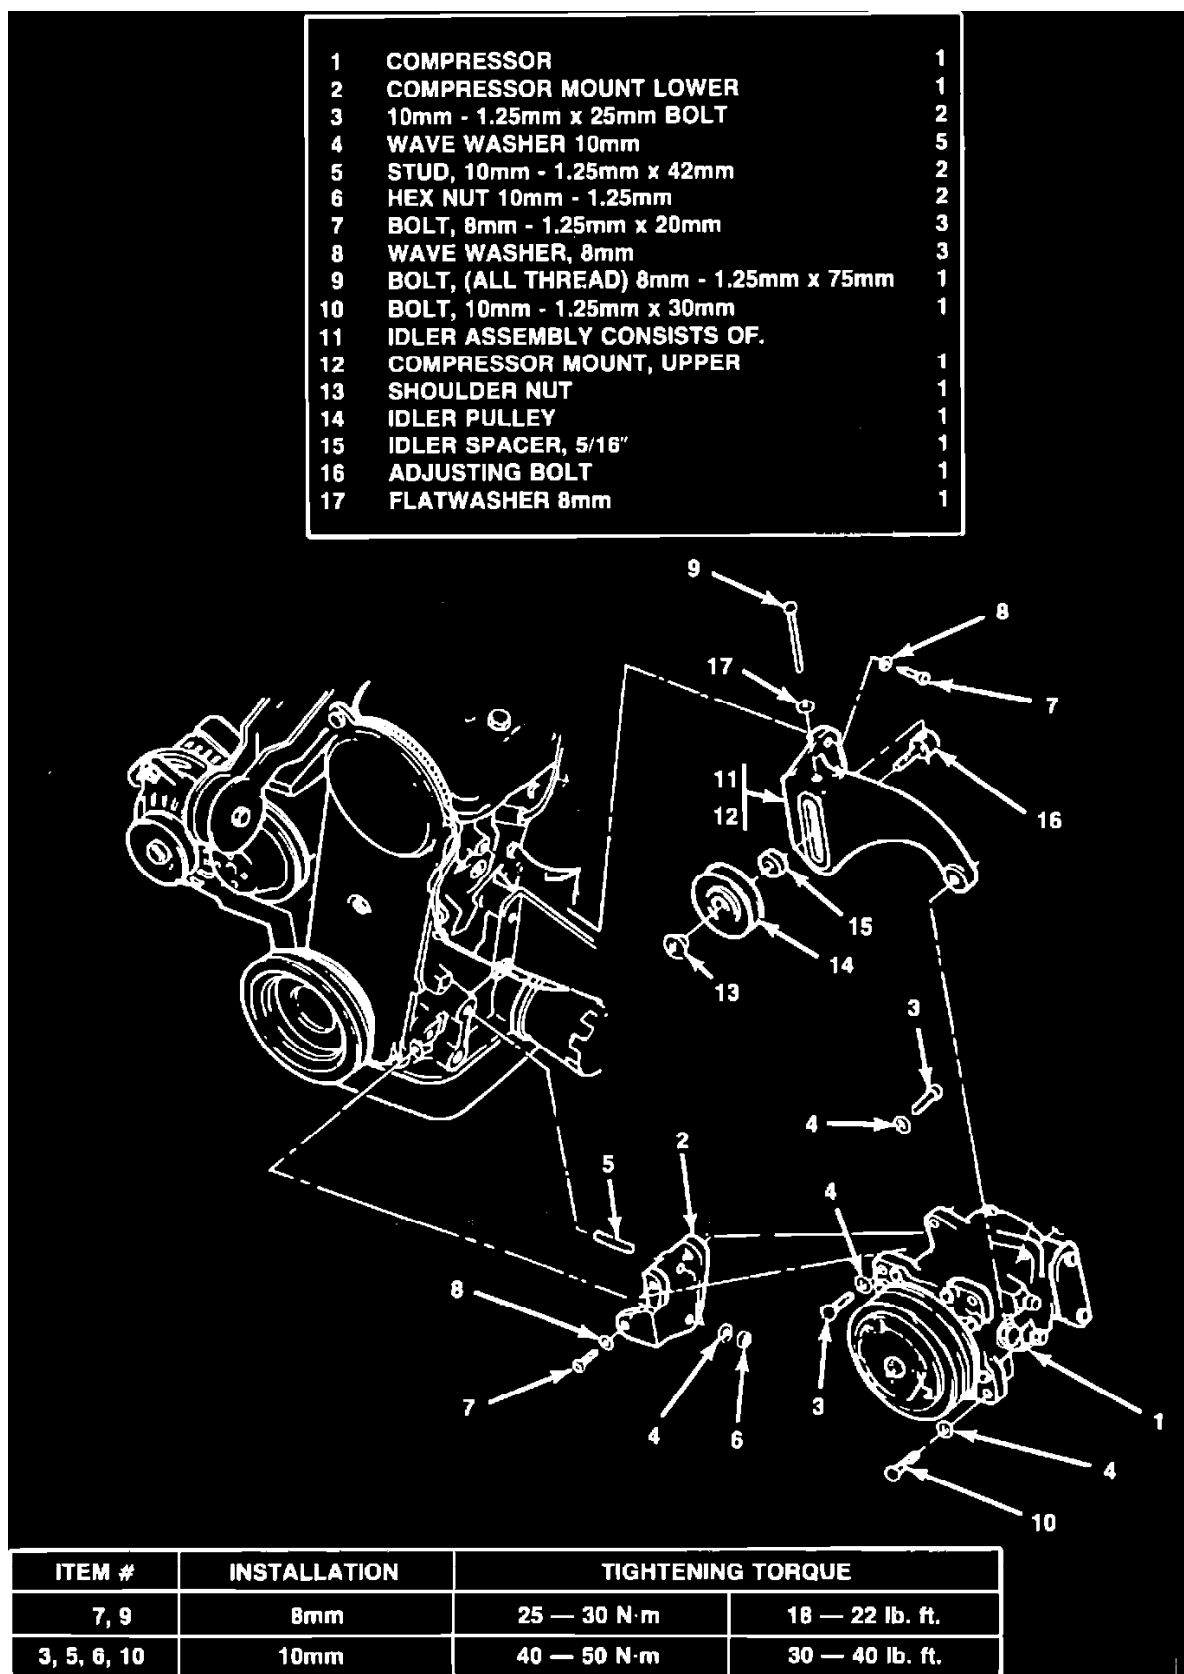
FIGURE 1

Fastener location and torques are provided in Figure 1. All compressor mounting hardware is to be checked for proper torque.

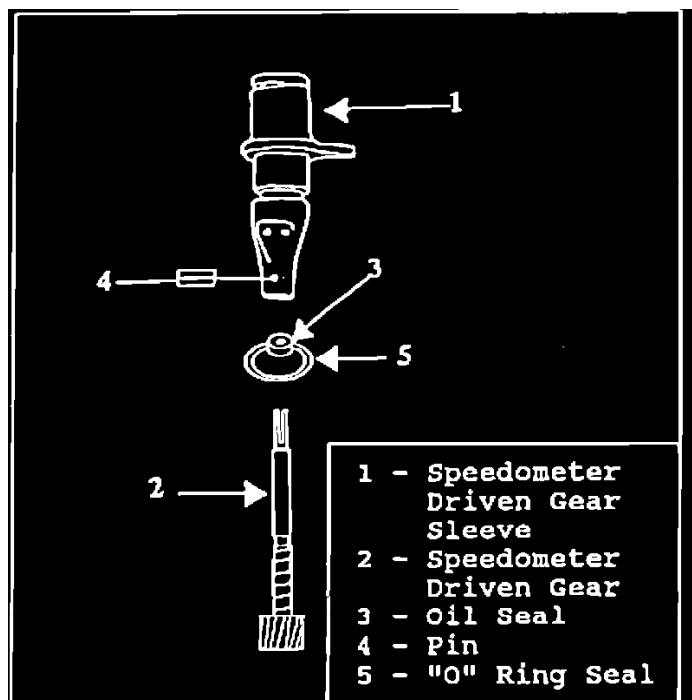
Replace the parts shown in the illustration, following the instructions in Section 7B of the Service Manual. Although the sleeve (# 1) is the only revised part, all the parts should be replaced to prevent any remaining oil from getting into the cluster again. In rare instances, the instrument cluster and/or carpet may also have to be replaced.

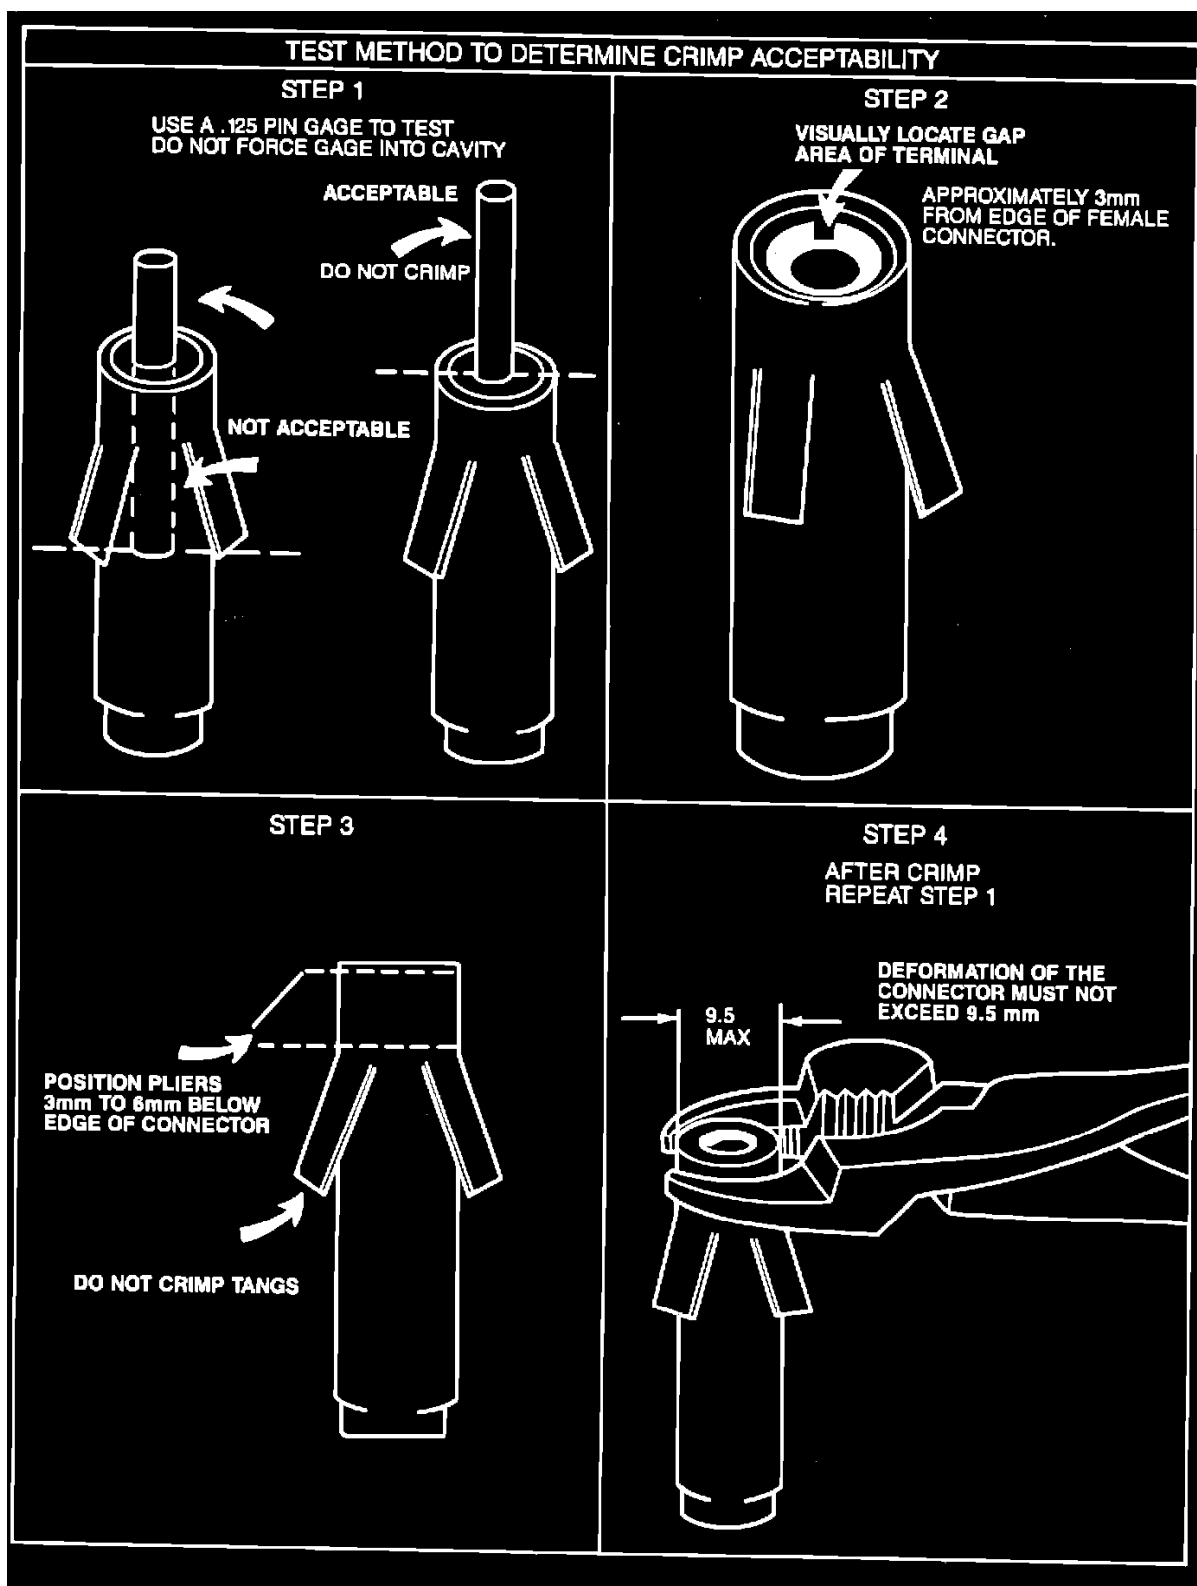
Subject: POOR AM OR FM RADIO RECEPTION

Some Chevrolet models may exhibit a condition of poor AM or FM radio reception. This may be caused by a poor contact on the female terminal of the antenna coaxial cable lead.

The illustration contains a four-step procedure to test and repair the female terminal. The opening in the female terminal should range from .120" to .125" in diameter. If the gage passes through freely, the terminal should be repaired as illustrated. Gage sets are available from Kent Moore, tool number J26900-14.

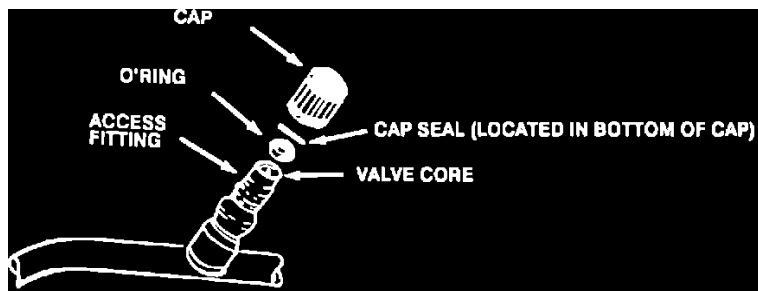
**FIGURE 1**

All Chevrolet air conditioning Hi side and Low side access fittings are supplied with a black plastic cap and seal assembly which provides the primary refrigerant seal for the service fittings.

If the cap and seal assembly is missing or loose, a significant amount of refrigerant may leak through the valve core located in the access fitting, which could result in poor A/C performance or failure.

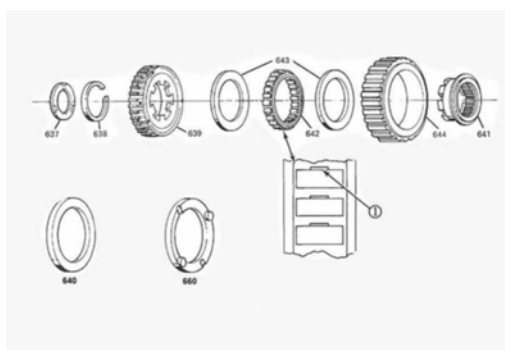
The notches above each sprag must point up as shown when assembled into the outer race.

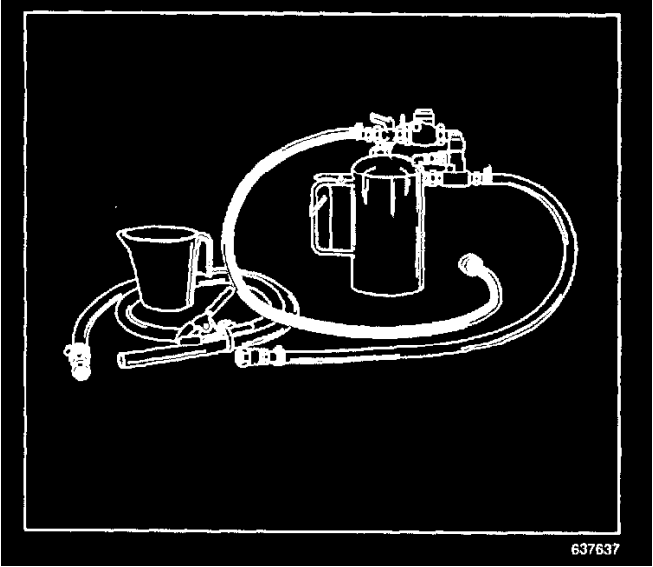
^ J 35944-A cooler flushing tool

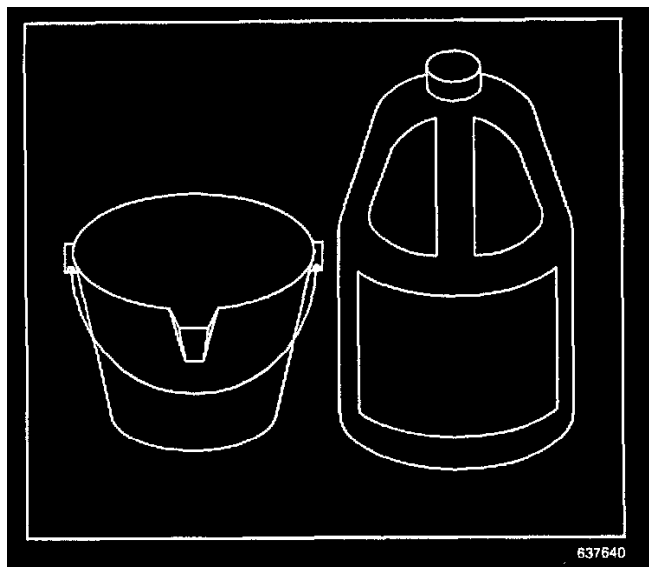
^ J 35944-22 or J 35944-CSE-A flushing solution

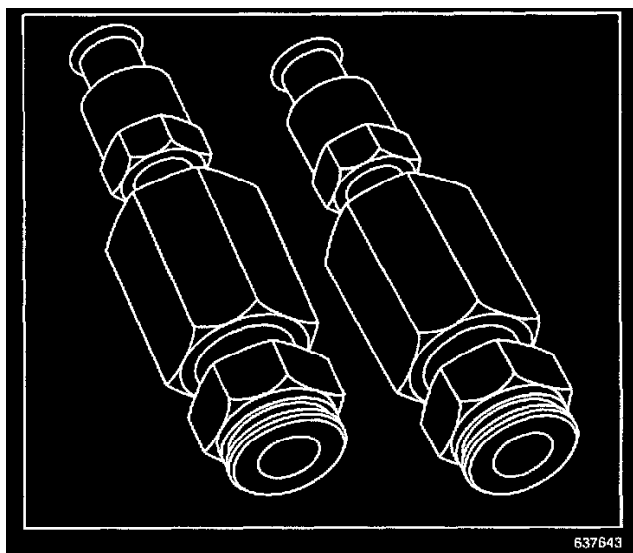
^ J 35944-200 cooler flushing adapter (4L60-E and 4L80-E)

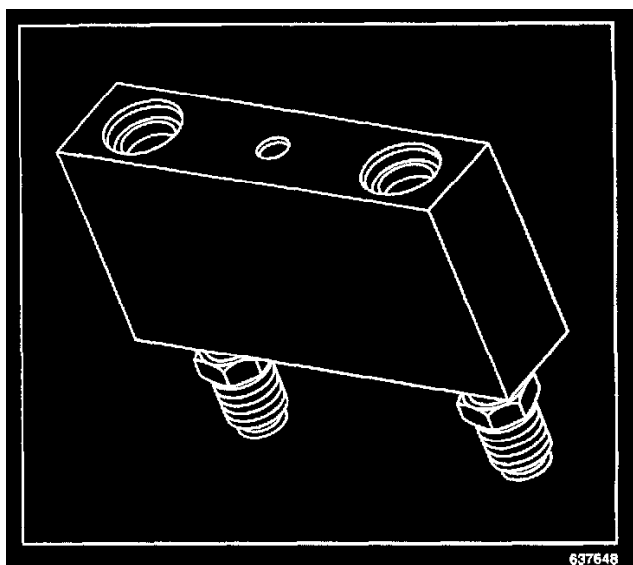
^ J 35944-440 cooler flushing adapter (4T40-E)

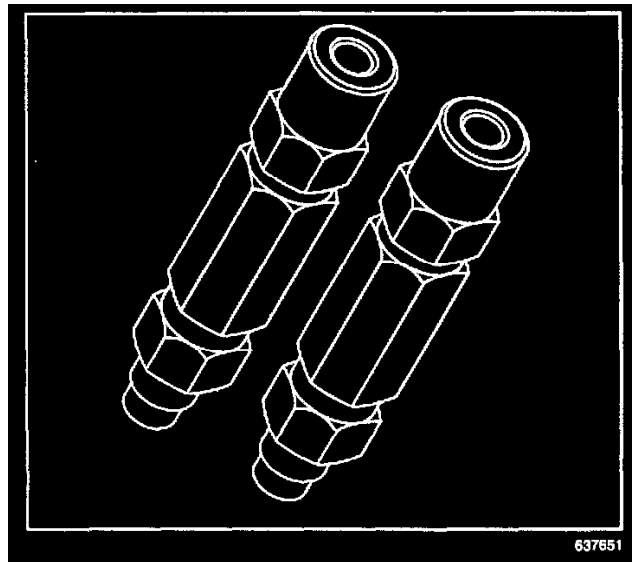
- ^ J 35944-600 cooler flushing adapter (4L60-E Y-Car)
- ^ Measuring cup
- ^ Funnel
- ^ Water supply (hot water recommended)
- ^ Water hose (at least 5/8" (16mm) ID)
- ^ Shop air supply (with water/oil filters, regulator and pressure gauge)
- ^ Air chuck (with clip if available)
- ^ Oil drain container
- ^ Five gallon (19 L) pail with lid
- ^ Eye protection
- ^ Rubber gloves

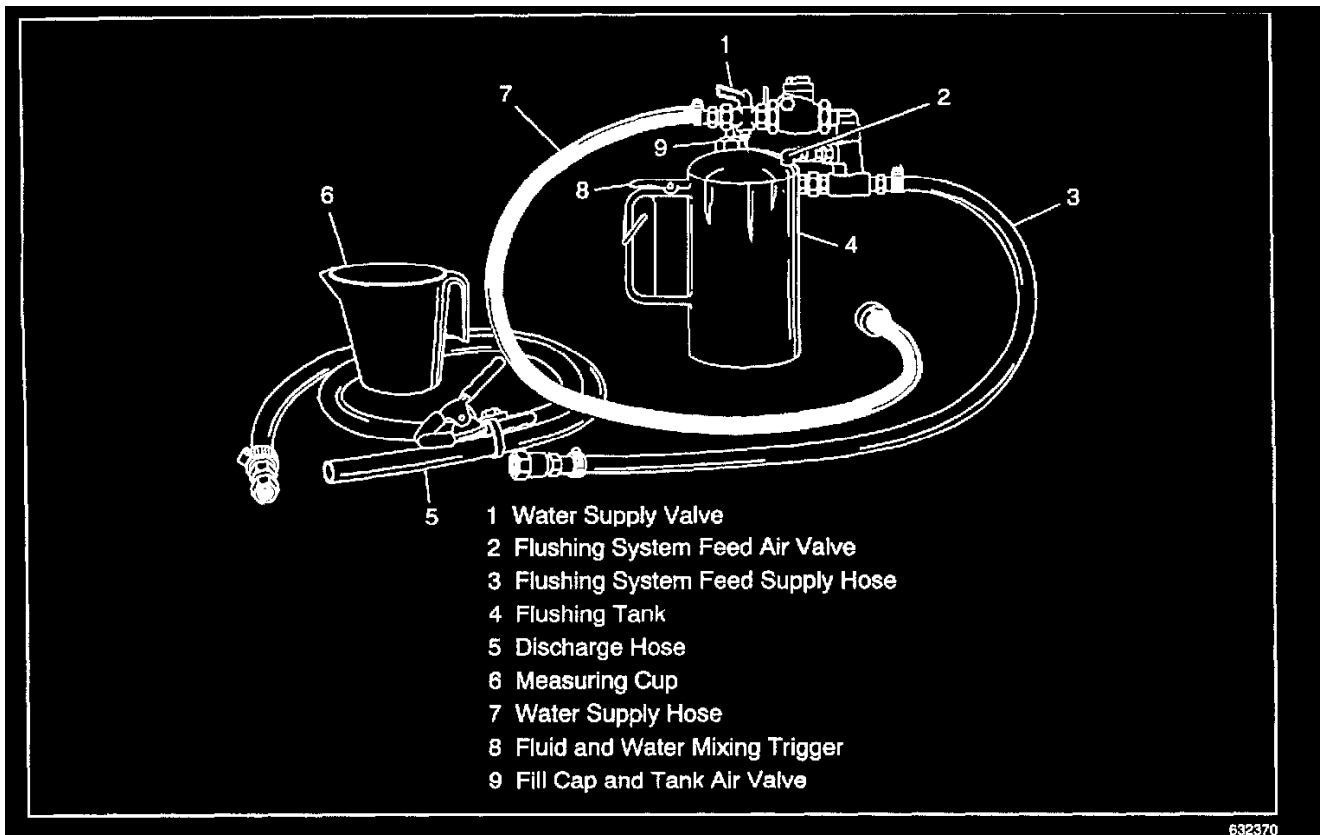
1. After the repair or replacement transmission is installed in the vehicle, do not reconnect the oil cooler pipes.

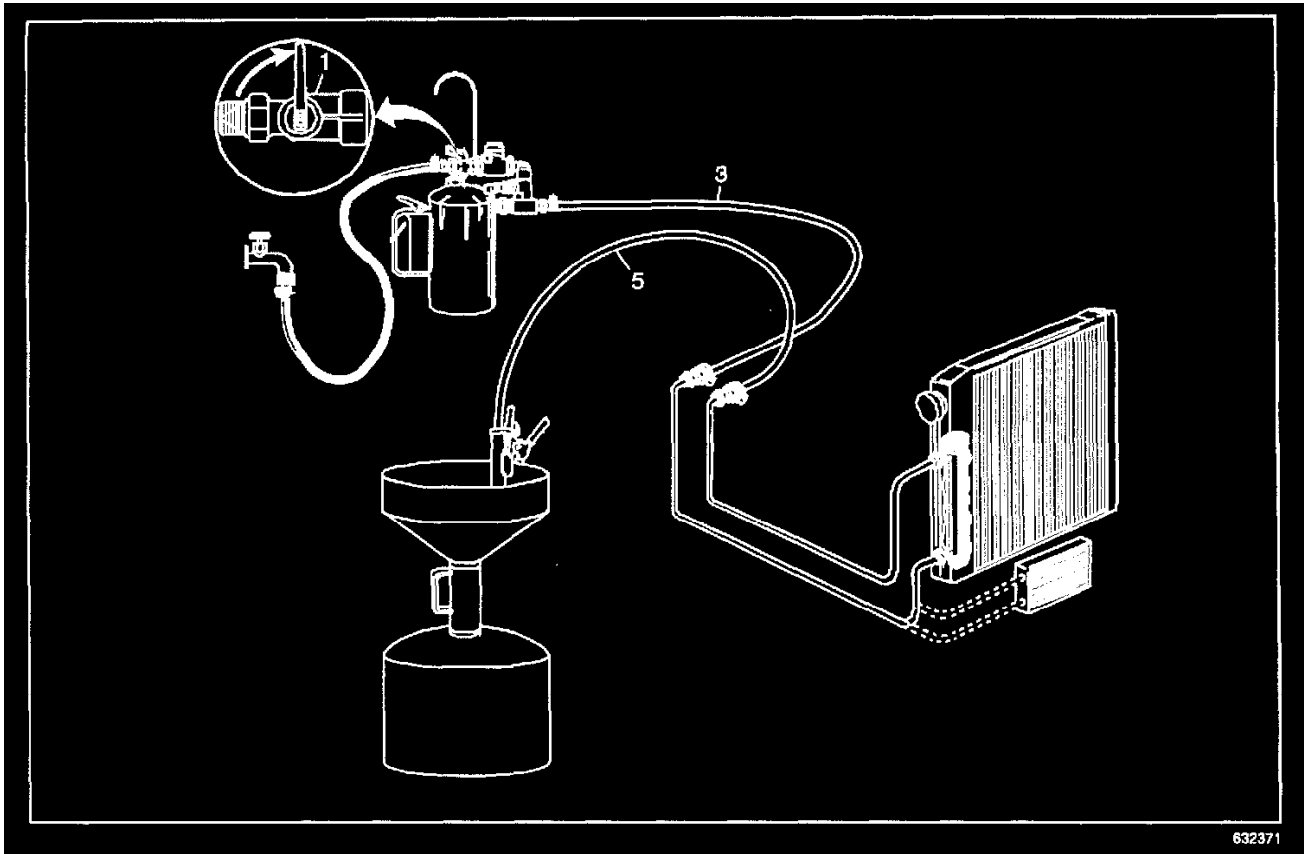
4. Connect the J 35944-A discharge hose (5) to the oil cooler return pipe. Use the J 35944-200 or the J 35944-440 if required.
5. Clip the discharge hose (5) onto the oil drain container.
6. Attach the J 35944-A to the undercarriage of the vehicle with the hook provided and connect the flushing system feed supply hose (3) from the J 35944-A to the other (feed) oil cooler pipe. Use the J 35944-200 or the J 35944-440 if required.
7. With the water supply valve (1) on the J 35944-A in the OFF position, connect the water supply hose (7) from the J 35944-A to the water supply at the faucet.
8. Turn ON the water supply at the faucet.

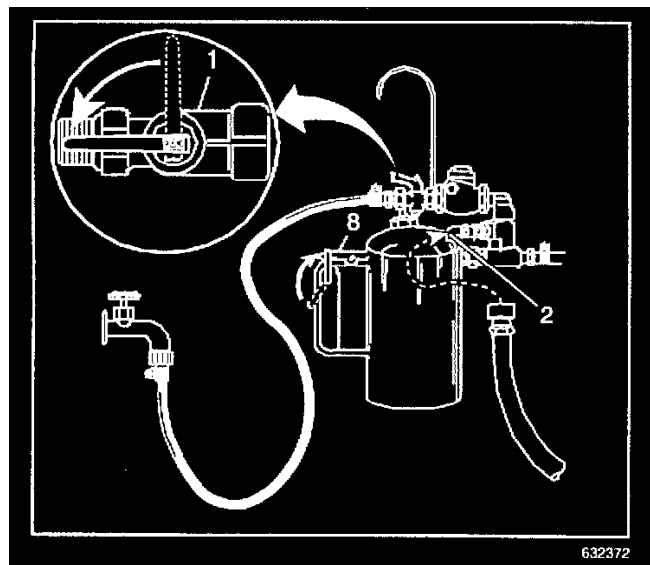
1. Turn the J 35944-A water supply valve (1) to the ON position and allow water to flow through the oil cooler and pipes for 10 seconds to remove any remaining transmission fluid. If water does not flow through the oil cooler and pipes, the cause of the blockage must be diagnosed and the plugged component must be repaired or replaced. Continue with the cooler flushing and flow check procedure once the blockage is corrected.
2. Turn the J 35944-A water supply valve (1) to the OFF position and clip the discharge hose (5) onto a five gallon (19 L) pail with a lid, to avoid splashback.
3. Turn the J 35944-A water supply valve (1) to the ON position and depress the trigger (8) to mix cooler flushing solution into the water flow. Use the clip provided on the handle to hold the trigger (8) down. The discharge will foam vigorously when the solution is introduced into the water stream.

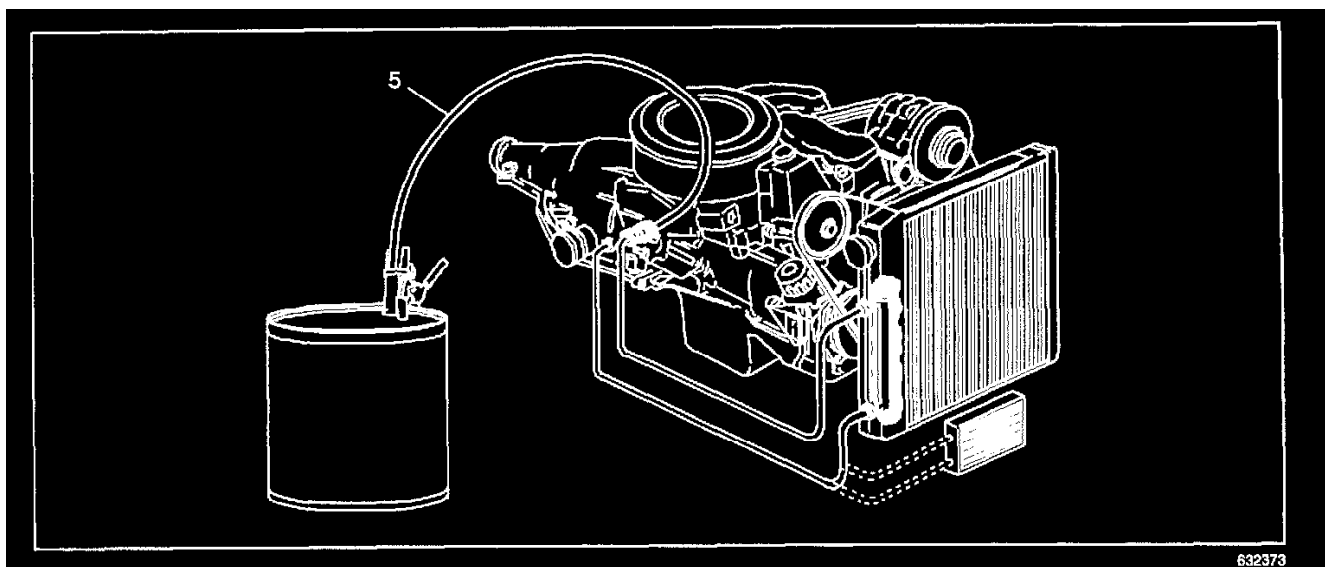
1. Disconnect both hoses from the oil cooler pipes. Connect the oil cooler feed pipe to the transmission and the return pipe to the discharge hose (5). Clip the discharge hose (5) onto the empty oil drain container.
2. Confirm the transmission is filled with automatic transmission fluid. Refer to SPECIFICATIONS in Section 7 of the appropriate Service Manual for the correct automatic transmission fluid capacity.
3. Start the engine with the transmission in PARK range and run for 30 seconds. A minimum of two (2) quarts (1.9 L) must be discharged during this 30 second run time.
  - ^ If fluid flow is greater than 2 qt (1.9 L) in 30 seconds, go to step 4.
  - ^ If fluid flow is less than 2 qt (1.9 L) in 30 seconds, perform the following diagnosis:

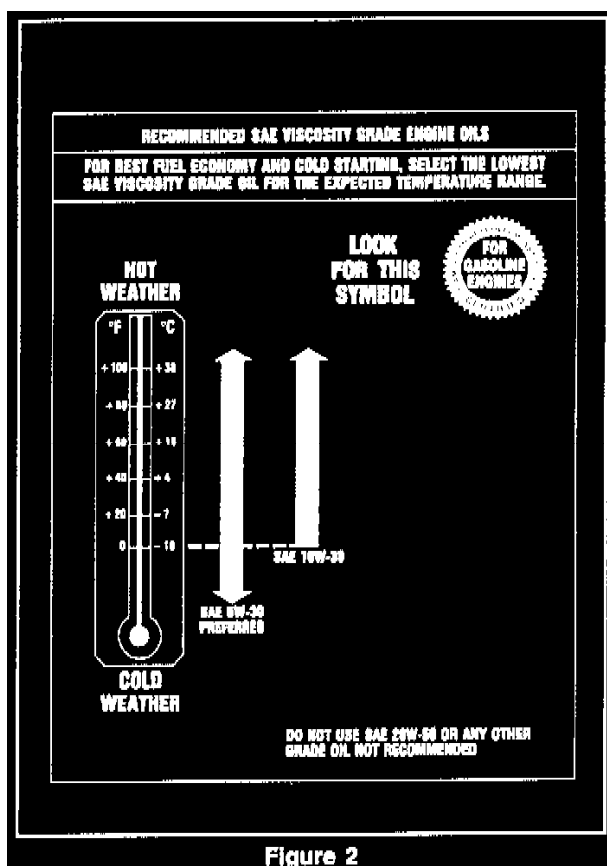
Figure 2

You should also use the proper viscosity oil for your vehicle, as shown in the following chart: (Figure 2) As shown in the chart, if you have the 3.1L engine, SAE 5W-30 is best for your vehicle. However, you can use SAE 10W-30 if it's going to be 0° F (-18° C) or above. These numbers on

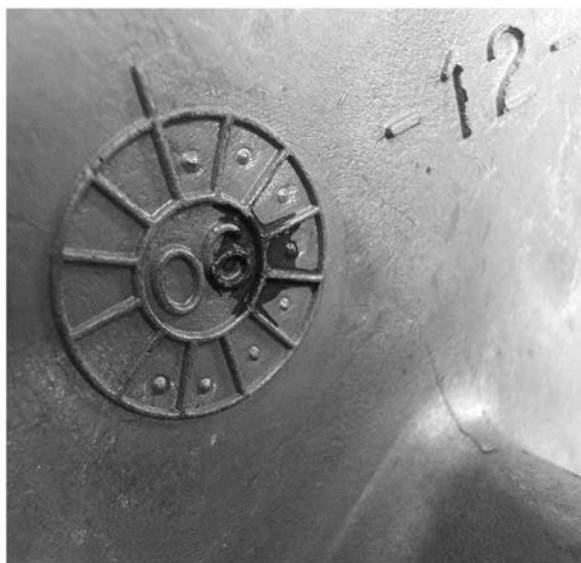
### Date Code Example

The sample picture is from a 2.4L 4 cylinder front engine cover. On this part, the date code appears as a "clock" wheel.

On the first day for each month of production, the casting dye is pulled. Using a center punch, an operator manually punches another point on the date code wheel. To decode, you simply count the number of center punches, or impression, in the dial of the clock and you have the month.
