Vehicle: Application and ID

## Engine: Service and Repair

## Camshaft: Service and Repair

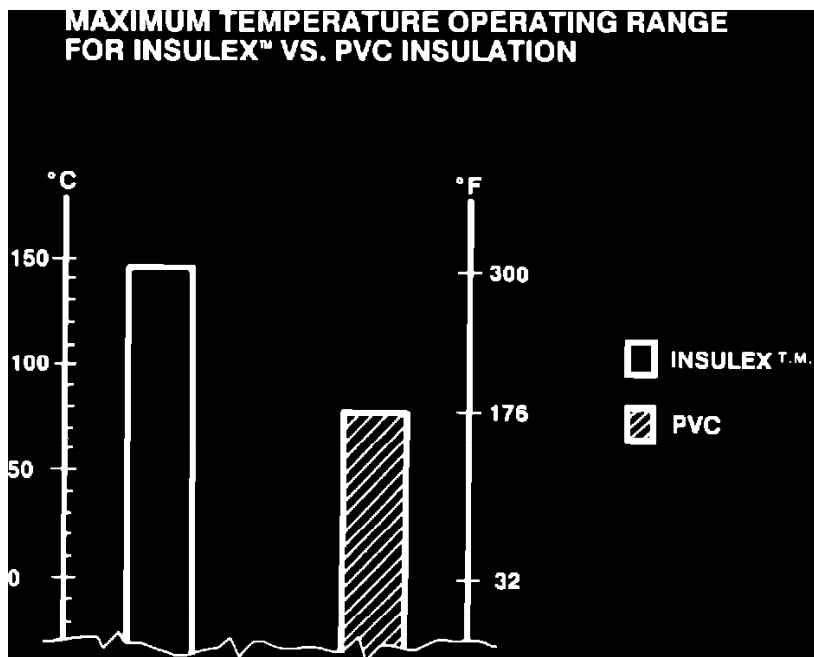
Subject: SELECTION OF CORRECT WIRE INSULATION MATERIAL FOR WIRE REPAIRS

Wiring repairs on a vehicle in an area that is not subjected to high temperatures (i.e. passenger compartment, instrument panel or cargo compartment) may be accomplished using a cable of sufficient size (sq.mm or gage) with a general purpose insulation. The common general purpose cable insulation material is polyvinyl chloride (PVC). PVC insulation should not be used for wiring repairs in areas where temperatures exceed 80 degrees C (176 degrees F).

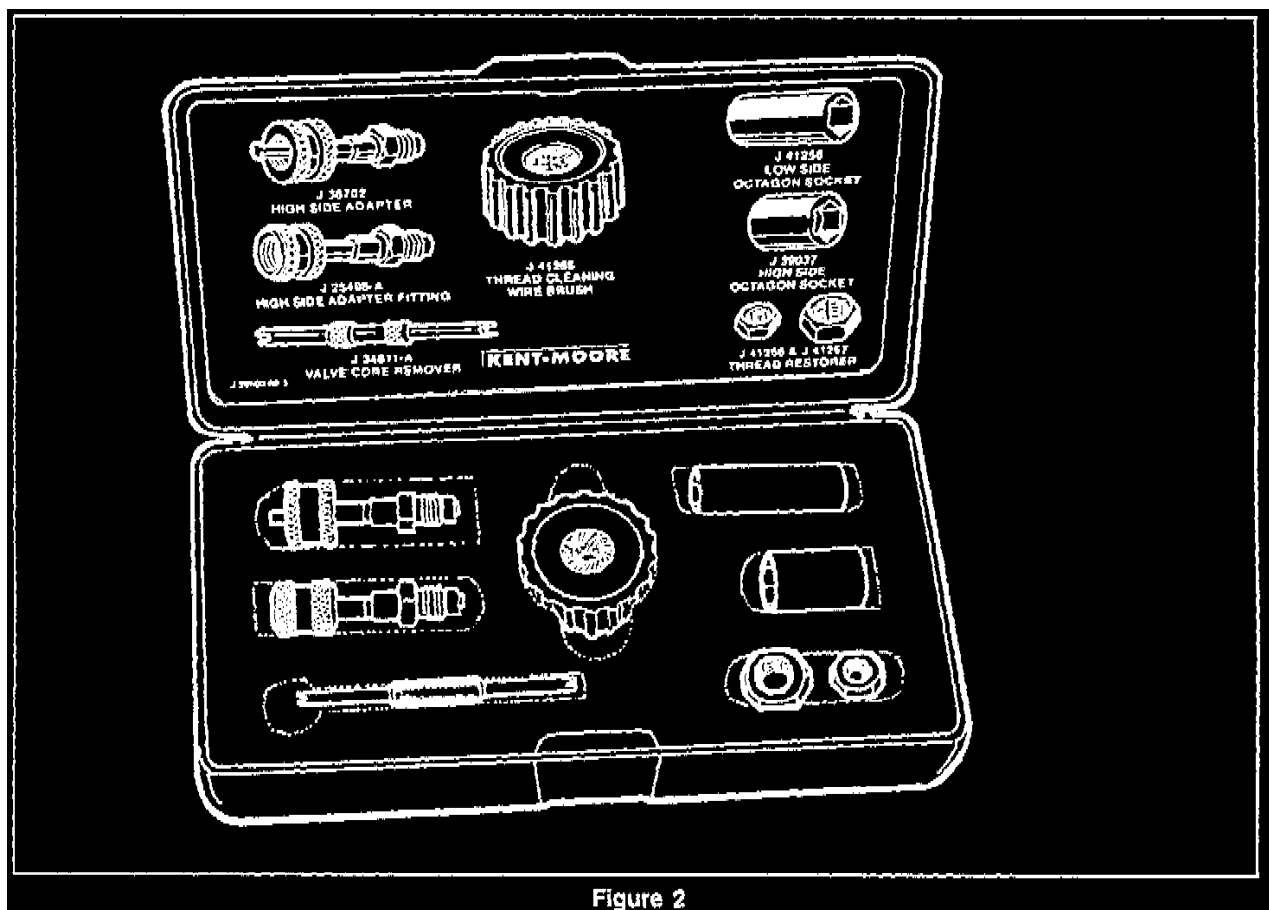
Figure 2

^ J 39500-275 Tool kit, including the following: (See Figure 2)

- J 34611-A Double ended valve core remover
- J 25498-A High side adapter fitting
- J 38702 Deep valve core adapter fitting
- J 41265 Thread cleaning wire brush
- J 41266 Low side port thread restorer
- J 41267 High side port thread restorer
- J 39037 High side octagon socket
- J 41256 Low side octagon socket

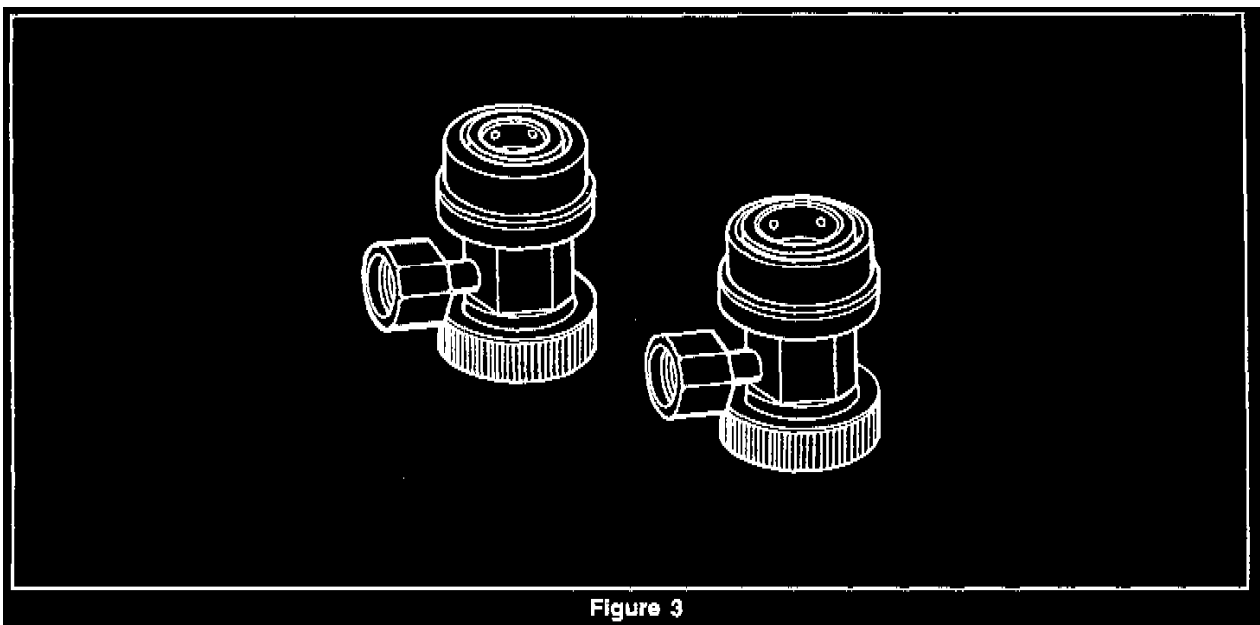
Figure 3

New low profile, quick connect couplers, J 39500-20A (High side), and J 39500-24A (Low side), have been released as essential tools, to attach to the ACR4 (see Figure 3). These are much smaller couplers than the existing ones, and will allow attachment to the port fittings in much tighter quarters.

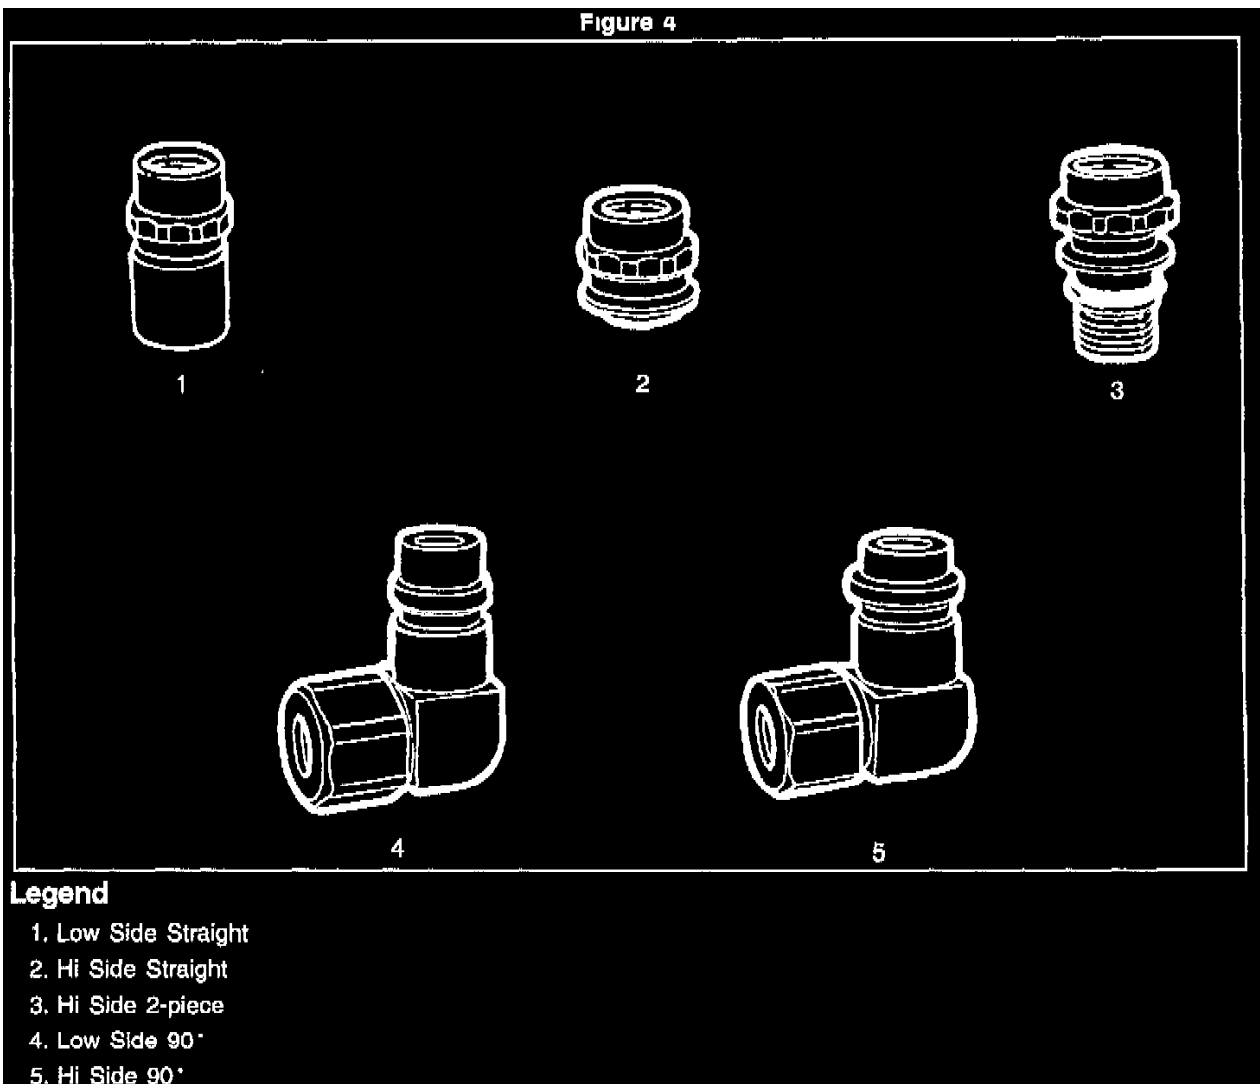
Select and install the proper R-134a fittings (shown in Figure 4) from the chart below, based on how the ACR4 couplers will attach. Also, remember to check for proper hood clearance with the conversion fittings. Try the straight fittings first. The two-piece high side fitting is used when the existing fitting is screwed into the pipe fitting (some 1992, and nearly all 1993 models, use these fittings). Use the 90° elbow if the straight fitting does not allow the ACR4 couplers to connect.

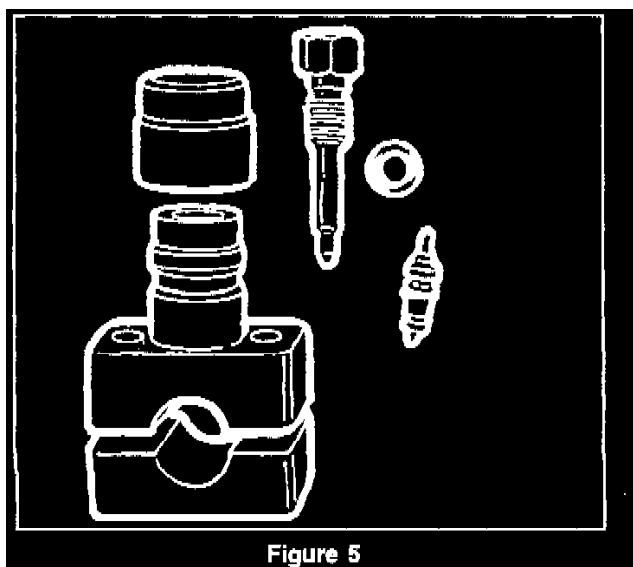
An additional type of conversion port fitting has been developed. This fitting is called a saddle clamp valve (see Figure 5). It can be clamped directly on a metal refrigerant line, and will be used if the existing fitting is damaged or is inaccessible. A drop of a thread locking compound, such as Loctite(R) 242, should be used on each bolt to prevent the threads from loosening.

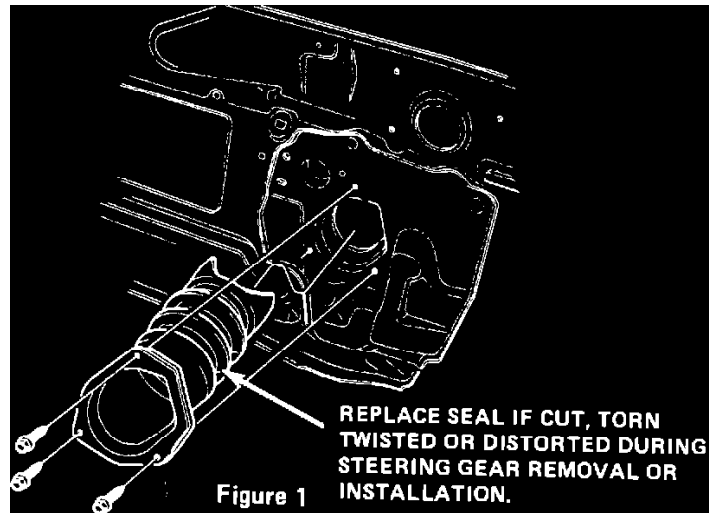
FIGURE 1

When removing or installing any rack and pinion steering gear for service, be sure to inspect the intermediate steering shaft or steering coupling seal for cuts or tears which would allow noises to be transmitted into the passenger area. Also inspect the seal for being twisted, crushed or distorted as this can cause a clunk or rubbing sound. See Figure 1 for typical cavalier car seal. Replace the seal as necessary.

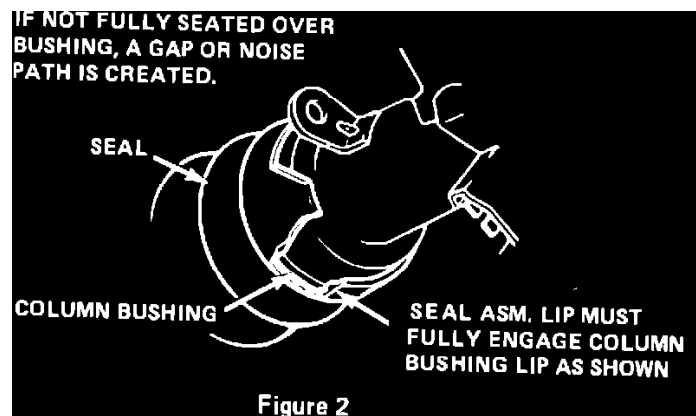
FIGURE 2

On Cavalier models, check the upper portion of the steering coupling seal to be sure it is fully seated over the bushing or a noise path could be created. The seal is retained by the lip on the bushing. Refer to Figure 2. On Celebrity models, check the seal to be sure it is securely fastened to the cowl and lower column.

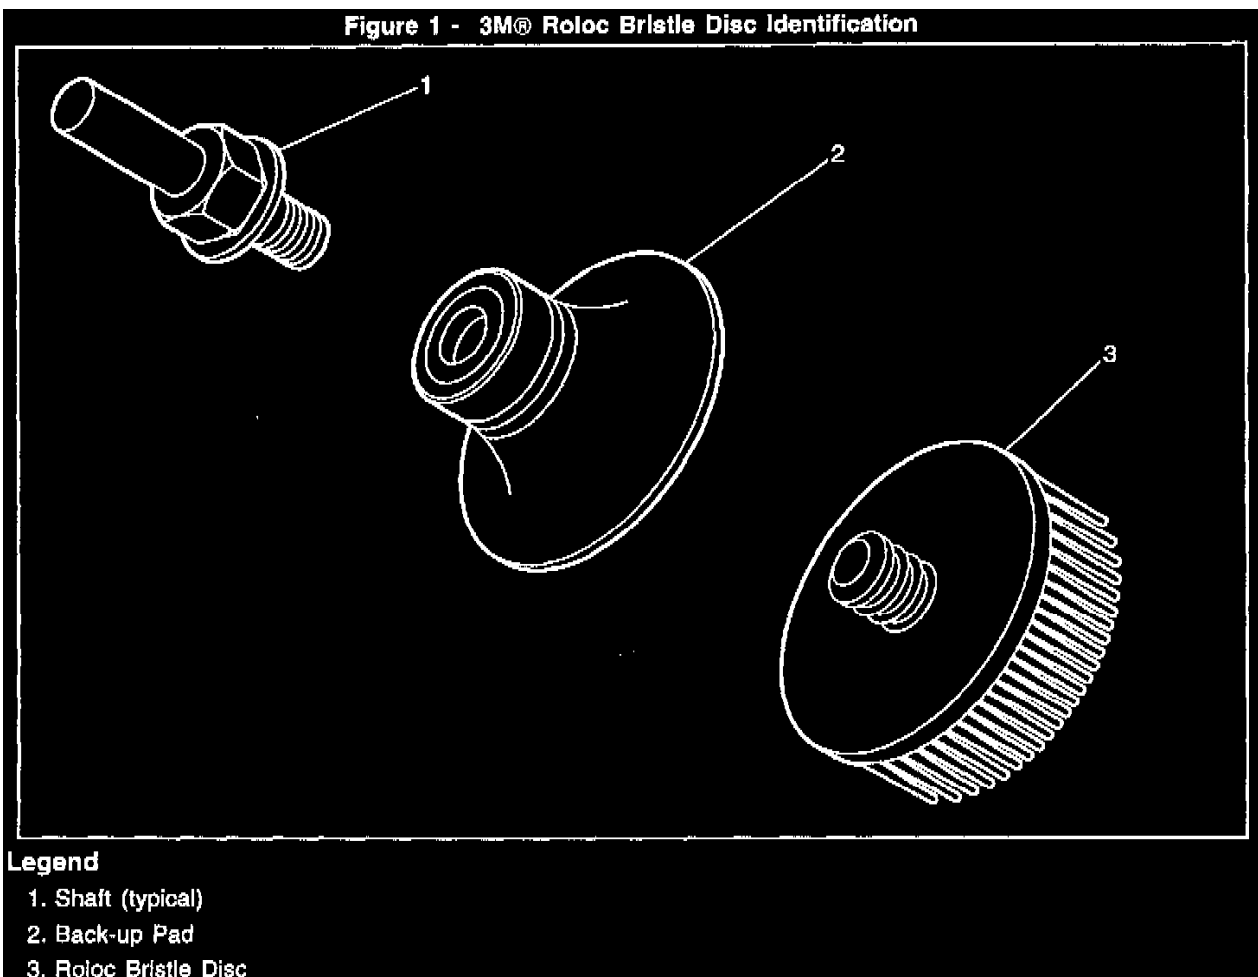
**Figure 1 - 3M® Roloc Bristle Disc Identification**

The Discs (see Figure 1 - 3M(R) Roloc Disc Identification) are available in different grit levels, with suggested applications as shown:

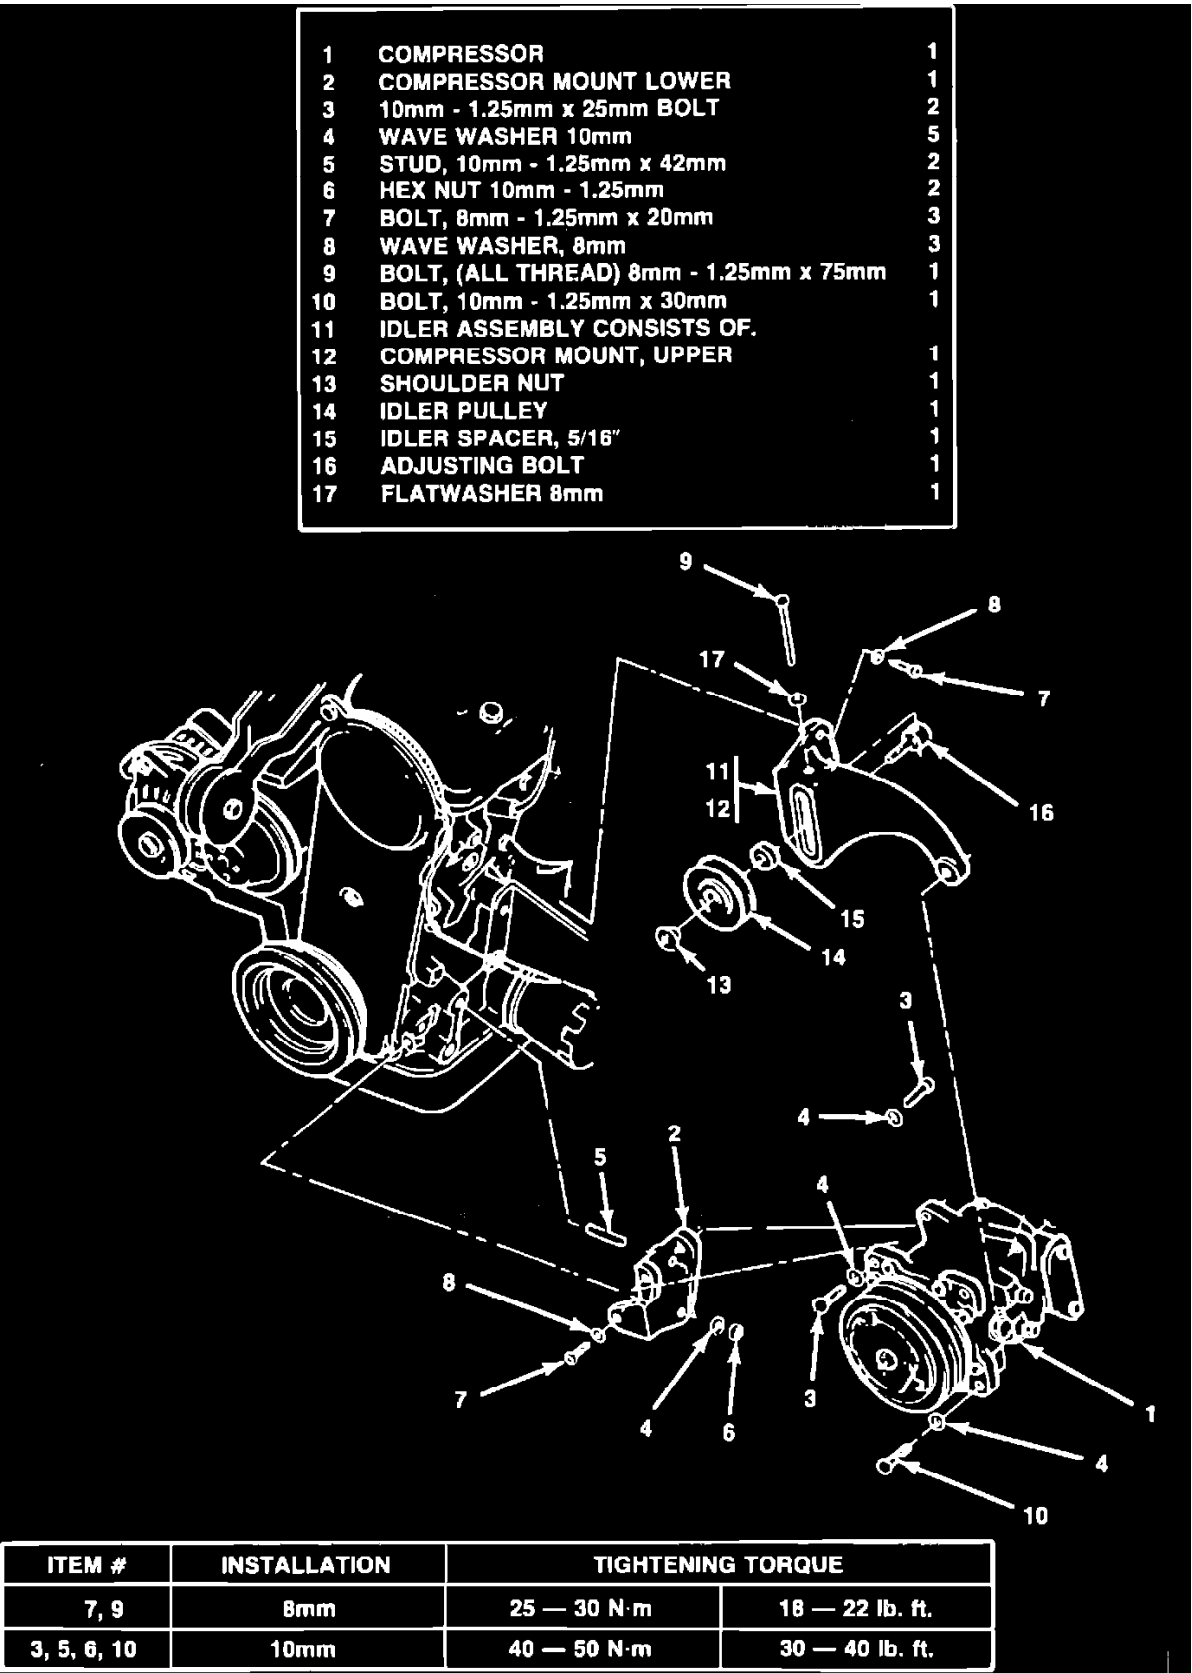
FIGURE 1

Fastener location and torques are provided in Figure 1. All compressor mounting hardware is to be checked for proper torque.

First tighten the 8 mm bolt (7). Second, tighten two (2) 10 mm nuts (6) Final assembly must be done from below vehicle using hand wrenches to assure sufficient torque.

3. Install upper bracket with idler pulley attached to engine using two (2) 8 mm x 1.25 mm x 20 mm bolts (7) and wave washers (8) and to compressor using one (1) 10 mm x 1.25 mm x 30 mm bolt (10) and wave washer (4). Tighten two (2) 8 mm bolts (7) and one 10 mm bolt (10).
4. **THIS STEP IS VERY IMPORTANT:** From below vehicle, tighten two (2) bolts (3) previously snugged through compressor ears (with Loctite), using hand wrenches to assure proper torque.

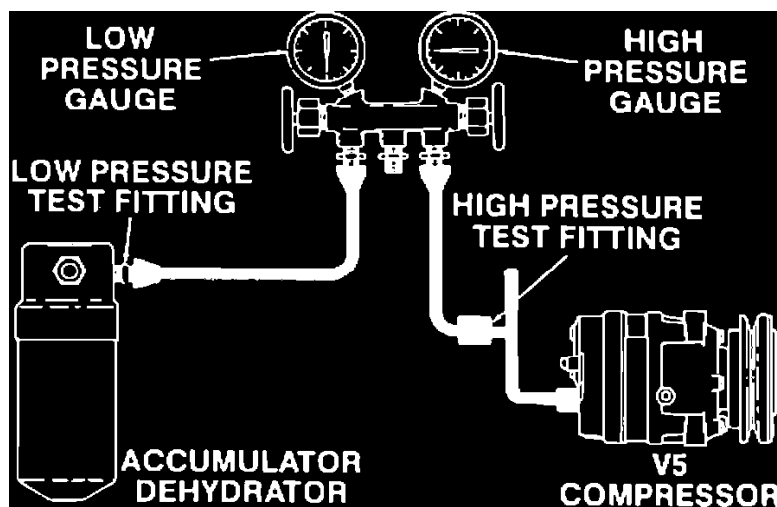
FIGURE 1 - TESTING HOOKUP

1. Connect gage set (Figure 1) to high and low A/C service fittings.

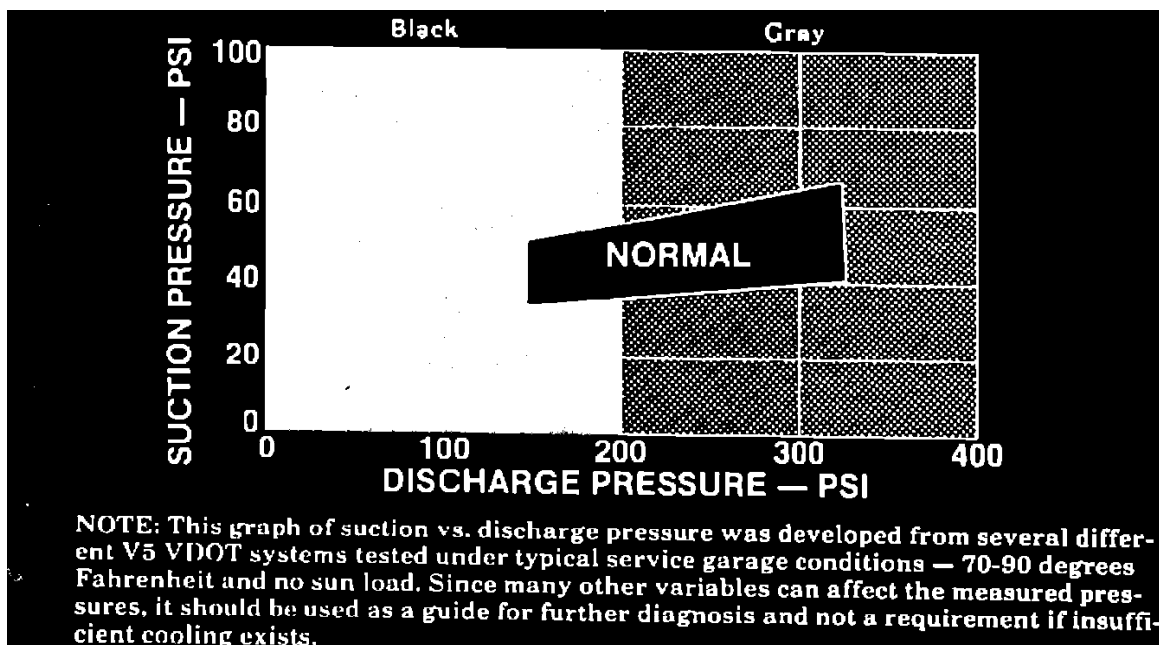
FIGURE 2 - SUCTION VS DISCHARGE PRESSURE

4. Record and evaluate test results:
- a. Record suction and discharge pressures. On systems having condenser fans that cycle on and off, pressure readings should be made when the fan is on.
  - b. Check diagnostic test chart (Figure 2) and locate intersection of recorded suction and discharge pressures. Determine color of area in which the pressures intersect (white, gray, or black).
  - c. Go to the proper color heading for Diagnosis and service Procedures. Diagnose in the sequence given to minimize time and expense of repair. Service tips are given with each diagnosis.

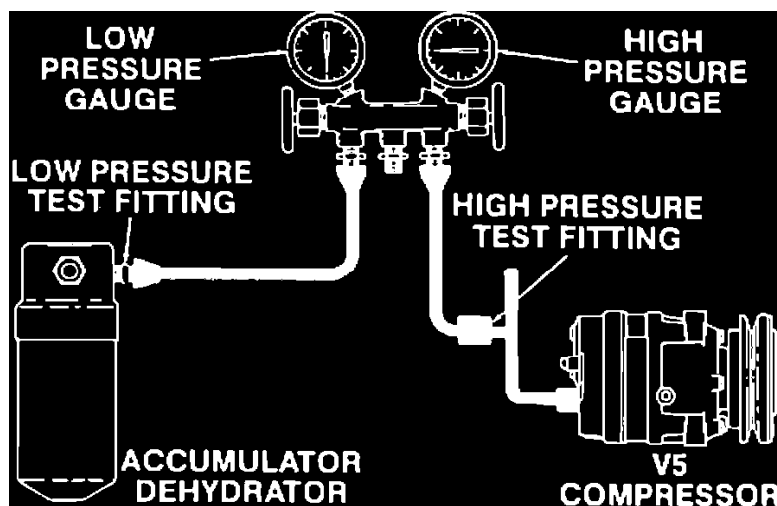
**FIGURE 1 - TESTING HOOKUP**

- Connect gage set (Figure 1) to high and low A/C Service fittings.
- Check gage accuracy by reading both gages. Correct gages as necessary.
- Disconnect blower motor.
- Set test conditions:
  1. Start engine and run at fast idle speed.
  2. Open hood, close windows and doors.
  3. Set A/C controls to LOW blower and MAX cooling.
- Record and evaluate test results:
  1. If suction pressure is 25-35 psi, control valve is functioning properly.

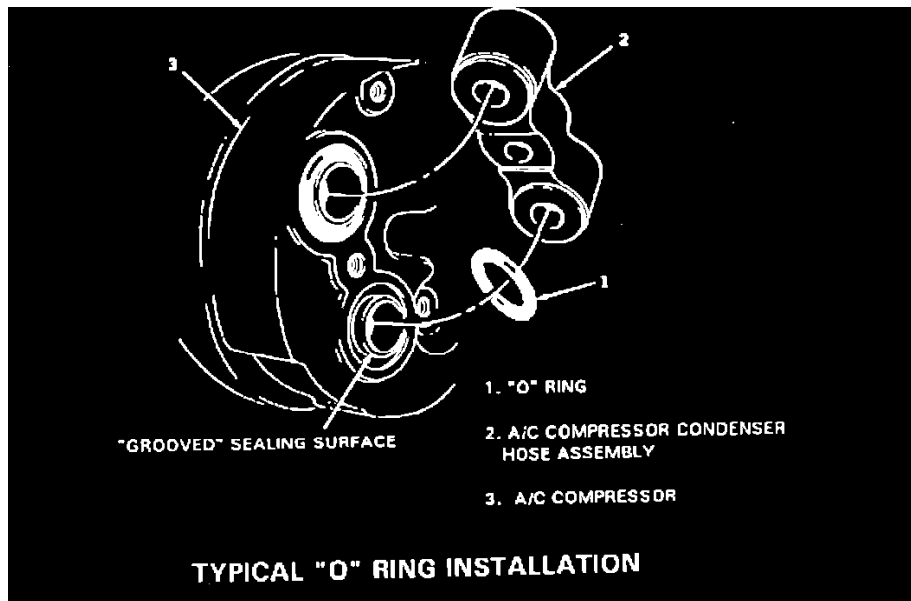
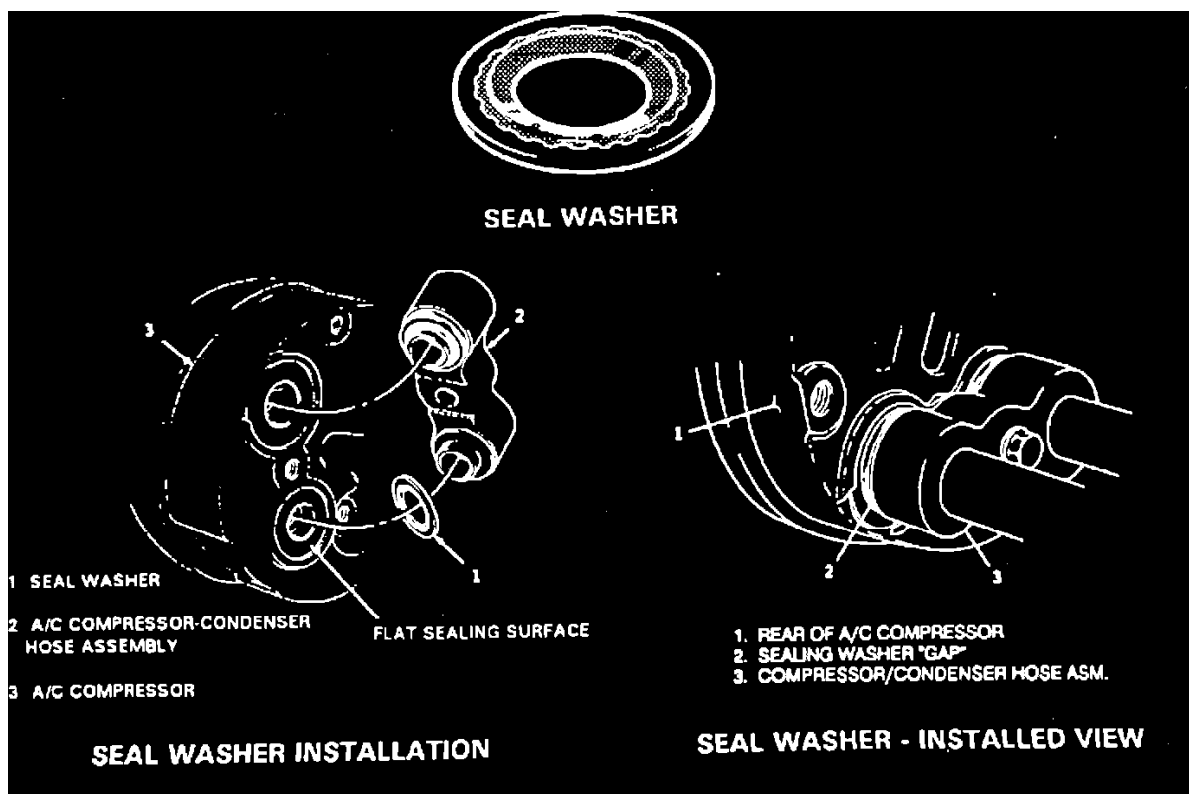
There has been a redesign of the GM Harrison A/C compressor rear head and the mating face of the attaching hose assembly. The redesign eliminates the two "O" ring seals from the compressor, replacing them with two "sealing washers added to the suctional discharge hose set". Each sealing washer consists of a metal washer with an integral molded rubber seal. (Refer to Illustrations).

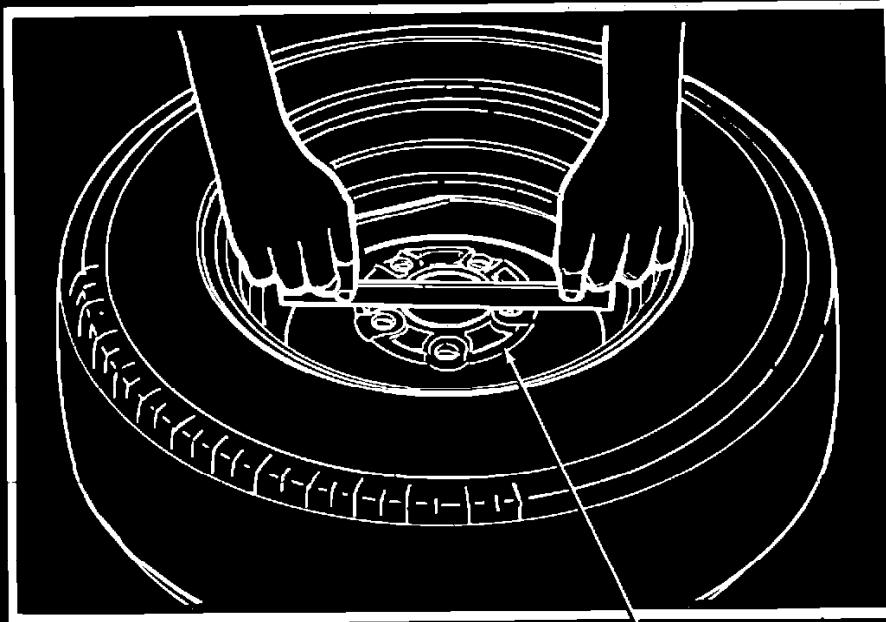
OUTER RING

- A. Obtain a straight edge approximately 8 - 9 inches long and, while holding it in two hands as shown, place it on the mounting surface of the wheel and try to rock it up and down.
- B. Repeat the above procedure on three or four different positions on the wheel mounting surface.
- C. The outer ring of the mounting surface is normally raised above everything inside it. If a wheel mounting surface has been bent on a tire changer, it will be raised above the outer ring and the straight edge will rock on this "raised" portion.
- D. If a bent wheel is found, it must be replaced.

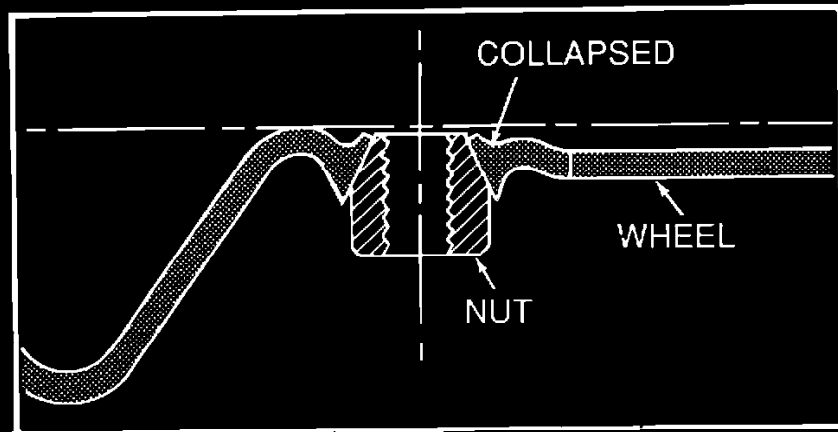
- A. Obtain a straight edge approximately 8-9 inches long and, while holding it in two hands, as shown in the attached illustration, place it on the inboard mounting surface of the wheel and try to rock it up and down.
- B. Repeat the above procedure on three or four different positions on the wheel inboard mounting surface.
- C. The outer ring of the mounting surface is normally raised above everything inside it. If a wheel mounting surface has been bent on a tire changer, it will be raised above the outer ring and the straight edge will rock on this "raised" portion.
- D. If a bent wheel is found, it must be replaced.

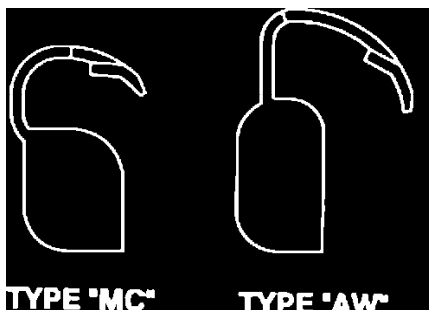
There are two types of coated wheel weights available to fit the GM vehicles (see illustration). Both types of weights are available from GMSPO in 1/4 ounce increments. See usage chart below to determine which type weight is correct for the vehicle.

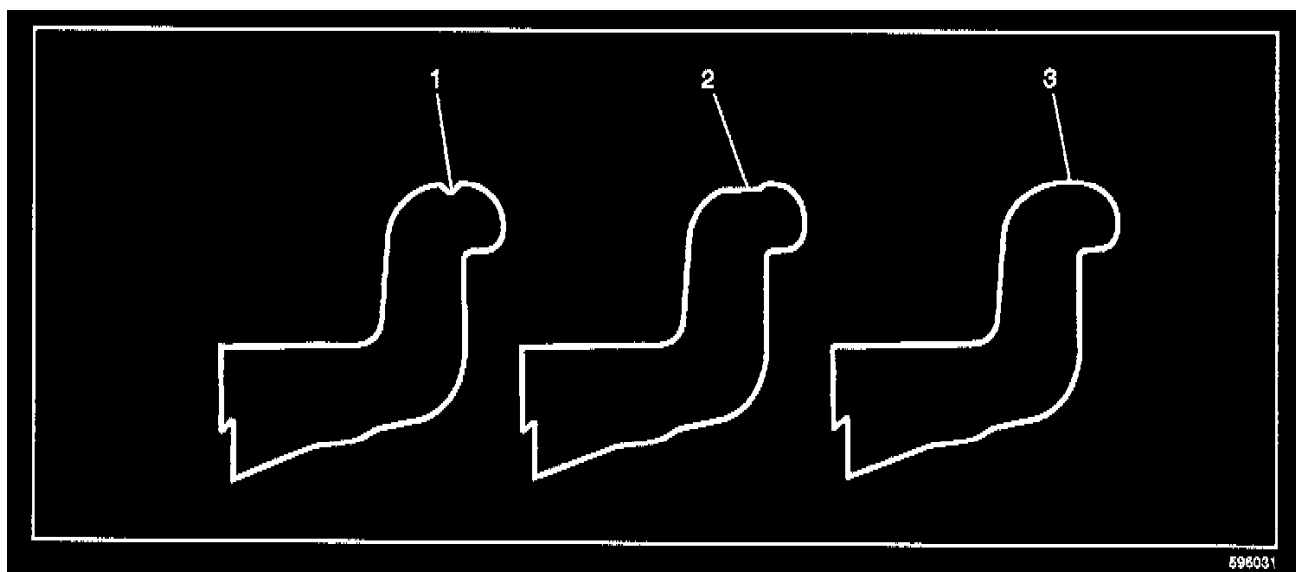
Original equipment chrome plated aluminum wheels can be identified by either a balance weight clip retention groove (1) or a step (2) that is machined around both of the wheel's rim flanges. The rim flanges (3) of painted original equipment aluminum wheels do not have a groove or a step.

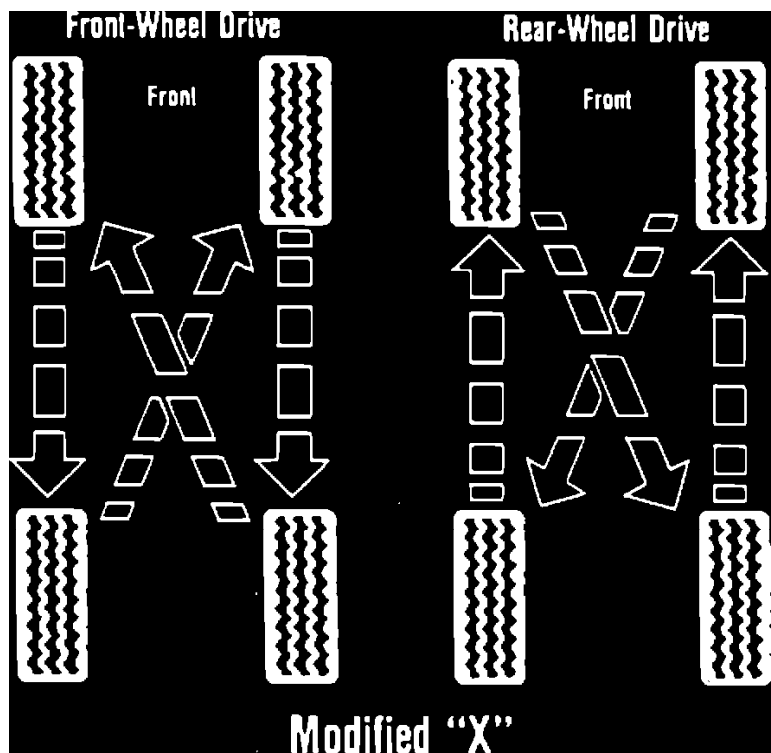
FIGURE 1

Figure 1 modified "X" tire rotation, front wheel drive, rear wheel drive. This rotation pattern eventually gets each tire on all four positions. It gets those tires on the non-drive axle, which are most prone to irregular wear, to turn in the opposite direction. This will equalize wear quickest, and tire noise related to tread wear will actually become quieter after a few thousand miles.

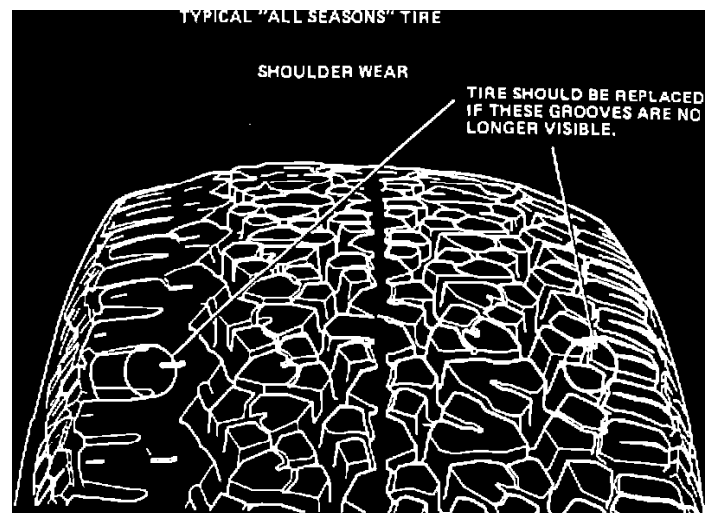
FIGURE 2

Figure 2 evaluating tire wear. Typical all-season tire. Tire should be replaced only if these grooves are no longer visible within first 12,000 miles.

Irregular/premature tire wear is aggravated by excessive toe-in (or toe-out). Excessive camber can also be a contributor, as can operating conditions, such as city driving with a lot of cornering. Irregular tire wear usually occurs on non-drive axles, such as the front wheel positions of rear drive vehicles. An early indication may be an increase in tire noise. In most cases, modified "X" tire rotation, which is a scheduled maintenance at 7500 miles, will equalize tire wear (see Figure 1). Some amount of wear is expected and should be considered normal. Only when the cross grooves in the tread disappear within 12,000 miles should the tires be replaced under warranty (see Figure 2). Even when these grooves disappear, however, the tire is normally only half worn in this area. Whenever tires are replaced for this reason, alignment should be checked and reset to specification, if necessary. If tires are needed for any of the above conditions, they should be purchased from your local tire outlet. If tires are not readily available, each tire manufacturer has a toll-free assistance line for car and truck dealers. These numbers have been previously provided. The tire invoice amount should be entered as a net item on the warranty claim. Labor code E0420, replace wheel and/or tire, should be used.

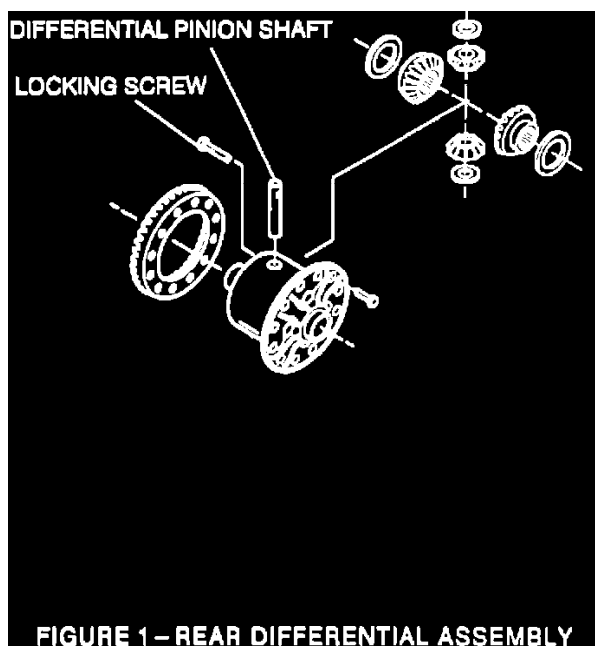
Anytime a differential pinion shaft locking screw is removed (Figure 1), it is important to coat the screw threads with Loctite 242 (GM Part number 12345382), or equivalent, before reinstalling. These screws are coated with an adhesive which helps to prevent the screw from loosening in the case. When this screw is removed, the adhesive is also removed. If a new locking screw is necessary, they are available through GMSPO and are coated with the correct adhesive.

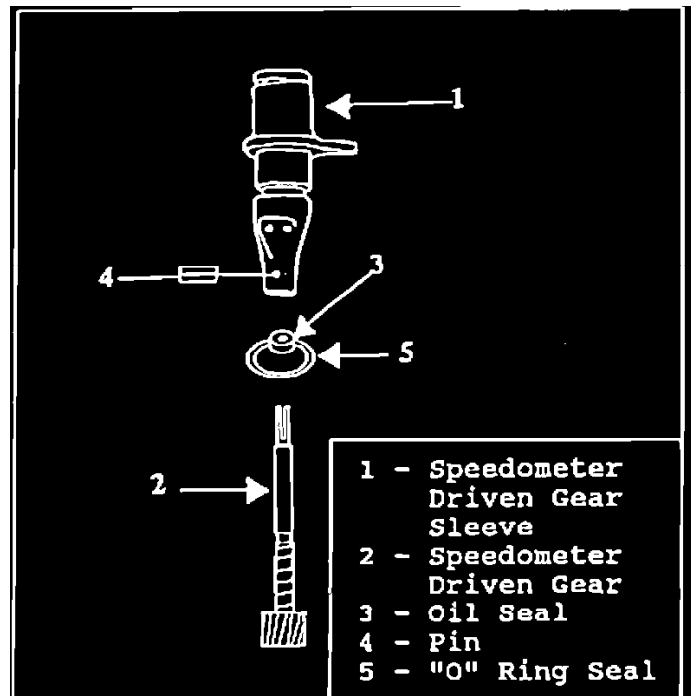
Replace the parts shown in the illustration, following the instructions in Section 7B of the Service Manual. Although the sleeve (# 1) is the only revised part, all the parts should be replaced to prevent any remaining oil from getting into the cluster again. In rare instances, the instrument cluster and/or carpet may also have to be replaced.

The oil used to lubricate the speedometer cable cannot drain back into the transmission because of the design of the driven gear sleeve. The new style has an oil drain hole added.

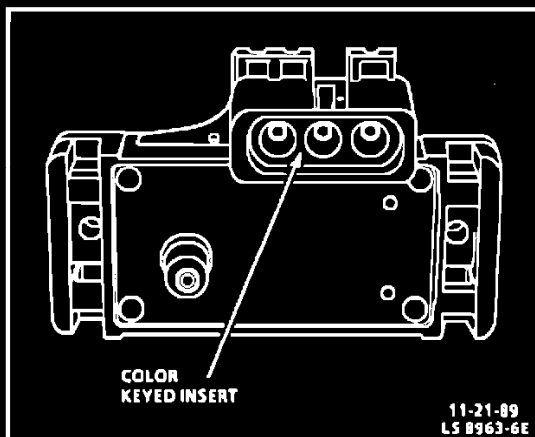
Figure 1 - Color Key Insert

**NOTE:** THIS CHART ONLY APPLIES TO MAP SENSORS HAVING GREEN OR BLACK COLOR KEY INSERT (SEE BELOW).

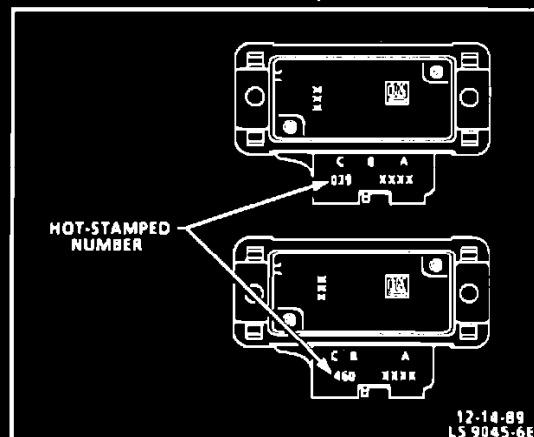
Figure 2 - Hot-Stamped Number

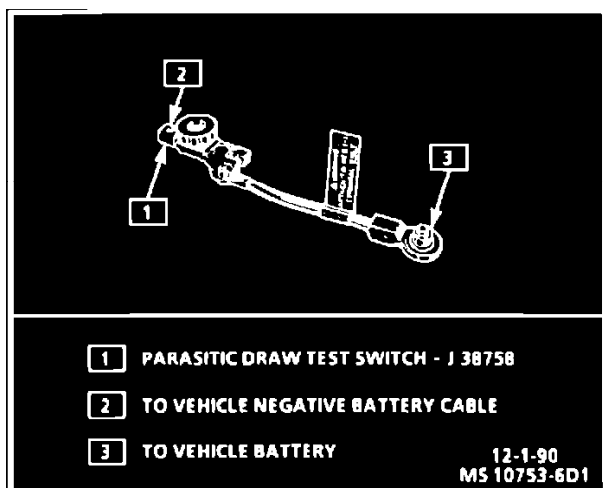
**Figure 1 - Parasitic Draw Test Switch: J-38758.**

Past service procedures do not address solid state failures that appear as intermittent after the battery has been disconnected and reconnected. Utilizing tool J 38758, allows the vehicle to be started, driven, and all electrical system items cycled, without interrupting electrical system continuity. The following procedure supersedes all past "Battery Electrical Drain Test Procedures."

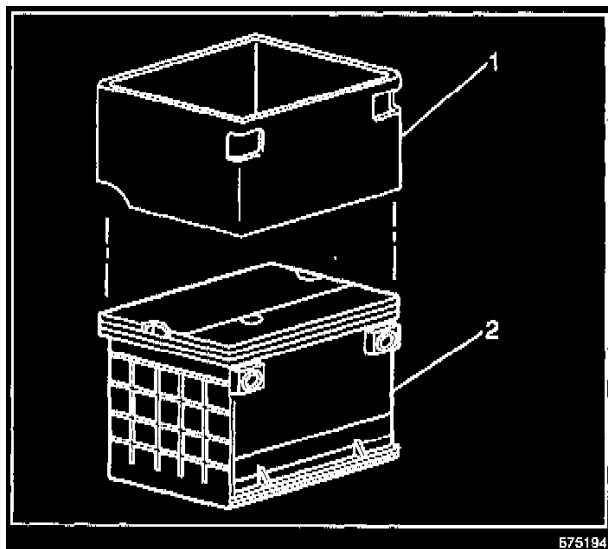
It has been found that the battery thermal insulator (1), installed on many new General Motors vehicles, is not always being placed back on the vehicle's battery (2) when the battery is removed or replaced. The installation of the insulator is essential for battery life.

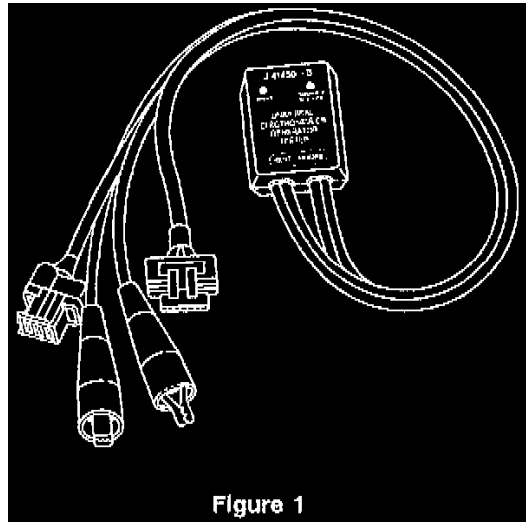
Figure 1

A new CS-Series Generator Tester, J 41450-B, has been sent to all dealers as part of the Essential Tool Package. This tool will work on all CS-Series generators for past model years. The tool is shown in Figure 1.

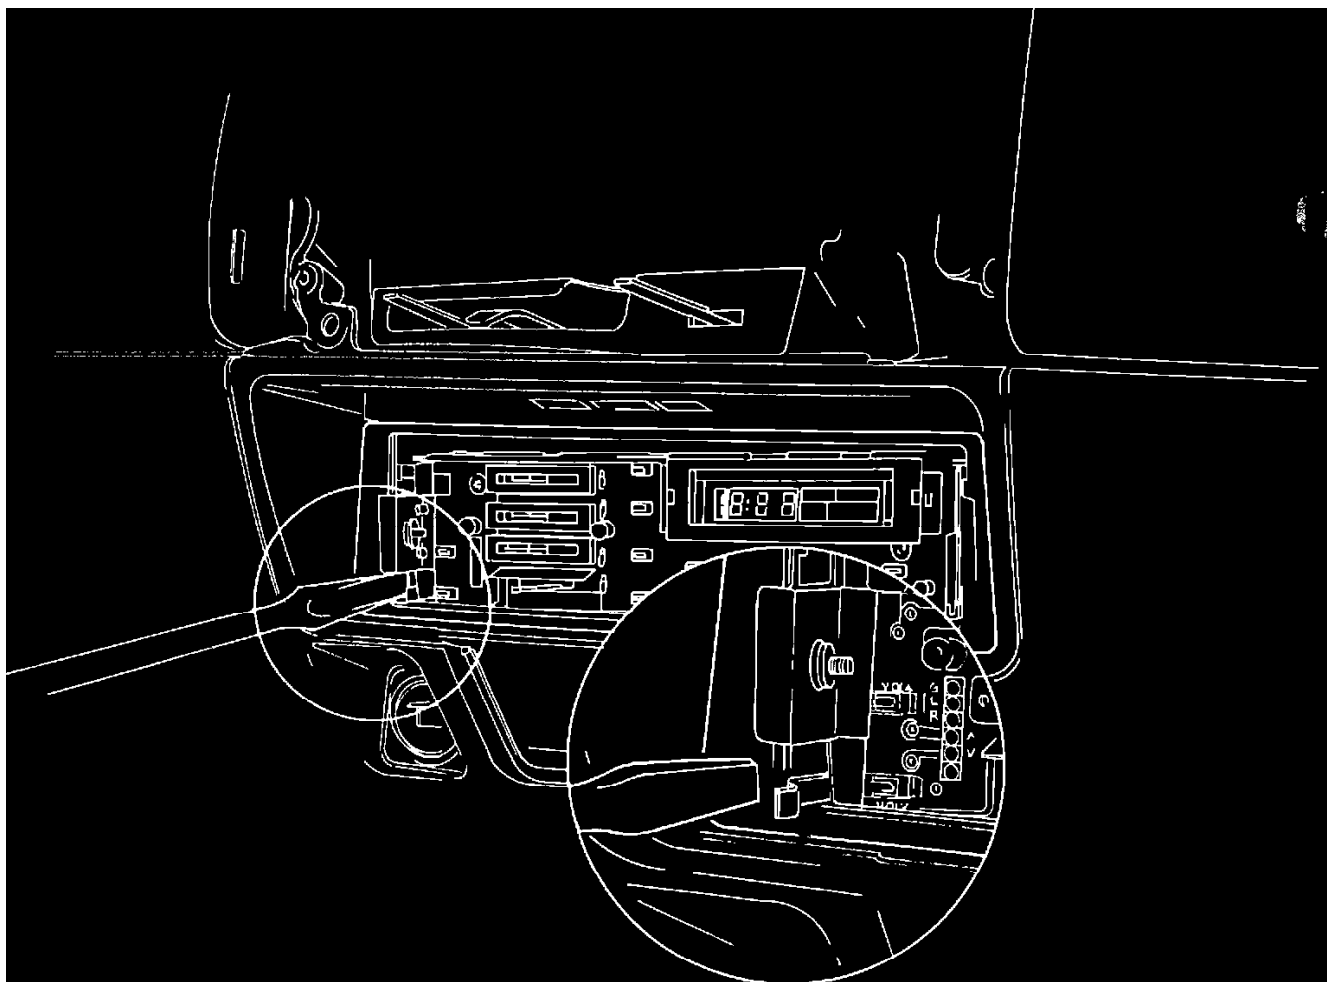
12. Release radio retainers located on both sides of the unit (See Illustration) and remove radio.
13. Disconnect antenna and electrical connectors.

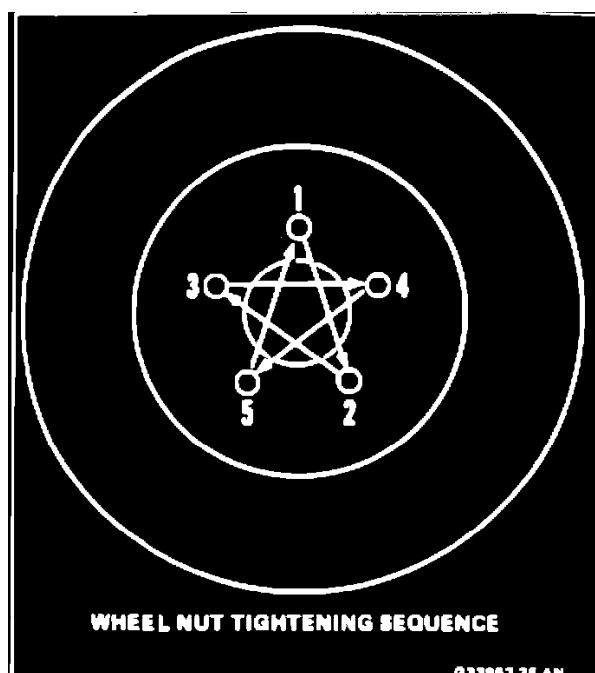
FIGURE 1 - WHEEL NUT TIGHTENING

Overtorqued wheel nuts or torquing wheel nuts without alternating the tightening sequence, especially on aluminum wheels, can also create a rotor runout condition. Refer to Figure 1.

The use of a torque wrench when tightening wheel nuts is necessary to prevent distortion of the rotor, hub or wheel. The wheel nuts should be tightened in two steps to assure an even clamp load.

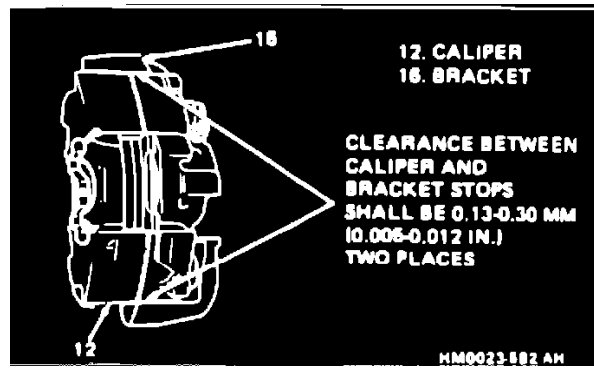
**FIGURE 2 - CALL TO BRACKET CLEARANCE**

Caliper to knuckle clearance is important. Clearance should be checked with the caliper in position and the caliper mounting bolts properly torqued. If excessive clearance exists, a clunking noise may occur on each brake apply. Too little clearance can cause caliper drag. The desired clearance is .005 - .012 in. at each caliper to knuckle bracket interface, or a total of .010 - .024 in. The caliper bracket stops can be filed -to obtain proper clearance. Refer to Figure 2.

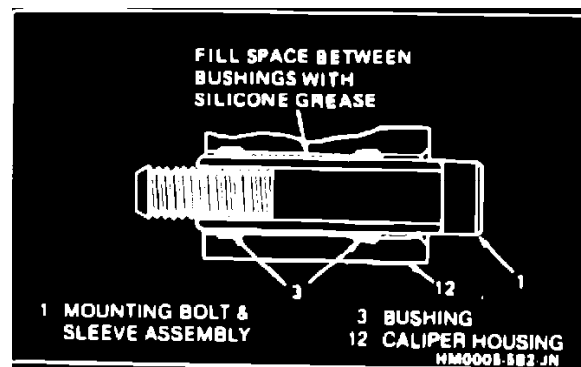
**FIGURE 3 - LUBRICATING CALIPER CAVITY**

When servicing the caliper, the caliper bolts should be cleaned and the space between the caliper bolt bushings should be filled with silicone grease such as Part Number 1052863 or equivalent. This will prevent the caliper dragging or binding on the mounting bolts. Refer to Figure 3.

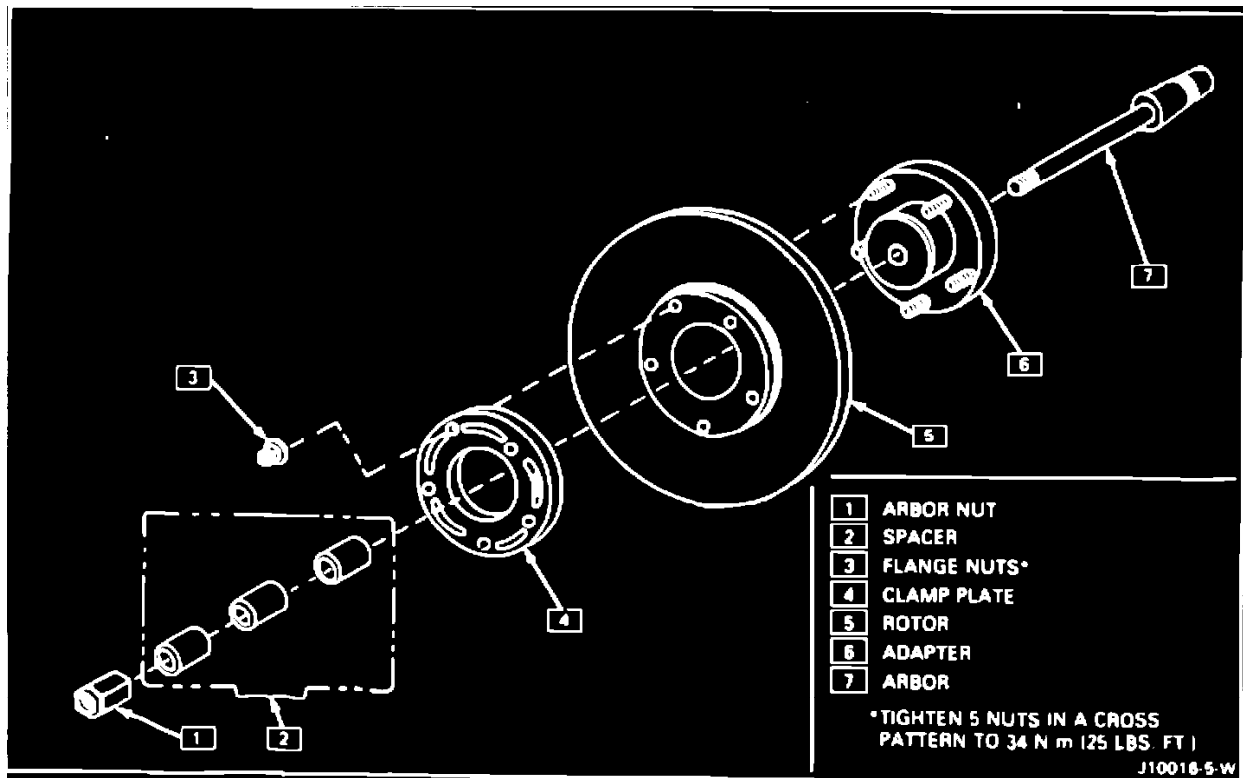
FIGURE 4 - ROTOR MOUNTING ADAPTER - J 37160

Adapters, if used, must be clean and free of nicks. Adapters may be used because of a two piece composite rotor design. (Refer to Figure 4). The rotor surface contacting the arbor and/or the adapter must be free of debris and coarse surface corrosion.
