Vehicle: Application and ID

## Engine: Service and Repair

## Camshaft: Service and Repair

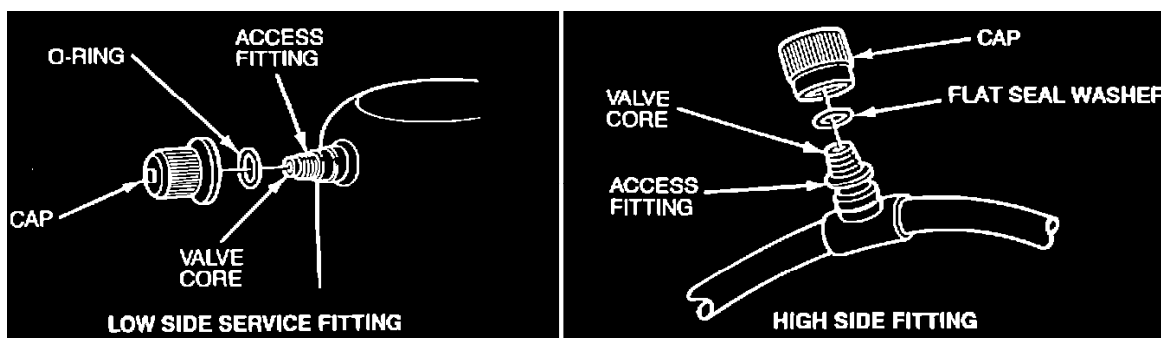
Subject: AIR CONDITIONING REFRIGERANT LOSS DUE TO LOOSE OR MISSING ACCESS FITTING CAPS

All GM air conditioning Hi side and Low side access fittings are supplied with a black plastic cap and seal assembly which provides the primary refrigerant seal for the service fittings.

If the cap and seal assembly is missing or loose, a significant amount of refrigerant may leak through the valve core located in the access fitting, which could result in poor A/C performance or failure.

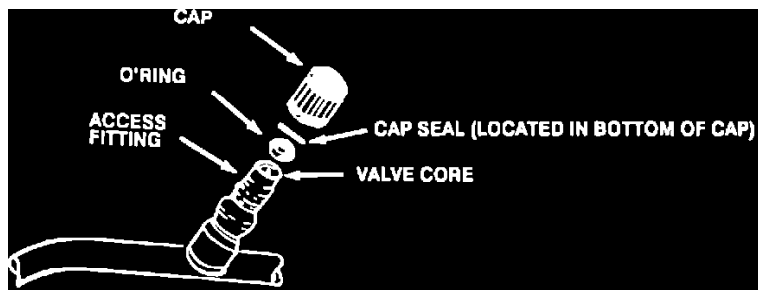
FIGURE 1

Subject: A/C REFRIGERANT LOSS DUE TO LOOSE OR MISSING ACCESS FITTING CAPS

All Chevrolet air conditioning Hi side and Low side access fittings are supplied with a black plastic cap and seal assembly which provides the primary refrigerant seal for the service fittings.

If the cap and seal assembly is missing or loose, a significant amount of refrigerant may leak through the valve core located in the access fitting, which could result in poor A/C performance or failure.

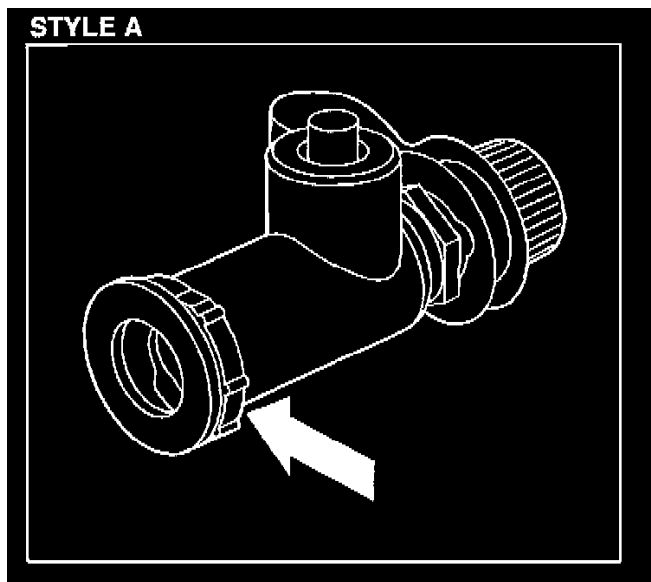
1. To properly disconnect this style of fitting, slide the tab in and pull the fittings apart.
2. To reconnect this style of fitting, install the fittings back together and gently pull back on the fittings to verify proper connection of the fittings.

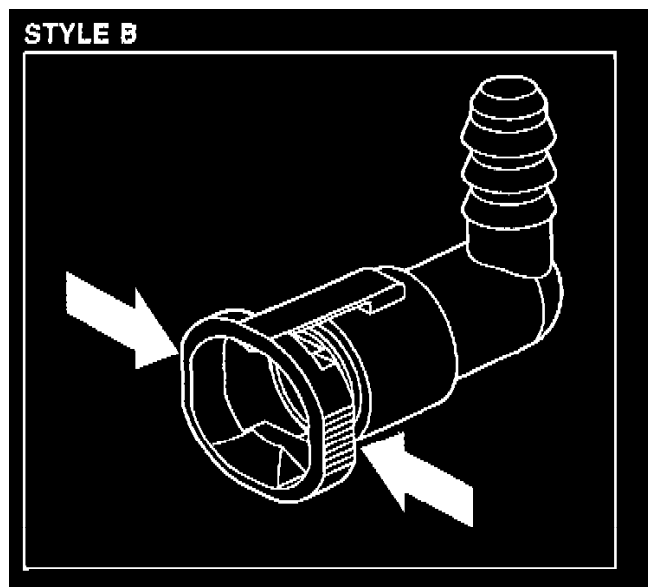
1. To properly disconnect this style of fitting, push in both sides of the retaining feature and pull the fittings apart.
2. To reconnect this style of fitting, install the fittings back together and gently pull back on the fittings to verify proper connection of the fittings.

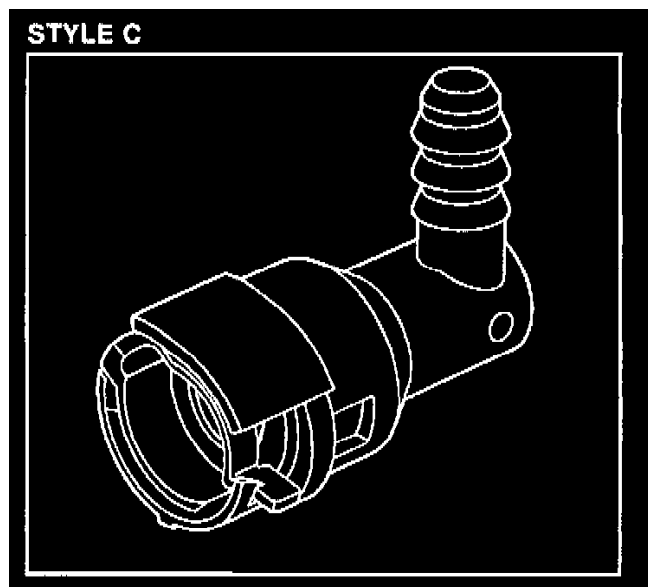
To properly disconnect this style of fitting, use the following procedure:

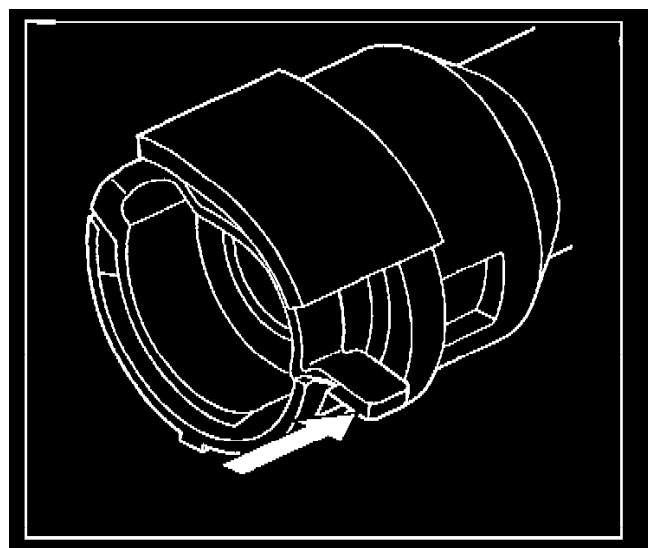
1. Move the tab of the retainer away from the male fitting in order to clear the retaining nub.

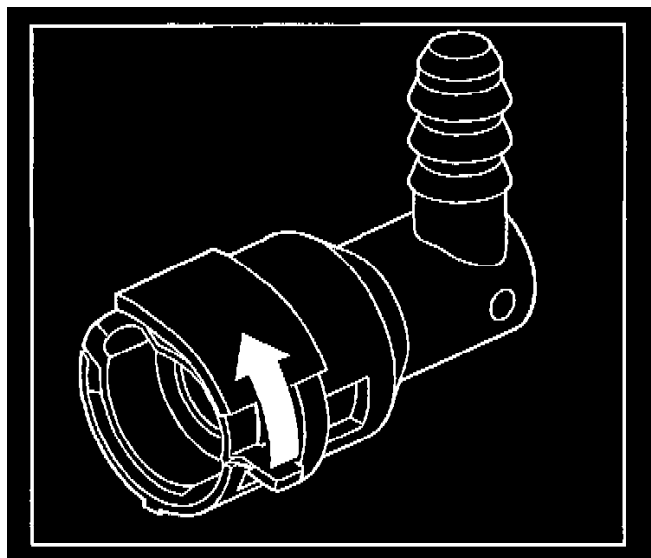
2. Move the tab of the retainer in the direction shown and pull the fittings apart.
3. To reconnect this style of fitting, install the fittings back together and gently pull back on the fittings to verify proper connection of the fittings.

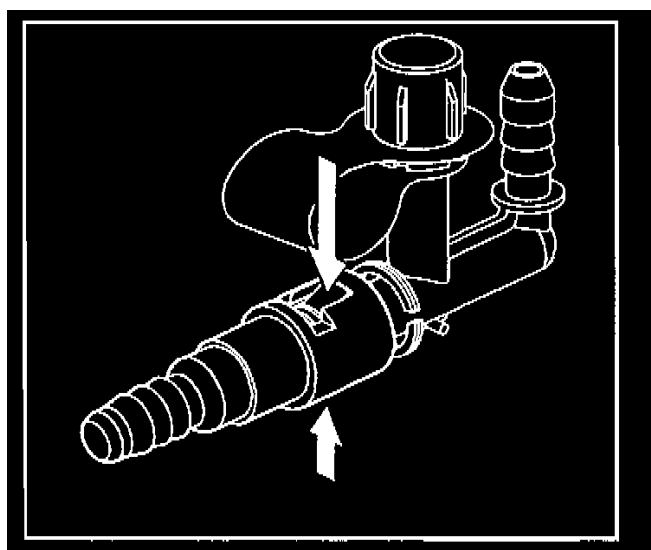
1. Push in both tabs of the retainer.

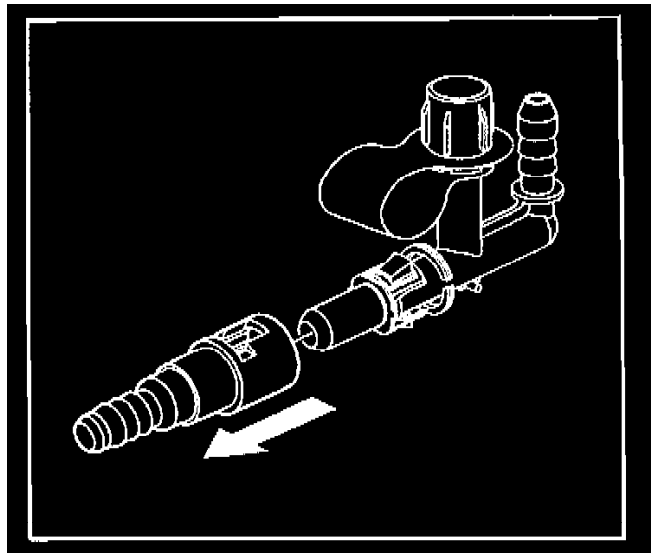
2. Pull the female fitting away from the male fitting.

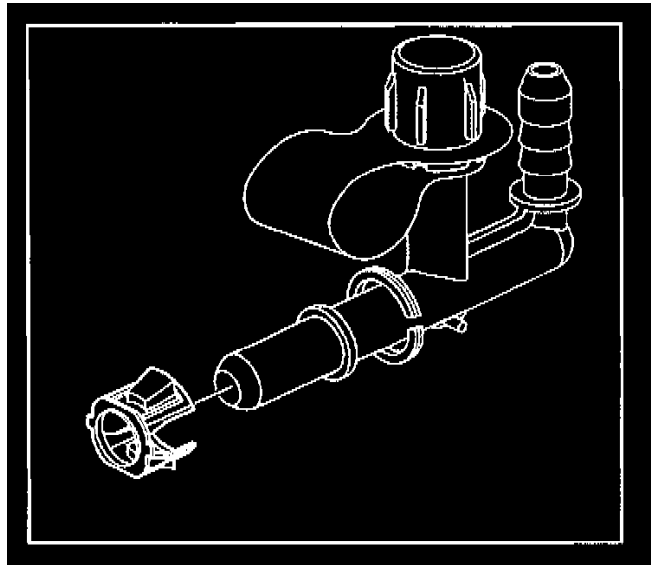
3. Remove and discard the retainer fitting from the male fitting.

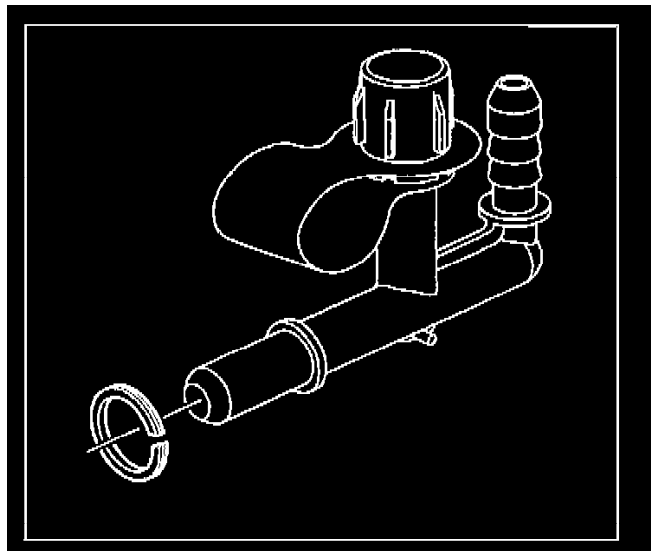
4. Remove and discard the indicator ring (factory use only) from the male fitting.

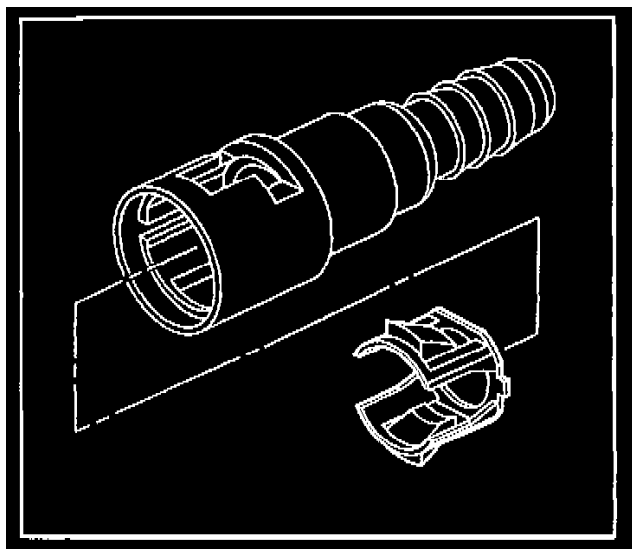
5. Install a NEW retainer fitting into the female fitting.

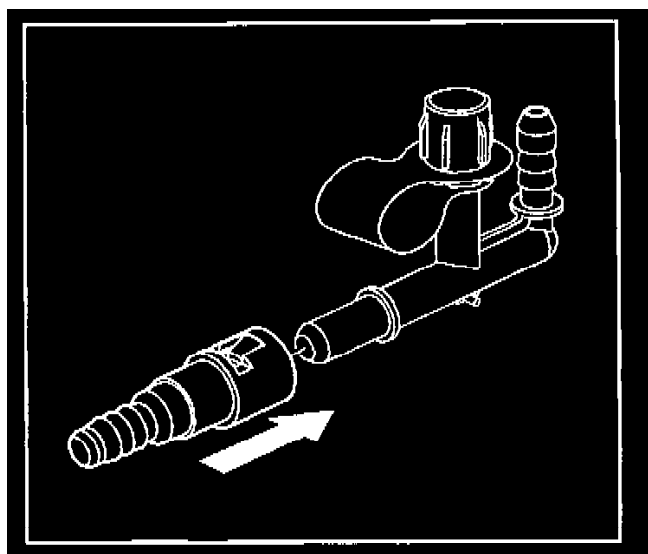
6. Connect the fittings together until a snap is heard and/or felt signifying the retainer tabs have engaged the raised feature of the male fitting.

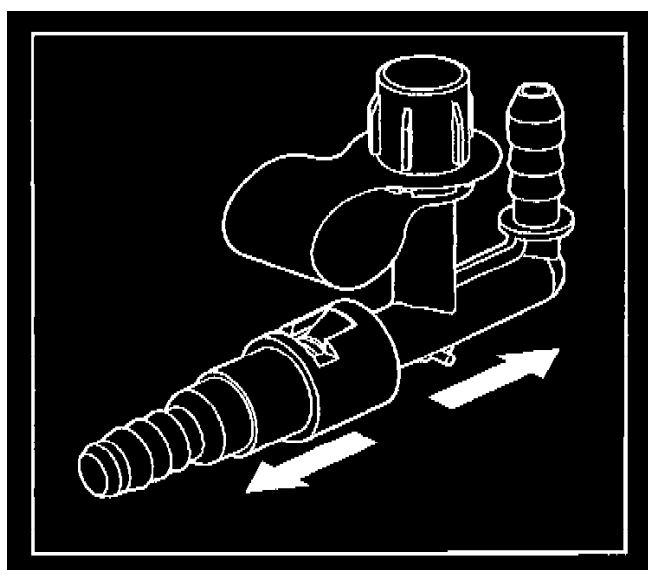
7. Gently pull back on the fittings to verify proper connection of the fittings.

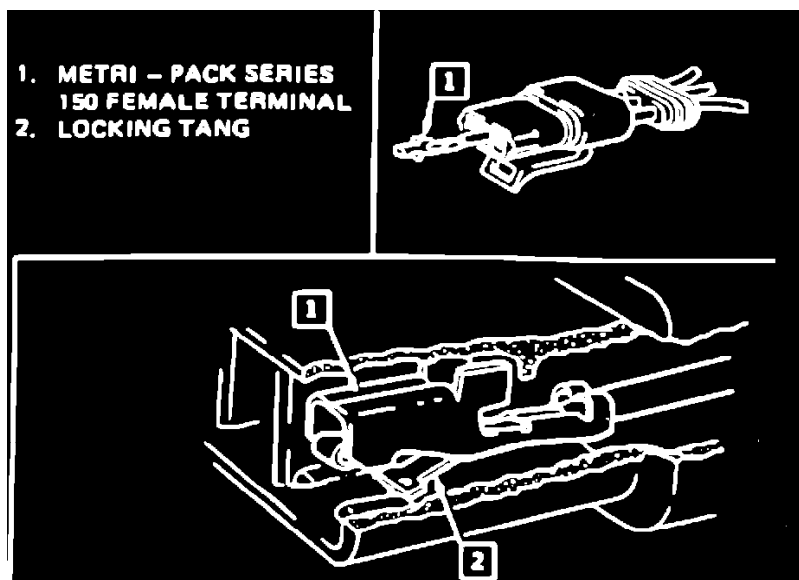
Improper handling of the Metri-pack 150 series electrical terminals may result in damage that could affect their performance. The Metri-pack 150 terminals are used on a variety of engine applications on all vehicle lines. Some of these usages include the direct fire ignition (DIS) wiring, MAT, TPS, and coolant sensor/connectors.

Pictured below is a sketch of the Metri-pack series terminals.

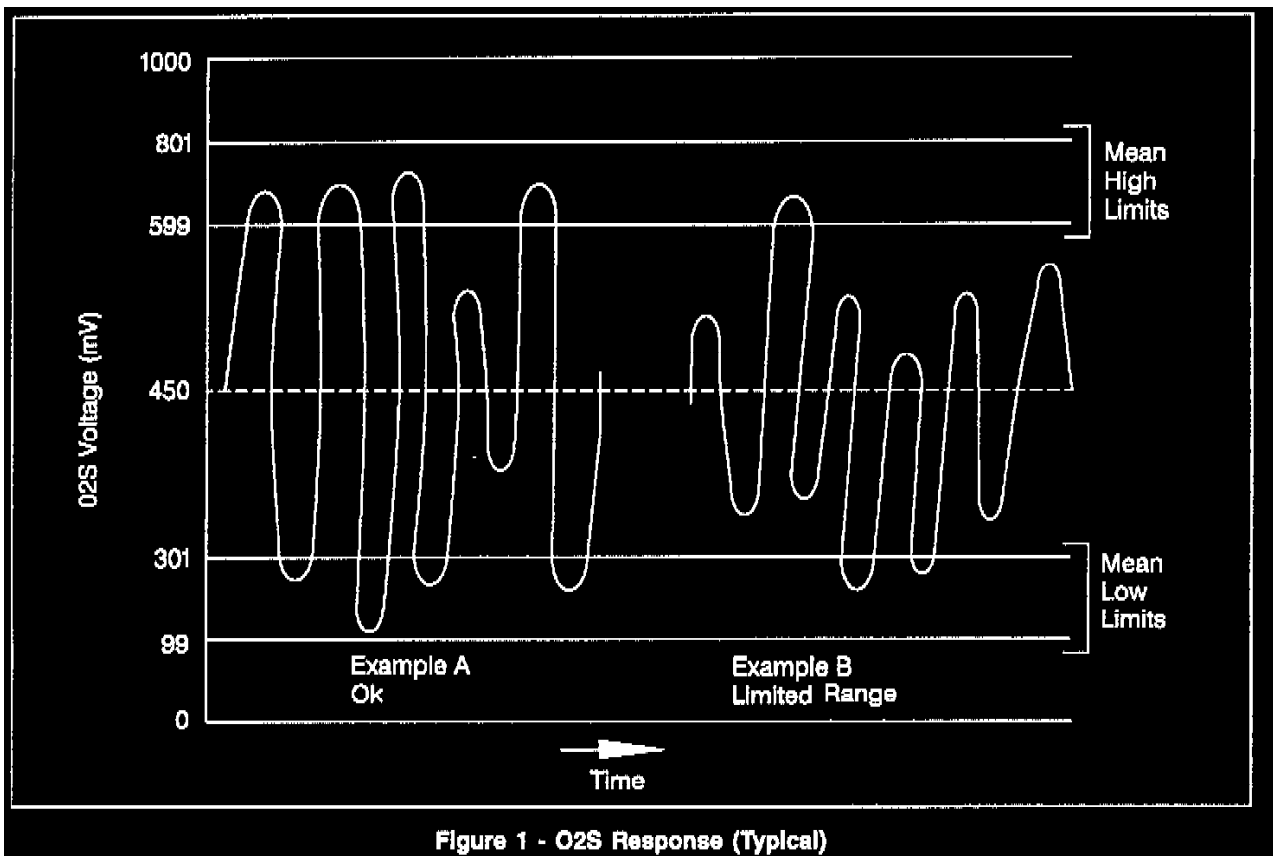
If both the high and low mean voltages are within the specified range, the O2S is switching through its full range indicating correct performance of the sensor, its circuitry and ECM/PCM closed loop fuel control. This is illustrated in Figure 1, Example A. Example B of Figure 1 shows an O2S waveform with a limited signal range. There are some voltage samples within the high and low mean limits but the majority of samples fail to reach either limit.

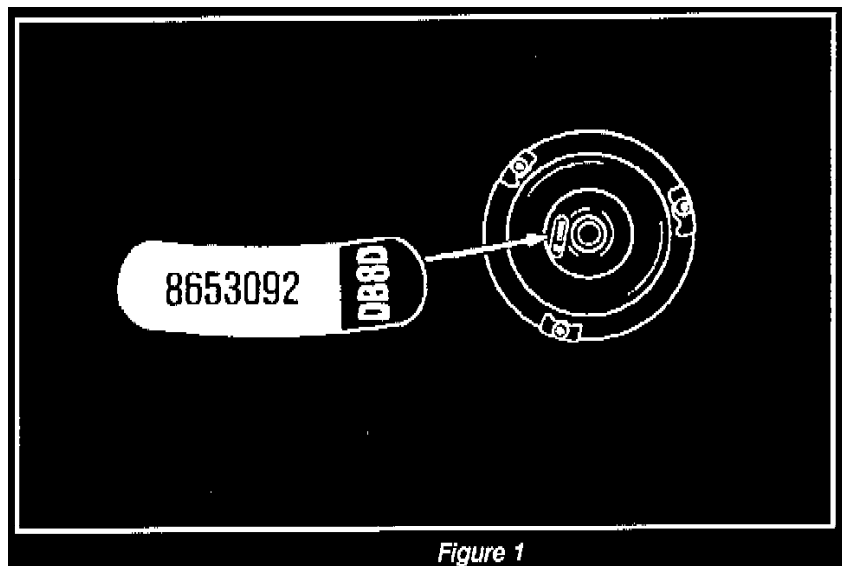
Figure 1

GM - Torque Converter Identification is easy once you know what the I.D. codes mean. Although each digit of the four digit code has its own meaning, the value of each code letter or number is different for 298 mm and 245 mm torque converters.

Look at the I.D. code in figure 1. The torque converter in figure 1 is 298 mm in dia. The first digit refers to the application. See figure 2.

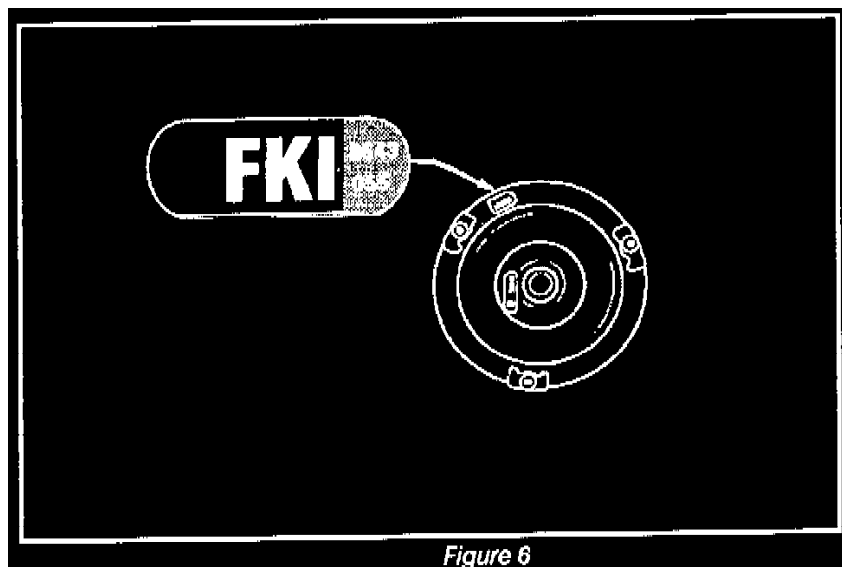
Figure 6

The 245 mm dia torque converter I.D. code works the same way as the 298 mm converters, but with different meanings.

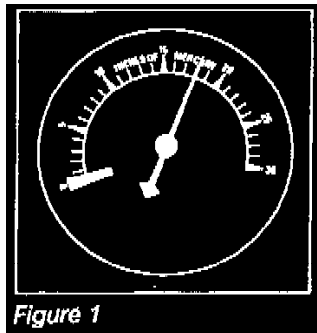
At idling speed, an engine at sea level should show a steady vacuum reading between 14" and 22" HG. A quick opening and closing of the throttle should cause vacuum to drop below 5" then rebound to 23" or more. See figure 1.

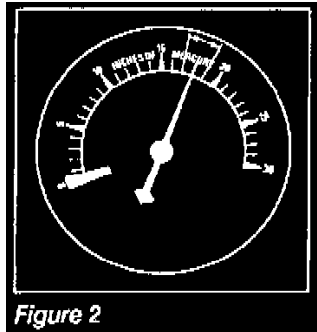
With the engine idling, continued fluctuation of 1 to 2 inches may indicate an ignition problem. Check the spark plugs, spark plug gap, primary ignition circuit, high tension cables, distributor cap or ignition coil. Fluctuations of 3 to 4 inches may be sticking valves. See figure 2.

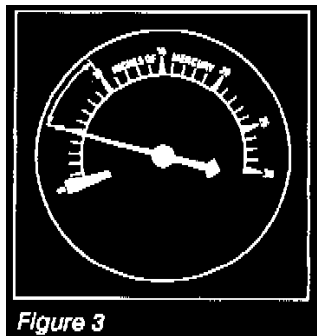
A vacuum reading at idle much lower than normal can indicate leakage through intake manifold gaskets, manifold-to-carburetor gaskets, vacuum brakes or the vacuum modulator. Low readings could also be very late valve timing or worn piston rings. See figure 3.

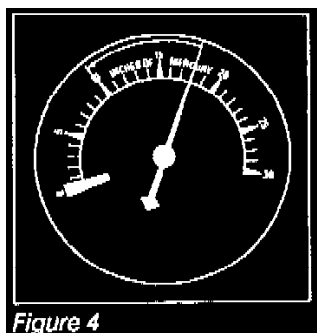
With the engine Idling, the vacuum gauge pointer will drop sharply, every time the leak occurs. The drop will be from the steady reading shown by the pointer to a reading of 10" to 12" Hg or less. If the leak is between two cylinders, the drop will be much greater. You can determine the location of the leak by compression tests. See figure 4.

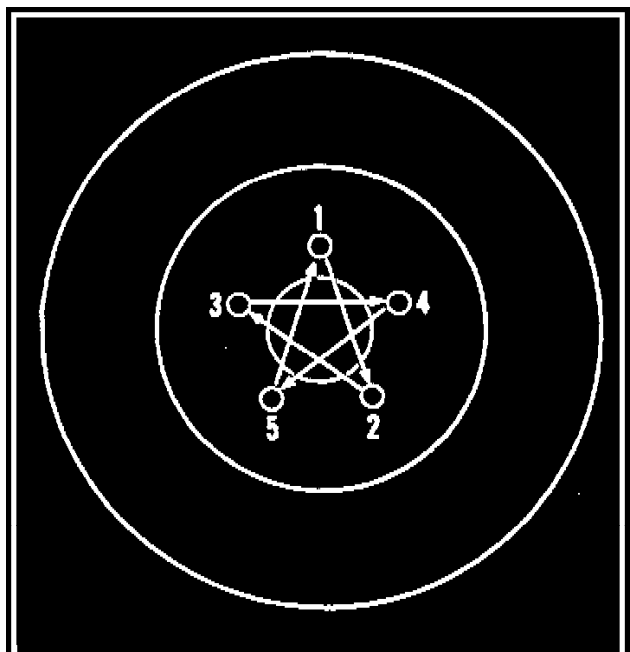
**Figure 1** Tighten the lug nuts in star pattern.

^ Using figures one and two, tighten nuts to specifications illustrated in the following tables.

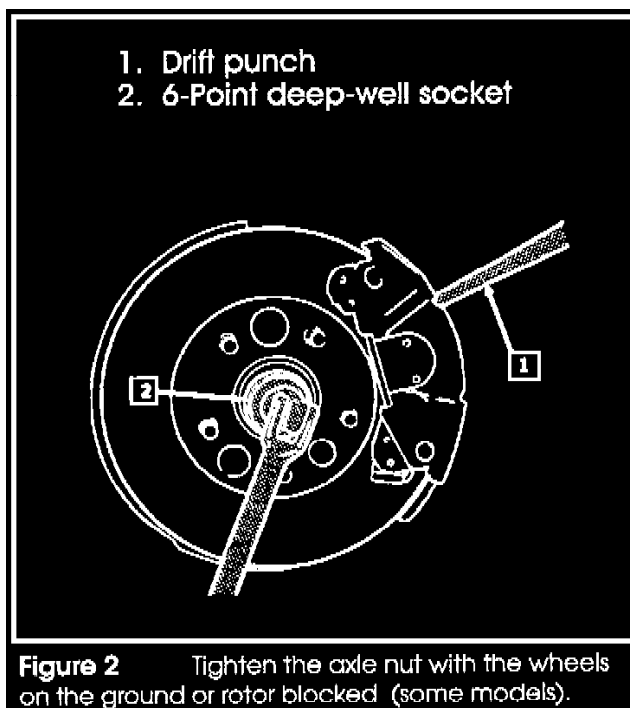
**Figure 2** Tighten the axle nut with the wheels on the ground or rotor blocked (some models).

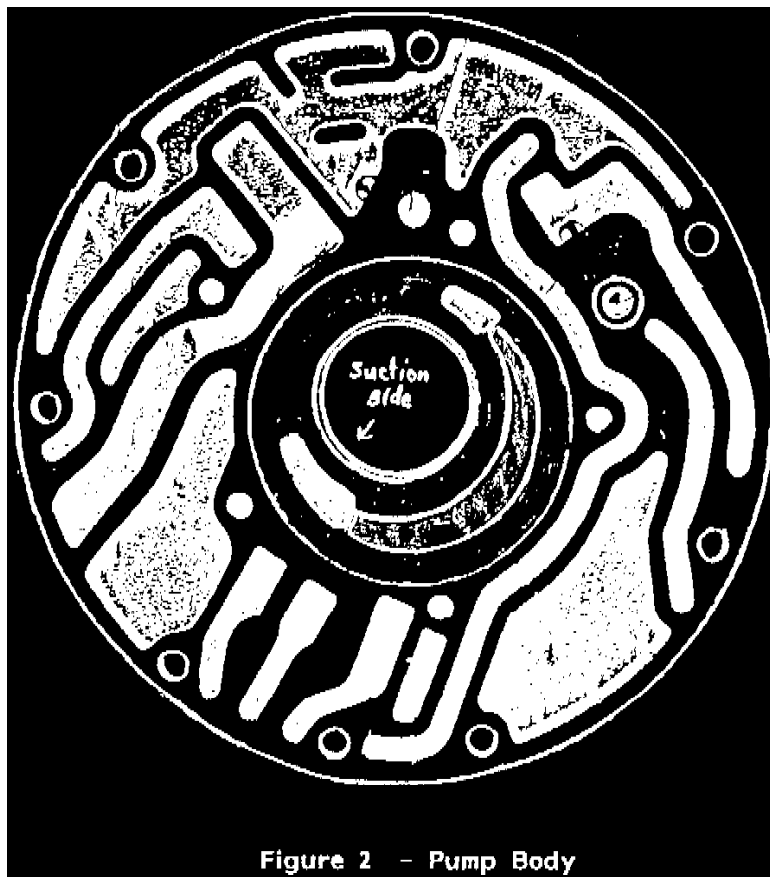
Figure 2 - Pump Body

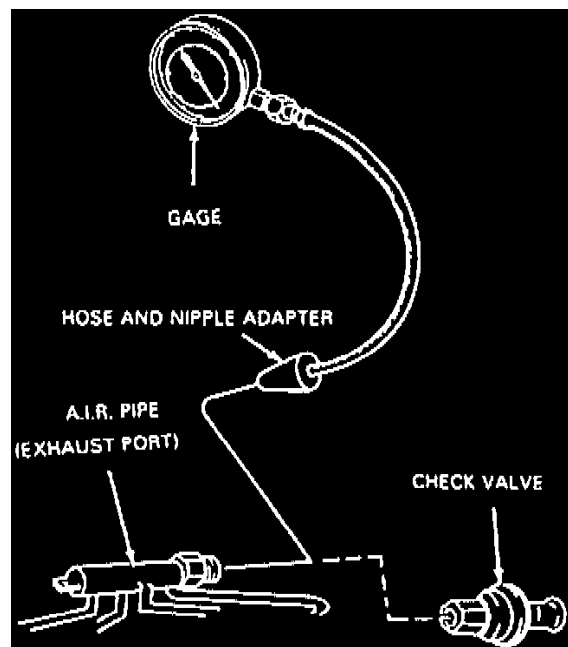
FIGURE 1

1. Remove the rubber hose at the exhaust manifold A.I.R. pipe check valve. Remove check valve.
2. Connect a fuel pump pressure/vacuum gauge to a hose and nipple.
3. Insert the nipple into the exhaust manifold A.I.R. pipe.
4. With the engine idling at normal operating temperature, observe the exhaust system backpressure reading on the gauge. Reading should not exceed 1 to 1-1/2 PSI.
5. Accelerate engine to 2000 RPM, and observe gauge. Reading should not exceed 3 PSI. If the backpressure, at either RPM exceeds specification a restricted exhaust system is indicated.

Figures # 1 and # 2 show ways to check for restricted exhaust system.

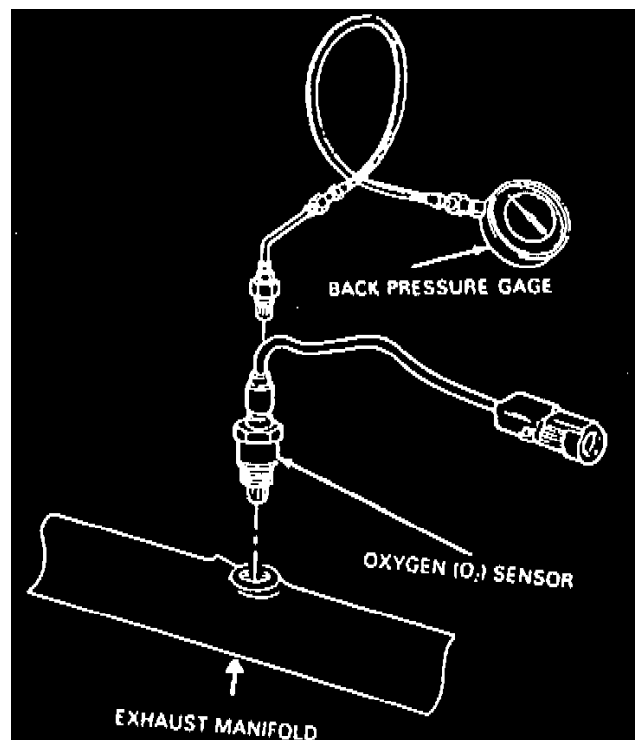
FIGURE 2

1. Carefully remove oxygen sensor.
2. Install Borroughs exhaust backpressure tester (BT 8515 or or equivalent in place of oxygen sensor).
3. With the engine idling at normal operation temperature, observe the exhaust system backpressure reading on the gauge. Reading should not exceed 1 to 1-1/2 PSI.
4. Accelerate engine to 2000 RPM and observe gauge. Reading should not exceed 3 PSI of backpressure, at either RPM, exceeds specification,

a restricted exhaust system is indicated.

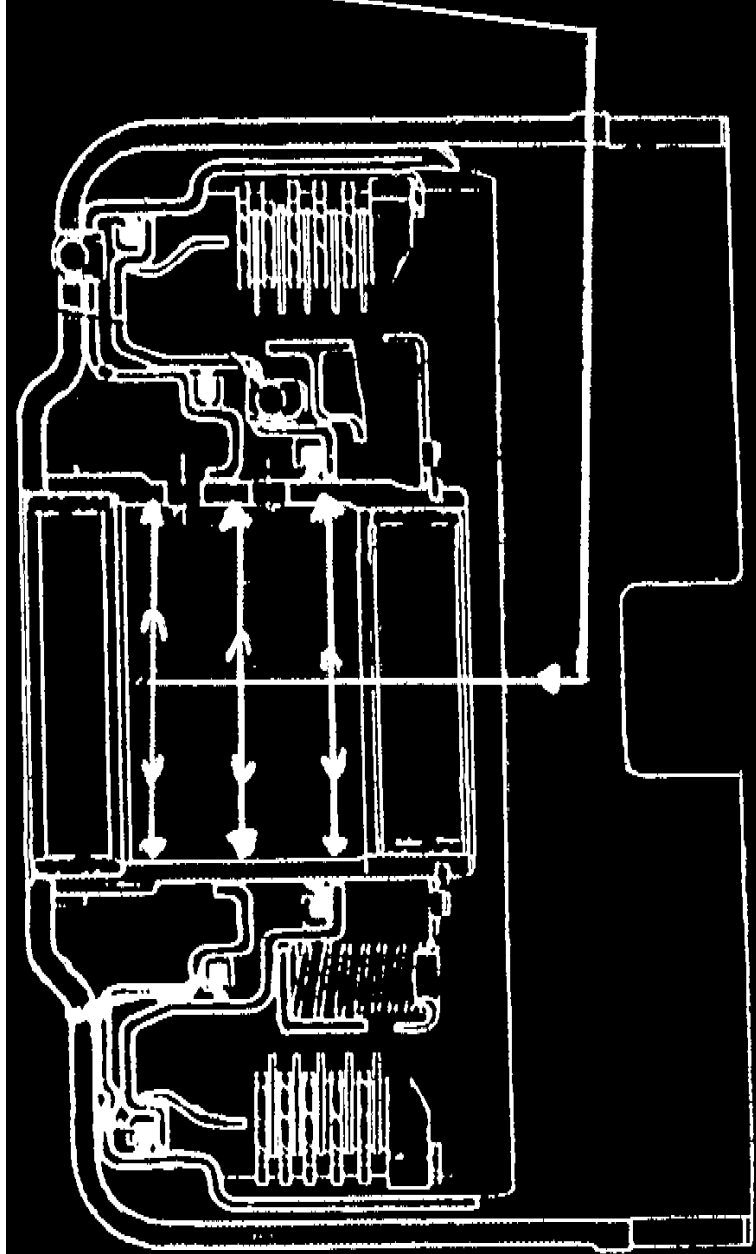
Figure 2

Sealing Ring Area

2. Place ring in bore of drum where they will be running. (See Figures 1 & 2)
3. Sealing rings should be snug in bore; rings should fit all around the drum. (drum could be out-of-round)
4. Air check all drums. (Use 30 PSI air pressure only.) If air escapes you have leaks -- better find now, than later. This represents lost clutch pressure, and could result in soft application and burned friction material.
5. Following these steps will help you save money, plus help you build better units.

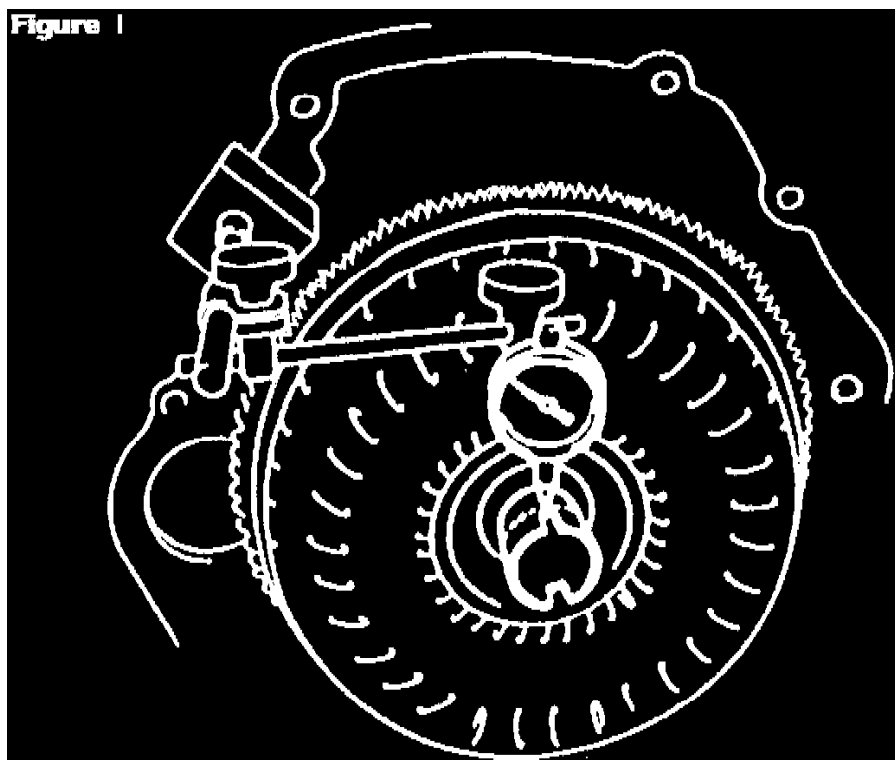
The torque converter can be checked visually, and with a dial indicator. (See Figure 1) Hub run-out should not exceed .010".

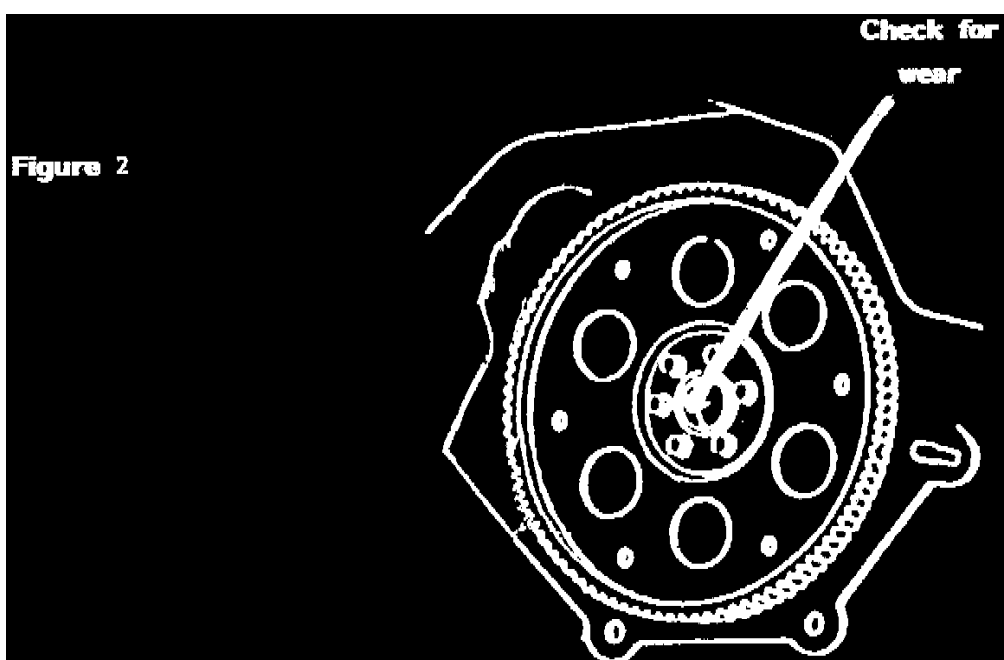
3. Another possibility is WEAR IN THE CRANKSHAFT, where it supports the torque converter pilot.(See Figure 2)

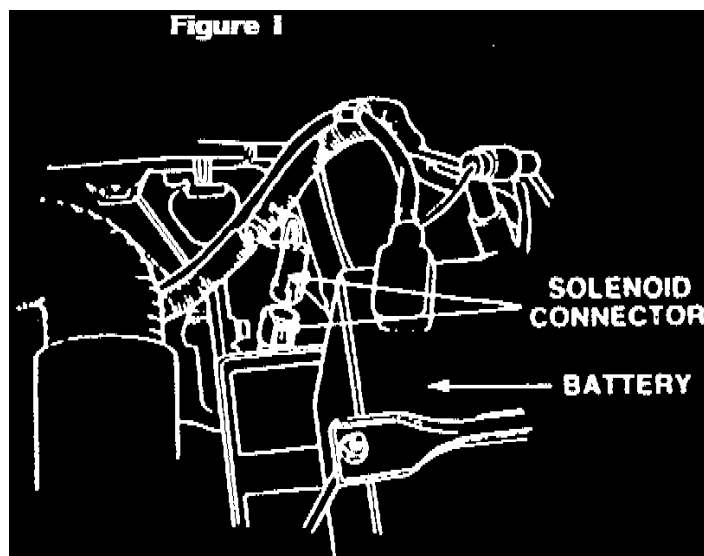
2. Disconnect solenoid wire (see Figure 1)
3. Start engine, shift to "L" range and accelerate to 18-20 mph. Car should be in first gear.
4. Shift to "2" range, and accelerate to 37-40 mph. Car should be in 2nd gear.
5. Shift to "D" range and accelerate. Car should be in 3rd gear when speed is about 37-40 mph.
6. If the transmission makes these shifts, the problem is not mechanical.

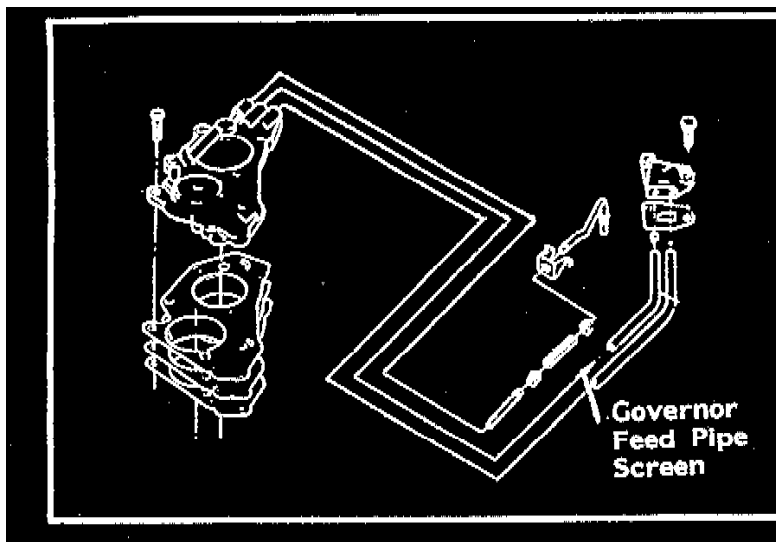
Figure 1

3. Plugged governor feed pipe screen (See Figure 1)

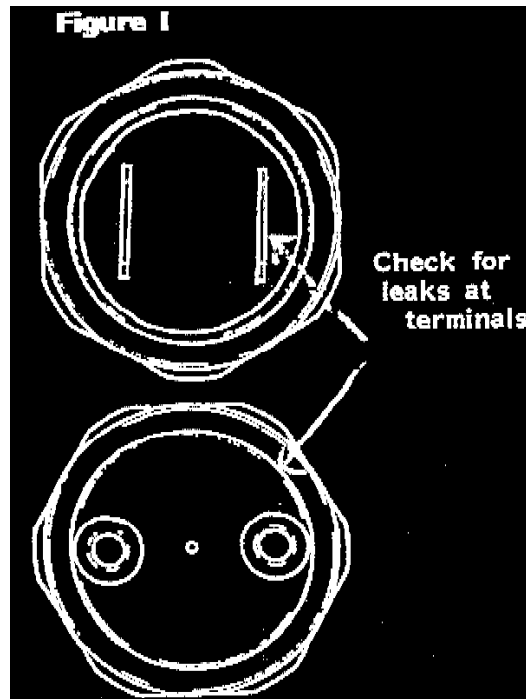
Put a couple drops of ATF into the switch, and tighten it snugly into the air blower. Apply pressure and check for air bubbles. (Figure 1)

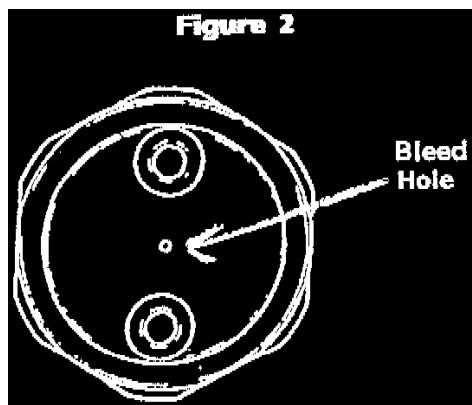
Remember some switches have an air bleed. DO NOT MISTAKE AN AIR BLEED FOR AN AIR LEAK. (See Figure 2 - Air bleed.)

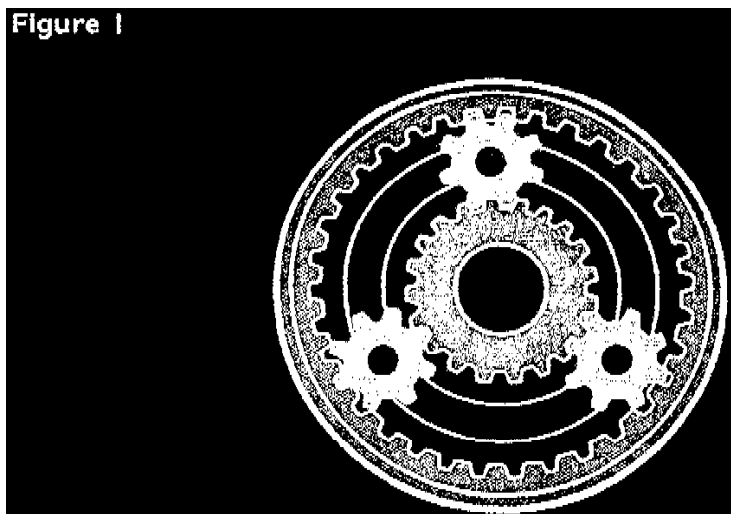
Now for the tricky part -- which gear do you consider the input, and which one the output? Figure 1 shows a planetary gear set with 34 teeth on the ring gear and 20 teeth on the Sun gear.

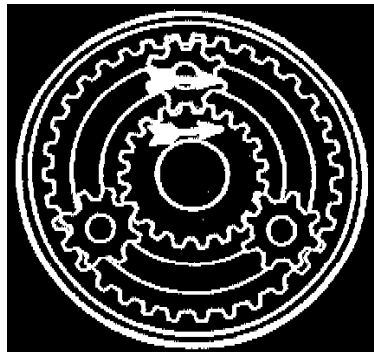
EXAMPLE:  $34 + 20$  divided by  $20 = 2.7:1$  This is how 1st gear on a THM 700 R4 is calculated. (See figure)

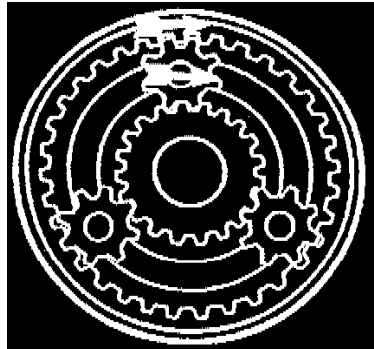
EXAMPLE:  $34 + 20$  divided by  $34 = 1.58$  This is now 2nd gear on a THM 350 is calculated. (See figure)

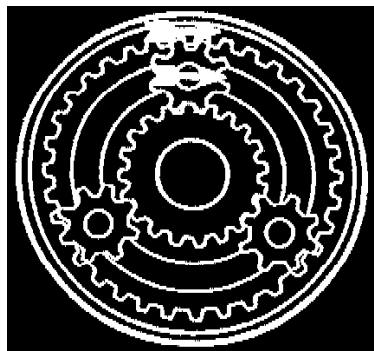
The A4LD, the THM 200-4R, the A-140E, the A-40D, the THM 325-4L are some of the units that use this method of getting overdrive. (See figure)

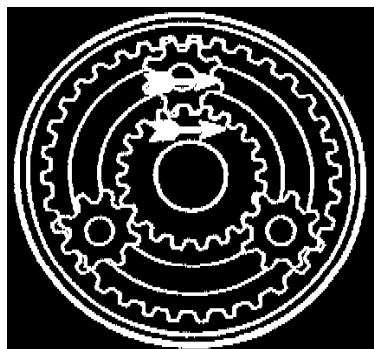
EXAMPLE:  $20$  divided by  $(34 + 20) = .37:1$  (See figure)

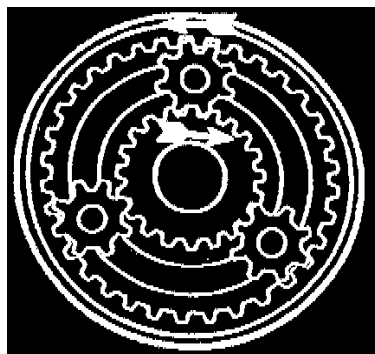
EXAMPLE: 34 divided by 20 = 1.7 (See figure)

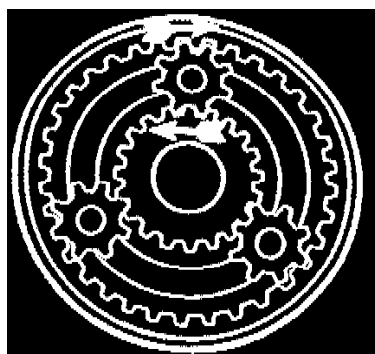
EXAMPLE: 20 divided by 34 = .59  
(See figure)

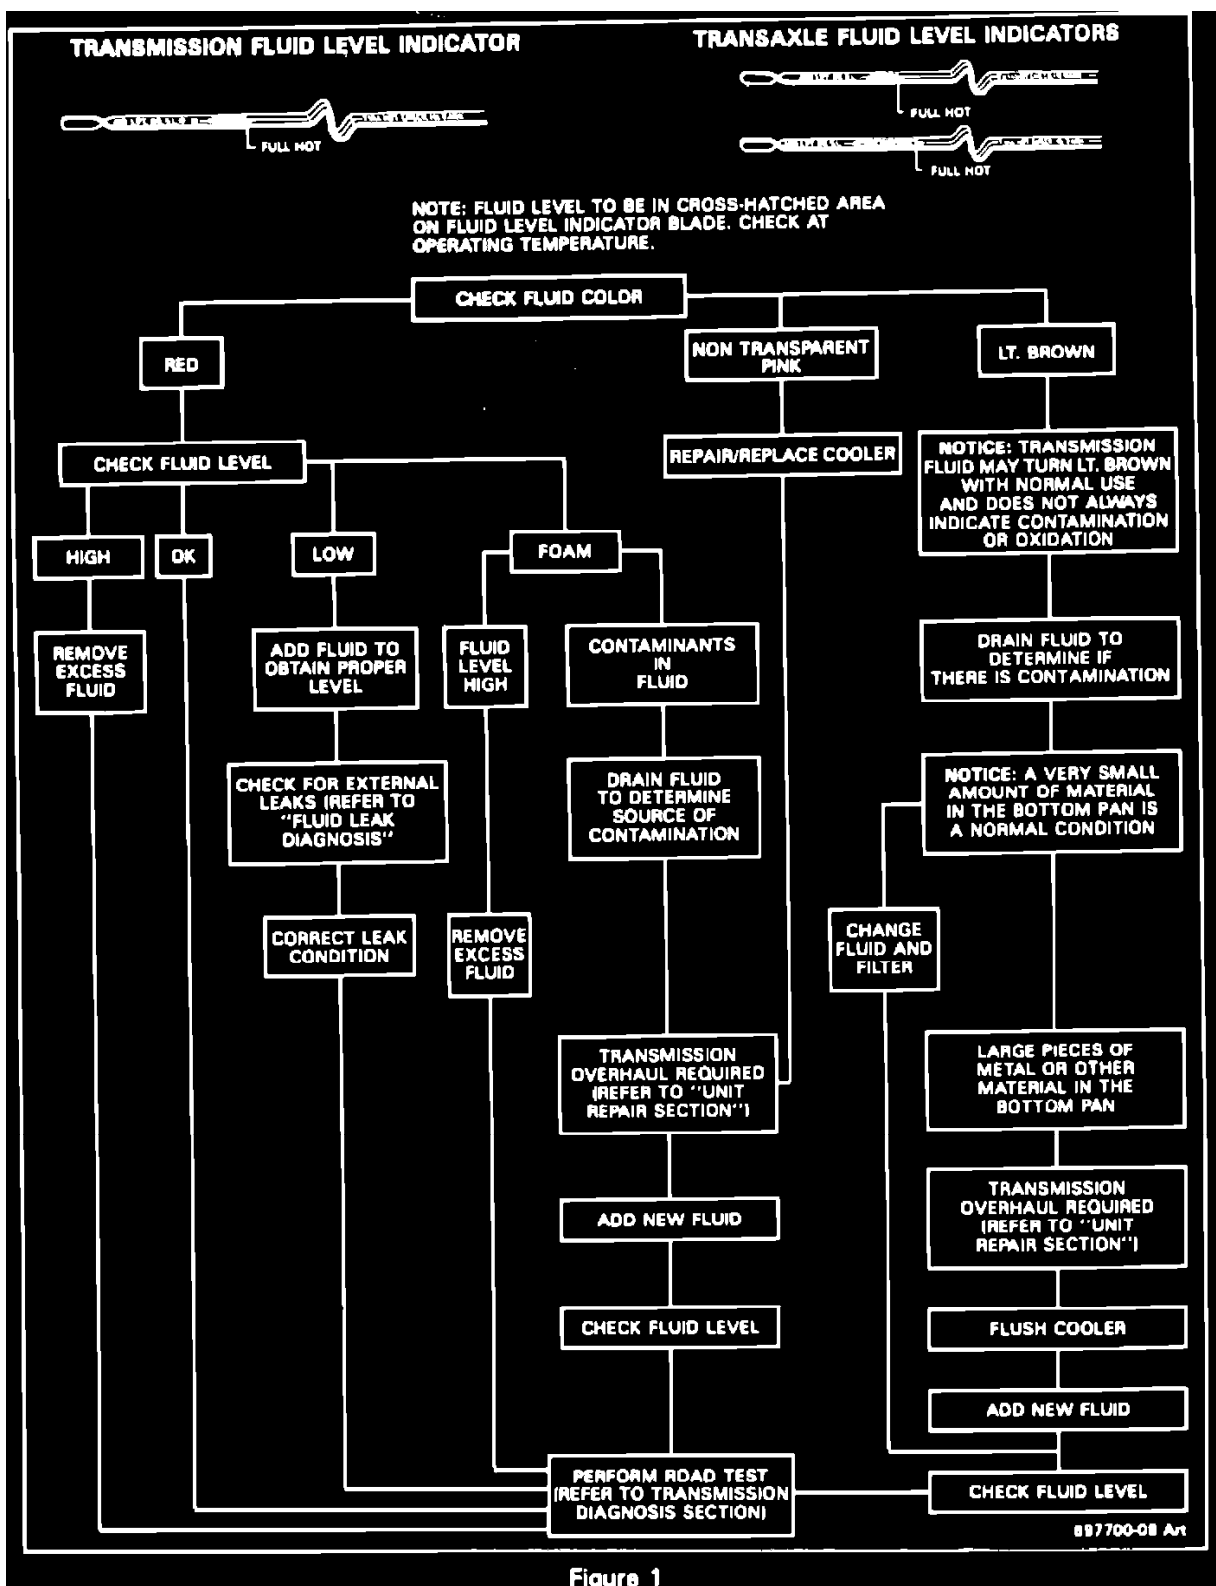
Figure 1

6. Check fluid level, color and condition (refer to Figure 1).

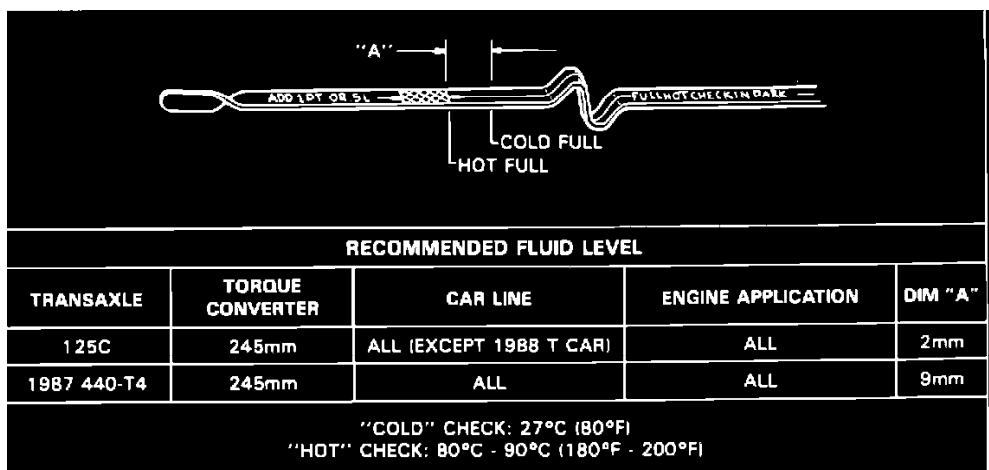
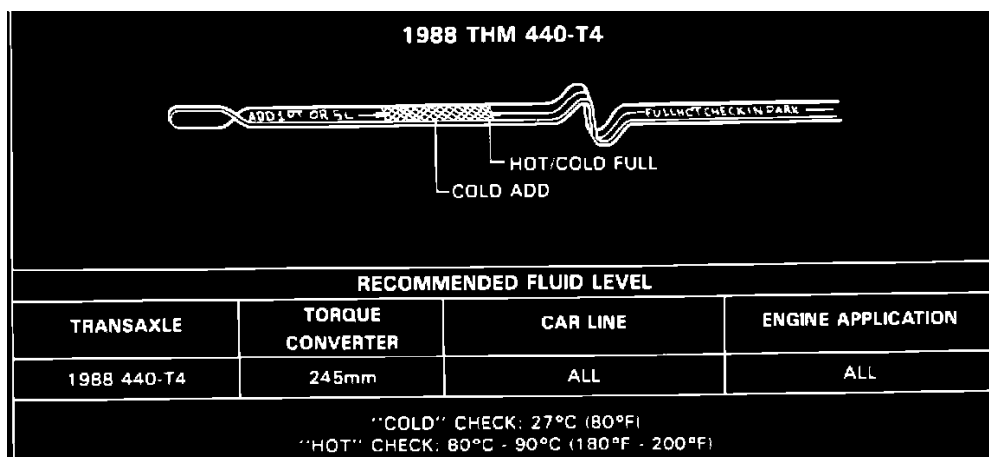
^ THM 125C, 440-T4 (Refer to Figures 2 and 3):

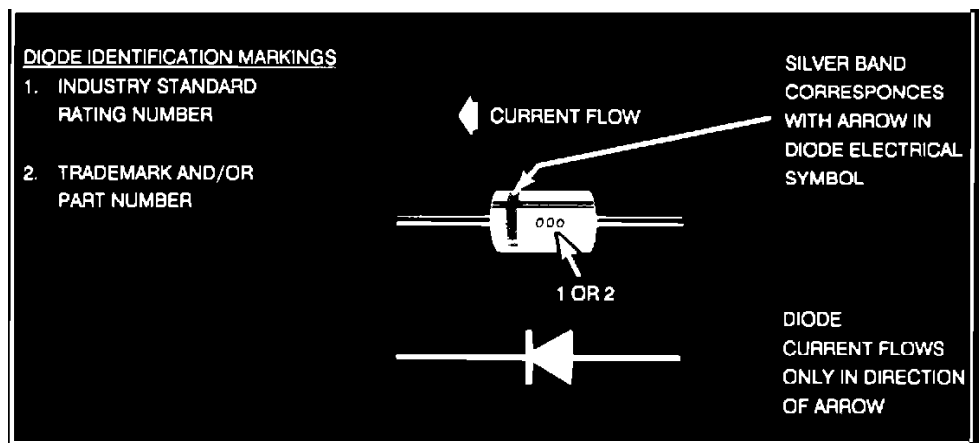
4. Check current flow direction of the new diode, being sure to install the diode with correct bias. Reference the appropriate service manual wiring schematic to obtain the correct diode installation position. Reference Figure 1 for replacement diode symbols and current flow explanations.
- Attach the new diode to the wire(s) using 60/40 rosin core solder. Use a heat sink (aluminum alligator clip) attached across the diode wire ends to protect the diode from excess heat. Follow the manufacturers instructions for the solderin equipment you are using.
5. Install terminal(s) into the connector body if previously removed in step number 2.
6. Tape the diode to the harness or connector using electrical tape. To prevent shorts to ground and water intrusion completely cover all exposed wire and diode attachment points.

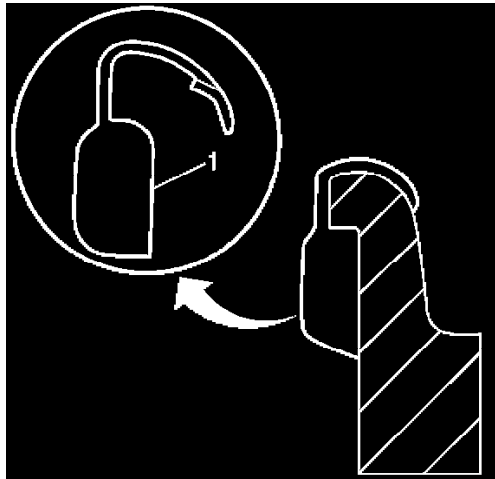
The contour and style of the wheel rim flange will determine which type of clip-on wheel weight (1) should be used. The weight should follow the contour of the rim flange. The weight clip should firmly grip the rim flange.

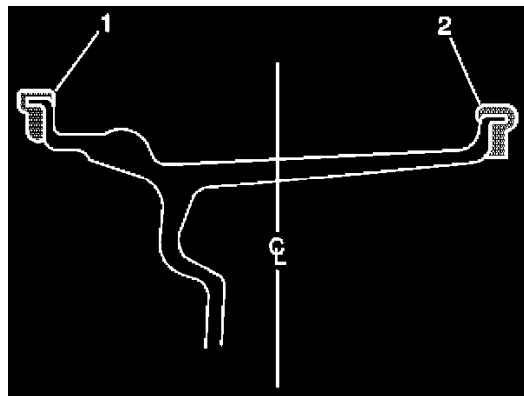
When static balancing, locate the wheel balance weights on the inboard flange (2) if only 28 g (1 oz) or less is called for. If more than 28 g (1 oz) is called for, split the weights as equally as possible between the inboard (2) and outboard (1) flanges.

When dynamic balancing, locate the wheel balance weights on the inboard (2) and outboard (1) rim flanges at the positions specified by the wheel balancer.

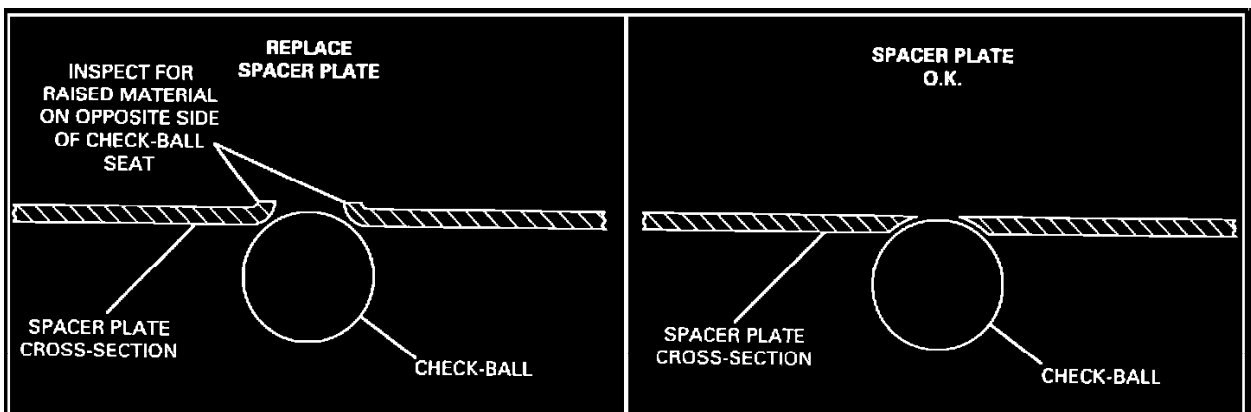
**Figure 1**

1. The spacer plate must be inspected 100% for raised material on the opposite side of the check-ball seat (see Figure 1). If the material on the opposite side is raised, the peening is too severe and the spacer plate must be replaced.
