Vehicle: Application and ID

## Engine: Service and Repair

## Camshaft: Service and Repair

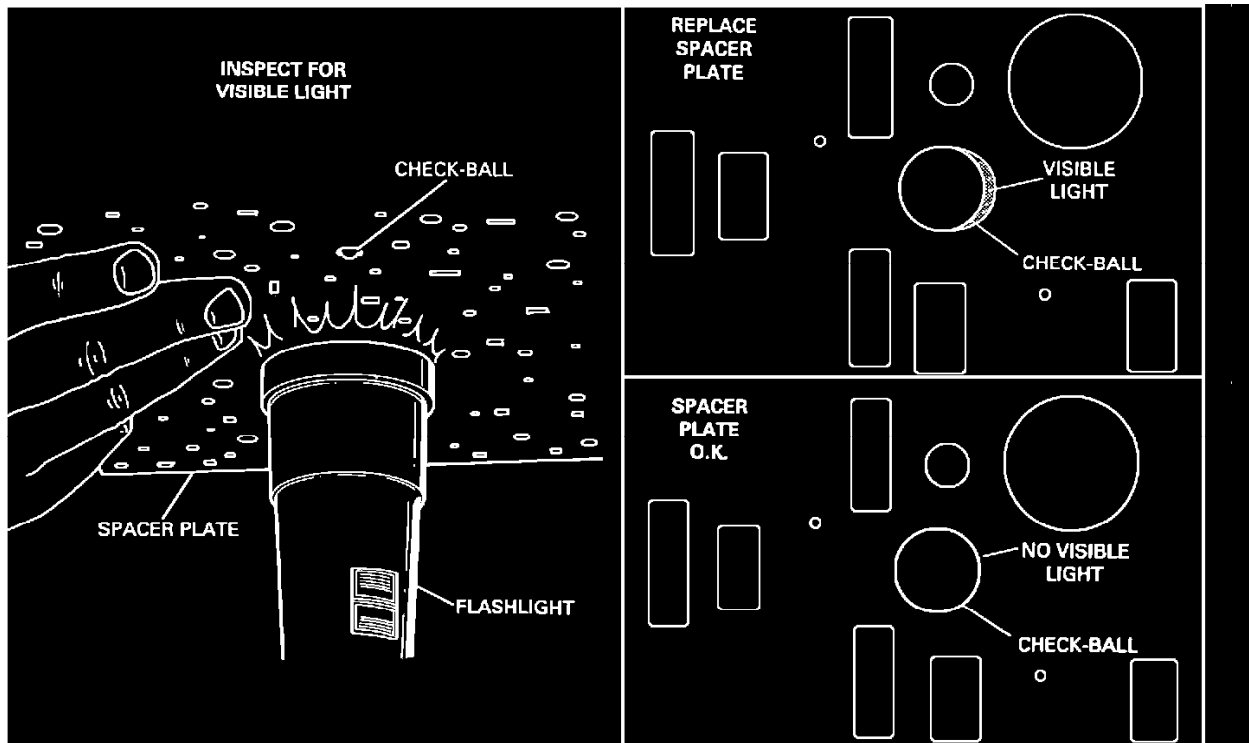
Figure 2

2. To verify that the spacer plate is peening evenly and the ball is sealing correctly, seat the check-ball on the spacer plate. Shine a beam of light on the opposite side and inspect for light between the spacer plate and check-ball (see Figure 2). No trace of light should be present. If light can be seen, a proper seal does not exist, and the spacer plate must be replaced.

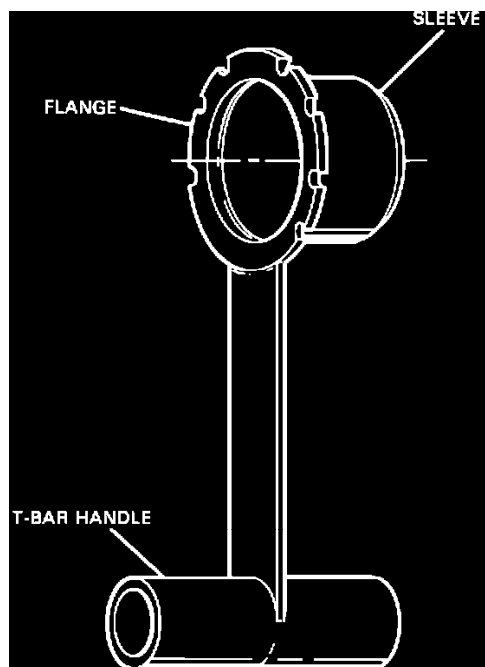
FIGURE 1 - AXLE SEAL PROTECTOR

This bulletin covers a new low cost disposable Axle Seal Protector (Figure 1) now available for 1989 and prior models on A, J, L, and X cars equipped with a THM 125/HYDRA-MATIC 3T40, THM A1/HYDRA-MATIC 3T40-A, THM 440-T4/HYDRA-MATIC 4T60, THM F-7, HM-282/HYDRA-MATIC 5TM40, FX-125 OR FX-170. The advantage of this Axle Seal Protector is to prevent axle seal damage during installation of the right side Drive Axle. The right side (both sides for some manual transaxles) Drive Axle has male splines and a snap ring groove that can potentially nick or cut the seal when the Axle Seal Protector is not used.

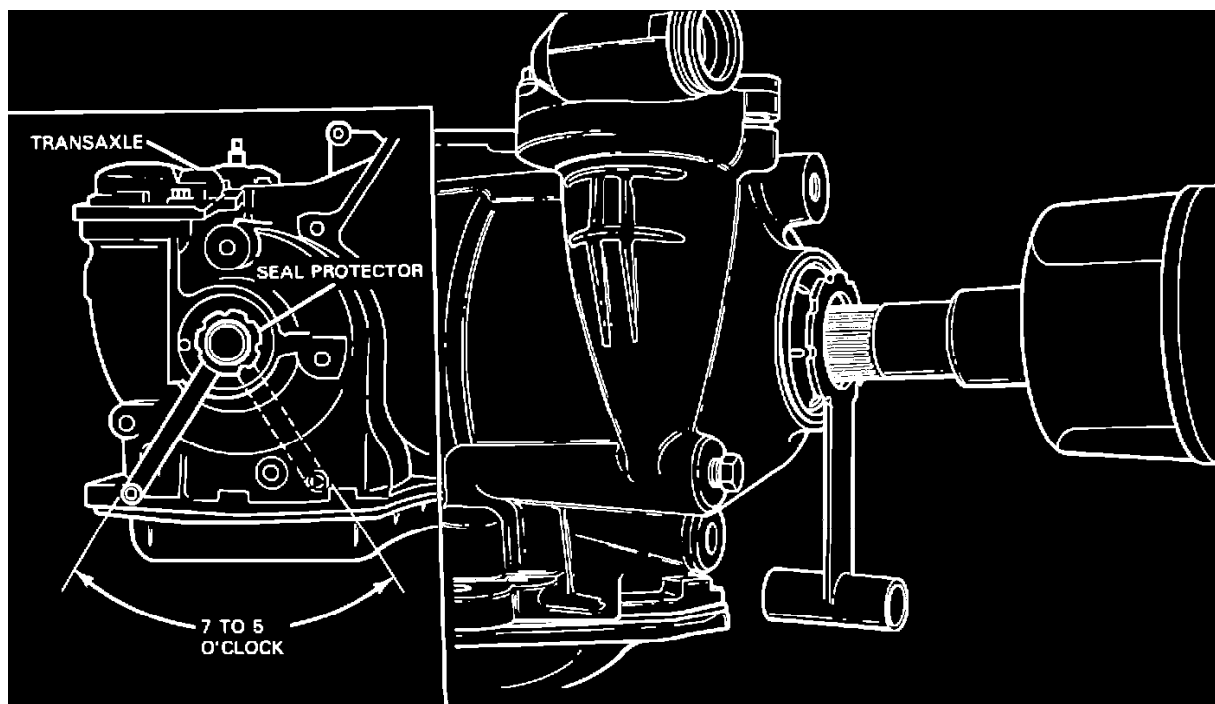
FIGURE 2 - RECOMMENDED INSTALLATION POSITION

**NOTICE:** The seal protector must be removed before the car is driven to prevent the protector from deteriorating inside the transaxle causing a leak and requiring Drive Axle removal to correct.

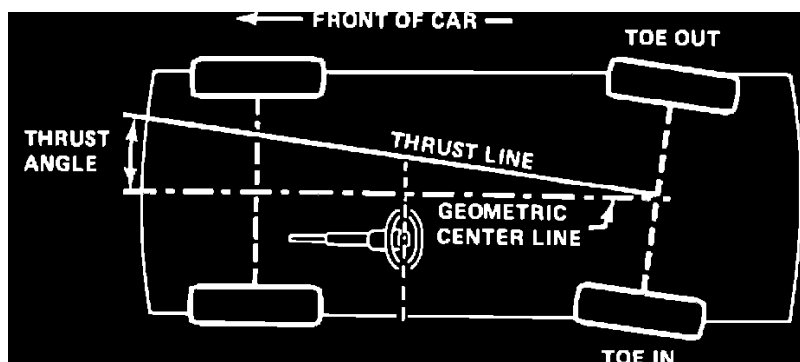
In which direction will the vehicle pictured below travel if the steering wheel is straight ahead?

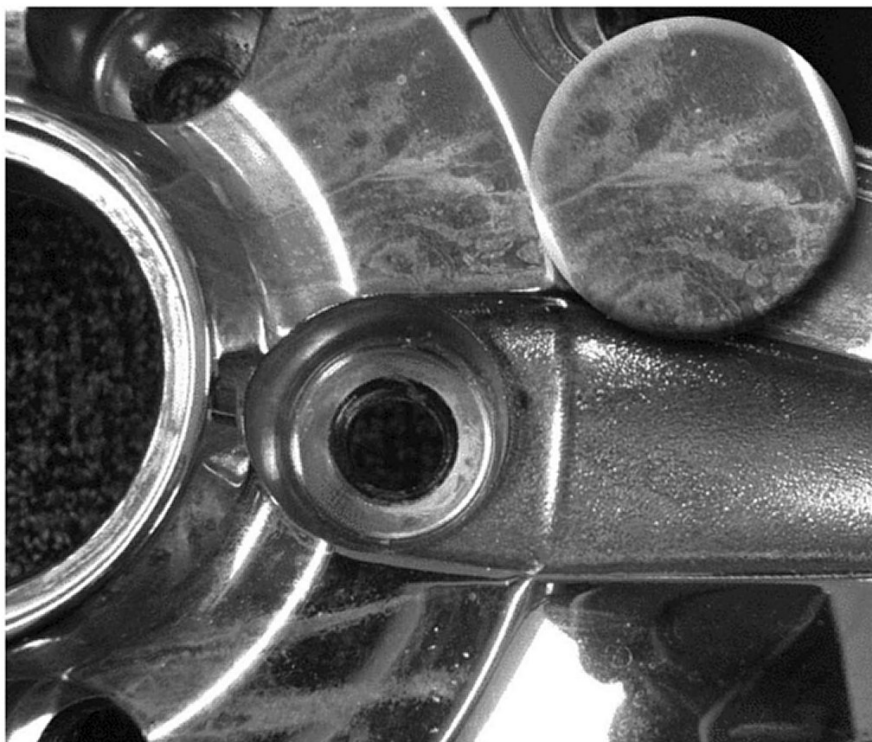
**Figure 1**

Chemical staining in most cases results from acid based cleaners (refer to Figure 1 for an example). These stains are frequently milky or greenish in appearance. They result from using cleaning solutions that contain hydrofluoric, oxalic and most other acids on chrome wheels (or any wheels).

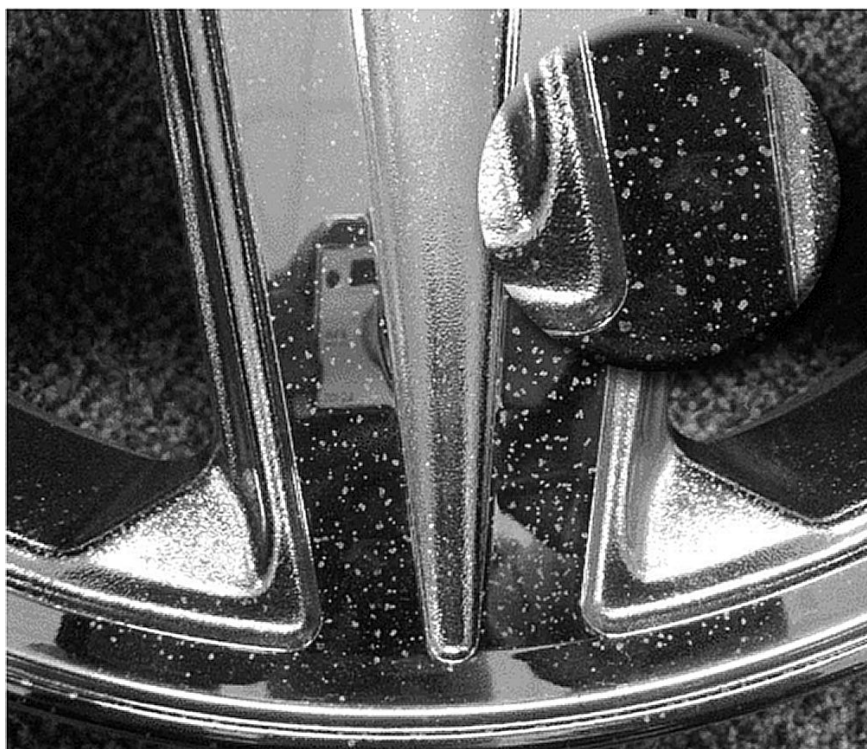
**Pitting or Spotted Appearance of Chrome Wheels**

A second type or staining or finish disturbance may result from road chemicals, such as calcium chloride used for dust control of unpaved roads. The staining will look like small pitting (refer to Figure 2 shown). This staining will usually be on the leading edges of each wheel spoke, but may be uniformly distributed. If a vehicle must be operated under such conditions, the chrome wheels should be washed with mild soap and water and thoroughly rinsed as soon as conveniently possible.

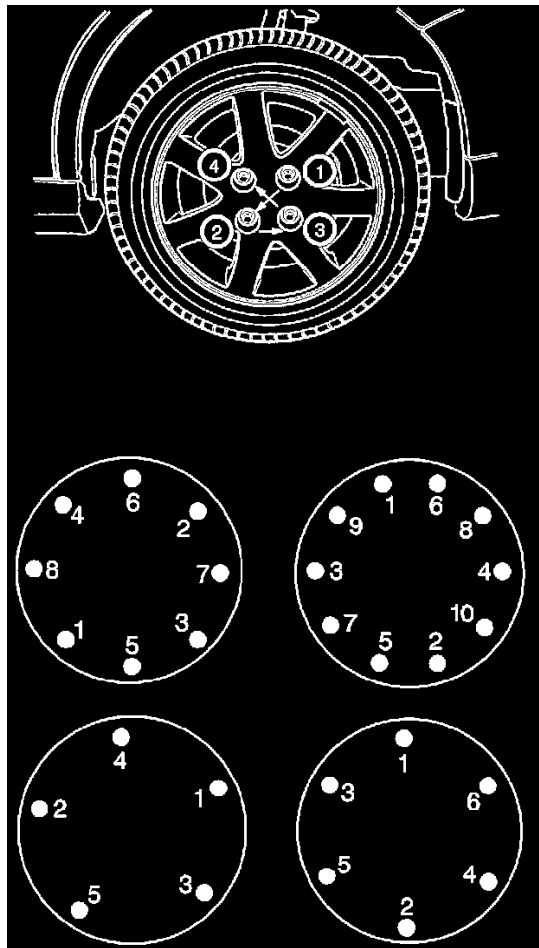
#### Wheel Nut Tightening and Torque

Improper wheel nut tightening can lead to brake pulsation and rotor damage. In order to avoid additional brake repairs, evenly tighten the wheel nuts to the proper torque specification as shown for each vehicle in SI. Use the J 39544-KIT, or the equivalent torque stick, in order to tighten the nuts with an impact wrench. When running the nuts down the studs, run the impact wrench at a reasonable speed. Always observe the proper wheel nut tightening sequence as shown in order to avoid trapping the wheel on the wheel stud threads or clamping the wheel slightly off center resulting in vibration.

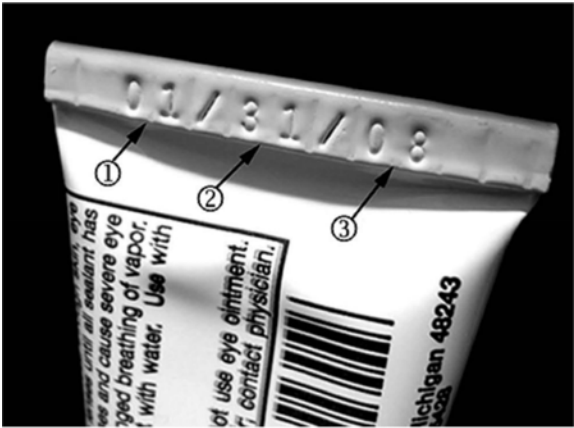
Use By Date Code

The use by date of the 0.075 kg (75 gram) tube is twelve months from the manufacture date printed on the crimp month (1), date (2), year (3).  
GMSPO recommends that dealers use the first-in first out (FIFO) system of stock rotation on chemicals. Use the oldest stock first by rotating the oldest to the front of a stock location.

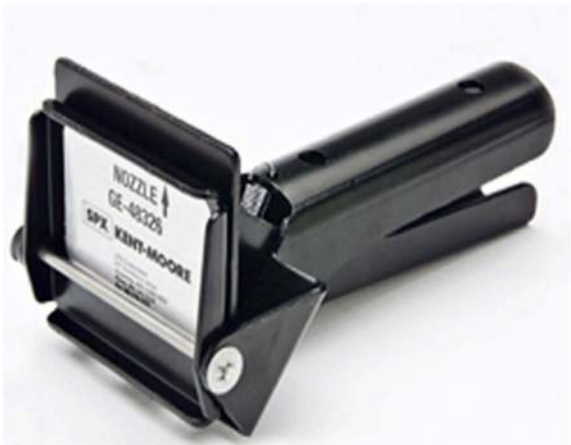
Special Service Tool GE-48326 Sealant Dispenser

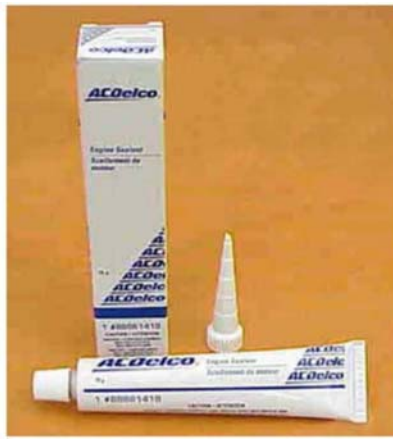
New Engine Sealant 0.075 kg (75 gram) Squeeze Tube (also available in Vehicle Care label for US dealers)

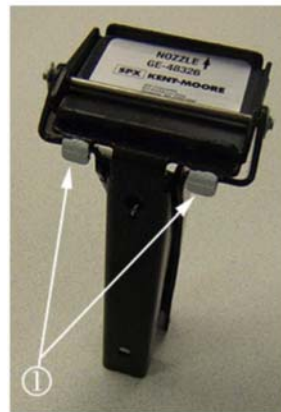
To use the sealant dispenser correctly, install the two white tabs on the rear handle (1) over the front handle. The white paint marks are for demonstration purposes only. Now your dispenser is ready to install engine sealant 0.075 kg (75 gram) squeeze tube.

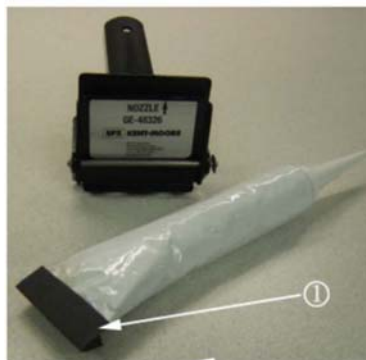
Before installing engine sealant 0.075 kg (75 gram) squeeze tube into the dispenser, install a small piece of medium grit sandpaper, or equivalent, by folding it over the bottom of the squeeze tube (1). This will help hold the squeeze tube firmly in place while using the sealant dispenser.

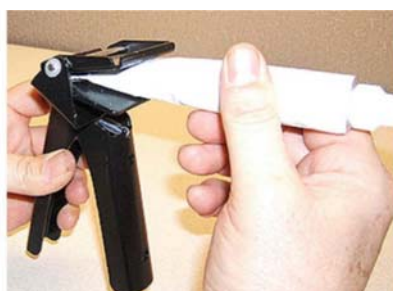
Install engine sealant 0.075 kg (75 gram) squeeze tube with a small piece of medium grit sandpaper into the dispenser (see above graphic

illustration). Remember to open the squeeze tube with a sharp knife or equivalent and cut the sealant nozzle to the correct diameter to apply a 3 mm (0.118 in) even bead of sealant.

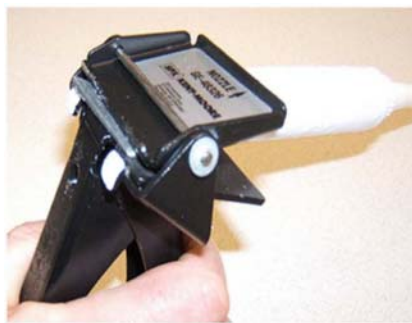
The sealant dispenser with the engine sealant is now ready to be used (see above graphic illustration).

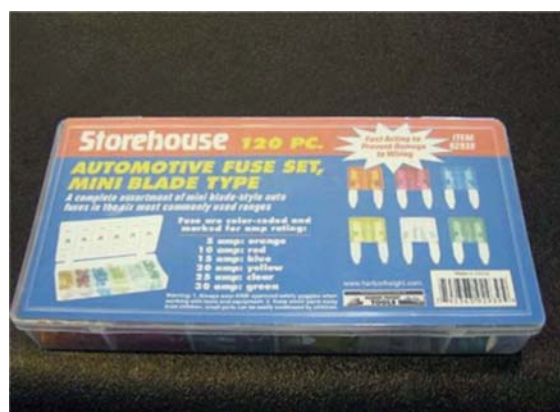
How to Identify These Fuses

Packed in a 120 piece set, the fuse has a translucent, hard plastic, blue body with the amperage stamped into the top. There are no white painted numbers on the fuse to indicate amperage. There are no identifying marks on the fuse to tell who is making it. The fuses are known to be distributed by Harbor Freight Tools but there may be other marketers, and packaging of this style of fuse. It would be prudent to replace these fuses if found in a customers vehicle. Likewise, if wiring overheating is found you should check the fuse panel for the presence of this style of fuse.

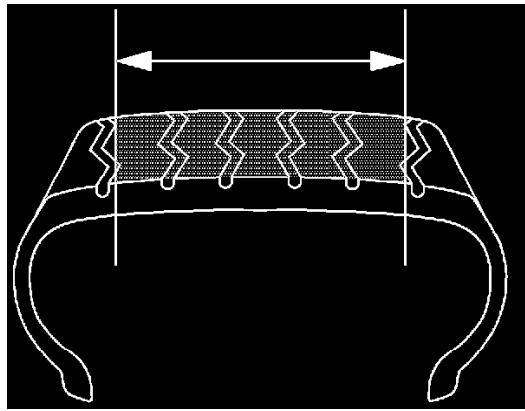
Repairable area on a radial tire.

NEVER repair tires worn to the tread indicators 1.59 mm (2/32") remaining depth).

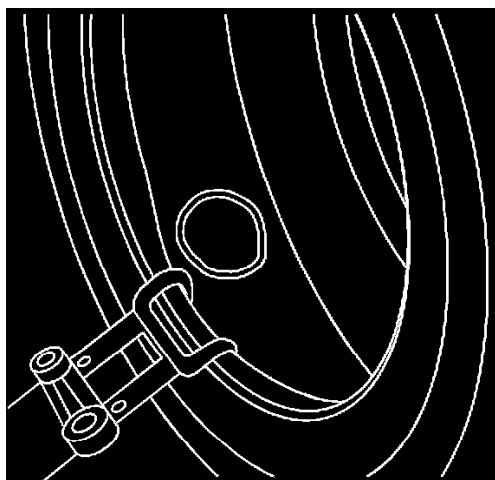
#### Internal Inspection

Spread the beads and mark the puncture with a tire crayon.

Inspect the inner tire for any signs of internal damage.

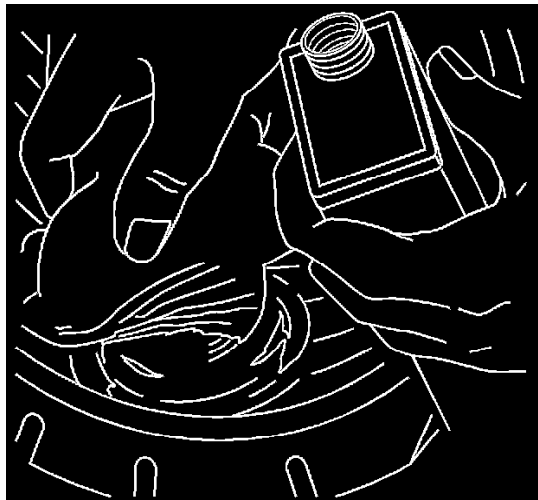
Cleaning

Clean the area around the puncture thoroughly with a proper liner cleaner clean cloth and a scraper. This step serves to remove dirt and mold lubricants to insure proper adhesion and non-contamination of the buffing tool.

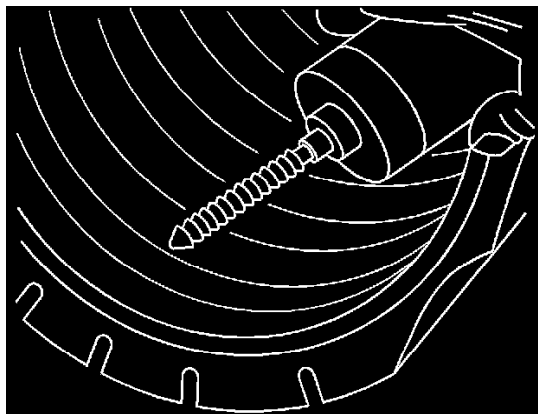
Clean the Injury Channel

Use a proper hand reamer carbide cutter or drill bit to ream the puncture channel from the inside of the tire in order to clean the injury.

Remove steel wires protruding above the liner surface to prevent damage to the repair unit.

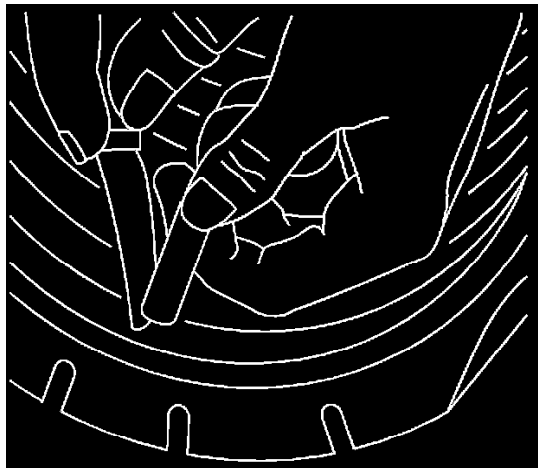
Fill the Injury

It is necessary to fill the injury channel to provide back up for the repair unit and to prevent moisture from entering the tire fabric and steel wires.

(For combination repair/plug units skip this step.) Cement the injured channel and fill the injury from the inside of the tire with the repair plug per repair material manufacturers recommendations. Without stretching the plug cut the plug off just above the inside tire surface.

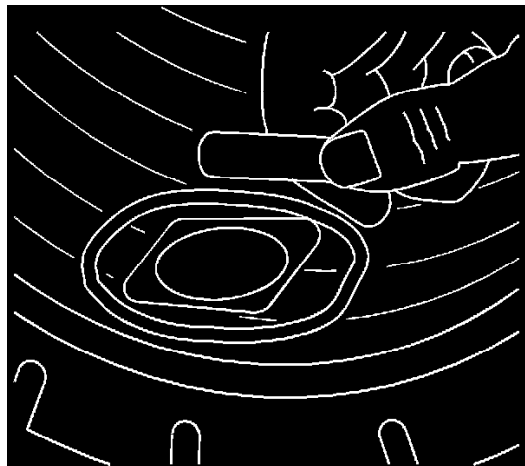
#### Repair Unit Selection

Do not install the repair unit in this step.

Center the repair unit over the injury as a reference and outline an area larger than the unit so that buffing will not remove the crayon marks.

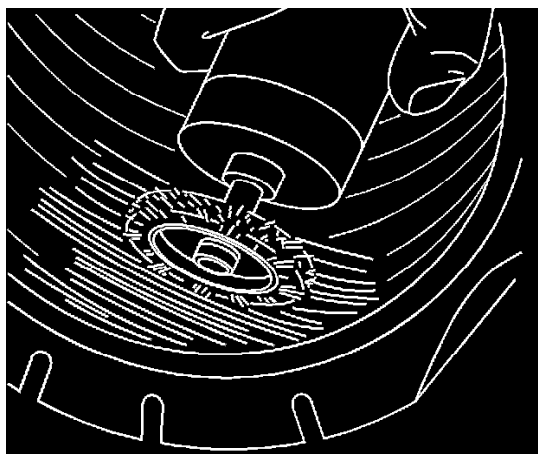
#### Buffing

To prevent contamination and preserve the outline buff within the marked area thoroughly and evenly with a low speed buffing tool using a fine wire brush or gritted rasp.

Buff to a smooth velvet surface (RMA # 1 or # 2 buffed texture).

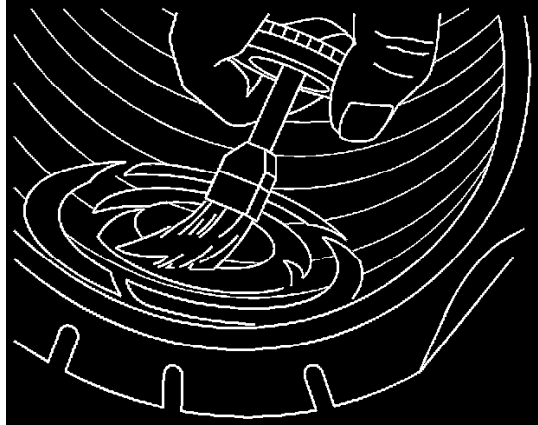
Cementing

Apply chemical cement according to the repair material manufacturers procedures.

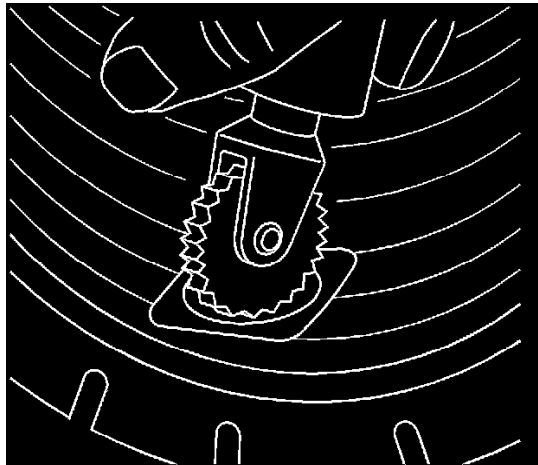
Repair Unit Application

The tire must be in the relaxed position when the repair unit is installed (Do not spread the beads excessively).

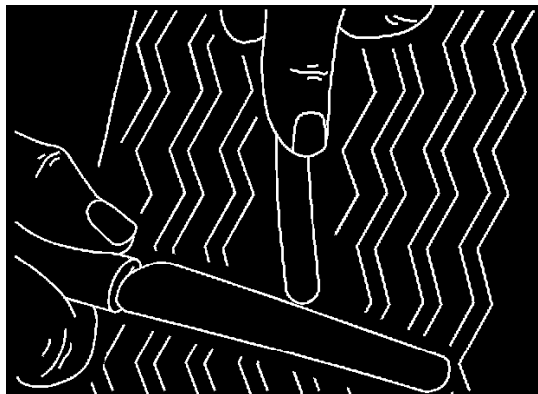
Center the repair unit over the injury and stitch down thoroughly with the stitching tool working from the center out.

Being careful not to stretch the plug material cut the plug flush with the outer tread.

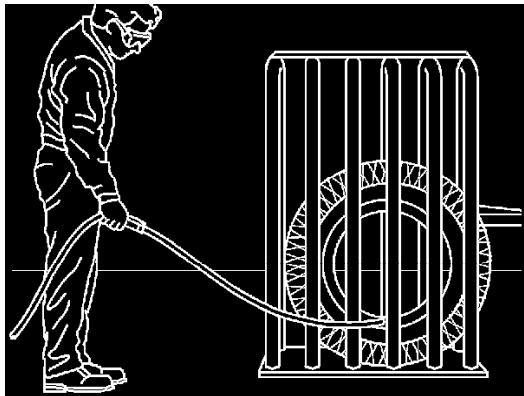
#### Safety Cage

Some run flat tires such as the Goodyear Extended Mobility Tire (EMT) used on the Corvette may require more than 275 kPa (40 psi) to seat the bead. In such a case a tire safety cage must be used. Consult the tire manufacturer for its individual repair policy.

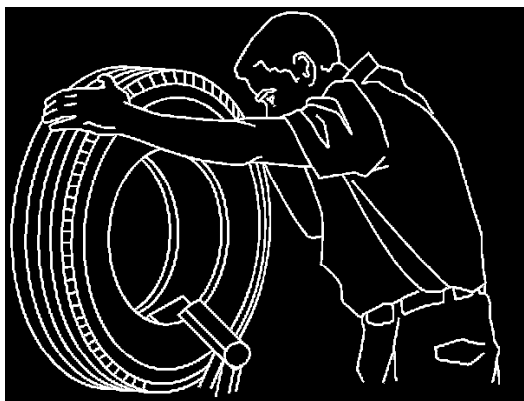
#### Final Inspection

After remounting and inflating the tire check both beads the repair and the valve with a water and soap solution in order to detect leaks.

If the tire continues to lose air the tire must be demounted and reinspected.

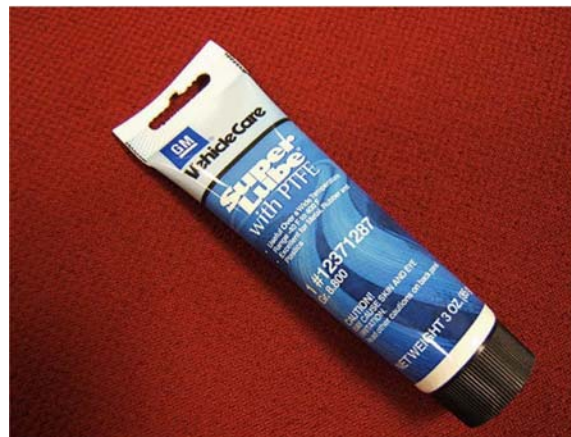
In all cases, GM Vehicle Care Super Lube(R) with PTFE performed the best at preventing corrosion in fastener to panel interface holes and is now the official GM recommended product as shown in the above illustration. It is recommended to apply the GM Vehicle Care Super Lube(R) with PTFE, to any hole and fastener before installing the fastener into the drilled attaching hole or inside the metal panel.

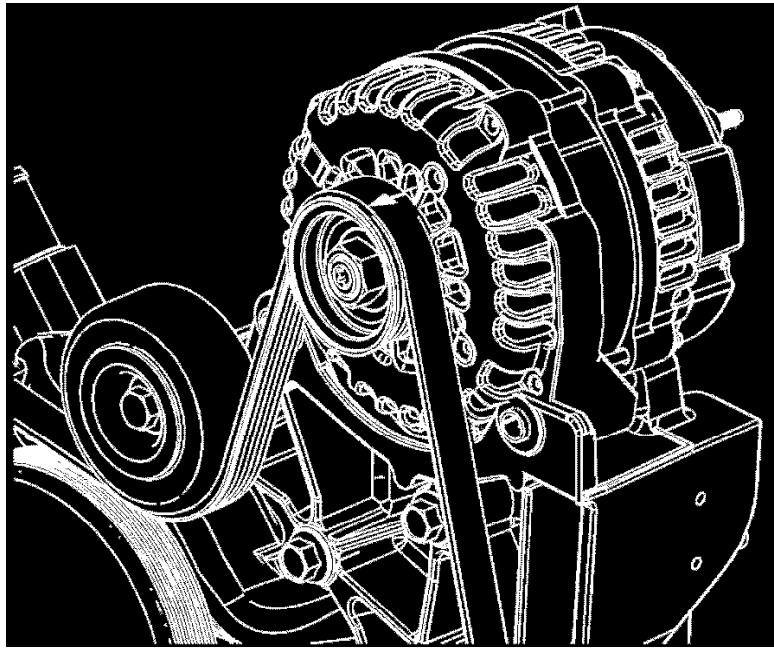
1. Observe and mark the serpentine belt orientation.
2. Remove the serpentine belt from the accessory drive system.

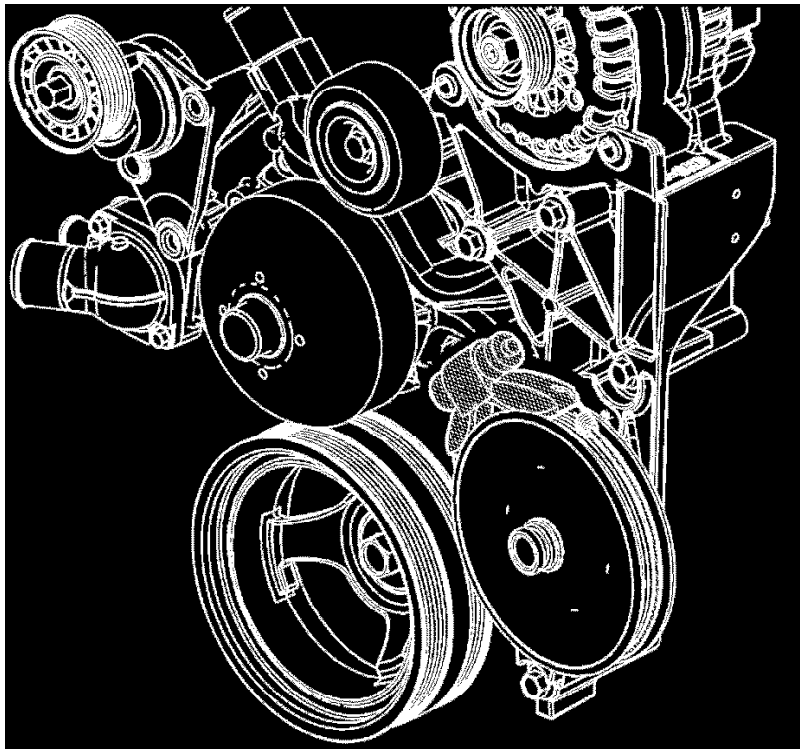
3. Install the tool onto the power steering pulley. Position the legs of the tool into the outer grooves of the pulley, farthest from the front of the engine.
4. Install the retaining cord around the pulley and to the legs of the tool.

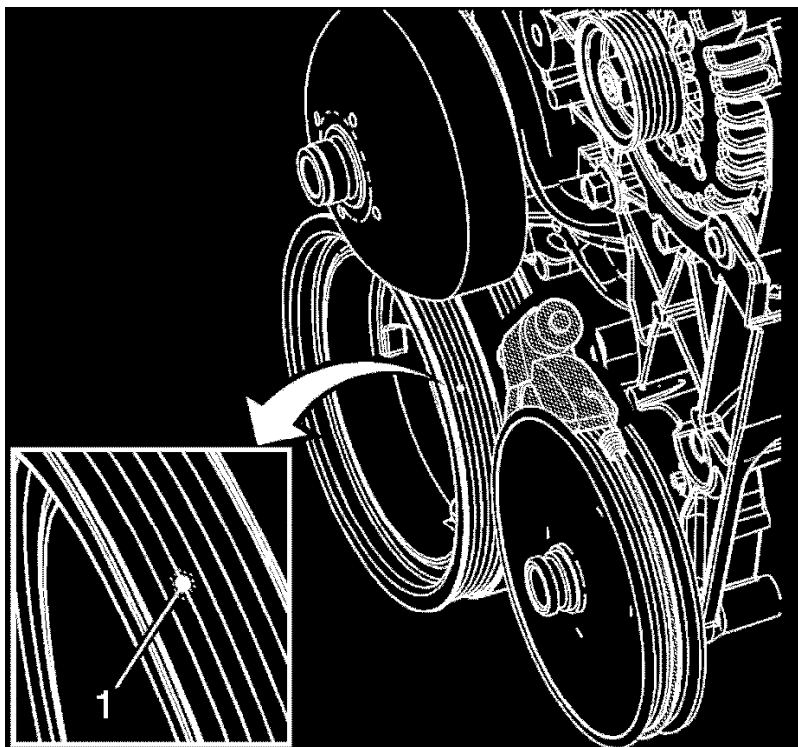
5. Put on the laser safety glasses provided with the tool.
6. Depress the switch on the rear of the tool to activate the light beam.
7. Rotate the power steering pulley as required to project the light beam onto the crankshaft balancer pulley grooves.
8. Inspect for proper power steering pulley alignment.
  - ^ If the laser beam projects onto the second rib or raised area (1) the pulleys are aligned properly.
  - ^ If the laser beam projects more than one-quarter rib 0.9 mm (0.035 in) mis-alignment, adjust the position of the power steering pulley as required.
  - ^ Refer to SI for Power Steering Pulley Removal and Installation procedures.
9. Install the serpentine belt to the accessory drive system in the original orientation.
10. Operate the vehicle and verify that the belt noise concern is no longer present.

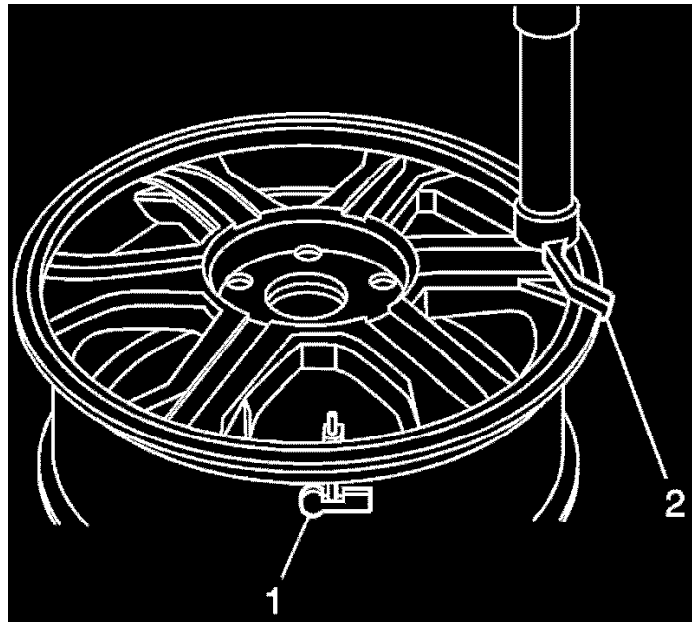
3. Position the rim so the TPM valve stem (1) is situated at the 3 o'clock position relative to the head (2). This will protect the TPM sensor body by ensuring that the bead is under the least amount of tension when it passes over it.

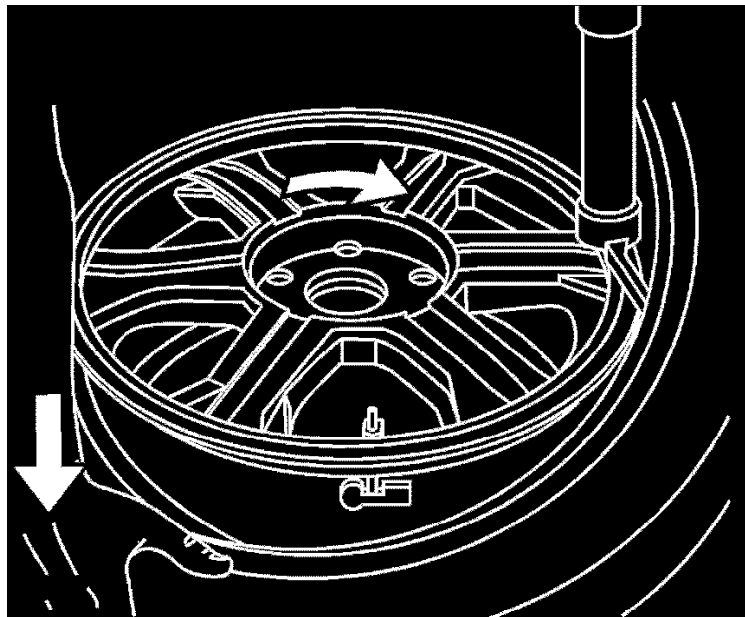
4. Using the tire changer, rotate the tire/wheel assembly clockwise when transferring the tire bead to the inside of the wheel rim.
5. After the bottom bead is on the wheel, reposition the wheel and tire so that the TPM valve stem is again situated at the 3 o'clock position relative to the head. This will protect the sensor while mounting the tire bead to the outside of the wheel.

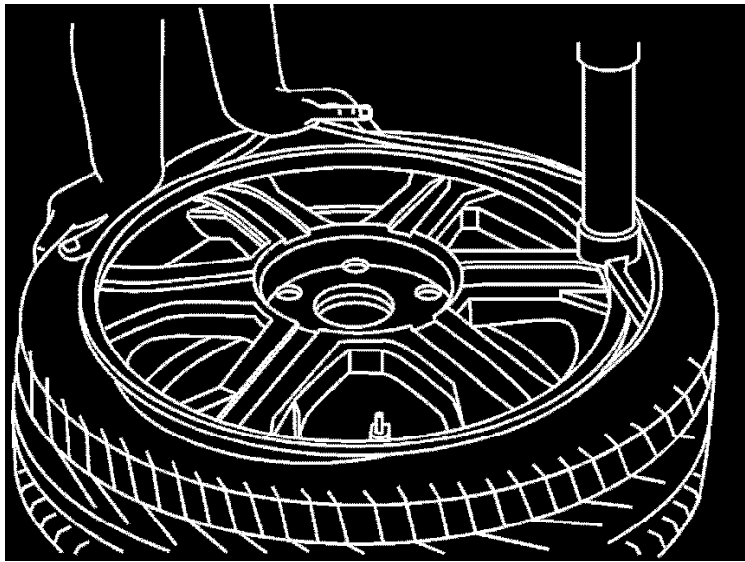
6. Using the tire changer, rotate the tire/wheel assembly clockwise when transferring the tire bead to the inside of the wheel rim.

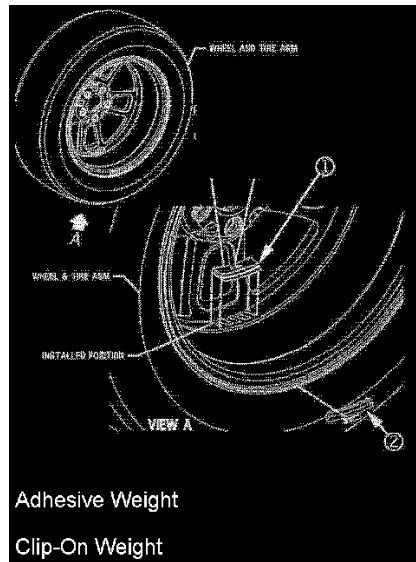
3. Install a clip-on balance weight on the inboard wheel flange per the weight indications on the balancer.
  - ^ Use only MC-series polyester-coated weights at this location. GM Accessory wheels have an MC-rim contour at the inboard location.
  - ^ Use only a nylon or plastic tipped hammer to avoid damaging the weight coating or the wheel finish.
  - ^ Never strike a wheel weight more than twice. If it doesn't seat properly after two hits, discard it and try a new weight.

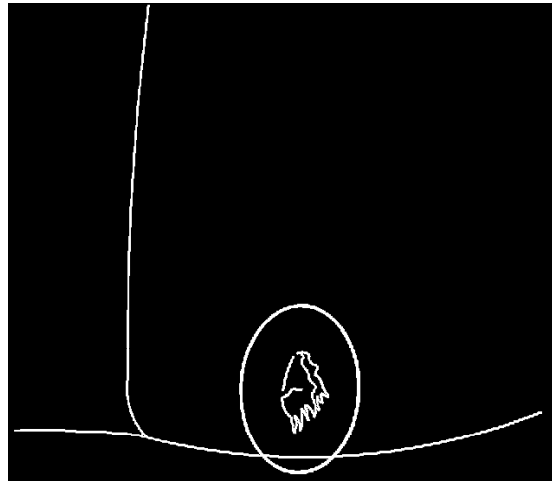
Customer induced cuts (knife cuts, cut by customer tools etc.)

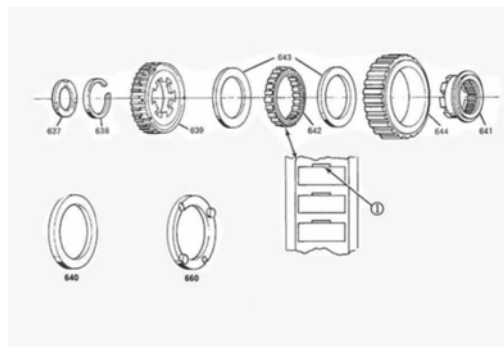
The notches above each sprag must point up as shown when assembled into the outer race.
