### **ABOUT THE EMS\* DIAGNOSTIC MANUAL**

The EMS(Engine Management System) diagnostic manual outlines the detailed procedures to troubleshoot complaints related to the Common Rail Diesel Engine and its controller (EMS ECU) fitted on **Scorpio VIx/Sle/Lx (Refresh)** vehicle. Procedures to treat each DTC retrieved from the EMS ECU is given in a step by step , trouble-shooting tree structure.

Scorpio VIx, Sle, Lx (Refresh)

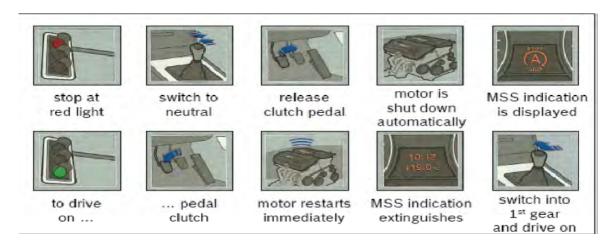
With ESS switch ON, below schematic representation explains the ESS functionality.

The block diagram of how the ESS functions is given in the next page.

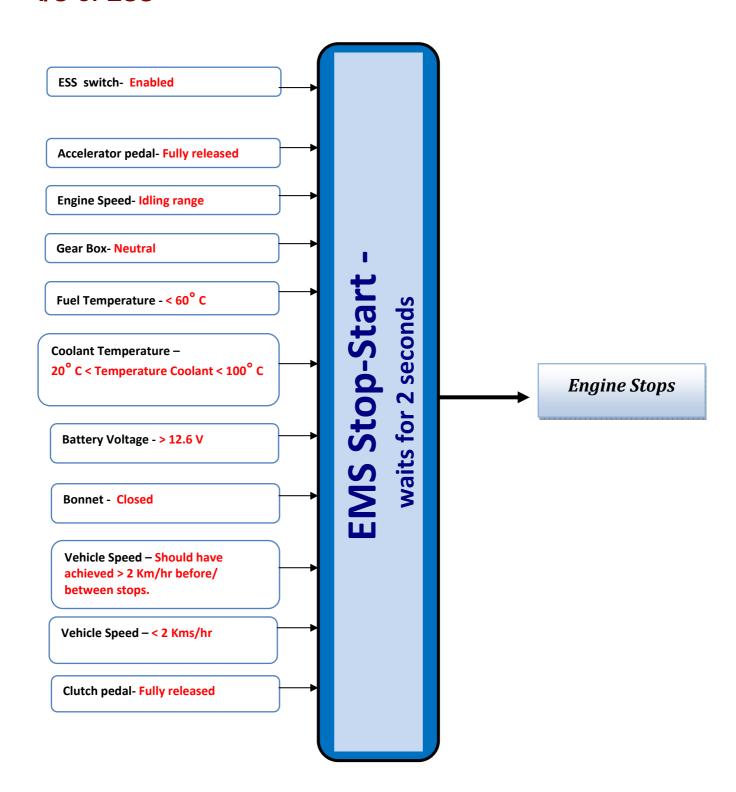
### I/O of ESS

ESS is controlled from the EMS ECU. If any of the sensors malfunction then the ESS is disabled and an error code generated.

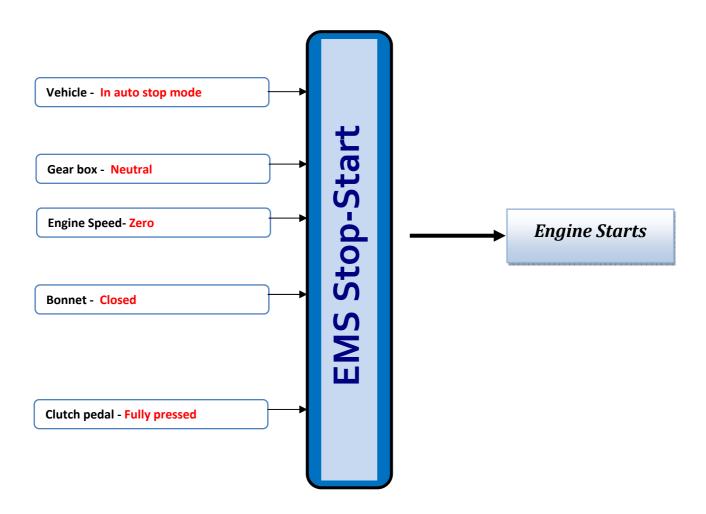
#### I/O of ESS

- 1) If the feature selection switch is reset (From ON OFF ON) when vehicle is in auto stop mode, then clutch start will not be possible but key crank would be possible.
- 2) If Bonnet is opened when the vehicle is in auto-stop mode, clutch start would be disabled and only key crank would be possible.

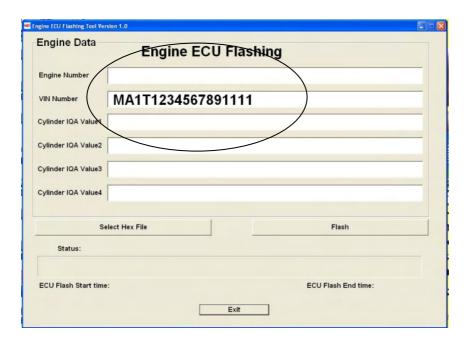
Write the correct 17 digit VIN

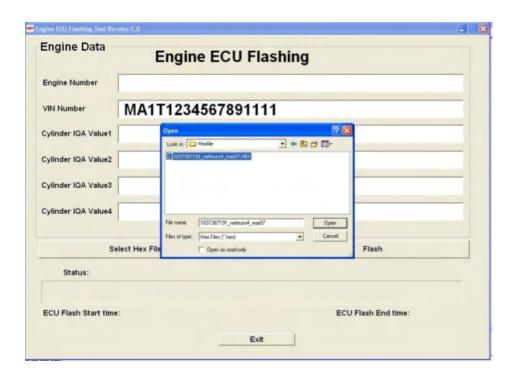
- Click on "Select Hex File" (Refer to latest TSB)
- Select the applicable dataset and click "open"
- Click "Flash"

- After completion of flashing, switch OFF the ignition for 1 minute and switch it ON
- Learn the EMS with Immobilizer ECU (ICU) Refer to diagnostic manual (immobilizer).
- Refit the starter relay if it has been removed for vehicle with ESS

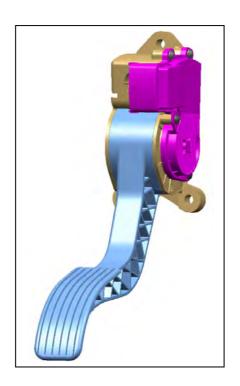
**Accelerator Pedal Module 1**

P-0123 P-0122 P-1120

DTO detection condition	Duckahla asusa
DTC detection condition	Probable cause
Normal Operation	
<ul> <li>The Accelerator pedal module (APM) outputs a voltage, which is proportional to the Position of accelerator pedal.</li> <li>The ECU checks whether the voltage output by the Accelerator pedal module is within a specified range. In addition, it checks that the voltage output does not become too large while the engine is in idling.</li> </ul>	<ul> <li>Open or shorted         Accelerator pedal         module circuits, loose         or wrongs         connections.</li> <li>Accelerator pedal         module failed or         maladjusted.</li> </ul>
Proper Performance Sensor output voltage has continued to between 0 to 5V, varying accelerator pedal position.	
Malfunction; out-of-range     With the changing Accelerator pedal position, the sensor output voltage has continued to be 5V or 0V.	
<ul> <li>Reaction:</li> <li>The engine speed not varying with changing accelerator pedal position. (Constant 1200 rpm)</li> <li>The system lamp is continuously on.</li> </ul>

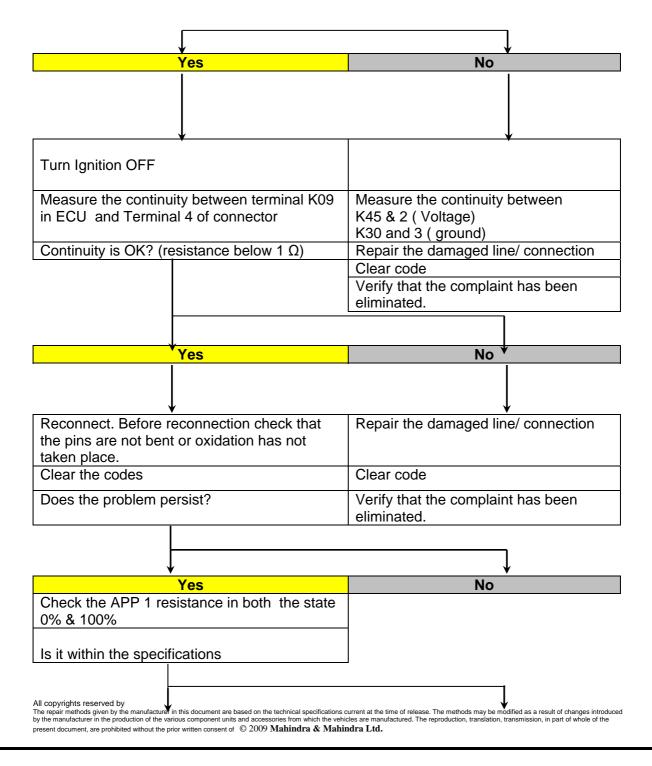
- 1. Connect the 'Smart Tester' to diagnostic connector.
- 2. Turn Ignition Switch ON.
- 3. Verify either P0123 or P122 or P1120 are present.
- Turn Ignition switch OFF & disconnect Accelerator Pedal connector.
- Turn the Ignition ON & measure voltage between terminal 2 & terminal 3 of the APP1 (from the APP1 connector side.)
- It should be 5 ± 0.3 V
- Is it?

Yes	No
Clear the code.	Replace the Accelerator pedal Module
Verify that the complaint has been eliminated.

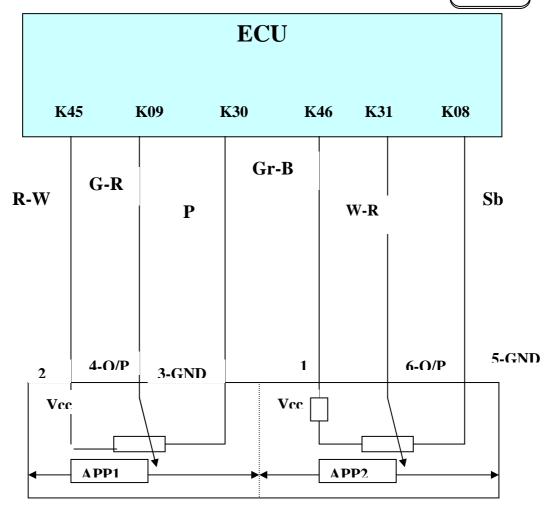
P-0223 P-0222 P-1220 P-1221

DTC detection condition	Probable cause
Proper Performance	
Sensor output voltage has continued to between 0 to 2.5V, with varying accelerator pedal position.	Open or shorted     Accelerator pedal     module circuits, loose or
Malfunction; out-of-range	wrong connections.
<ul> <li>With the fully pressed Accelerator pedal module,</li> </ul>	
the sensor output voltage has continued to be 2.5V or 0 for 4 sec.	Accelerator pedal module failed or maladjusted.
Reaction	,
<ul> <li>The engine speed not varying with changing accelerator pedal position. (Constant 1200 rpm)</li> <li>The system lamp is continuously on.</li> </ul>

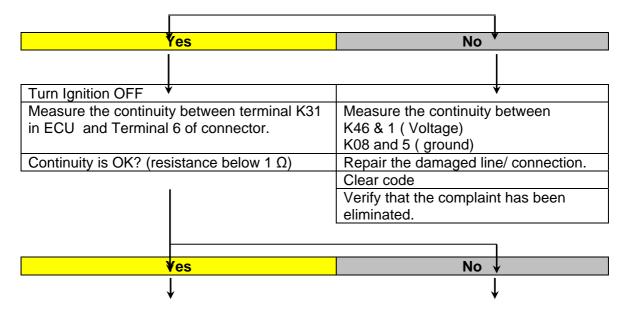
- 3. Verify that either P0223/P0222/P1220 / or P1221 is present.
- Turn Ignition switches OFF & disconnect Accelerator pedal connector.
- Turn the Ignition ON & measure voltage between terminal 2 & terminal 3 of the APP2 (from the APP2 connector side.)
- It should be  $2.5 \pm 0.15 \text{ V}$
- Is it?

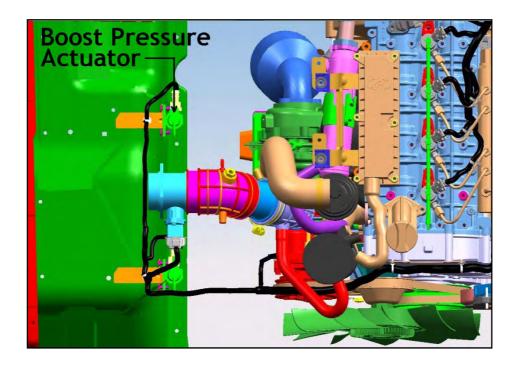
**Boost Pressure Actuator**

P-1604 P-1605 P-1606 P-1607

DTC	Diagnostic item	
P-1604	Short circuit Battery	
P-1605	Short circuit Ground	
P-1606	No Load	
P-1607	Excess Temperature	
	DTC detection condition	Probable cause
Proper Performance		Possible Causes
The ECU monito	ors the Boost pressure actuator (	
modulator) during the normal operation as well as during		<ul> <li>Short circuit to battery</li> </ul>
actuator test)		or ground.
Malfunction; out-of-range		<ul> <li>Excess temperature</li> </ul>
<ul> <li>With the fully pressed Accelerator pedal module,</li> </ul>		No load.
the sensor output voltage has continued to be		
2.5V or 0	) for 4 sec.	
Reaction		
<ul> <li>Torque v</li> </ul>	vill be reduced	
EGR is s	witched off.	
<ul><li>System (</li></ul>	Check lamp is ON

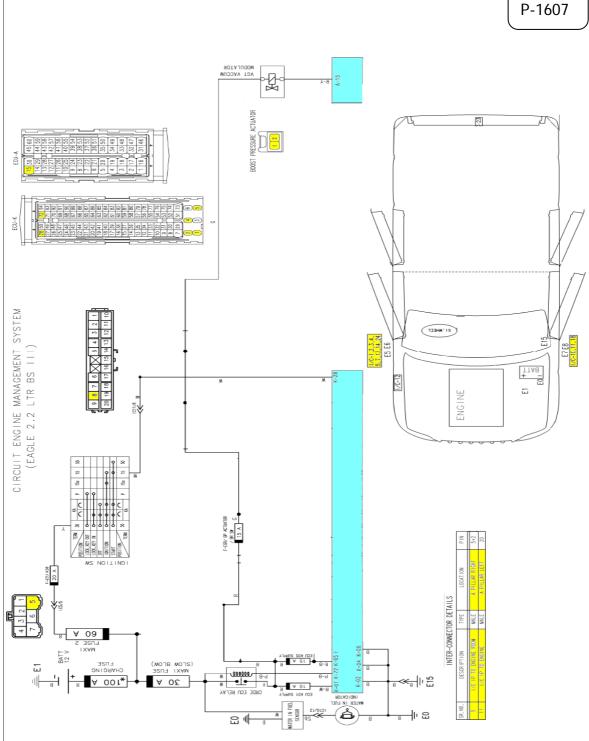
P-1605 P-1606 P-1607

P-1604 P-1605 P-1606 Repair the damaged line/ connection Measure the continuity from Battery to BPA P-1607 Clear code Verify that the complaint has been eliminated. No Yes Reconnect. Before reconnection check that Check the vacuum lines (in particular the pins are not bent or oxidation has not the line from the BPA to the actuatorcheck for looseness. Or hardening due to aging. Does the problem persist? No **V**Yes Change the BPA with a known good one Reconnect. Before reconnection check that

- 1. Error present in modulator and reported by ECU.
- 2. There is vacuum leak in the system. Thus when the x amount of boost but the actual amount is y. The BPA will supply more vacuum to the VGT so that the vanes open further and boost is
  - increased. If however the VGT movement is not proportional to the demand, then after a limit, the complaint will be registered as an error.
- 3. If the boost pressure is not proportional to the expected performance as the VGT is not able to respond to the changes then the ECU will register is as an error of the BPA.

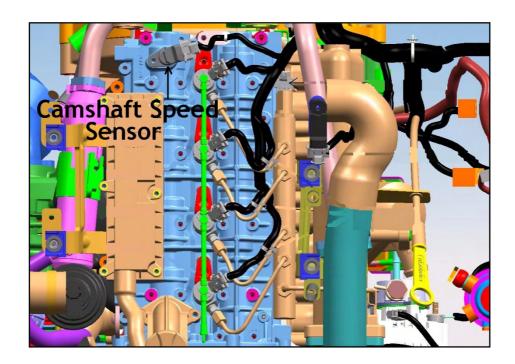
**Camshaft Speed Sensor**

P-0340 P-0341

The Hall effect camshaft position sensor senses the Top dead center (TDC) point of the # 1 cylinder in the compression stroke. Which allows the ECU to determine when to start the injection.

DTC detection condition	Probable cause
Normal Operation  When the engine is running, the Camshaft Position sensor outputs a pulse signal.  The ECU checks whether the pulse signal is input.  Malfunction  Normal signal pattern has not been input for cylinder identification from the camshaft position	<ul> <li>Open or shorted camshaft position sensor circuit, loose or wrong connection.</li> <li>Camshaft Position sensor malfunction.</li> </ul>
sensor signal for 4 sec. (Engine should be cranked to check this error).  Reaction  Engine will not start  System lamp will be continuously on.

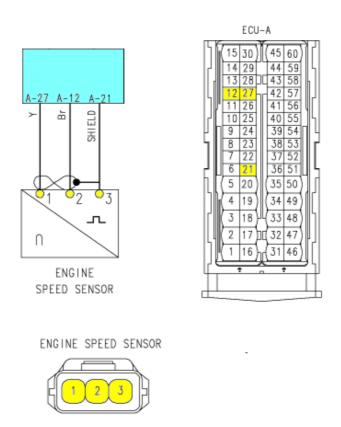
P-0336

- 1. Connect the 'Smart Tester' to diagnostic connector.
- Turn Ignition Switch ON.
   Verify that either P0335 or P0336 are present. Please verify while cranking the engine.
- Turn the Ignition switch OFF.
- Disconnect the crankshaft position sensor connector and also the connector at ECU.
- Measure the continuity between the sensor terminal 1 and ECU terminal A 27.

<u>Description</u> - In order that the ECU can control the engine at all the position of the crankshaft must be known so that the cylinder in compression and the timing of the next fuel injection can be calculated. The CKP is an inductive pulse generator, which scans protrusions on the flywheel. Two teeth are missing, and this gap is situated at 90° before TDC.

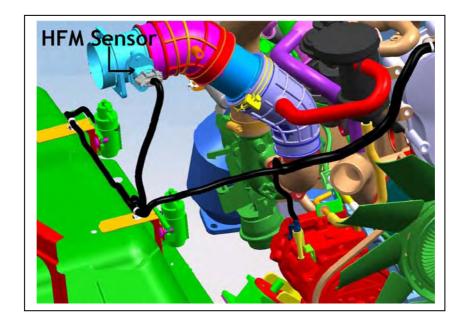
**Air Flow**

P-0103 P-0102

DTC detection condition	Probable cause
Normal Operation	
<ul> <li>The HFM sensor outputs a voltage, which corresponds to the intake airflow.</li> </ul>	Open or shorted HFM sensor circuit, loose or
<ul> <li>The ECU checks whether this voltage is within a specified range.</li> </ul>	<ul><li>wrong connections.</li><li>Failed HFM sensor.</li></ul>
Normal Operating Requirements	
Ignition switch: ON	
<ul> <li>Malfunction lamp: OFF after 2 Sec</li> </ul>	
<ul> <li>Battery voltage is 8V-16V or more.</li> </ul>	
Malfunction	
<ul> <li>The sensor output voltage has continued to be 5V or higher.</li> </ul>	
The sensor output voltage has continued to be	
0.5V or lower.	
Reactions:	
<ul> <li>System lamp will continuously blink.</li> </ul>	
Engine will continue to run with default air flow (depending	
on Speed & Fuelling)

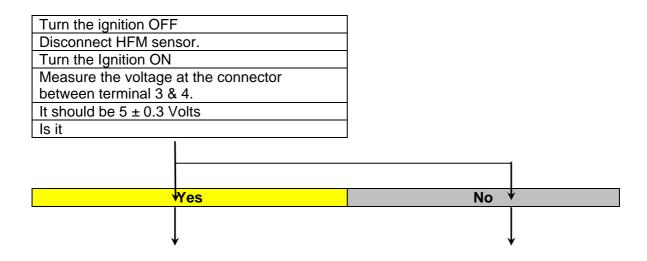
#### **Test Procedure HFM**

- 1. Connect the 'Smart Tester' to diagnostic connector.
- 2. Turn Ignition Switch ON.
- 3. Verify that either P0103 or P0102 are present.

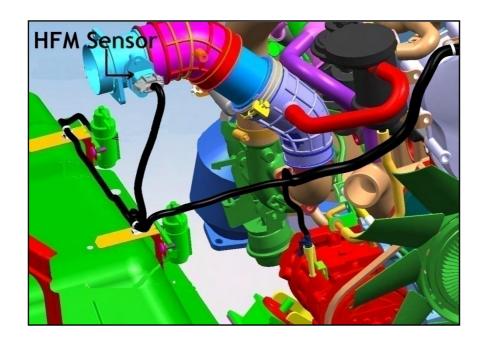
**Air Temperature**

P-0113 P-0112

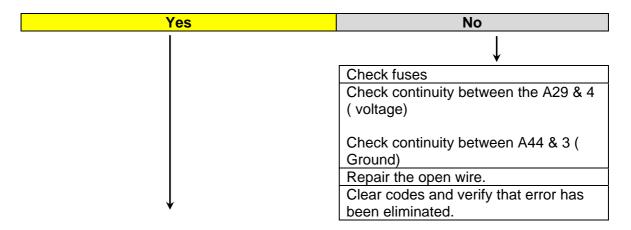
#### Test Procedure AFTSCD -

- 1. Connect the 'Smart Tester' to diagnostic connector.
- 2. Turn Ignition Switch ON.
- 3. Verify that either P0113 or P0112 are present.

Turn the ignition OFF
Disconnect HFM sensor Connector.
Turn the Ignition ON
Measure the voltage between the Terminal 3
& 4 of HFM Sensor Connector.
It should be 5 ± 0.3 Volts
Is it

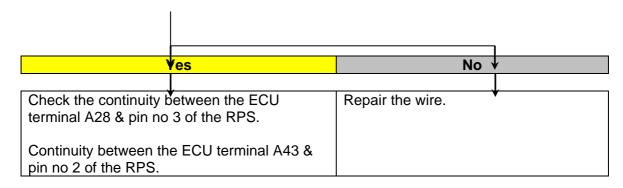
- 1. Connect the 'Smart Tester' to diagnostic connector.
- 2. Turn Ignition Switch ON.
- 3. Verify that either P-0193 or P-0192 is present.
- Switch off the Ignition
- Disconnect the rail pressure sensor connector.
- Turn ON the Ignition.
- Measure the voltage between the supply and the ground of the Rail pressure sensor (Pin no 1 & 3 of the RPS connector).
- It should be 5 ± 0.3 Volts
- Is it?

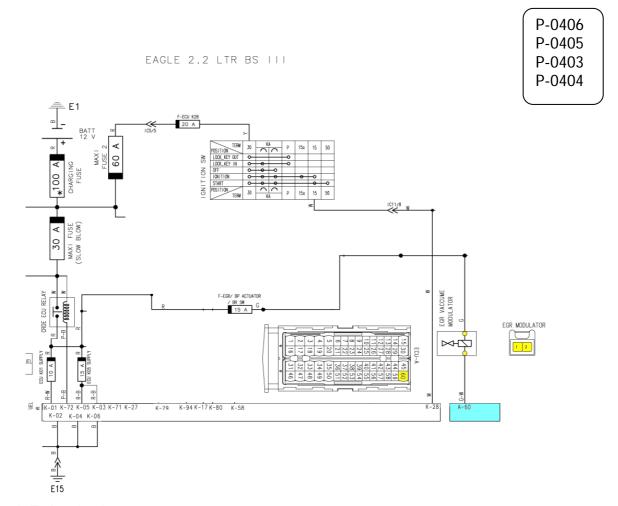
A pulse-width-modulated signal is output for the Exhaust Gas Recirculation actuator control. Converting the air control output into duty cycle carries this out. The possible defects are short circuit to battery, ground & no load.

DTC detection condition	Probable cause
Background	
<ul> <li>* The ECU checks current flows in the EGR solenoid drive circuit when the solenoid is ON and OFF. Range of check, set conditions.</li> <li>* When the EGR solenoid is turned OFF, no surge voltage is detected.</li> <li>Normal operation</li> <li>• When engine is running per the EGR mapping.</li> <li>• System lamp off after 2 sec.</li> <li>Malfunction</li> </ul>	<ul> <li>* Open or shorted EGR solenoid circuit, loose or wrong connection.</li> <li>* EGR solenoid failed</li> <li>* EGR control vacuum is too low</li> </ul>
EGR valve will remain open in case of short circuit to ground fault & remain closed for other fault conditions.  Reaction	
<ul> <li>System lamp will blink in case of short circuit to ground condition i.e.P0405.For all other fault condition (related to EGR) lamp will be OFF.</li> <li>Emission will affect.</li> </ul>

- \*- Twisted pair
  - 1. Connect the 'Smart Tester' to diagnostic connector.
  - 2. Turn Ignition Switch ON.
  - 3. Verify that either P0406 or P0405 or P0403 or P0404 are present.
- Disconnect the EGR control solenoid valve connector.
- Turn Ignition ON
- Check the voltage between Ground & EGR control solenoid, valve harness connector terminal. Battery voltage should be present.
- It should be 12 V when Ignition ON.

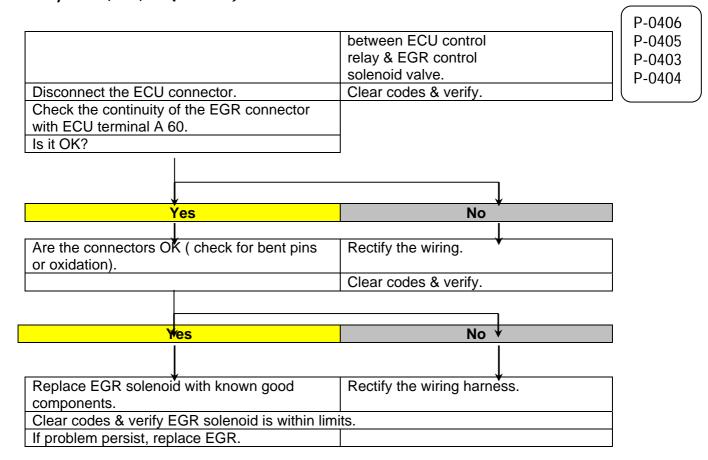
Note - The Modulator for EGR is Black in colour.

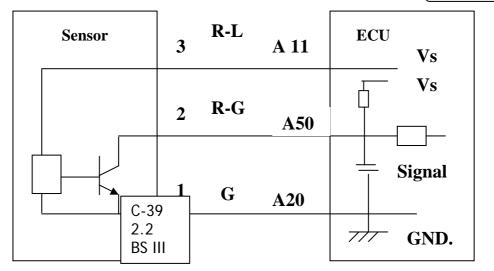
**Segment Speed Sensor (camshaft sensor)**

P-1340

Vs= Supply voltage- 5V

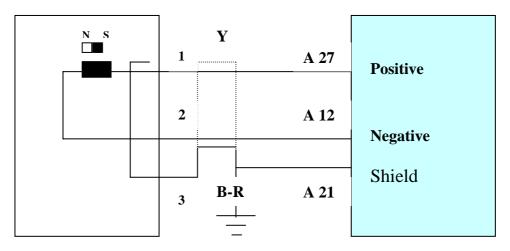
### ISS (Incremental speed sensor/ Crankshaft speed sensor)

**ECU** Sensor

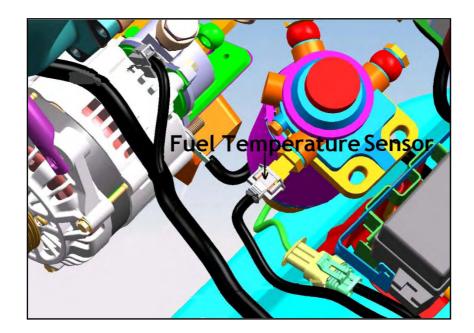
**Fuel Temperature Sensor**

P-0182 P-0183

DTC detection condition	Probable cause
Back	ground	
*	The fuel temperature sensor converts the engine fuel temperature to a voltage and outputs it. The ECU checks whether the voltage is within a specified range.	Open or shorted     Engine fuel     temperature sensor     circuit, loose or wrong     connection
Malfu	nction; out-of-range	Fuel temperature
*	Sensor output voltage has continued to be 5V or higher for 4 sec.	sensor failed.
*	Sensor output voltage has continued to be 0.1V or lower for 4 sec.	
React	tion	
*	System lamp will blink continuously.	
*	Engine will run with default fuel temp of 20 Deg C.

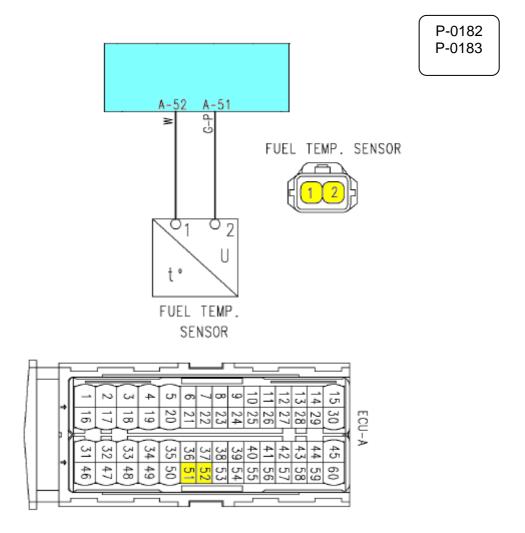
### <u>Test Procedure Fuel Temperature Sensor</u> -

Codes: P-0182, P-0183

Turn the Ignition OFF.	Open or short between
	FTS signal terminal 1 and ECU.
Measure continuity between A 52 of ECU &	Repair as necessary.
connector terminal 1.	
Measure continuity between A 51 of ECU &	
connector terminal 2.	
Is it OK?	
Yes	No <sup>v</sup>
Connect FTS connector.	Open or short between FTS signal
	terminal 1 and ECU.
Turn Ignition ON.	Repair as necessary.
Check the voltage of FTS ( at A51 & A52)	
Is it as per specification?	
↓	<b>↓</b>
Yes	No
Poor terminal contact due to oxidation , bent	Temporarily install a known good FTS
or misplaced terminal.	and check for proper operation.
Repair as necessary.	If problem is corrected, replace FTS.
rrepair as riecessary.	I II DIODIGIII IS COITECIEU, TEDIACE I I S.

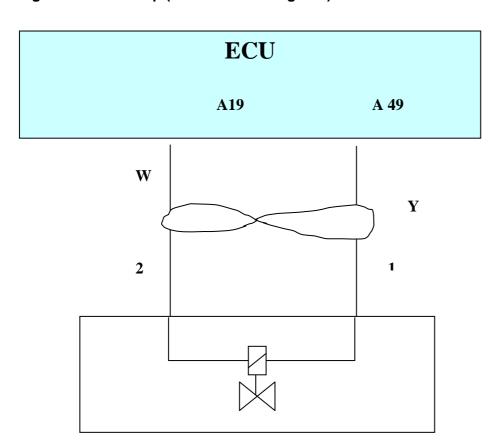
### **High Pressure Pump (with fuel metering unit)**

DTC detection condition	Probable cause
Normal operation	
<ul><li>When ignition is ON pump is getting supply from ECU.</li><li>Engine is starting properly.</li></ul>	Open, shorted or wrong connection of pump circuit.
Malfunction	
<ul> <li>When ignition is ON pump is not getting PWM signal from ECU.</li> </ul>	
Reaction	
<ul> <li>Engine is not starting &amp; error is recorded in ECU error memory.</li> </ul>	
Fuel output is not available from pump.	
System lamp will remain ON.

> > P-1250 P-1251

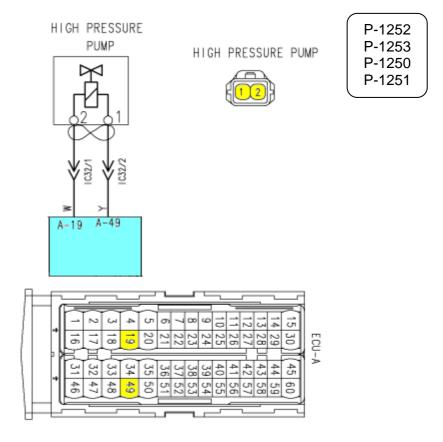
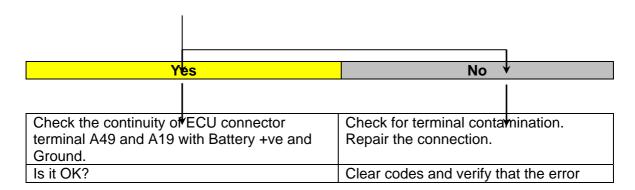
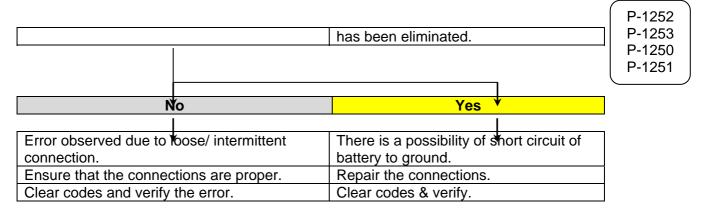
- 1. Connect the 'Smart Tester' to diagnostic connector.
- 2. Turn Ignition Switch ON.
- 3. Verify that either P-1252 or P-1253 or P-1250 or P-1251 is present.
- Check the connections to the pump.
- Check that the connections are connected correctly; and that it is not connected in reverse way.
- Disconnect the pump and ECU connectors.
- Check the continuity between the ECU terminal A19 and pump terminal 2.
- Check the continuity between the ACY terminal A49 with pump terminal 1.
- Is it OK?

Hint: The Error Code P 1251 can also be generated if there is leakage in the HPP adaptor.

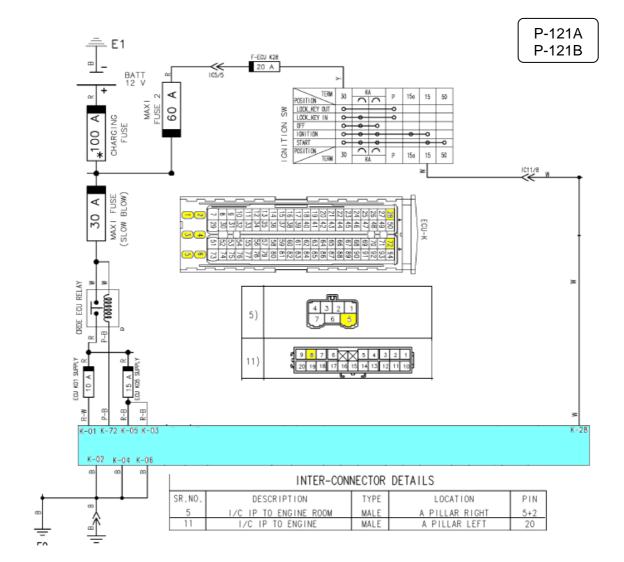
DTC detection condition	Probable cause
Normal operation	
While cranking engine will start properly.	<ul> <li>Open, shorted or wrong connection of</li> </ul>
Malfunction	main relay.
Supply will not come to ECU input.	<ul> <li>Main relay fuse is blown.</li> </ul>
Reaction	<ul> <li>Relay is not working</li> </ul>
Engine will not start.	
<ul> <li>No communication with smart tester.</li> </ul>	
System check lamp will be on.

Engine not cranking – 'Smart Tester' not responding.

- 1. Connect the 'Smart Tester' to diagnostic connector.
- 2. Turn Ignition Switch ON.
- 3. Verify that either P121A or P121B is present.
- Ensure that the main relay is inserted properly in the connector
- Remove relay.
- · Check the relay externally.
- Give 12 Volts to terminal 86 and Ground the terminal 85.
- A clicking sound should be heard.
- If the sound is not heard, replace the relay.
- Check if 12 Volts is available at terminal 30, 86 & 85.
- With respect to ground, terminal 87 should show 0 Volts.
- Is it OK?

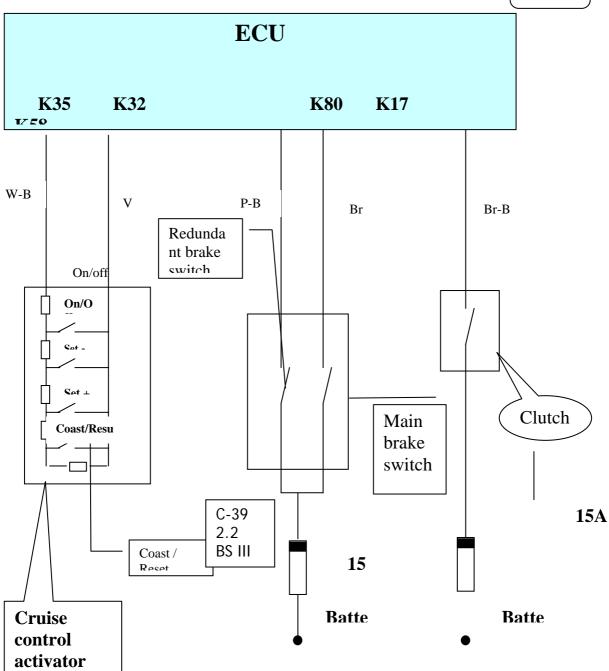
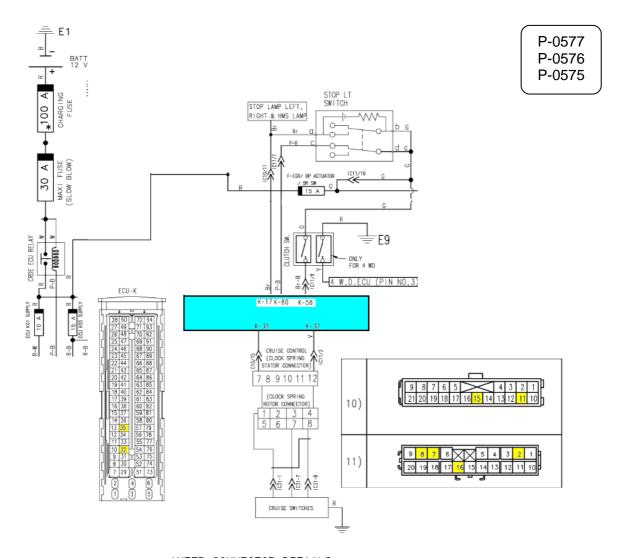
DTC detection condition	Pı	robable cause
•	Normal operation  When vehicle is running, no clutch & brake is pressed, by pressing cruise control switch vehicle will go into cruise mode.  Pressing resume key; vehicle will set the previous set speed.  Pressing set + or Set - vehicle speed can be adjusted.  Pressing OFF switch, vehicle will come out of cruise mode.  It will be operational in 2 <sup>nd</sup> /3 <sup>rd</sup> /4 <sup>th</sup> & 5 <sup>th</sup> Gear.  Clutch signal & brake switch signal are ok.  Engine RPM is > 1200	*	Open, shorted or wrong connection of cruise control circuit. Brake or clutch error is set into ECU. Switches are not responding or faulty. Engine RPM less than 1200.
Malfunction			
•	By pressing any of the cruise control switch vehicle will not go into cruise mode.		
•	Vehicle will not respond to set +, Set -, OFF or resume switch when vehicle is in cruise mode.

P-0577 P-0576 P-0575

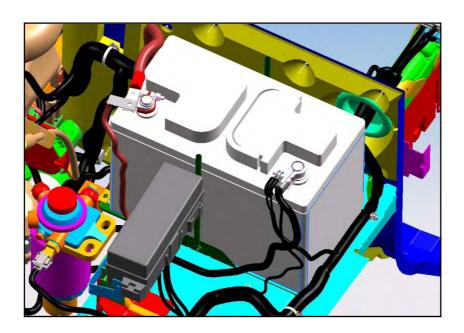
**Battery**

P-0563 P-0562

DTC detection condition	Probable cause	
<b>Detecting Condition</b>		
<ul> <li>* Battery voltage &lt;8 V</li> <li>Enable Condition</li> <li>No main relay failure</li> </ul>	<ul> <li>Charging system not working.</li> <li>Wiring harness to ECU faulty.</li> </ul>	
<ul><li>* Battery voltage &gt; 16V</li><li>Enable Condition</li><li>No main relay failure</li></ul>

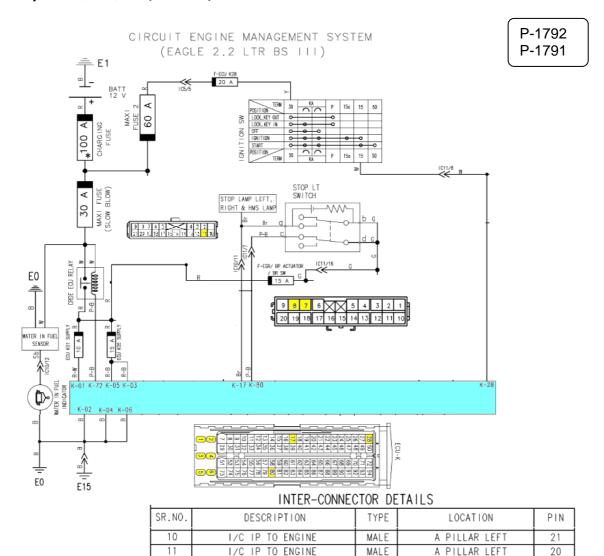
DTC detection condition	Probable cause
Principle	
<ul> <li>* The brake switch outputs a voltage, which corresponds to the brake position.</li> <li>* The ECU checks whether this voltage is within</li> </ul>	5
specified range (0 or 12V).	<ul> <li>Brake switch damage or faulty</li> </ul>
Normal Operation	<ul> <li>Brake switch failed or</li> </ul>
* Ignition switch: ON	maladjusted.
<ul> <li>* System lamp: OFF after 2 Sec</li> </ul>	
* Battery voltage is 8V –16V.	·
Malfunction	
* The sensor output voltage has continued to be in spite of brake pedal being pressed/not press	
* The sensor output voltage has continued to 12' spite of brake pedal being pressed/not pressed	
<ul><li>* Main or redundant switch is not working.</li></ul>	
Reaction	
<ul> <li>System lamp will be off.</li> </ul>	
Cruise control will not work.

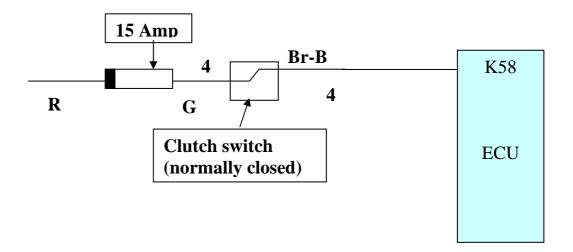
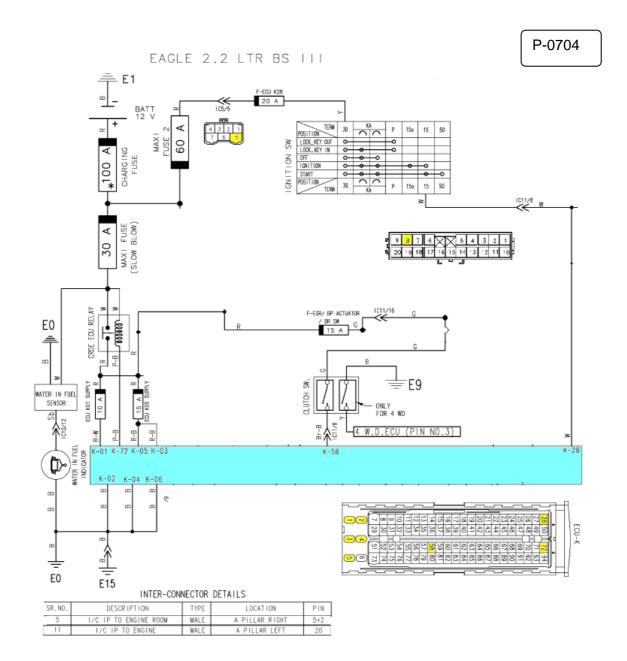
The clutch signal is acquired as a hardware signal. The signal is checked for plausibility using gear information. Error is detected, if there is a valid gear change without the clutch being pressed during the time that elapsed since the last gear change.

DTC detection condition	Probable cause
Normal Operation	
<ul> <li>* The clutch switch outputs a voltage, which corresponds to the clutch position.</li> <li>* The ECU checks whether this voltage is within a specified range (0 or 12V).</li> </ul>	<ul> <li>Open, shorted, loose or wrong connections of brake switch Wiring.</li> <li>Clutch switch failed or maladjusted.</li> </ul>
Normal Operating Requirements:	Clutch switch damage
* Ignition switch: ON	or faulty.
<ul> <li>* Malfunction lamp: OFF after 2 Sec</li> </ul>	
* Battery voltage is 8V –16V.	
Malfunction	
<ul> <li>* The sensor output voltage has continued to be 0V</li> </ul>	
in spite of clutch pedal being pressed/not pressed.	
* The sensor output voltage has continued to 12V in	
spite of clutch pedal being pressed/not pressed.	
Reaction:	
System lamp will be off.	
* Cruise control will not work.

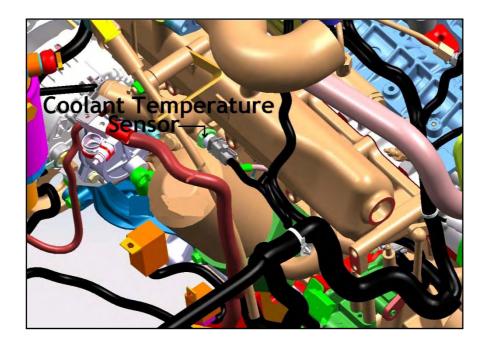
### **Coolant Temperature Sensor**

DTC detection condition	Probable cause	
Background		
* The engine coolant temperature sensor converts the engine coolant temperature to a voltage and outputs it.	* Open or shorted Engine Coolant Temperature	
* The ECU checks whether the voltage is within a specified range. In addition, it checks that the engine coolant temperature (signal) does not drop while the engine is warming up.	sensor circuit, or loose or wrong connection * Engine Coolant	
Malfunction; out-of-range	Temperature sensor failed.	
<ul> <li>Sensor output voltage has continued to be 5V or higher for 4 sec.</li> </ul>		
<ul> <li>Sensor output voltage has continued to be 0.1V or lower for 4 sec.</li> </ul>		
Reaction:		
System lamp will be on.		
Engine will continue to run with water		
temperature of 120 deg C.

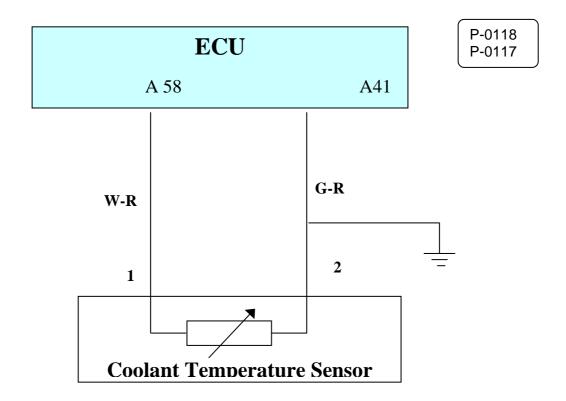
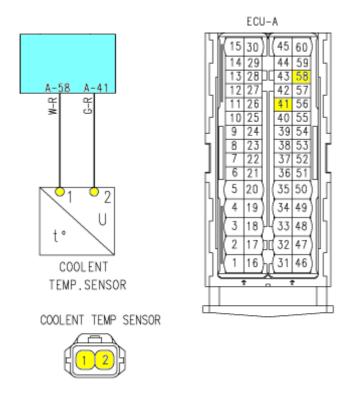
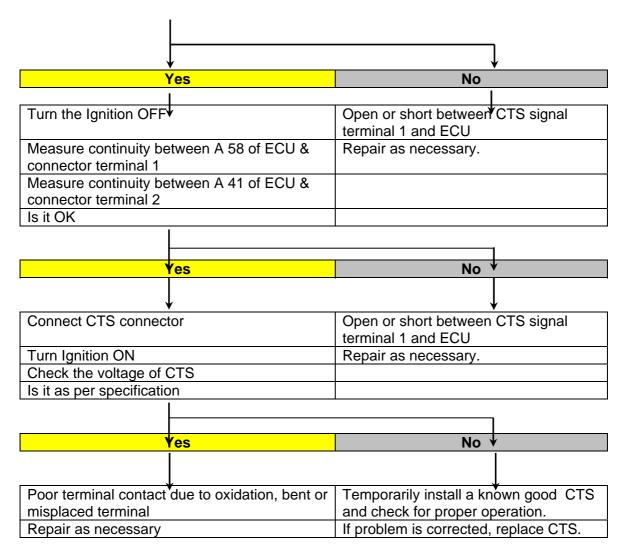
### <u>Test Procedure Coolant Temperature Sensor</u> --

P-0118 P-0117

- Verify DTC P0118 or P0117 are present.
- Turn the Ignition OFF
- Disconnect the CTS connector.
- Turn Ignition ON and check the voltage between 'CTS' signal terminal 1 and ground.
- It should be 5 V when Ignition ON
- Is it?

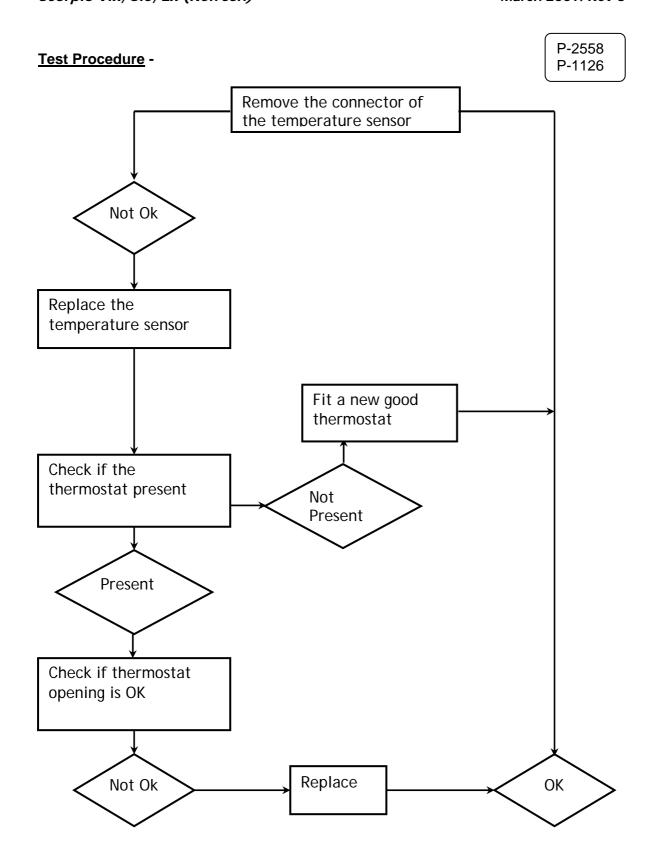
DTC detection condition	Probable cause
Proper Performance The coolant temperature rises to a specified temperature within a specific time period.  It also compares the rate of rise with a defined rate of rise	<ul> <li>Defective temperature sensor.</li> <li>Thermostat stuck in open condition</li> </ul>
Malfunction; out-of-range The coolant temperature do not rise enough within a specific time period,  • The coolant temperature do not reach a warmed-up fuel control temperature within a specific time period.	Thermostat removed.
Reaction System check lamp : OFF

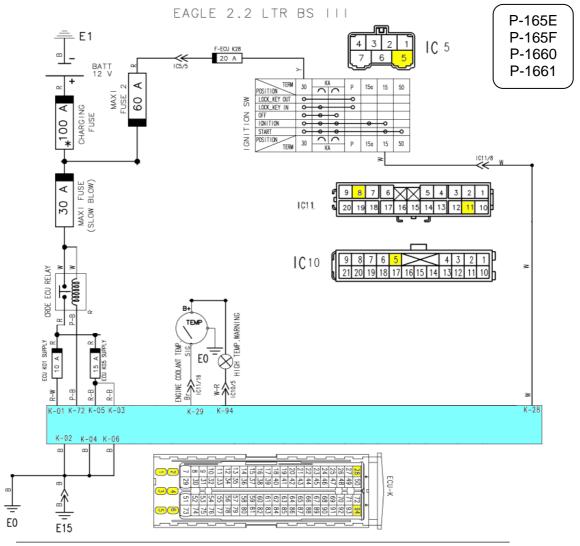
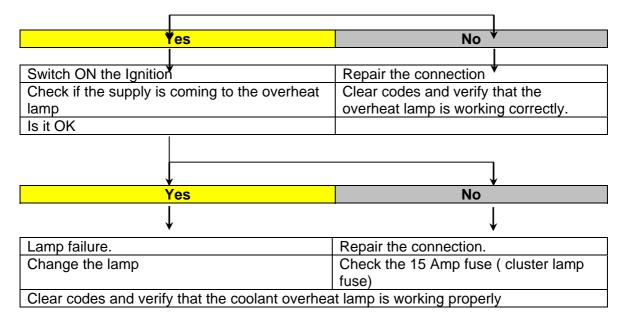
DTC detection condition	Probable cause
<ul> <li>Normal operation</li> <li>When ignition is ON coolant overheat lamp will be ON &amp; OFF after 2 sec.</li> <li>When coolant temperature crosses the set value lamp will glow.</li> <li>Malfunction</li> <li>Coolant overheat lamp will not respond, during the lamp test.</li> <li>Show wrong display.</li> </ul>	<ul> <li>Open short circuit to battery or ground.</li> <li>Wrong connection for coolant overheats lamp circuit.</li> </ul>

P-165E P-165F P-1660 P-1661

- Switch off the Ignition
- Check the connection to the coolant overheat lamp.
- Go to the Actuator Test # ACT 1. If the lamp is working as per the command then the lamp & connections are OK.
- If not working then:-
- Check the continuity between ECU terminal K94 with overheat lamp.
- Is it OK?

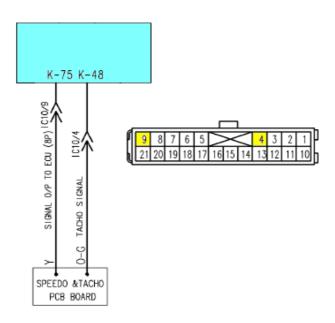
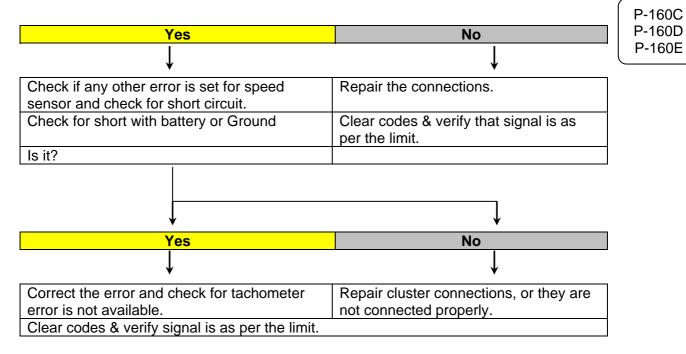
DTC detection condition	Probable cause
Normal operation	
<ul> <li>When ignition is ON system lamp will be switch OFF after 2sec.</li> </ul>	* Open, shorted or wrong connection
<ul> <li>When engine is running it will show corresponding</li> </ul>	of tachometer
engine speed on dash panel.	circuit.
Malfunction	
When engine is running it wouldn't show	
corresponding engine speed on dash panel.	
Reaction	
3. No impact on vehicle performance. Only engine	
speed indication on dash panel can not be seen.	
4. Cruise control will not work.

P-160C P-160D P-160E

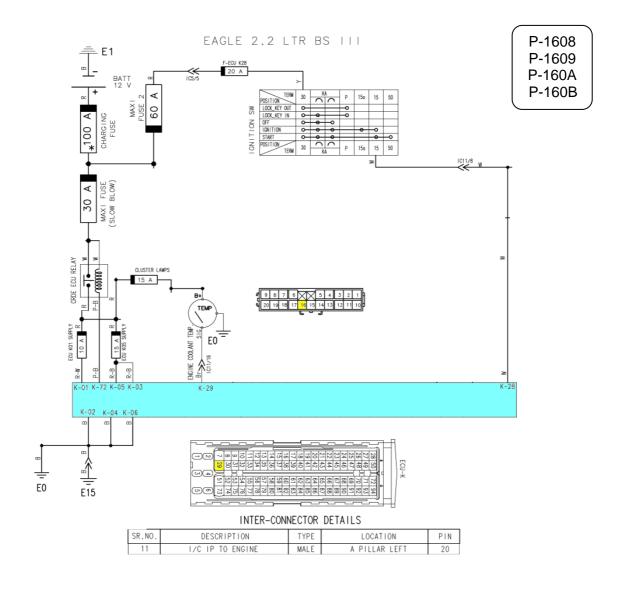
### Test Procedure Coolant temperature output --

DTC detection condition	Probable cause
	Normal Operation	<ul> <li>* Open or shorted</li> </ul>
*	The coolant temperature output voltage, which is	Engine Coolant
	given to the cluster from ECU as an output.	Temperature
*	The ECU checks whether this voltage is within a	output sensor
	specified range (0 or 5V).	circuit, or loose or
	,	wrong connection.
	Normal Operating Conditions	
*	Ignition switch: ON	
*	System lamp: OFF after 2 Sec	
	Malfunction	
•	No indication of water temperature on the instrument cluster.

- 1. Connect the 'Smart Tester' to diagnostic connector.
- 2. Turn Ignition Switch ON.
- 3. Verify that the either of the error codes P1608 or P1609 or P160A or P160B is present.

### MAN-00057-122 **Diagnostic Manual (EMS)** Scorpio VIx, Sle, Lx (Refresh) March 2009/Rev 3 P-1608 P-1609 P-160A P-160B Check the cluster lamp fuse Open or short between coolant temperature output & ECU K29 Check the temperature value in smart tester. Repair as necessary. Compare it with physical measurements. Check the output at K29 when Ignition is ON. Is it OK? Clear the error & verify. No ₩es Replace the instrument cluster. Clear codes & verify.

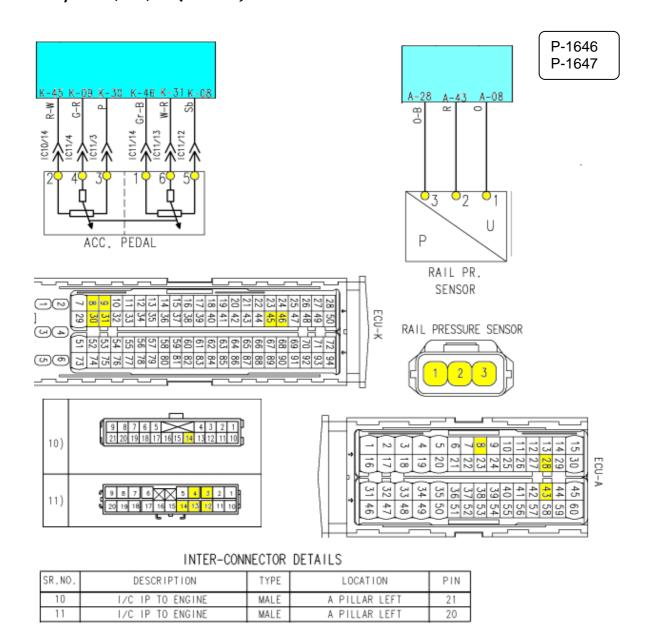
DTC detection condition	Probable cause
Normal Operation	
The ECU monitors the supply voltage to Rail pressure	
sensor, HFM and accelerator pedal (APP 2)	
Malfunction	
The voltages are beyond the range.	
Reactions	
Reactions	
System lamp status for this error is ON.

- 1. Connect the 'Smart Tester' to diagnostic connector.
- 2. Turn Ignition Switch ON.
- 3. Verify that either P-1646 or P-1647 is present.
- This is related to the rail pressure sensor, HFM and APP2 supply voltage.
- Check the connection of the rail pressure sensor, HFM & accelerator pedal connector.
- Is it OK?

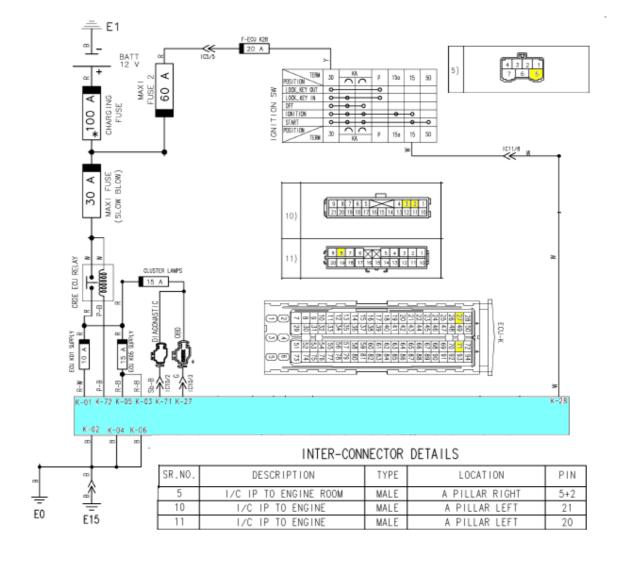
DTC detection condition	Probable cause
<ul> <li>Normal Operation</li> <li>When Ignition is switched ON the system lamp will glow ON for 2 sec.</li> <li>It will switch OFF if no error is set.</li> </ul>	Open, shorted or wrong connection of system lamp circuit.
<ul> <li>Malfunction</li> <li>When ignition is switched ON the system lamp does not glow ON.</li> </ul>

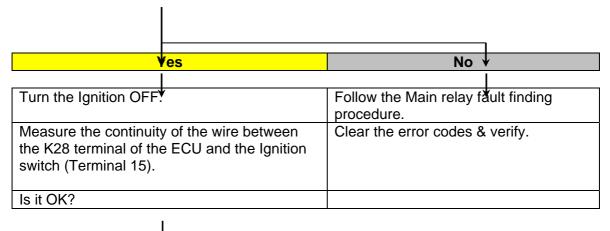
- Check that the main relay is getting energized.
- To check that the relay is getting energized, hear for the clicking sound from the main relay when the Ignition is switched ON.
- Is it OK?

<b>Y</b> es <b>Y</b> es	No *
Check for loose or intermittent connection.  Repair the connection	Repair the connection.  Clear the codes and verify that the vehicle is working perfectly.
Clear the codes and verify that the vehicle is working perfectly.

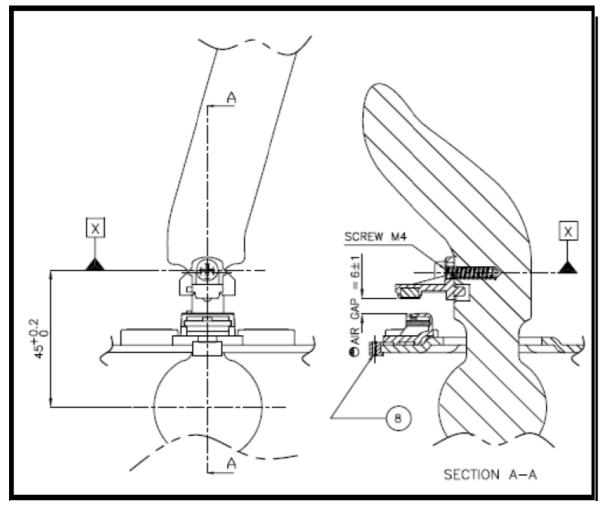
P-1704 P-168E

3 D and the installation view of the Gear Neutral Switch

DTC	Diagnostic item
P-1704	Gear Neutral signal is not plausible

DTC detection condition	Probable cause
Normal operation  The ECU monitors the vehicle speed and gear ratio.  During each gear change it monitors if the neutral is detected.	Gear Neutral Switch ( GNS)defective/wrong signal
Malfunction When ECU detects gear change but no neutral position then it takes it as an error Reaction * Check lamp does not glow, error is registered.	
* The Engine Start Stop system will not work	
* Gets healed if GNS status change (Neutral) is detected for 3 consecutive gear shifts in that particular driving cycle.

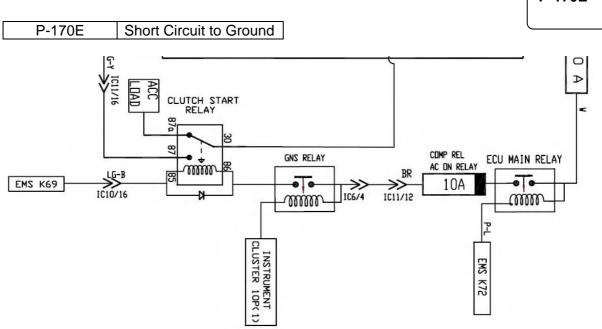
P-170E

P 170E is registered when any of the wires are short to ground- replice the wiring.

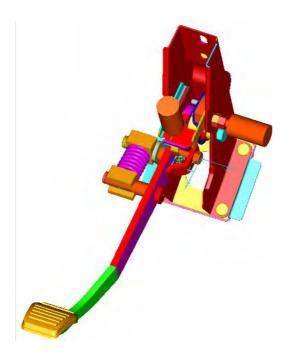
P-170A

**Redundant Clutch Switch**

Nut for removing the clutch switch

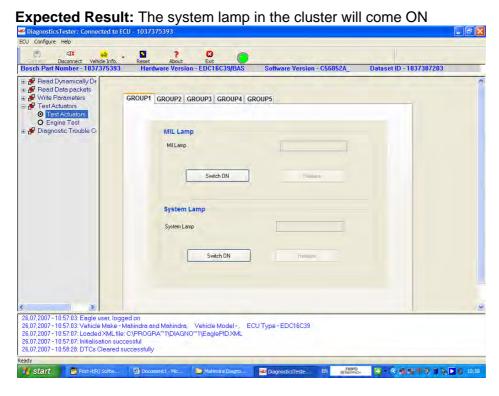
ACT#1

Test condition: Ignition ON

Actuate: Click on the System Lamp ON.

Click on the release to release the lamp

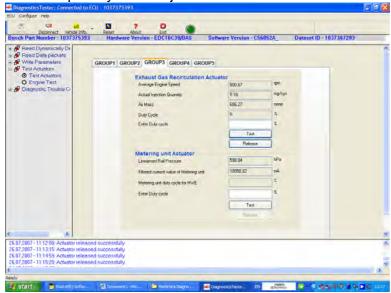
Note the quantity of the injection and the air mass.

Action: Put EGR quantity >80%. In the Enter duty cycle. Actuate

**Expected result:** The actual duty cycle will change.

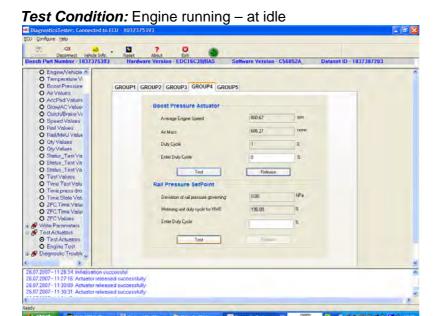
ACT#5

#### **ACT #5– Boost Pressure Actuator (BPA) Test**

Enter duty cycle – between 0 to 100%. Click on Test

Expected result: There is a change in Engine RPM and also the air mass quantity changes. The engine noise change is also clearly audible

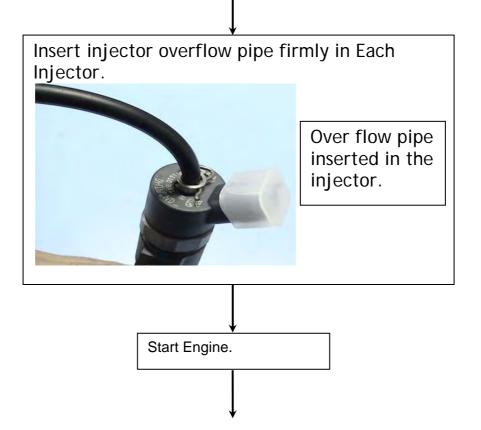
Remove injector overflow connections from all the four injectors.

Do not remove overflow tube connection from the fuel return line 'T' joint

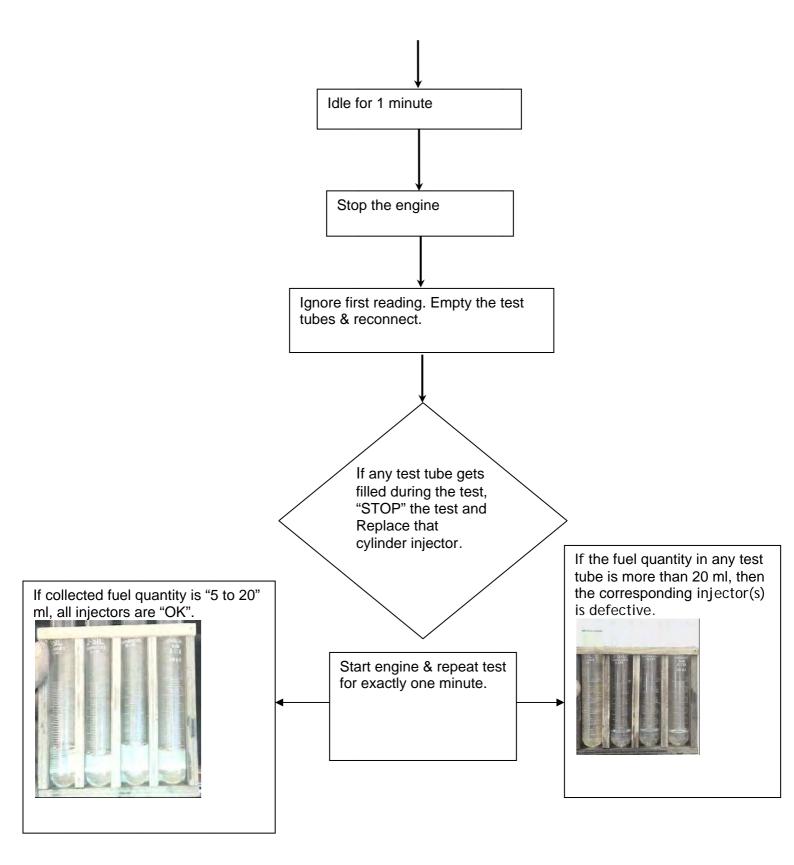
Insert the pipes open end in to the test tubes as shown in photograph).

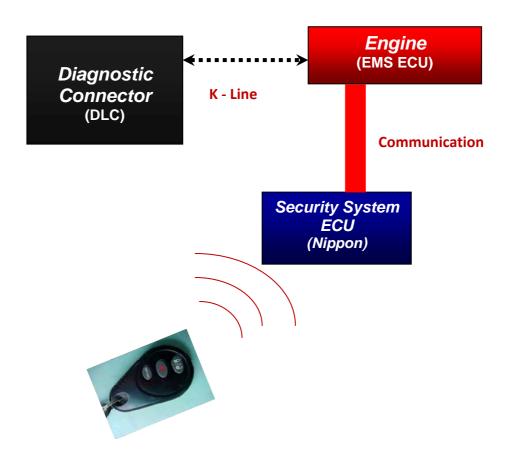
# Overview of the in-vehicle communication network-with analog Immobilizer

### Note on Function of Analog based immobilizer -

- 1. In the Analog immobilizer, the immobilizer function will become active, only if the vehicle is locked using the remote.
- 2. Using the mechanical key to lock the vehicle will not activate the immobilizer function.
- 3. The customer should be educated to change the PIN code of the immobilizer unit (Refer to relevant TSB)

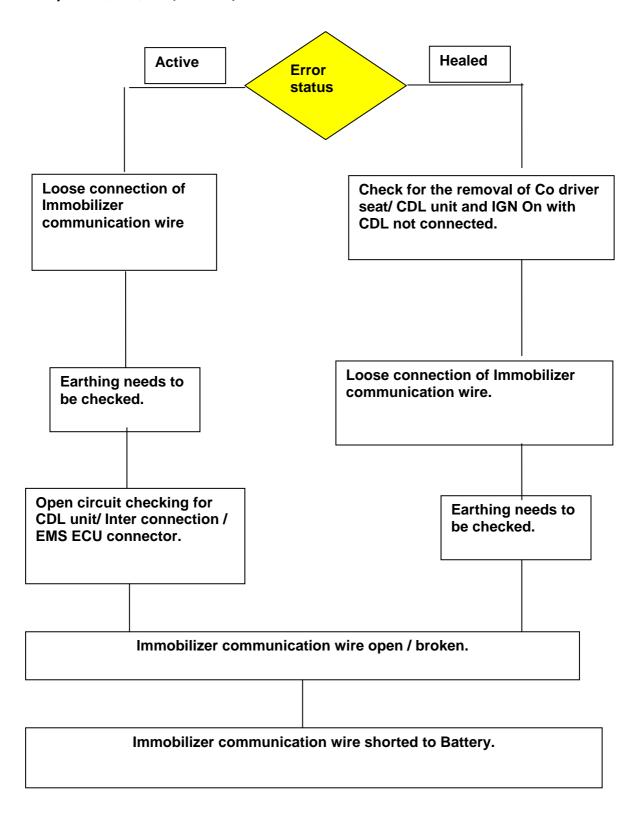
#### Checking the earthing:

Main earth near the battery on the LH fender. Check for the star washer's presence.
